**Fish Passage Assessment of Culverted Road Crossings  
in King Salmon, Naknek, and Dillingham: 2012-2013**

**Gillian O'Doherty**

December 2014

Alaska Department of Fish and Game

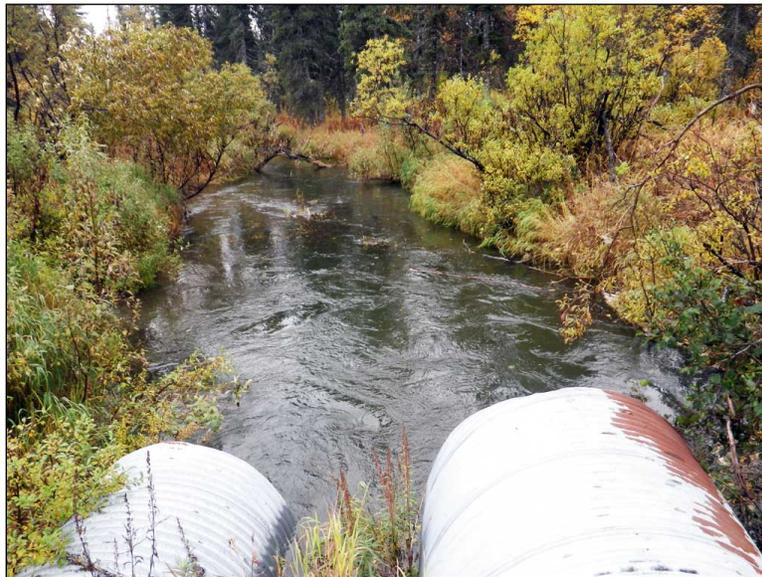
Site #30303067 and Site #30303068 are both located on unnamed creeks on Snake Lake Road. Both of these crossings consist of undersized culverts with high water velocities and associated scour and channel impacts. Site #30303068 is on AWC stream 325-20-10030-2024-3100, and is cataloged for coho salmon rearing. Site #30303067 is on a large unmapped stream that appears to be a tributary to AWC stream 325-20-10030-2024-3100.

Figure 8.—Site #30303067 showing undersized culverts on a tributary to the Snake River, Dillingham.

Four high-priority sites were identified in Dillingham based on the severity of the barrier and the amount of potential fish habitat. Other Red and Gray culverts are located on small systems with limited habitat and potential for anadromy. Road ownership is both state and local.

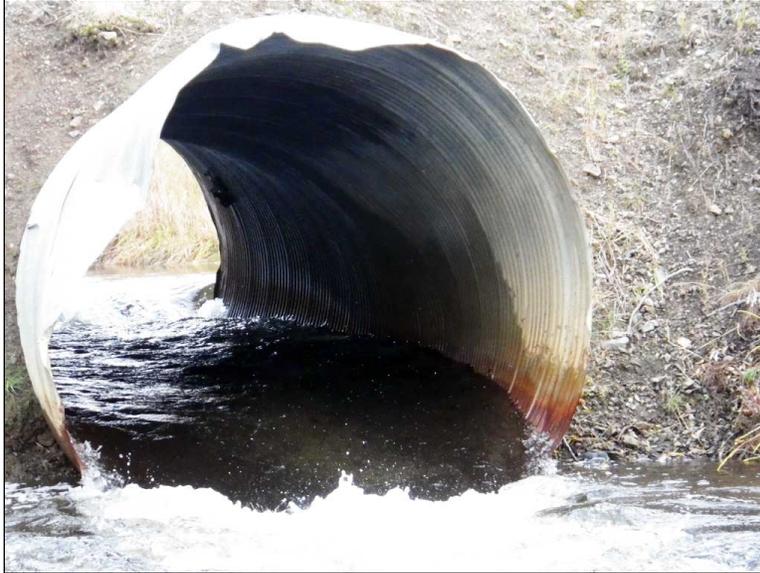
Figure 9.–Site #30303068, an undersized culvert on an unnamed Snake River tributary, Dillingham.

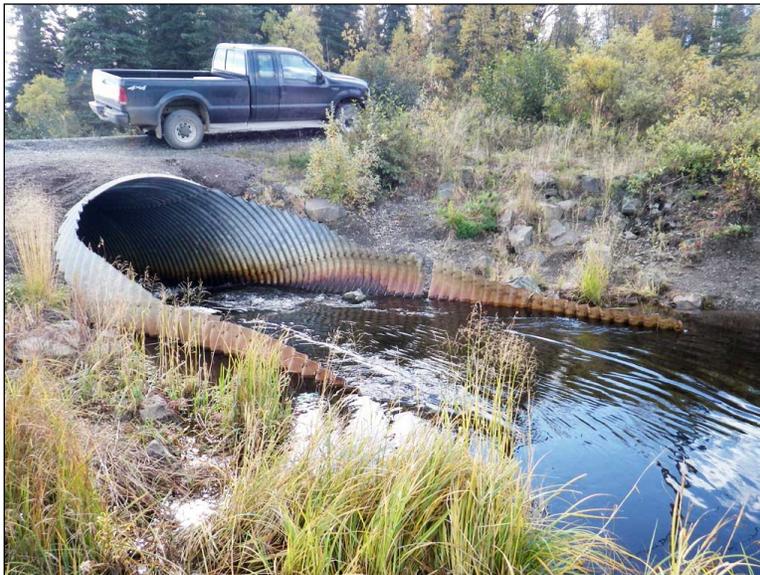
Site #30303073 is Squaw Creek at Lupine Drive. Squaw Creek is catalogued to support Chinook, coho, pink, chum and Sockeye salmon. This culvert was installed in 1999 as part of a United State Fish and Wildlife Service (USFWS) funded fish passage project but has been damaged by frost heave. It is almost certainly a total barrier to juvenile fish and is a partial barrier to adult fish.

Figure 10.–Site #30303073 Squaw Creek at Lupine Road, Dillingham showing frost heave that has raised the inlet of the culvert several feet causing ponding upstream and a fish passage barrier inside the culvert.

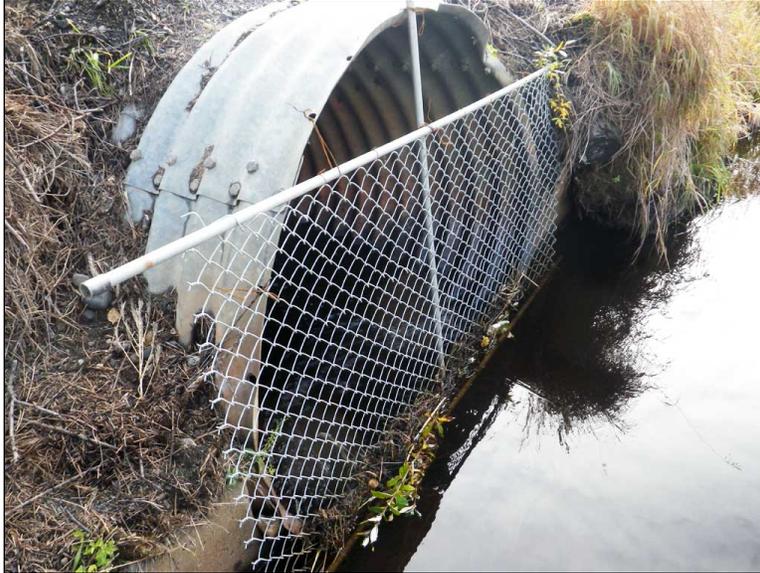
Site #30303078 is the South Fork of Squaw Creek at Aleknagik Lake Road. At the time of survey this culvert was blocked by a chain-link fence, presumably to prevent beavers blocking the culvert.

Figure 11.—Site #30303078 showing a chainlink fence preventing fish passage on the South Fork of Squaw Creek, Dillingham.

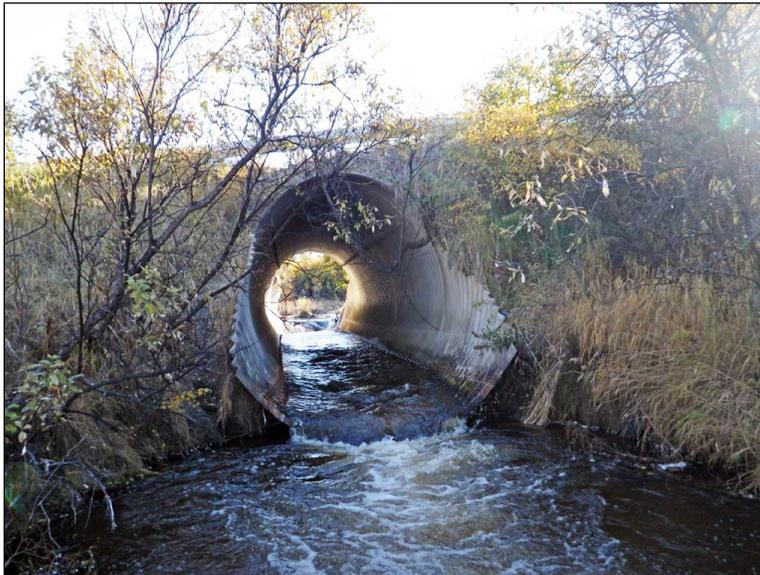
A single high-priority project was identified in King Salmon. Site #30203269 is Eskimo Creek at the Alaska Peninsula Highway. This pipe is undersized and perched. This was the sole barrier on a stream of any significant size located in the King Salmon-Nakenk area. There are believed to be culverts on military land, but crews were not able to access them for assessment.

Figure 12.—Site #30203269 Eskimo Creek and the Alaska Peninsula Highway, King Salmon.
