Fish Passage Assessment and Prioritization of Culverts in Gustavus, Haines, Juneau, Skagway, and Sitka, 2011–2012

May 2020

Alaska Department of Fish and Game

FISHERY DATA SERIES NO. 20-12

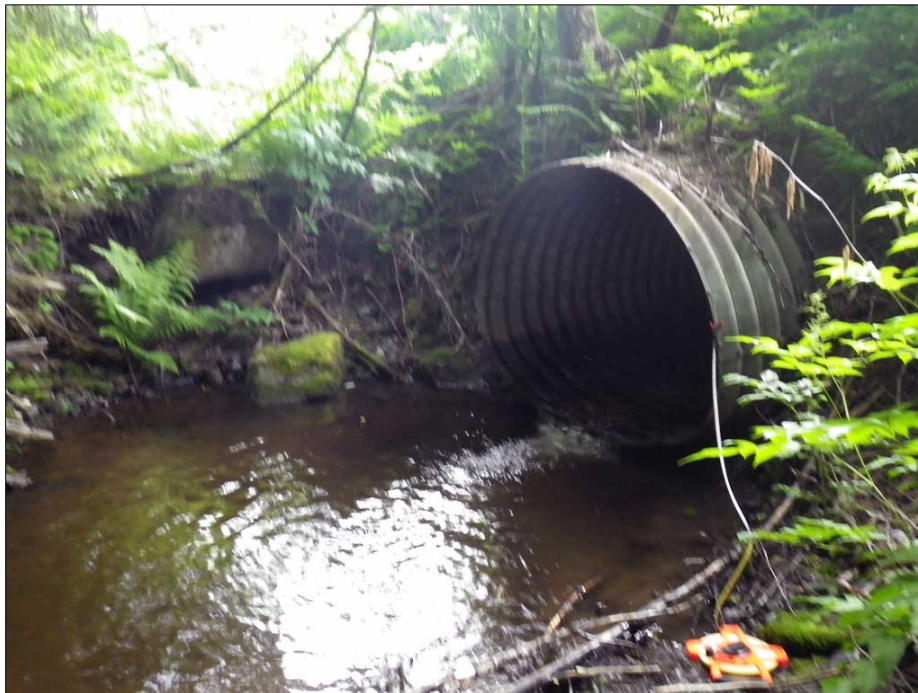
Figure 25.—Site #10302165 culvert on Hendrickson Creek on the North Douglas Highway. Culvert is a gradient barrier and has a Gray constriction ration and outfall height. Creek is cataloged for coho and pink salmon, Dolly Varden, and cutthroat trout.
