KENAI RIVERBANK EROSION STUDY

by
Lowell S. Barrick
Number 41

Alaska Department of Fish & Game
Division of Fisheries Rehabilitation,
Enhancement and Development

July, 1984

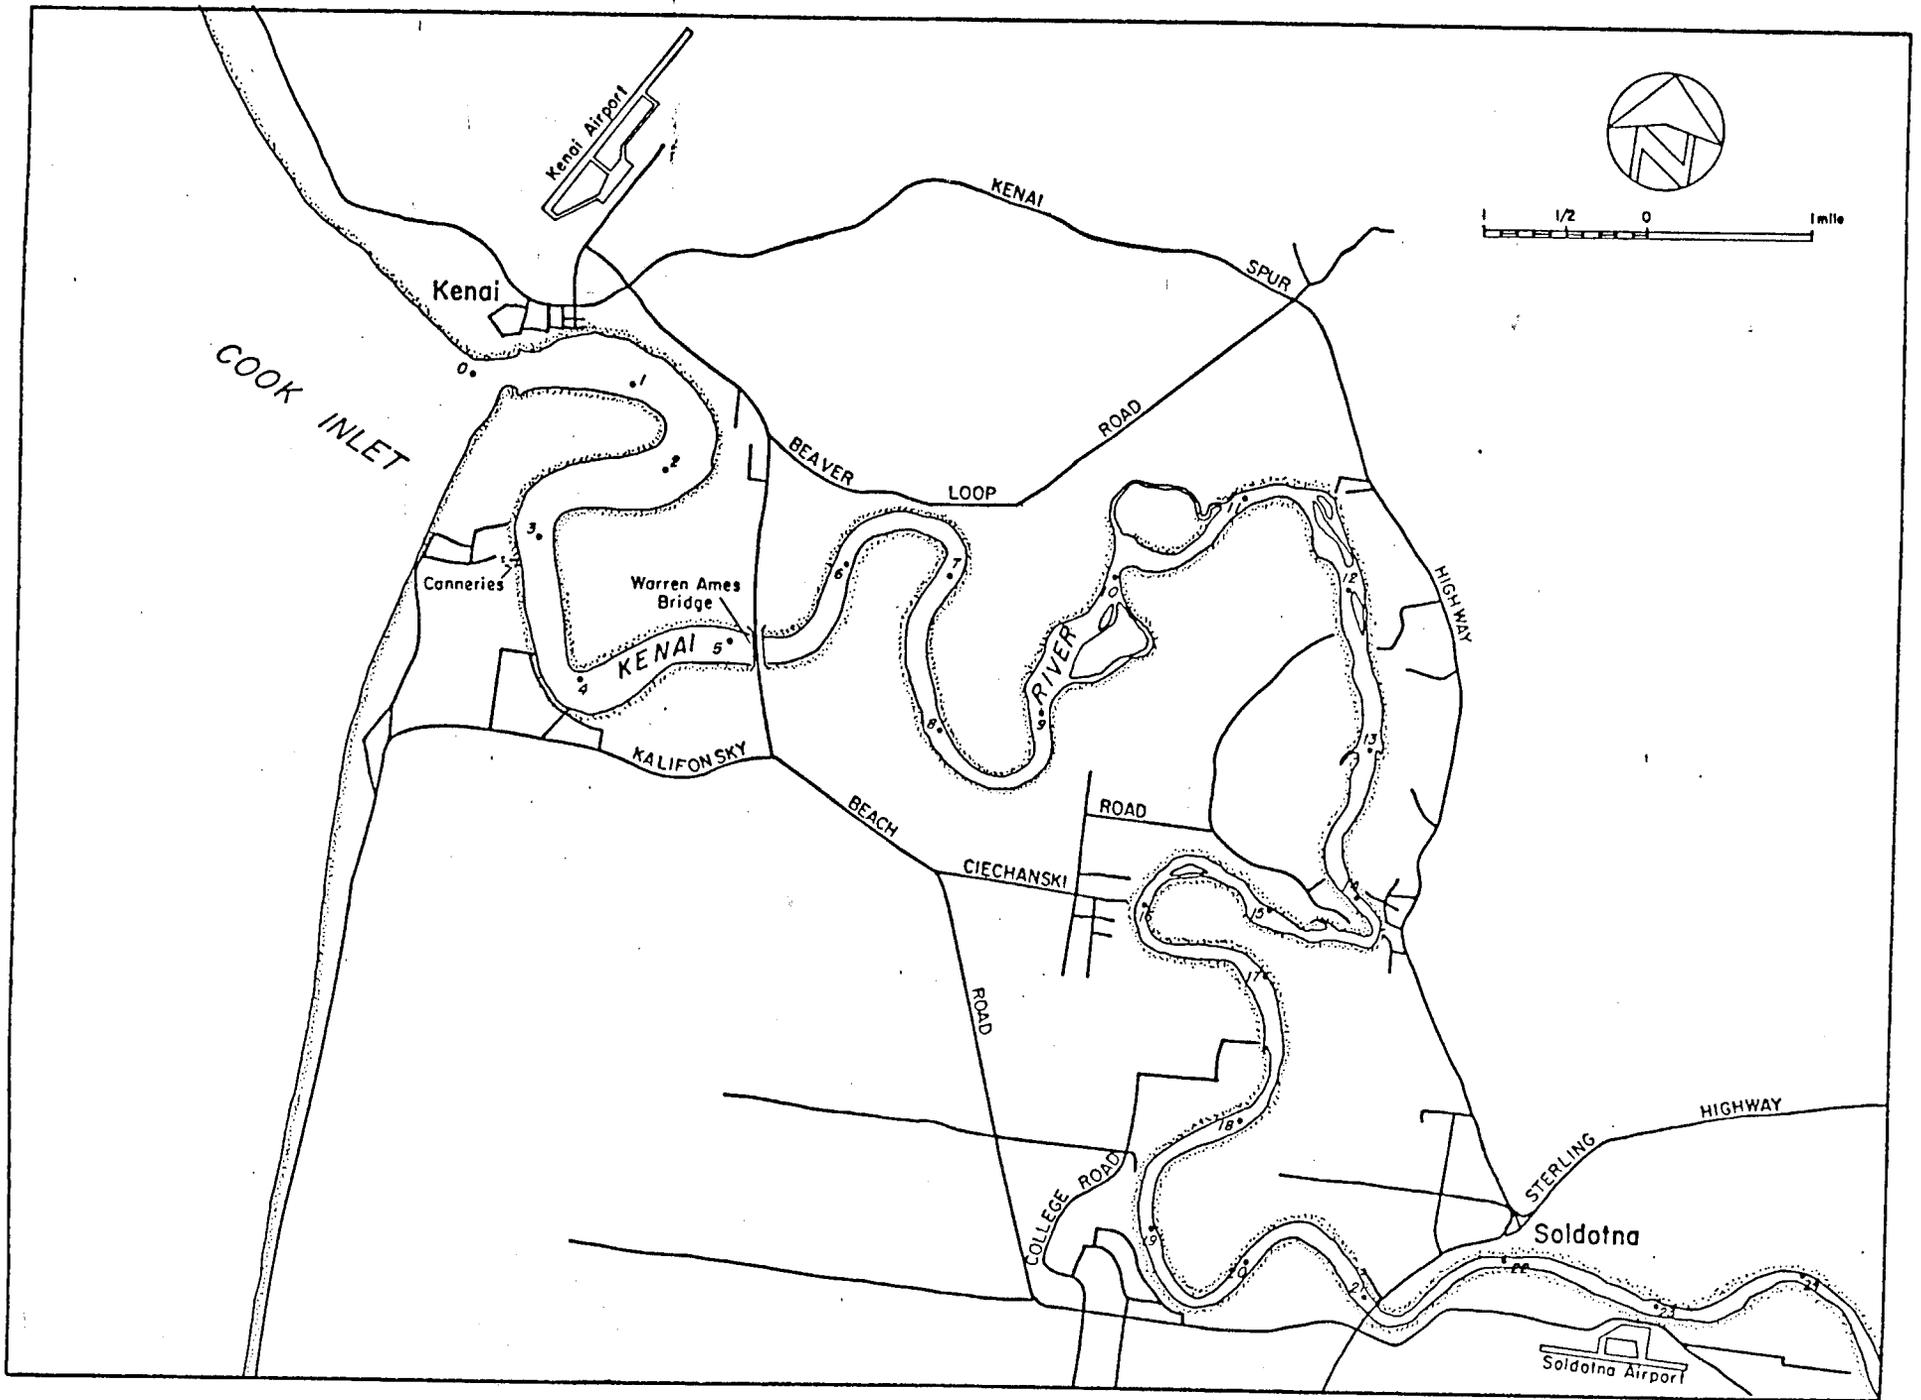
Figure 1. Kenai River from river mile 0 to 22.

Commercial and residential development does not appear to have had a major impact on the river below RM 12. There is commercial development associated with the City of Kenai along the right bank of the river from RM 0 to 1.5. Cannery docks and wharfs are on the left bank near RM 3, and residential development is underway on the left bank bluff near RM 4. The Warren Ames Bridge (RM 5.1) and the associated roadway embankment have created some alteration of the riverbanks and wetlands in that area. There is a pioneer

trail for boat launching on the right bank at Cunningham Park (RM 6.5), and there are indications of residential development underway along Beaver Creek with boats entering the Kenai River from a slough channel at RM 10.2. The 10-mile river segment from RM 12 to 22 is, however, undergoing rapid change from both residential and commercial development. Many of the sites were large, extending several hundred feet along the river bank. Some private and commercial property owners have had portions of the riverbank excavated to provide boat canal access to the river. These canals lead to individual houses, trailers, and campsites and are used as mooring sites for numerous boats. One new development on the right bank at RM 21, immediately downstream of the Soldotna Bridge, is a vivid example of how riverfront development should not be conducted as soil fill has been dozed over a high bank (15' to 20'). The new embankment has covered the natural vegetation, killing it, and the fill is sloughing into the river. The new embankment will start eroding away with the first high water, and the property owner will probably seek a COE permit to riprap his riverfront property to protect it.

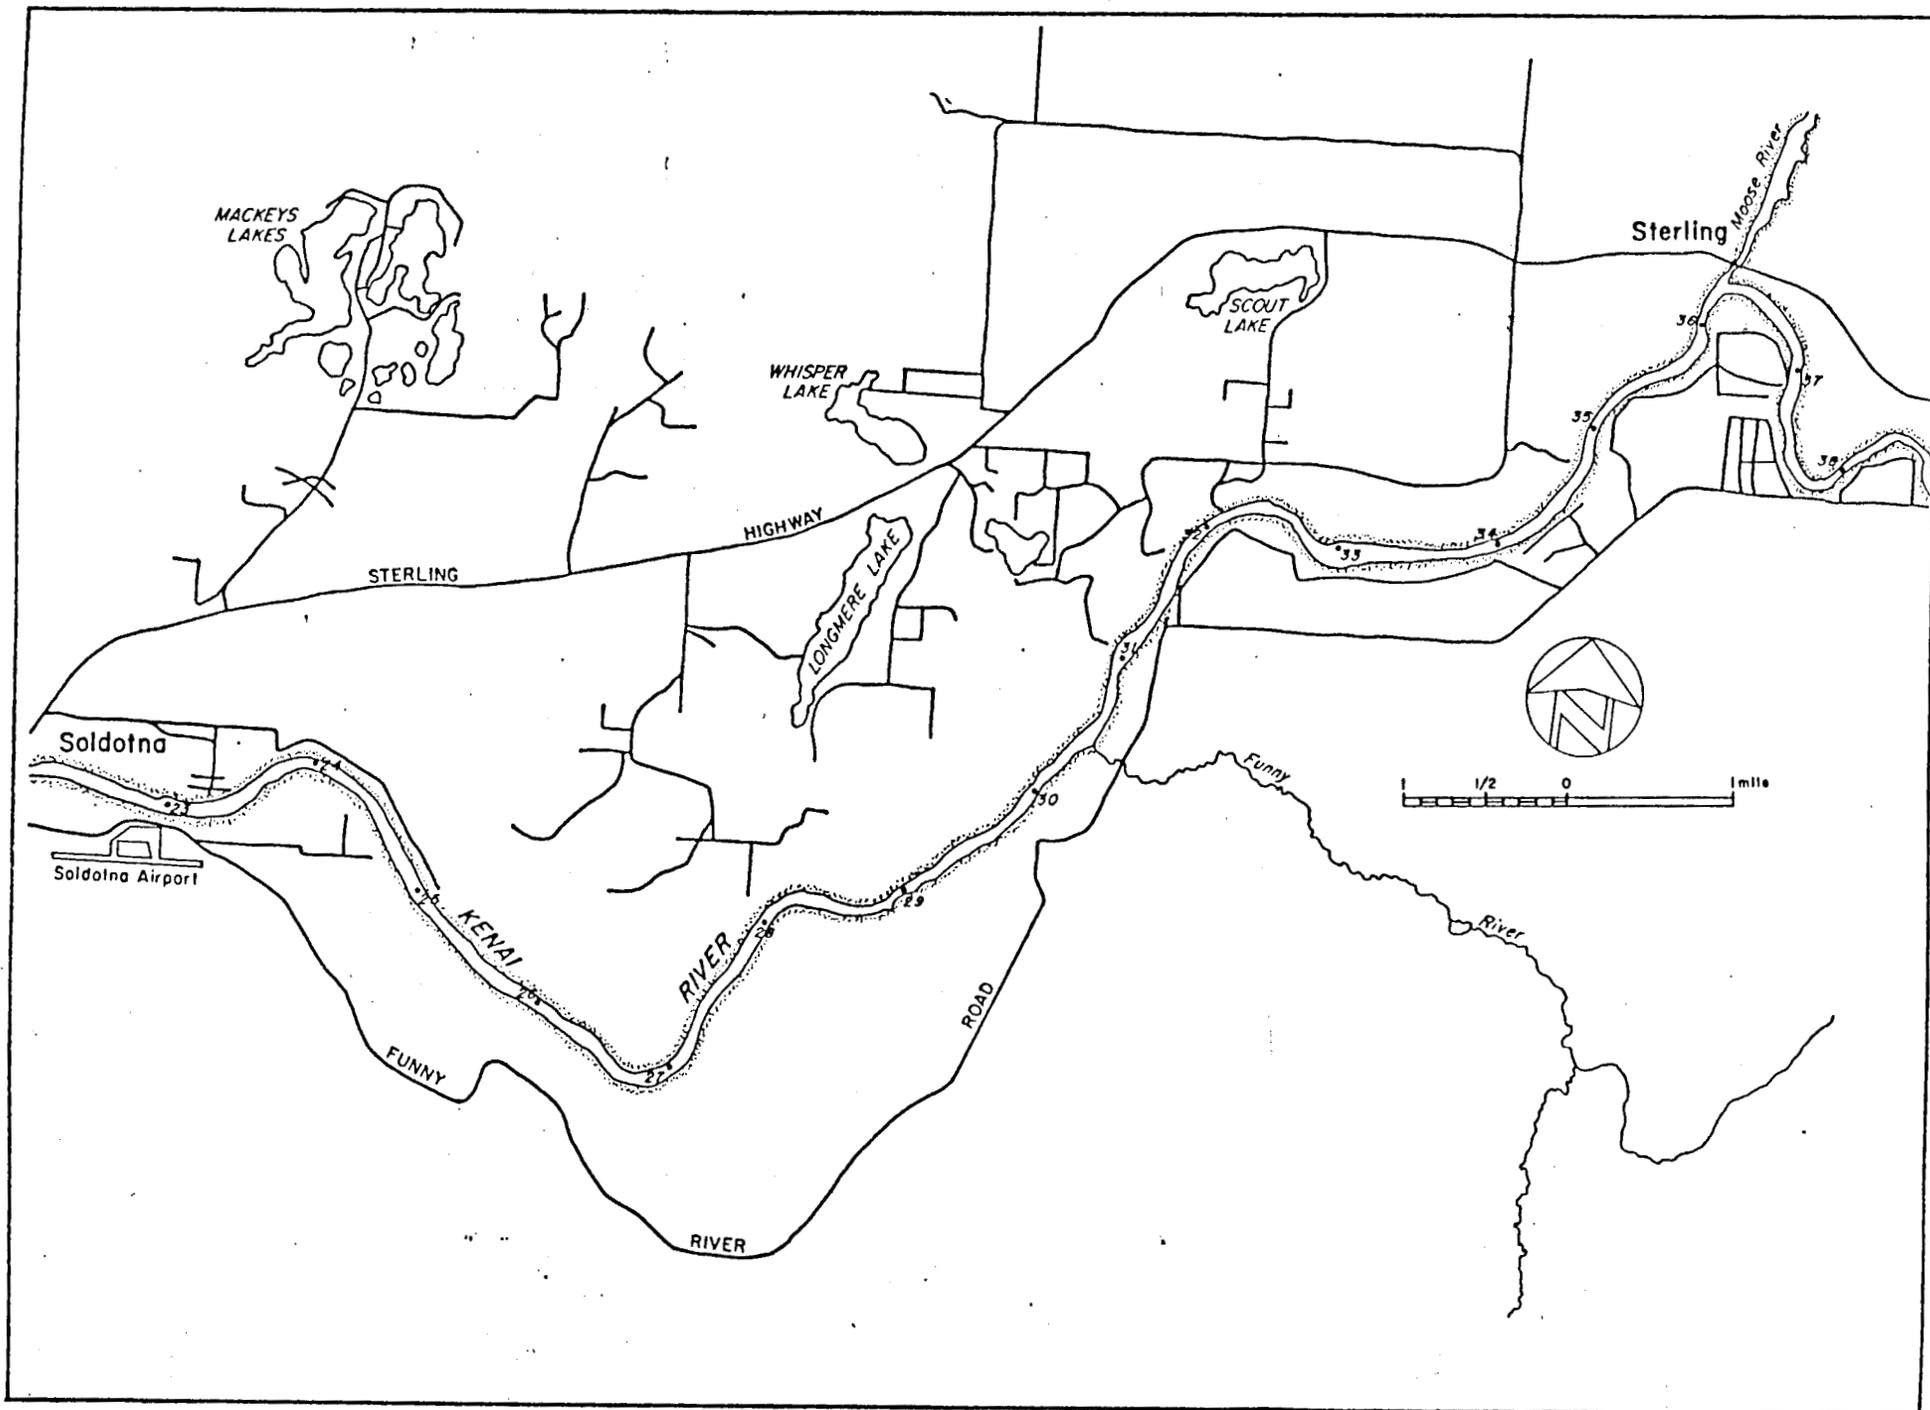
Figure 2. Kenai River from river mile 22 to 37.

Most of the riverfront developments in this area are single-family residences with a few of the houses showing signs of commercialism, e.g., "bait for sale" or "food and drinks" signs. An example of poor riverfront development is the DOT&PF equipment yard located on the right bank near RM 22. At

this location, stockpiled gravel is sloughing off the embankment and into the river. Brushed property lines and ROW clearing for utility lines indicate that considerably more development is pending.

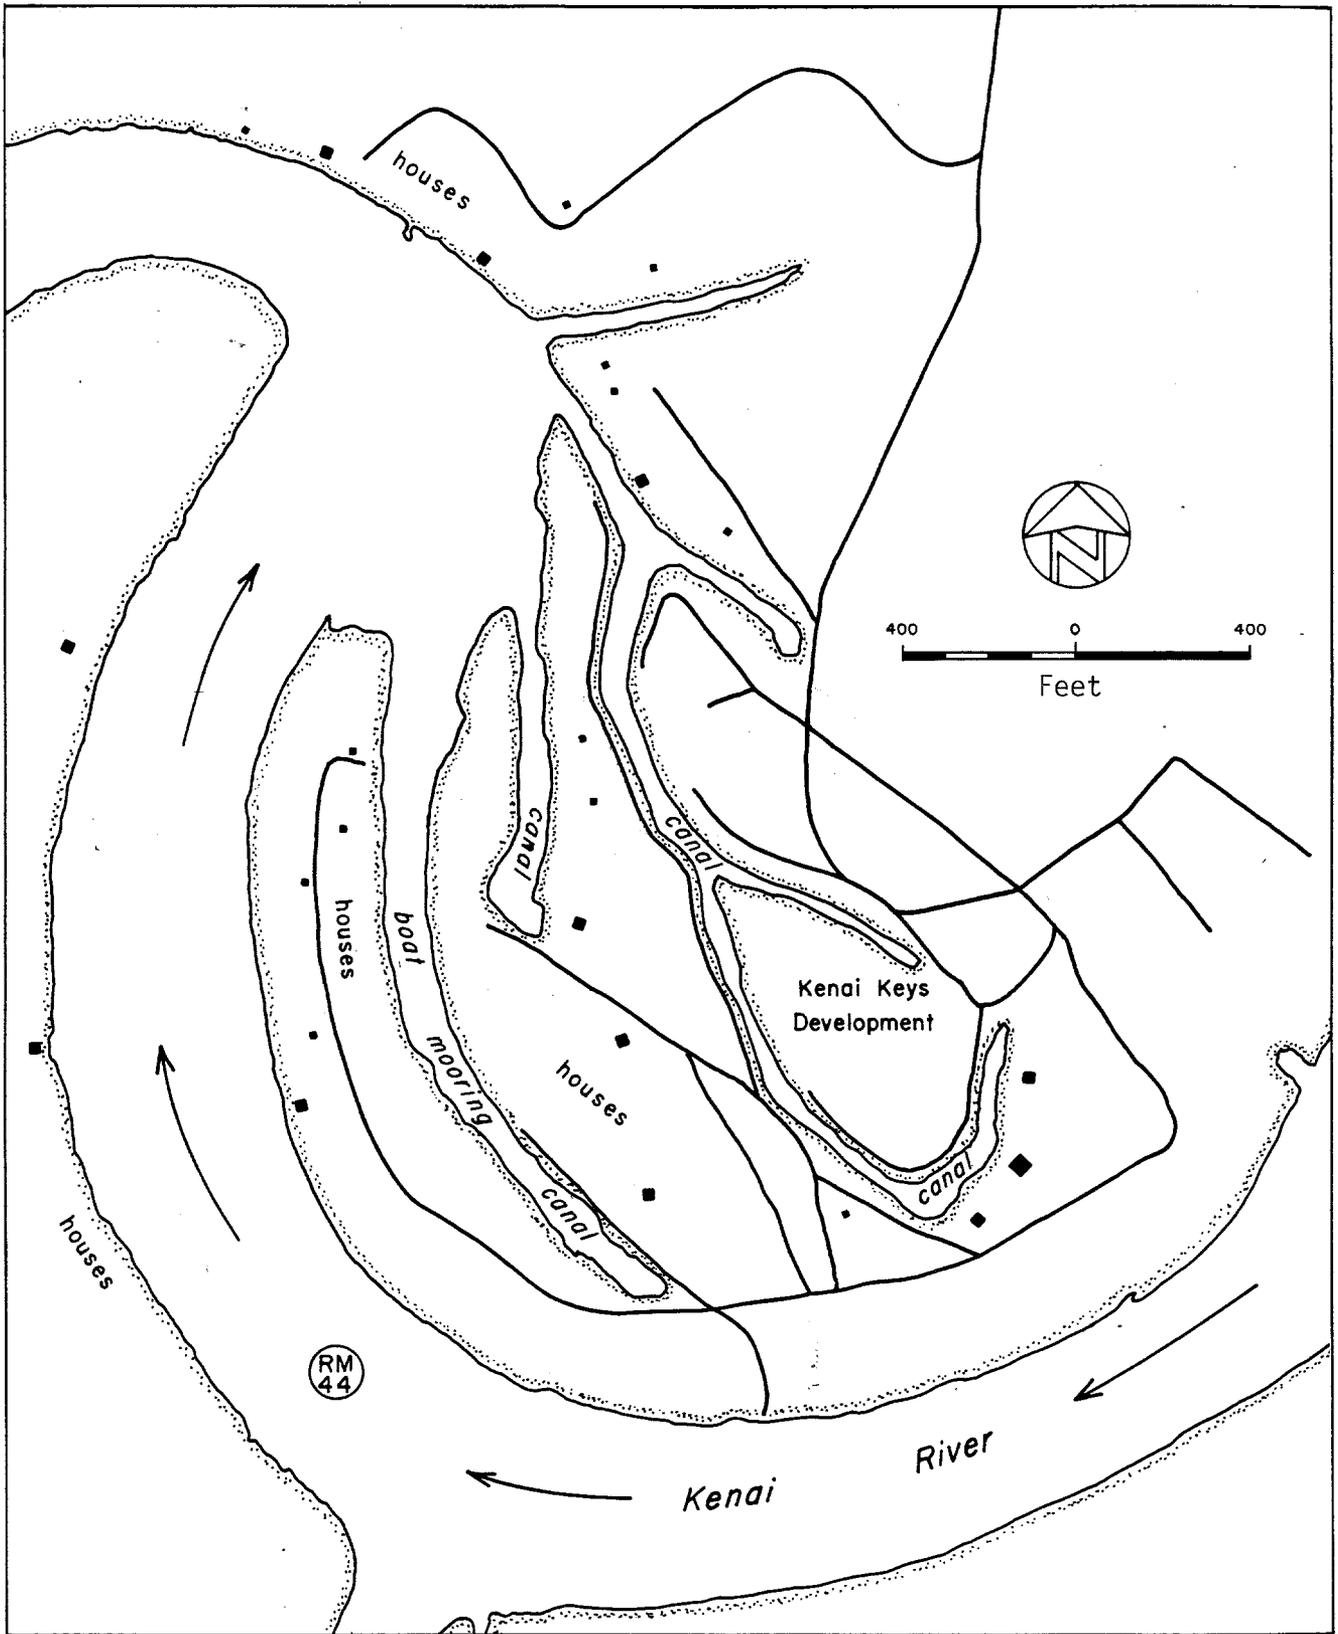
Figure 5. Kenai Keys (river mile 44).

A major commercial, residential, and recreational site has been developed at RM 44 in an area that is known as "Kenai Keys" (Figure 5). Here, numerous access canals, leading to charter businesses and residences, have been

excavated in the right bank. The canals provide river access and moorage for a large number of boats. Although the canals provide convenient boat storage and access, they also present a threat to the stability of the river. According to data depicted in the ADNR Kenai River State Park Units Master Plan (1983), these canals lie in the 100-year flood plain. In the event of a flood, there is a good chance that the river will cut through the meander and into the canals. An entirely new river channel could be formed. This same potential for river channel diversion holds true for other canal systems that have been developed on downstream properties.
