Repair of the Lower Diversion Weir at Frazer Lake, 2003

Regional Information Report<sup>1</sup> No. 4K03-48

Alaska Department of Fish and Game  
Division of Commercial Fisheries  
211 Mission Road  
Kodiak, Alaska 99615

September 2003

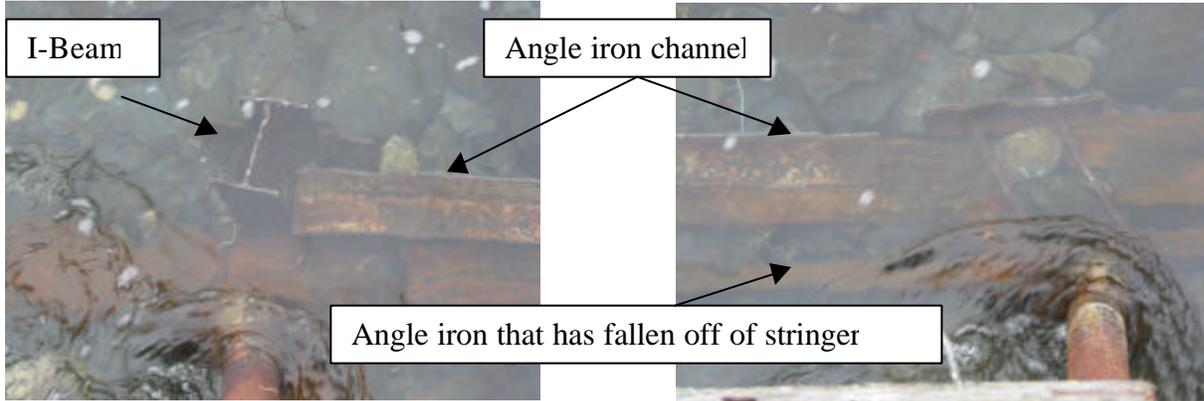
**Diversion Weir.** Weather, brown bears, and time have taken their toll on the diversion weir. The front stringer was still in good shape; however, most of the angle iron that held the weir panels had fallen off the front stringer by 2002 (Figure 8).

Figure 8. Pictures of angle iron used to hold the bottom of the weir panels, Frazer Lake, 2001.

The angle iron was still useable, but the bolts that held the angle iron to the stringer were rusted. Without the angle iron, it was very difficult to keep the weir fish tight. The upper stringer, connecting the bipods, was rotted in many places, weakening the lateral support for the weir (Figure 9).

Angle iron was re-fastened to the front stringer using lag bolts (Figure 19).

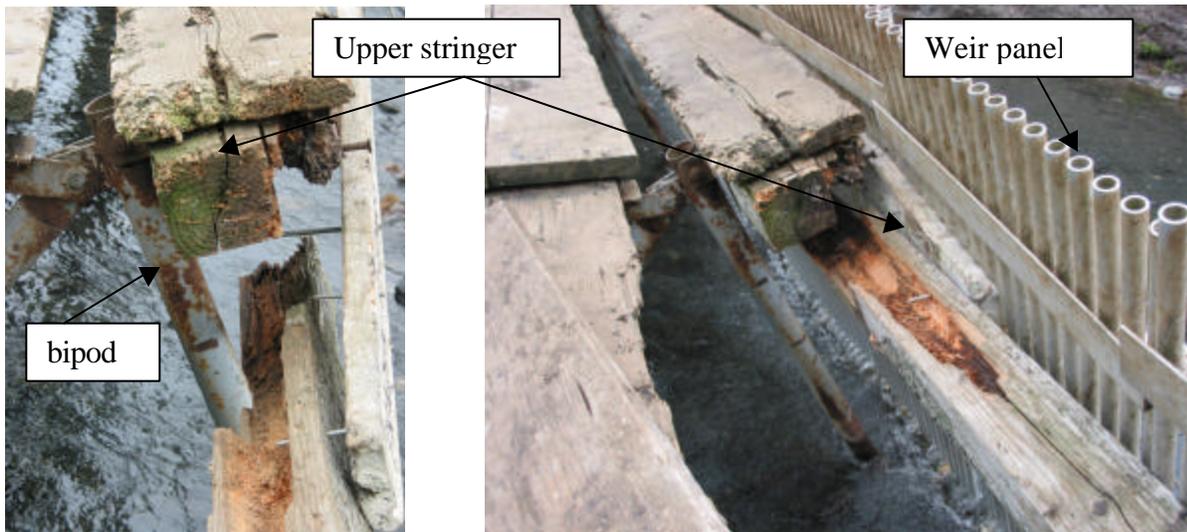
Figure 9. Broken pieces on upper stringer on lower diversion weir, Frazer Lake, 2001.

Figure 18. New aluminum tube replacing the wood on the diversion weir, Frazer Lake, 2003.

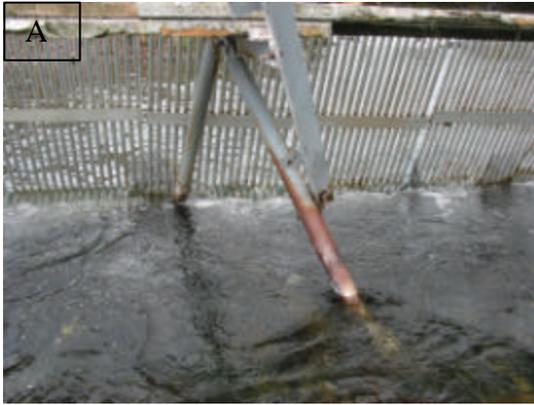
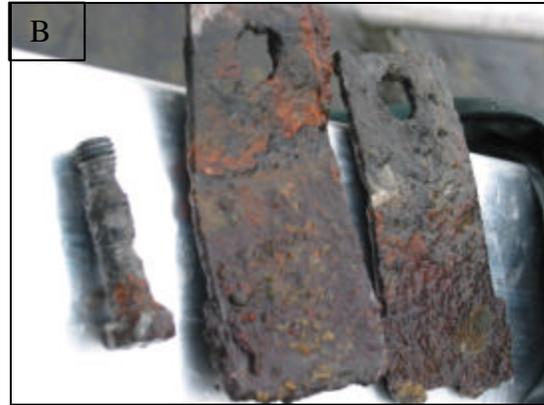
Many of the bipods were bent making the entire weir out of alignment, and many of the bolts connecting the pieces of bipod together were heavily rusted (Figure 10).

Figure 10. Upstream view of weir bipod showing the bent back leg, Frazer Lake, 2001 (A) and rusted bolt and brackets removed from the bipod, Frazer Lake, 2003 during the remodel (B).

Bolts were disconnected underwater and bipods were realigned (Figure 17). The bipods were placed in 10-foot intervals; although, some bipods were spaced slightly more than 10 feet and others were spaced slightly less than 10 feet due to the I-beam placement. Replacing the upper stringer with aluminum required that bipods be placed exactly 10-feet apart in order to connect them to the c-brackets (Figure 18). All-thread (5/8" zinc plated) was used to attach the aluminum tube to the brackets.

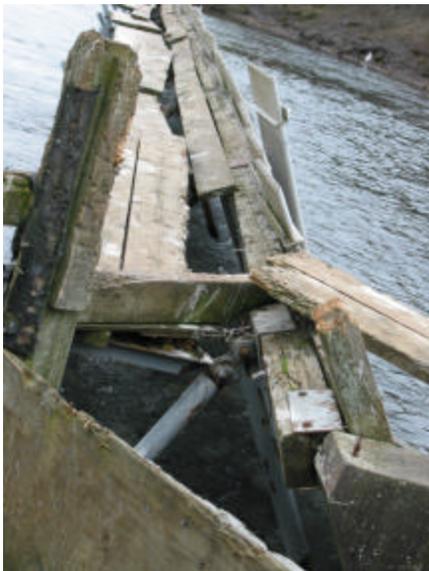
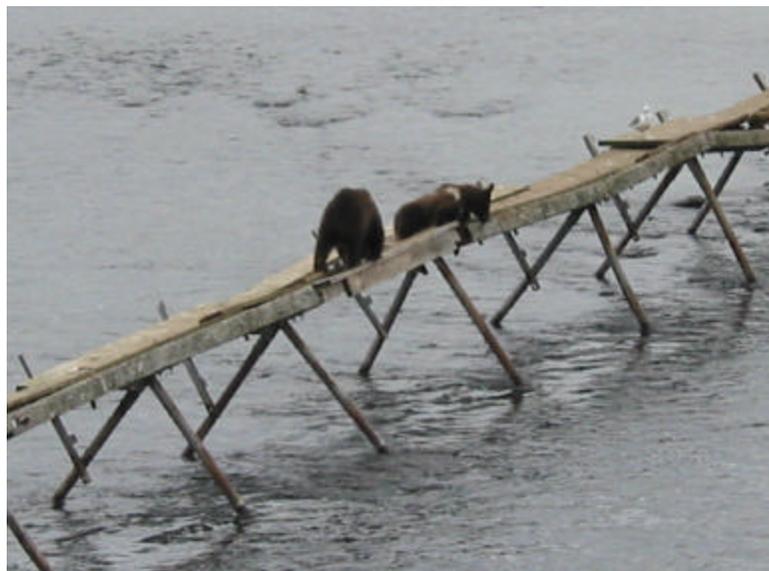
**Catwalk.** The catwalk was made of 2"x12" rough cut planks and was heavily abused by weather and bears (Figure 11). While the catwalk provided very little structural support to the weir, it was important to the operation of the fish pass because it allowed the crew to inspect the weir for gaps. The damaged planks were also a safety issue because the crew could have easily broken a plank and fallen into the stream.

Figure 11. Frazer Lake catwalk, 2001.

The catwalk was replaced with galvanized steel Grip-strut®. Grip-strut® was mounted on top of 4"x4" rough cut spruce (Figure 21). The Grip-strut® was fastened to the 4x4s with 6" lag bolts. A stairway was also built on the edge of the entrance tank to access the catwalk.

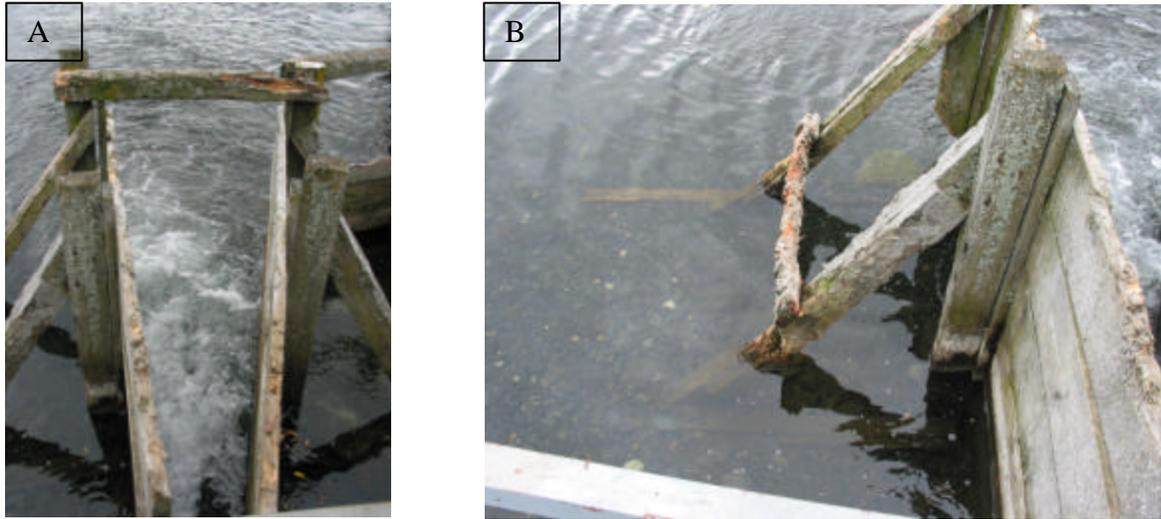
dropout rate (Blackett 1987). These chutes were heavily abused by the weather and bears (Figure 12).

Figure 12. Chute to the Frazer Lake fish pass (A) and braces for the chute (B), 2001.

The wooden fish pass chute was replaced with 3/8" aluminum. The new chute has a notched bottom that fits in the groove created by the entrance tank (Figure 22). The old chute was eight feet long and the new chute is 10 feet long. A hinged lid was added that tapers down toward the water line to prevent bears from blocking the entrance (Figure 23). The hinge allows the crew to access the chute to clean or make repairs.

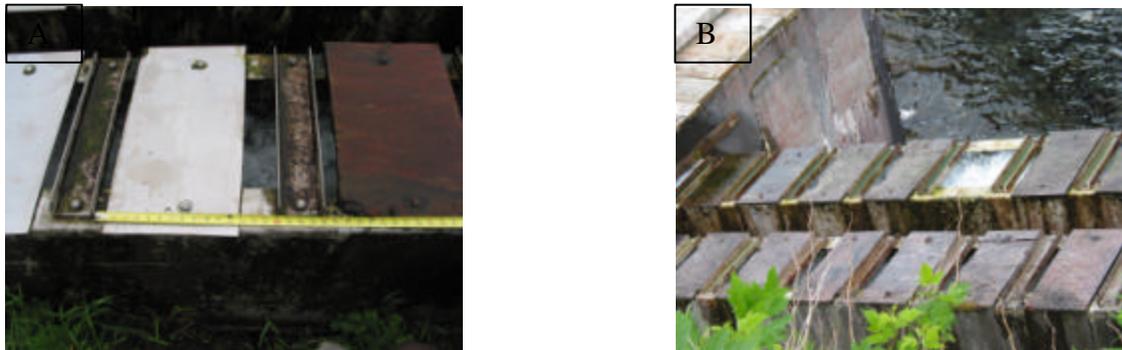
**Fish Pass Covers.** The bottom and sides of the fish pass were made of aluminum (Blackett 1987). The top of the fish pass had aluminum cross braces spaced approximately every 16 cm. Between these braces the fish pass was open. Openings were covered with plywood to prevent fish from falling out and to allow personnel to walk up the fish pass. Many of the plywood covers had rotted or were broken by bears (Figure 13). Some of the openings were already replaced by aluminum; however, many more covers needed to be replaced.

Figure 13. Aluminum and plywood fish pass covers (A), and missing plywood cover (B), Frazer Lake fish pass, 2001.

New fish pass covers were made out of 3/8" aluminum. New covers were made for the operational fish pass where they were missing.

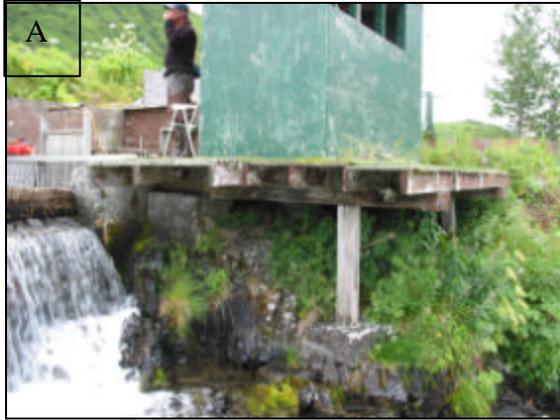
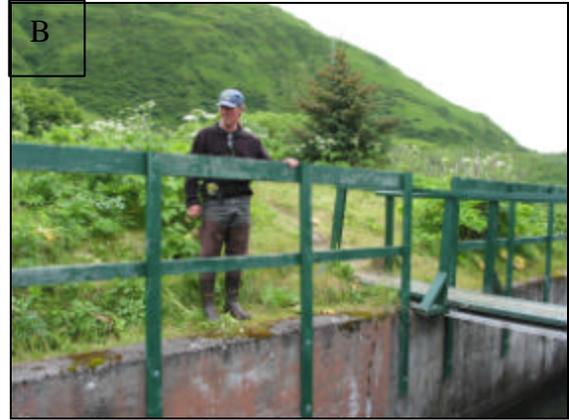
**Sample Platform and Walkway.** Fish were sampled at the top of the fish pass on a wooden sample platform. The sample platform, made of dimensional lumber and plywood, was rotting, creating safety problems (Figure 14). The walkway to the sample platform crossed over the upper holding tank. This walkway was rotten and was also a safety issue.

Figure 14. Sample platform (A) and walkway across the upper holding tank (B), Frazer Lake, 2001.

The wood from the old sampling platform and walkway were rotten. The new sampling platform and walkway were made from treated (AWWF) wood (Figure 24).

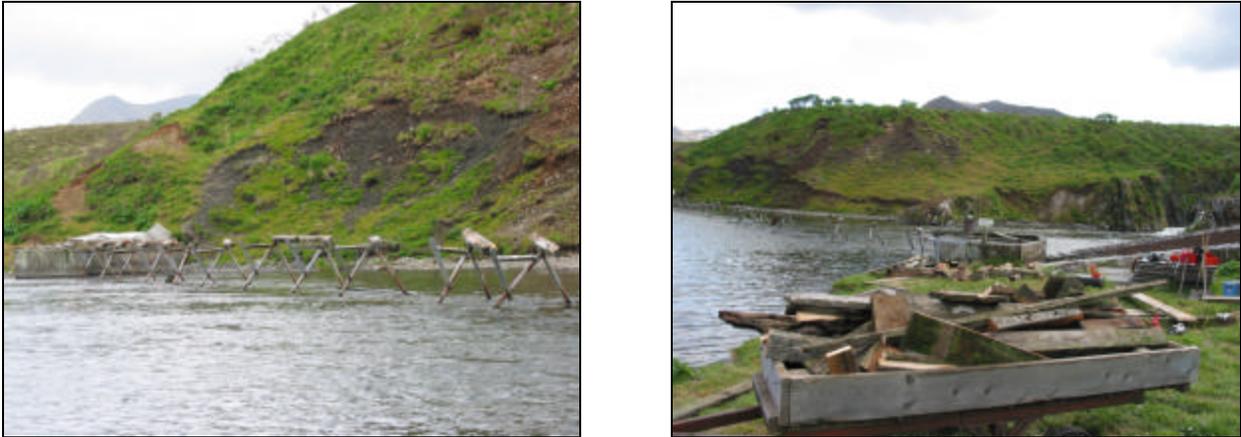
Figure 16. Dismantling the Frazer Lake diversion weir catwalk and upper stringer, 2003.

The entrance chute, diversion weir catwalk, and diversion weir upper stringer were dismantled 5 to 6 June 2003 (Figure 16).

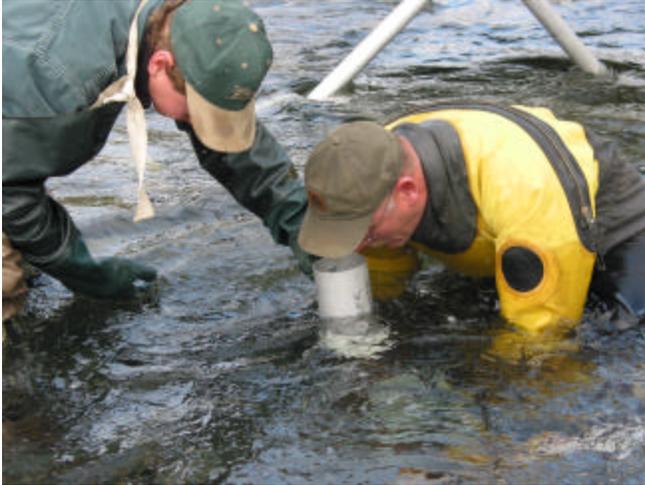
Figure 17. Dale Johnson and Rob Baer disconnecting an underwater bolt, Frazer Lake, 2003.

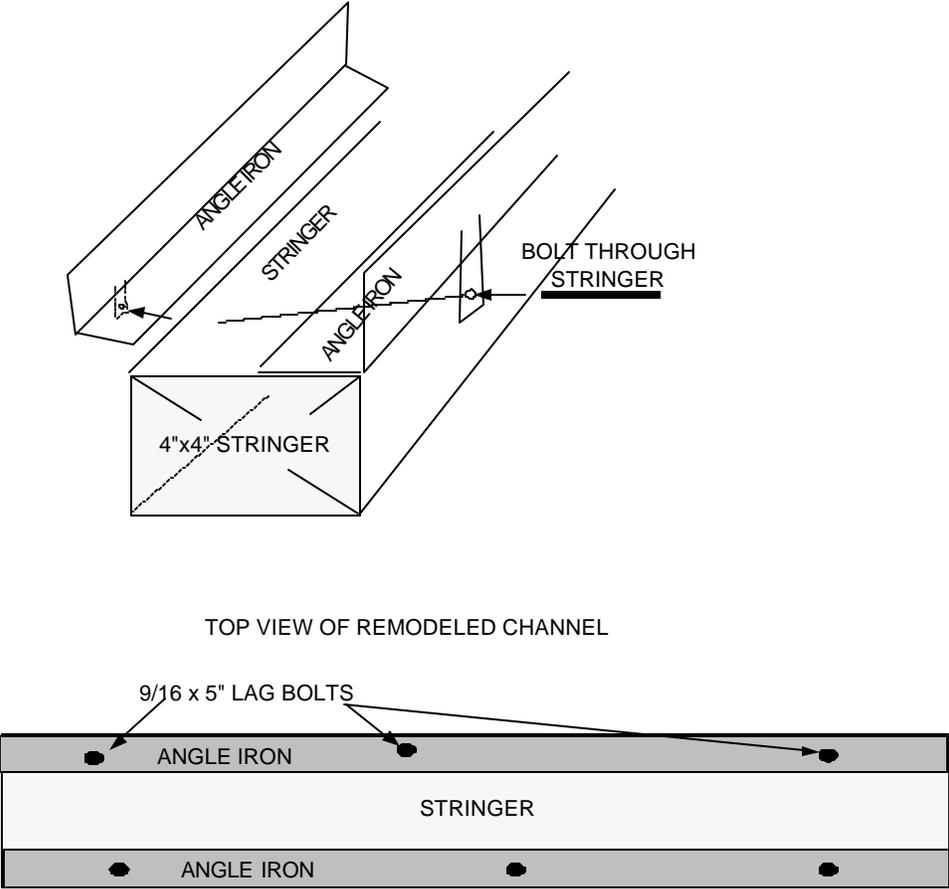
Figure 19. Angle iron attachment to the front stringer of the diversion weir, Frazer Lake, 2003.

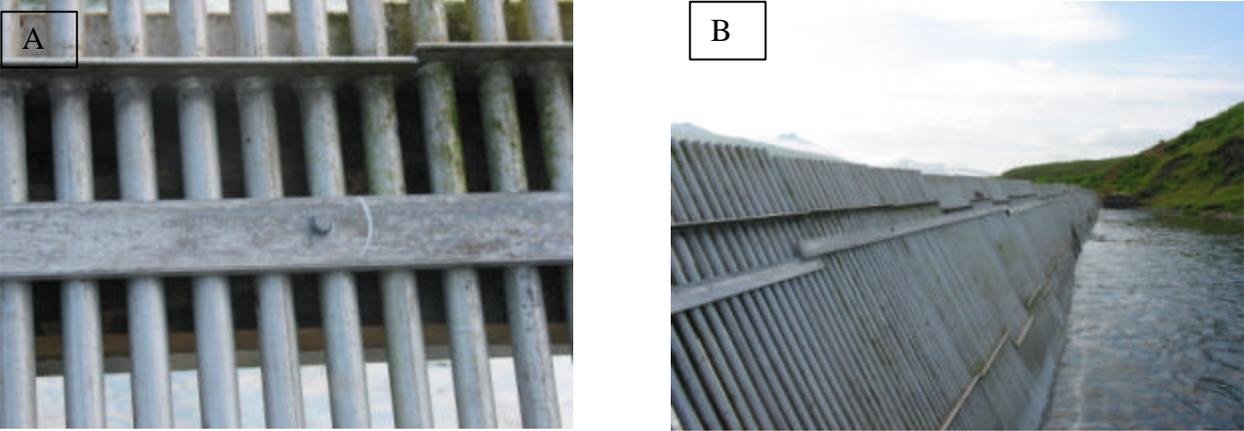
Figure 20. Close up of aluminum flat stock securing the weir panel to the weir (A), and wide angle view of the weir showing the flat stock securing the weir panels (B).

To prevent bears from tipping over weir panels, aluminum flat stock (1/2"x1"x10') were secured to the board attached to the aluminum tube, 'sandwiching' the weir panel in between (Figure 20).

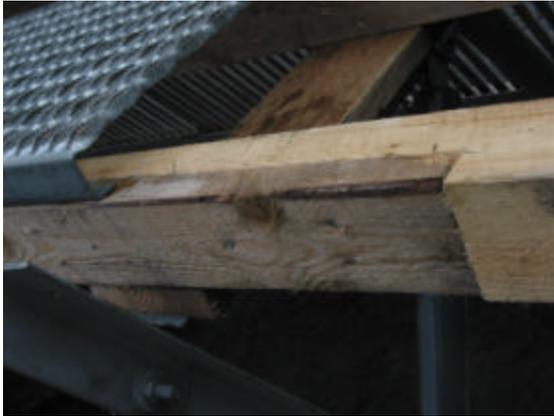
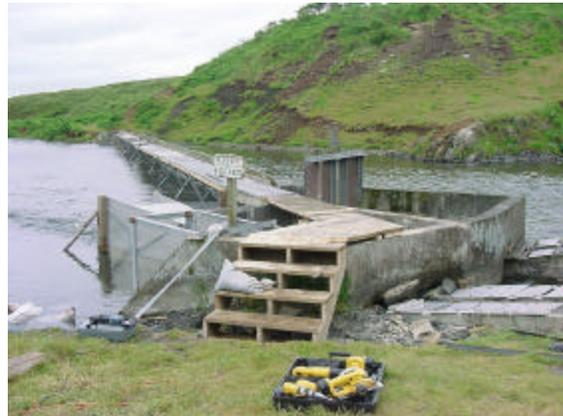
Figure 21. Frazer Lake diversion weir catwalk, 2003.

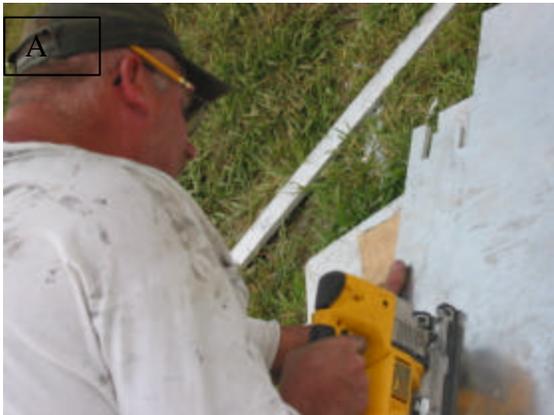
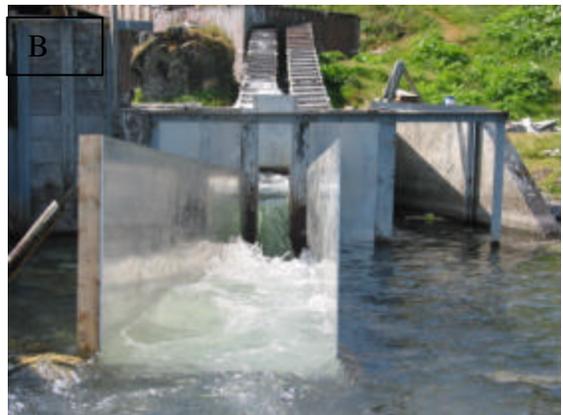
Figure 22. Notched bottom of the new entrance chute (A) and new chute under construction (B), Frazer Lake, 2003.

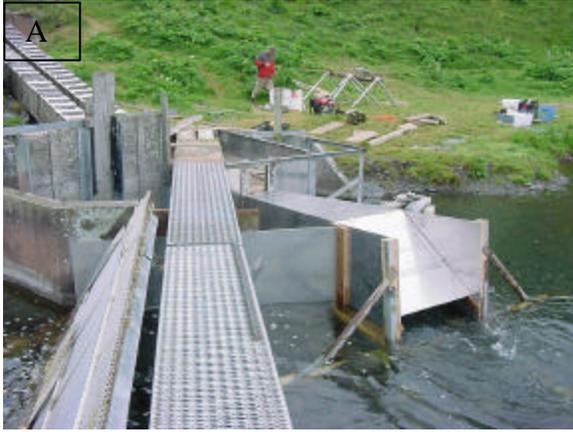
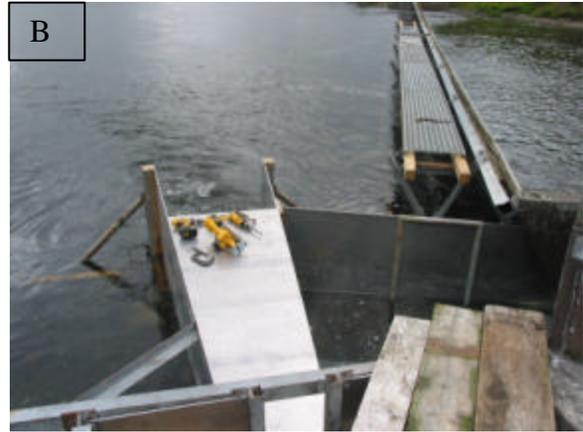
Figure 23. The new entrance chute with the hinged lid (A,B), Frazer Lake, 2003.

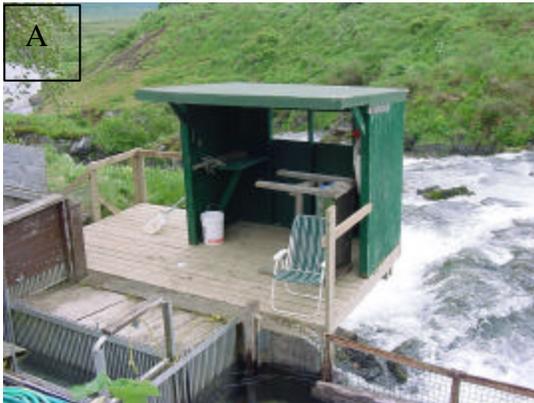
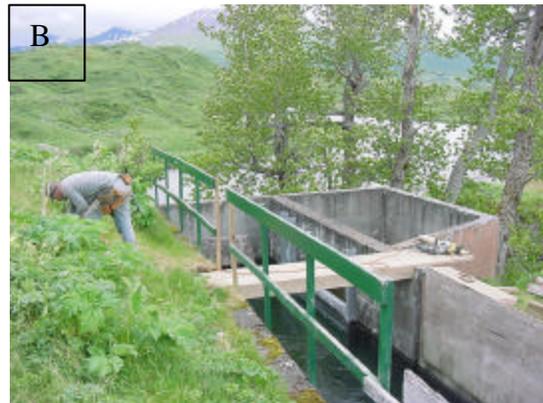
Figure 24. New Frazer Lake sampling platform (A), and walkway across the holding tank (B), Frazer Lake, 2003.

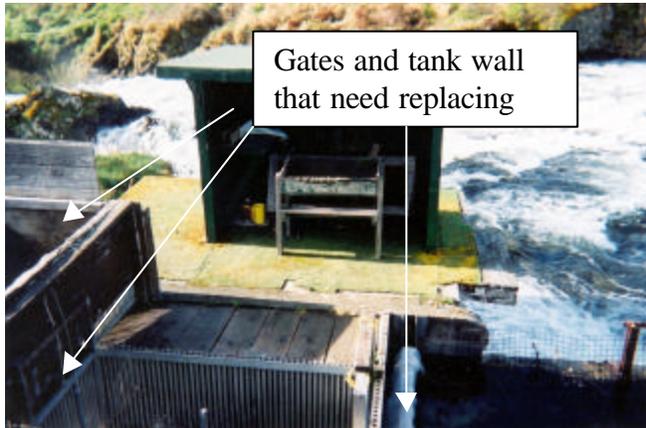
The upper holding tank is primarily made of concrete and is in good shape. However, one side of the tank is made of plywood and is rotten. The plywood acts as a railing to prevent crew from falling into the tank. The frame for the exit tank is made of wood and is rotten. Finally, the wood surrounding the trap of the exit tank is not rotten, but heavily weathered and should be replaced soon (Figure 25). Recently (summer 2003), bears have begun breaking the gates allowing fish to swim out of the holding tank without being counted.

Figure 25. Sample platform area showing the gates and holding tank wall that need to be replaced, Frazer Lake 2000.
