Nomination Form
Anadromous Waters Catalog

Region Southcentral USGS Quad(s) Tyonek A-5
 Anadromous Waters Catalog Number of Waterway 247-10-10200-2219
 Name of Waterway Unnamed Tributary Nikolai Creek USGS Name Local Name
 Addition Deletion Correction Backup Information

MEMORANDUM

SUBJECT: August 2012 Tyonek Trip Report

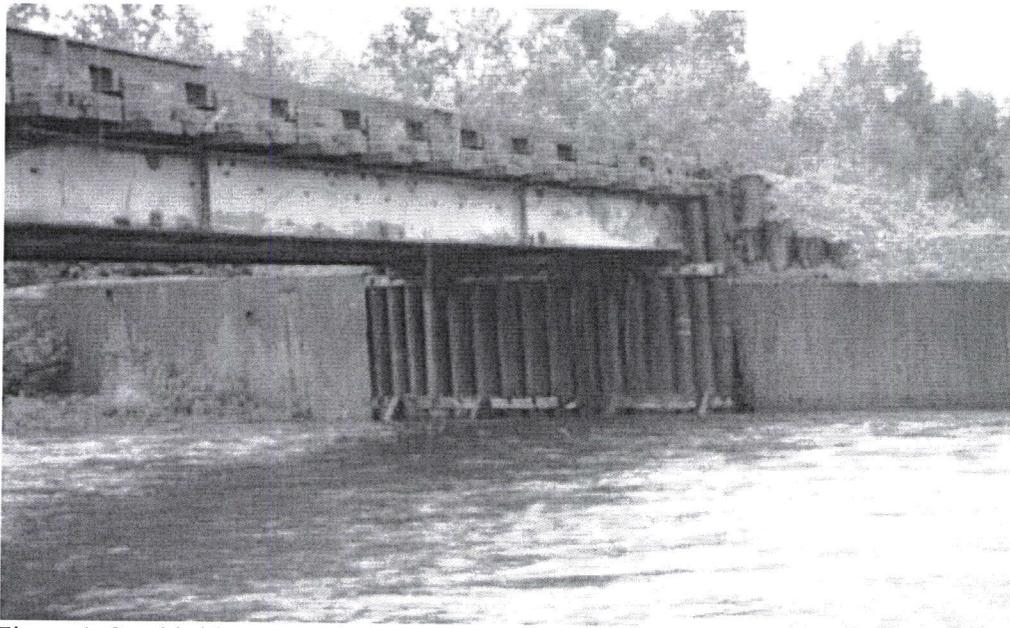
On the afternoon of August 20, Mr. Nudelman, Ms. Alas and I drove from the Beluga Camp to Road TYO-0017. A bridge is located over the Chuitna River (Stream No. 247-20-10010). We inspected a steel bridge supported by old drill casings and sheet pile (Figure 1). An overflow culvert about 8-feet in diameter has been recently installed adjacent to the bridge. I had no site specific concerns with the bridge or culvert.

Figure 1. Steel bridge over Chuitna River.

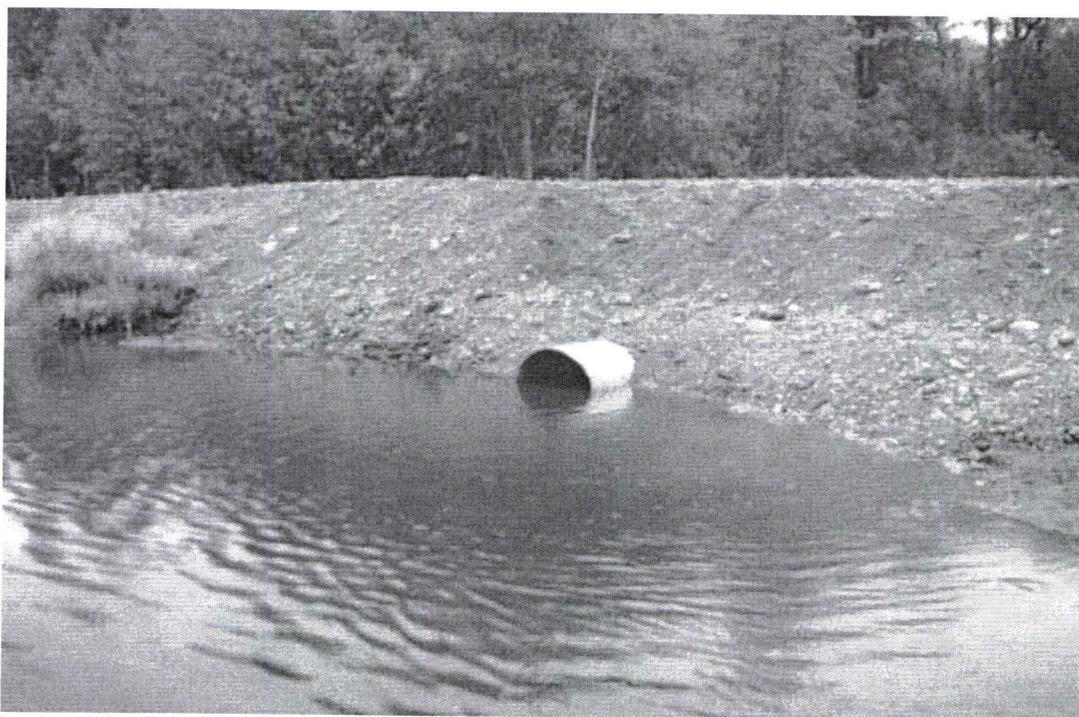
We drove to Road TYO-0015. We set two baited minnow traps in a pond above the road. The pond flows through ADF&G Culvert TYCS1-TY012 into Indian Creek (Stream No. 247-20-10020 (Figure 2)). The traps soaked about three hours. The traps captured stickleback. No other fish were observed. The culvert has structural damage under the road and the diameter is too small to pass fish. The culvert will need to be replaced with a culvert designed for fish passage.

Figure 2. Culvert inlet in Indian Creek.

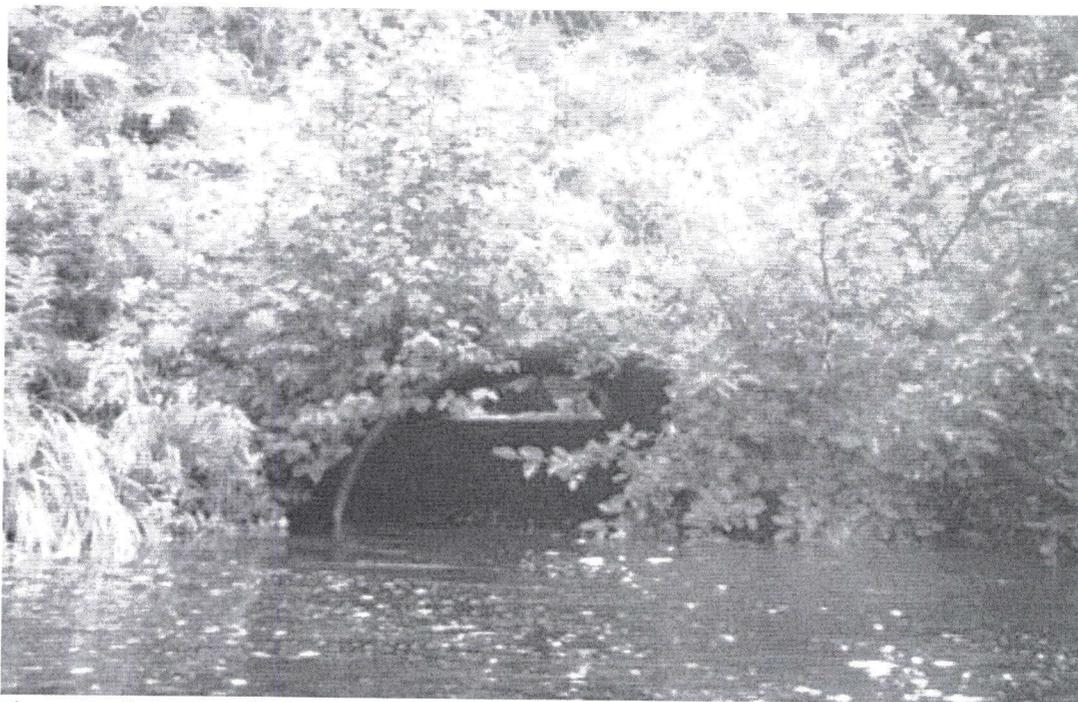
Figure 3. Culvert outlet in Tyonek Creek.

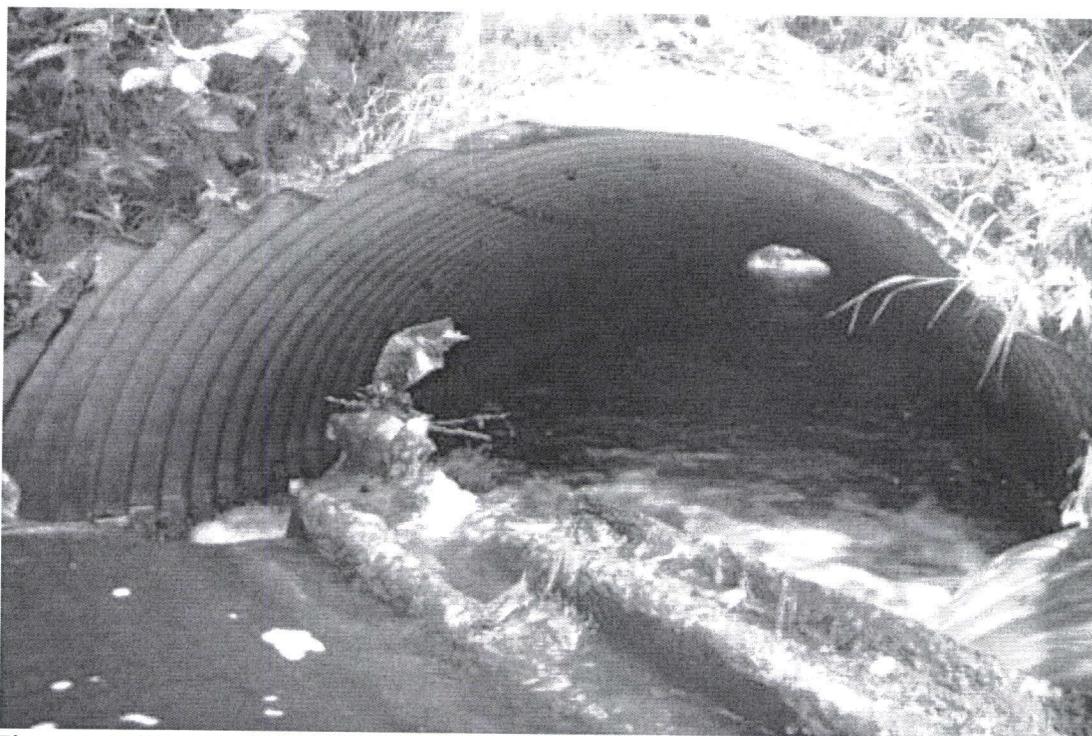
We drove to Road TYO-00013. The road crosses Tyonek Creek (Stream No. 247-20-10040). Tyonek Creek flows through ADF&G Culvert TYCS1-TY014 (Figure 3). The steel culvert invert has folded back into the culvert inlet and is preventing fish passage (Figure 4). The culvert will need the damaged steel removed to restore fish passage.

Figure 4. Failed culvert inlet in Tyonek Creek.

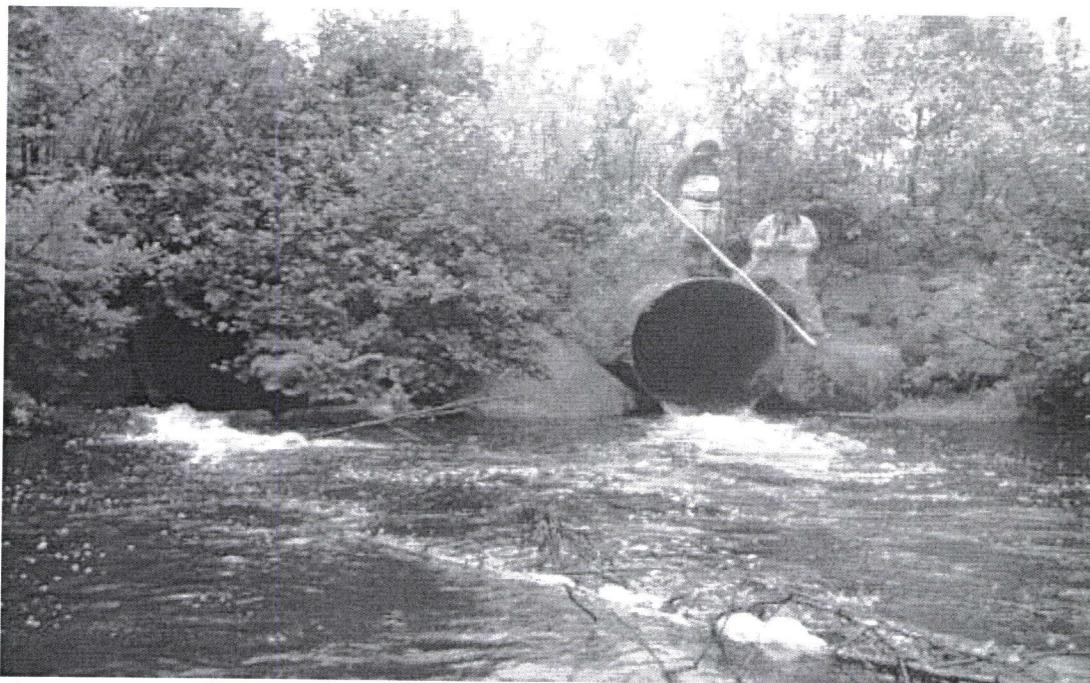
We drove to Road TYO-0006. The road crosses Tyonek Creek. Tyonek Creek flows through ADF&G Culvert TYCS1-TY016 (Figure 5). The twin culverts may be a barrier to fish passage. The ADF&G recommends the culverts are removed and a bridge installed.

Figure 5. Outlet of twin culverts in Tyonek Creek.

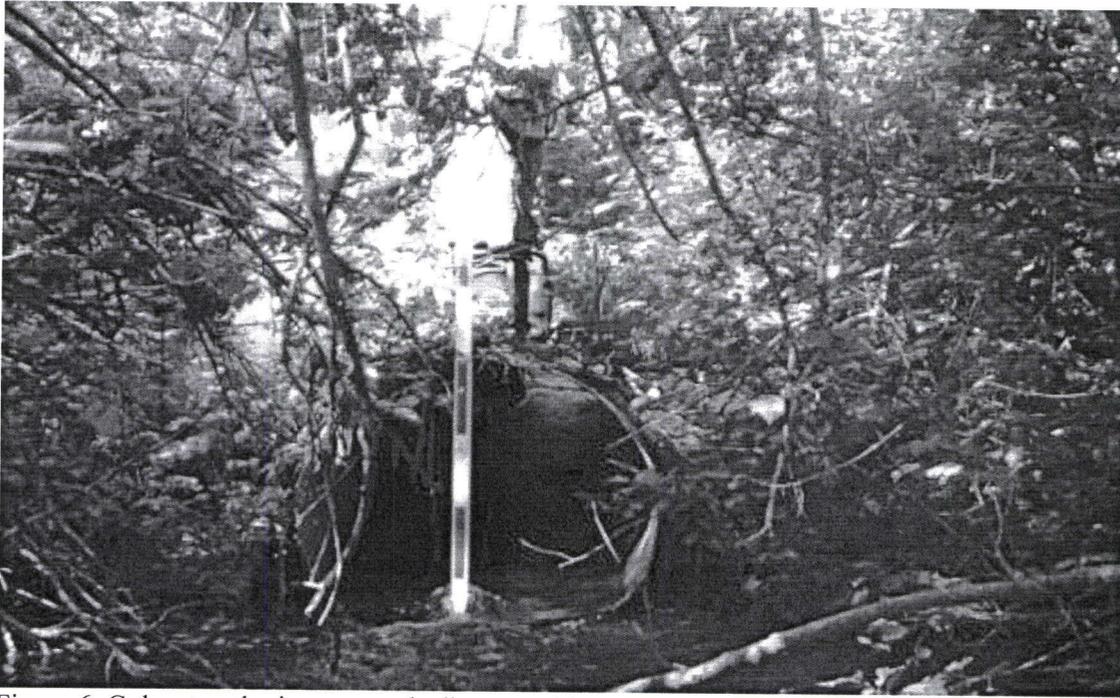
On the morning of August 21, Mr. Nudelman, Mr. Winters, Ms. Alas, and I drove to Road SOA1061. The road crosses an unnamed tributary (Stream No. 247-20-10050-2025) of Old Tyonek Creek. The unnamed tributary flows through ADF&G Culvert TYCS1-TY028 (Figure 6). I observed juvenile coho salmon about 200 feet above the culvert inlet in pool habitat. The water clarity was excellent. The juvenile coho salmon will be nominated for addition to the Anadromous Waters Catalog. The culvert may be a barrier to fish passage. The ADF&G recommends the culvert is removed and a bridge is installed.

Figure 6. Culvert outlet in unnamed tributary Old Tyonek Creek.

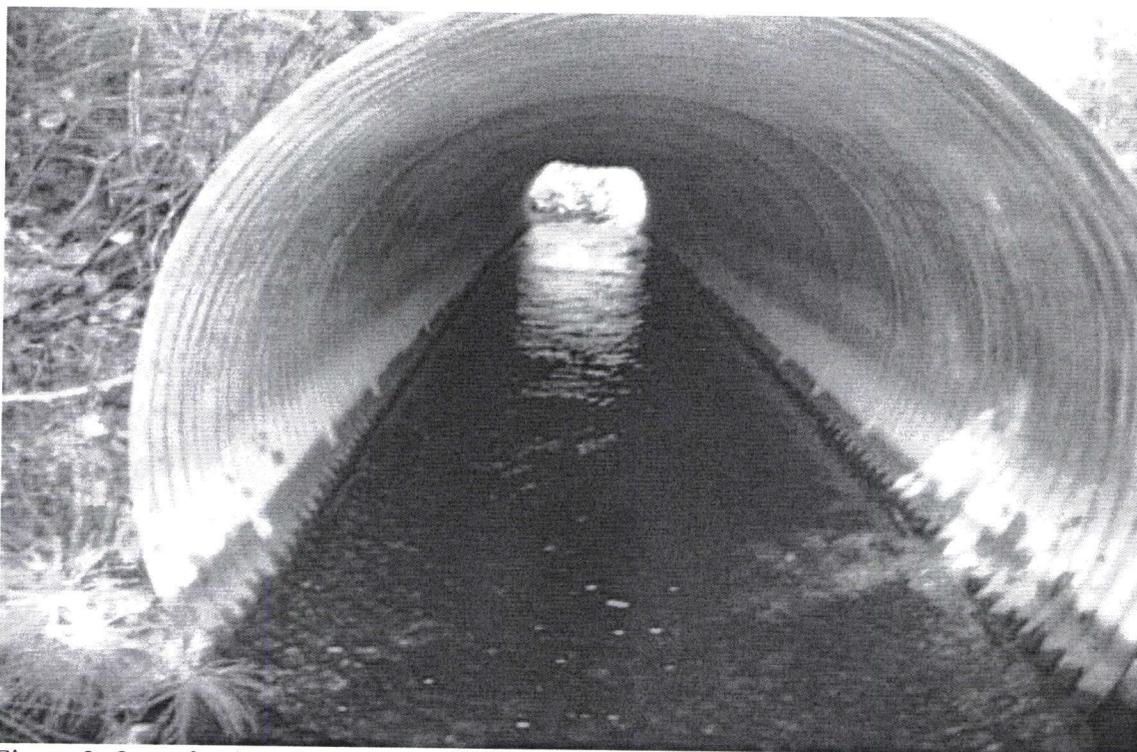
We drove to Road TYO-0011. The road crosses Tyonek Creek which flows through twin ADF&G Culverts TYCS1-TY008 (Figure 8). I observed 5 juvenile coho salmon about 500 feet below the culvert outlet in pool habitat. The juvenile coho salmon will be nominated for addition to the Anadromous Waters Catalog. The culverts may not be a barrier to fish passage.

Figure 8. One of twin culverts on Tyonek Creek.

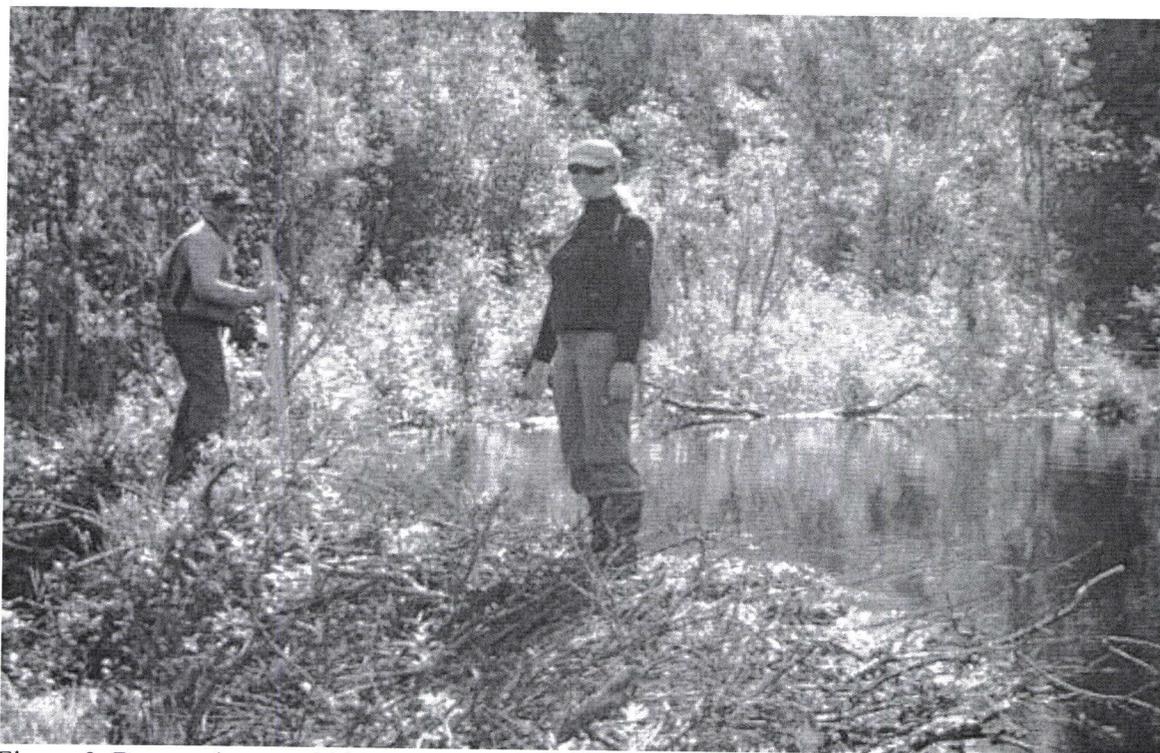
We drove to Road MHT-1002. The road is closed and alder has grown in covering the road. We walked about 1,500 feet to Old Tyonek Creek. A 7-foot high beaver dam is in the location of an old stream crossing (Figure 9). No culvert was located. I observed about 50 juvenile coho salmon in the beaver pond. The juvenile coho salmon will be nominated for addition to the Anadromous Waters Catalog.

Figure 9. Beaver dam on Old Tyonek Creek.

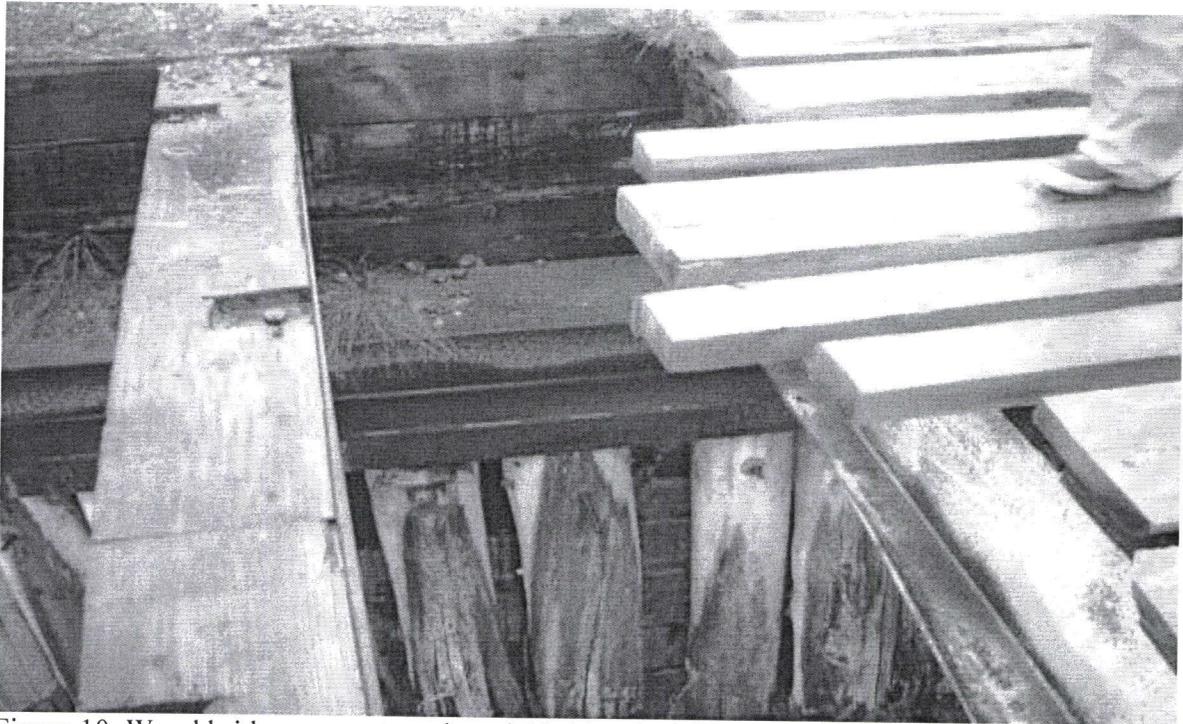
We drove an additional 0.6 miles on Road SOA-1054. We located a 60.5 foot long bridge over Nikolai Creek. The steel bridge is supported by a wood bulkhead (Figure 10). The wood is rotting at ground level. The deck of the bridge has untreated wood beams covering half the bridge width (Figure 10). We did not attempt to cross the bridge with a vehicle. We observed two adult pink salmon below the bridge. The pink salmon will be nominated for addition to the Anadromous Waters Catalog.

Figure 10. Wood bridge supports and partial bridge deck in Nikolai Creek.

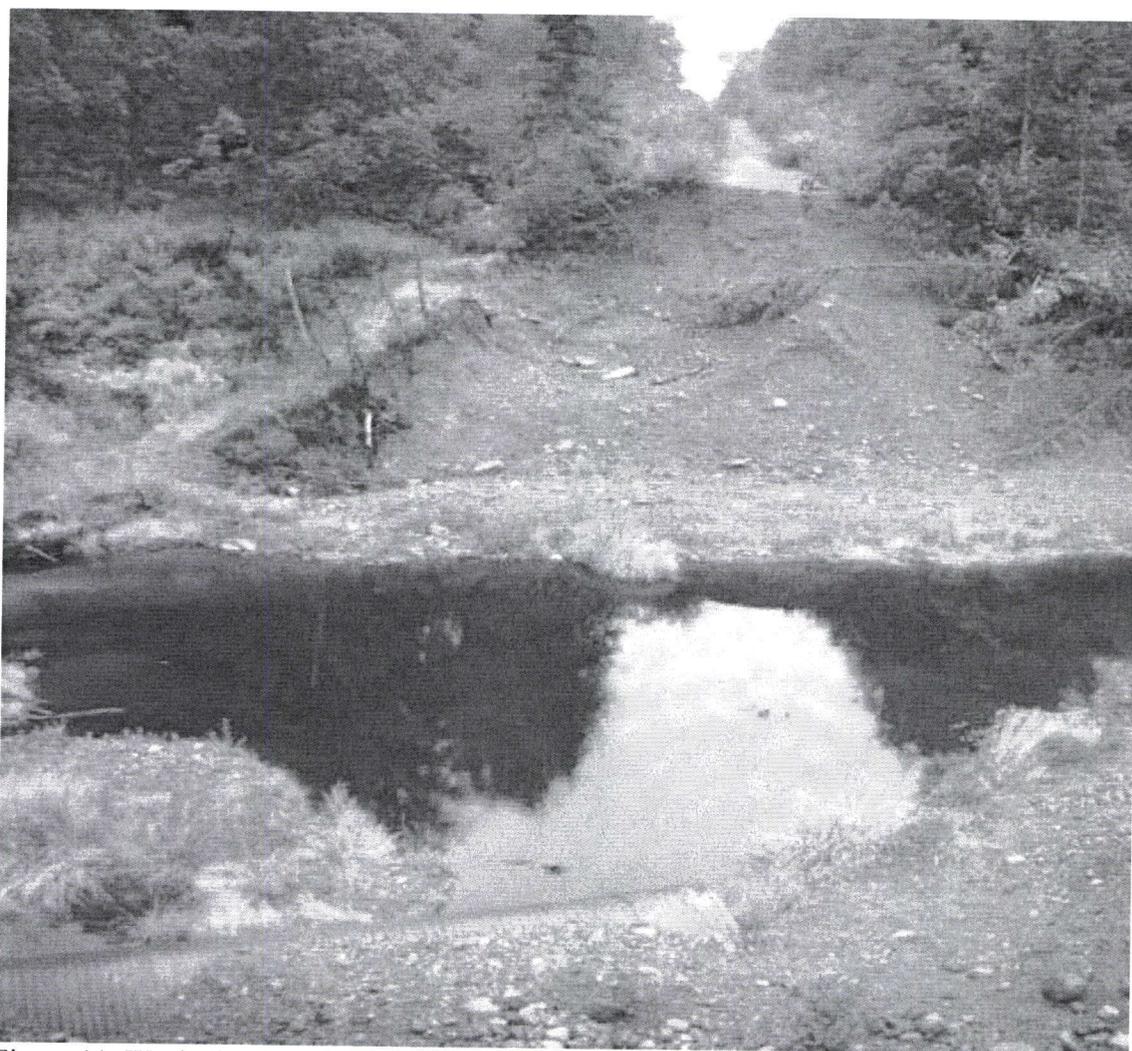
We drove to the site of ADF&G Culvert TYCS1-TY011 located in Three Mile Creek. The 5-foot diameter culvert has failed and about 300 feet of the roadbed has washed into the creek (Figures 11 and 12). The failed roadbed is continuing to erode, discharging sediment into the creek. Three Mile Creek (Stream No. 247-20-10002) is a specified waterbody about 0.5 miles below the road. The ADF&G will require action to be taken to stabilize the roadbed. I sampled the stream about 100 feet above the road and 500 feet below the road. I captured sculpin and stickleback.

Figure 11. Washed out roadbed on Three Mile Creek.

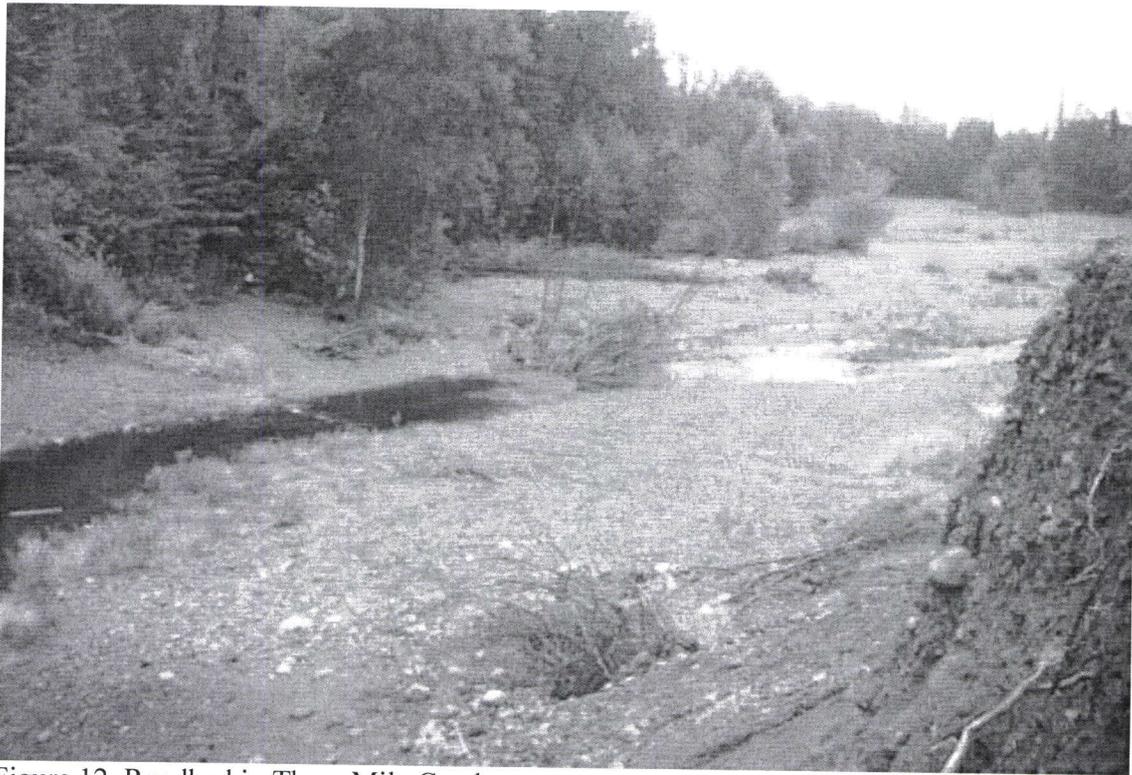
Figure 12. Roadbed in Three Mile Creek.
