Nomination Form
Anadromous Waters Catalog

Name of Waterway Unnamed Tributary Nikolai Creek USGS Name Local Name
 Addition Deletion Correction Backup Information

MEMORANDUM

SUBJECT: August 2012 Tyonek Trip Report

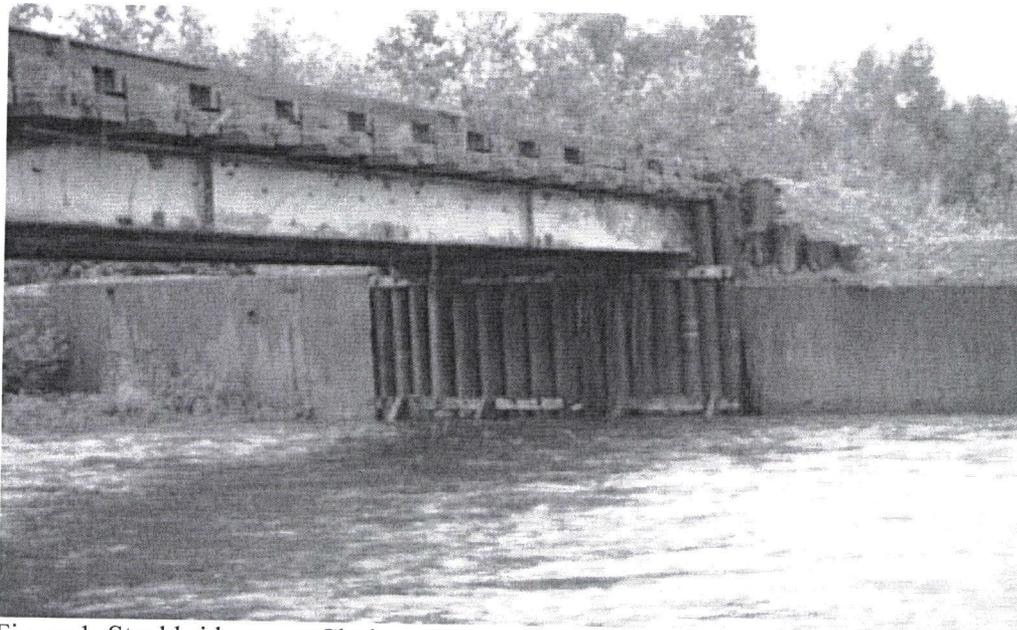
On the afternoon of August 20, Mr. Nudelman, Ms. Alas and I drove from the Beluga Camp to Road TYO-0017. A bridge is located over the Chuitna River (Stream No. 247-20-10010). We inspected a steel bridge supported by old drill casings and sheet pile (Figure 1). An overflow culvert about 8-feet in diameter has been recently installed adjacent to the bridge. I had no site specific concerns with the bridge or culvert.

Figure 1. Steel bridge over Chuitna River.

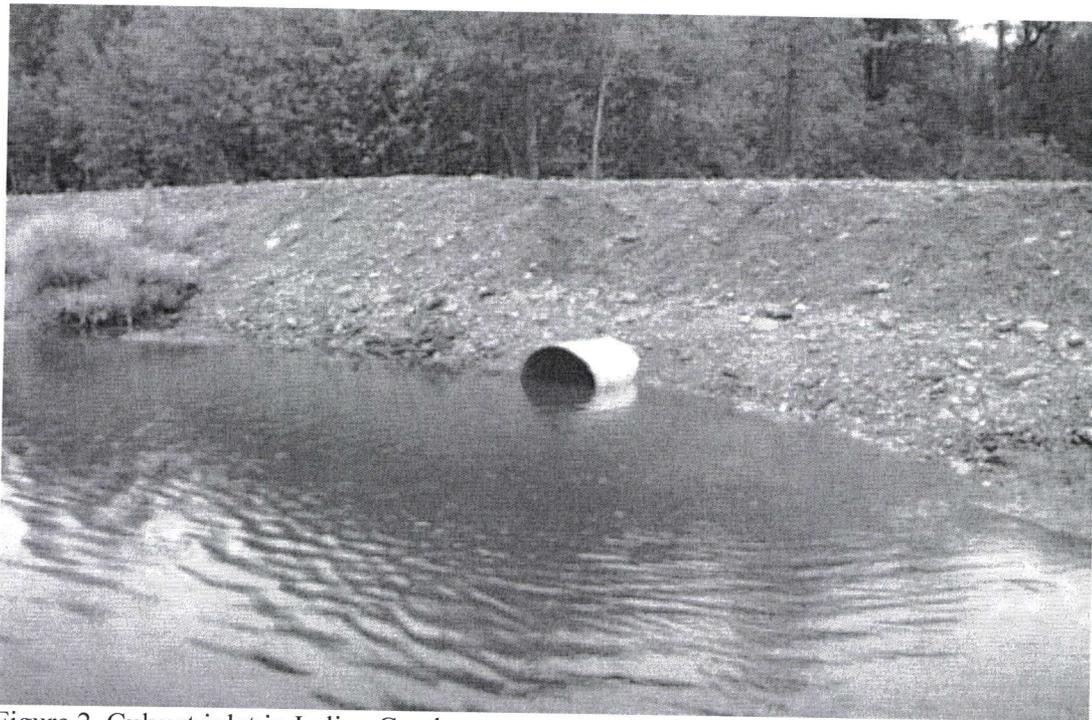
We drove to Road TYO-0015. We set two baited minnow traps in a pond above the road. The pond flows through ADF&G Culvert TYCS1-TY012 into Indian Creek (Stream No. 247-20-10020 (Figure 2)). The traps soaked about three hours. The traps captured stickleback. No other fish were observed. The culvert has structural damage under the road and the diameter is too small to pass fish. The culvert will need to be replaced with a culvert designed for fish passage.

Figure 2. Culvert inlet in Indian Creek.

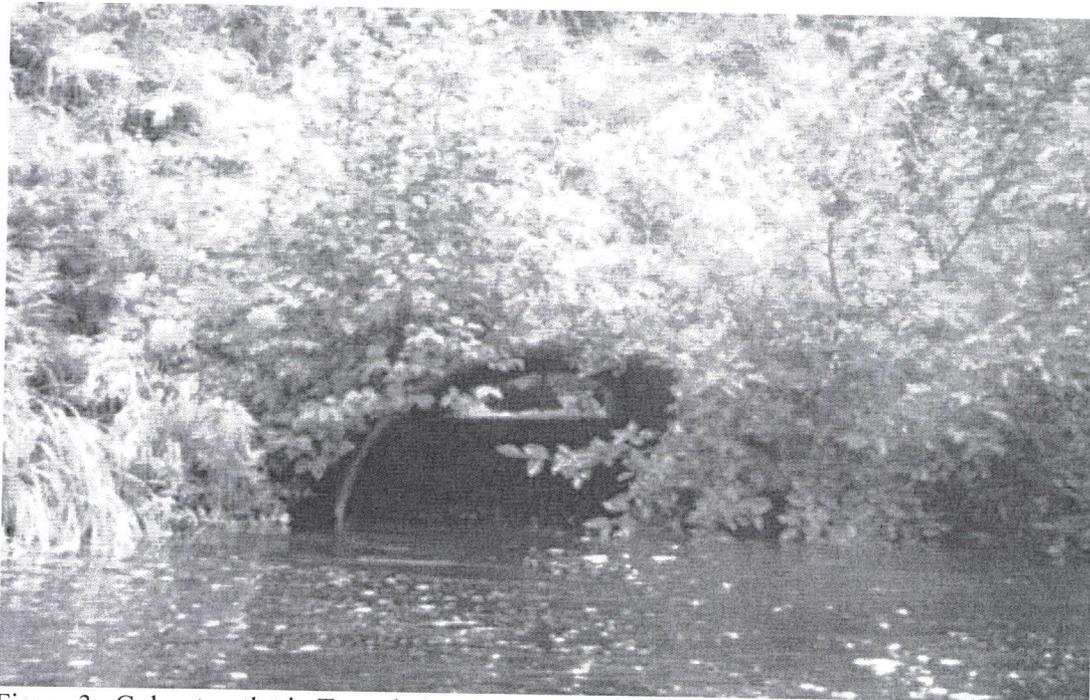
Figure 3. Culvert outlet in Tyonek Creek.

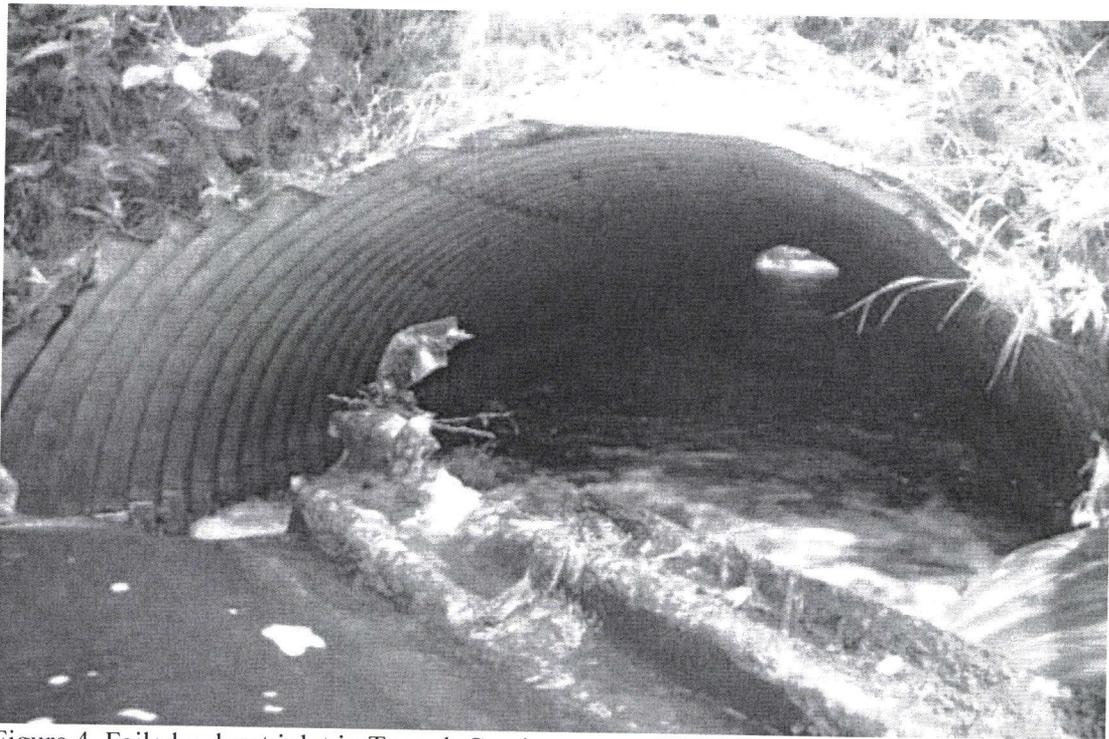
We drove to Road TYO-00013. The road crosses Tyonek Creek (Stream No. 247-20-10040). Tyonek Creek flows through ADF&G Culvert TYCS1-TY014 (Figure 3). The steel culvert invert has folded back into the culvert inlet and is preventing fish passage (Figure 4). The culvert will need the damaged steel removed to restore fish passage.

Figure 4. Failed culvert inlet in Tyonek Creek.

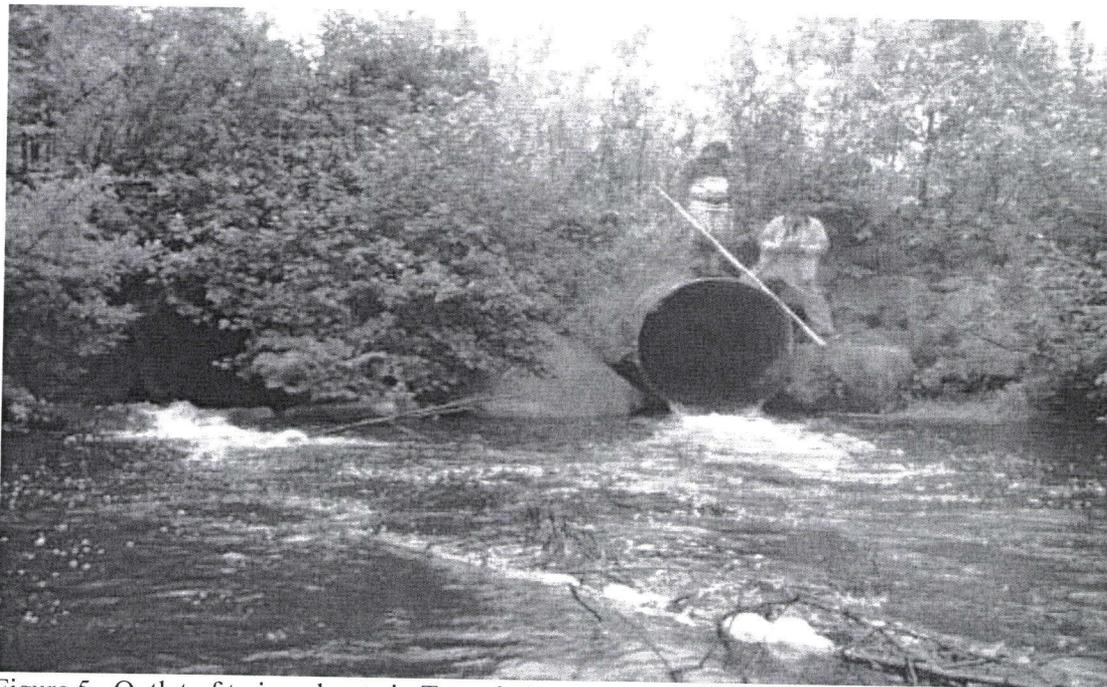
We drove to Road TYO-0006. The road crosses Tyonek Creek. Tyonek Creek flows through ADF&G Culvert TYCS1-TY016 (Figure 5). The twin culverts may be a barrier to fish passage. The ADF&G recommends the culverts are removed and a bridge installed.

Figure 5. Outlet of twin culverts in Tyonek Creek.

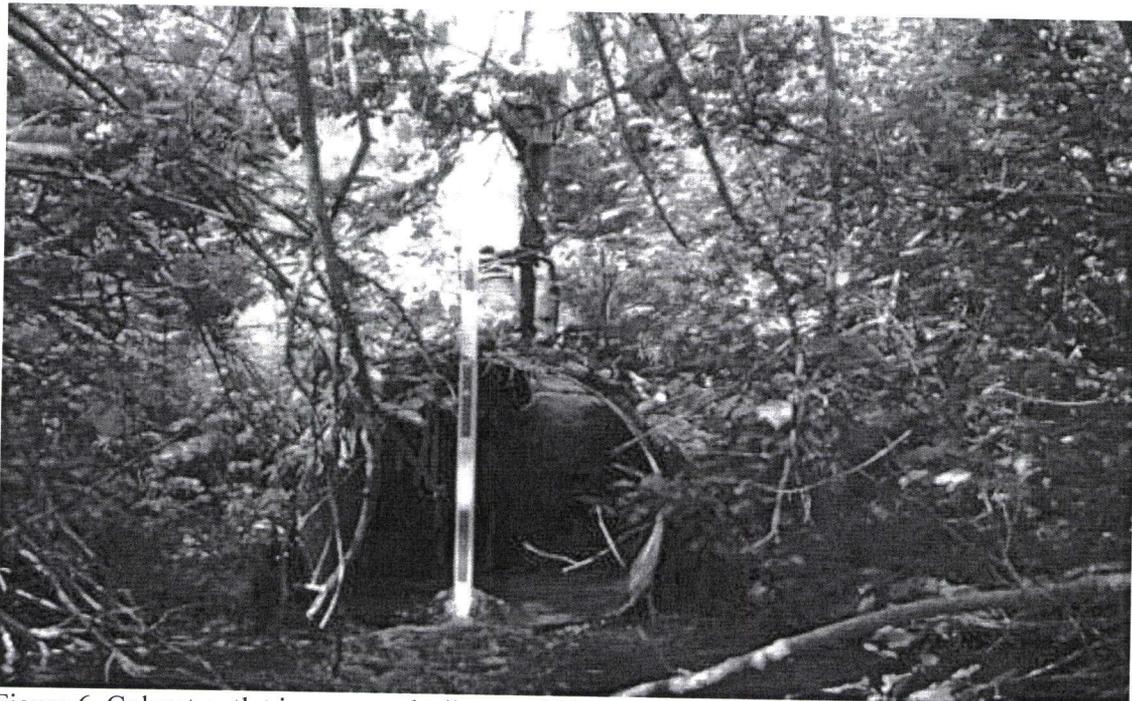
On the morning of August 21, Mr. Nudelman, Mr. Winters, Ms. Alas, and I drove to Road SOA1061. The road crosses an unnamed tributary (Stream No. 247-20-10050-2025) of Old Tyonek Creek. The unnamed tributary flows through ADF&G Culvert TYCS1-TY028 (Figure 6). I observed juvenile coho salmon about 200 feet above the culvert inlet in pool habitat. The water clarity was excellent. The juvenile coho salmon will be nominated for addition to the Anadromous Waters Catalog. The culvert may be a barrier to fish passage. The ADF&G recommends the culvert is removed and a bridge is installed.

Figure 6. Culvert outlet in unnamed tributary Old Tyonek Creek.

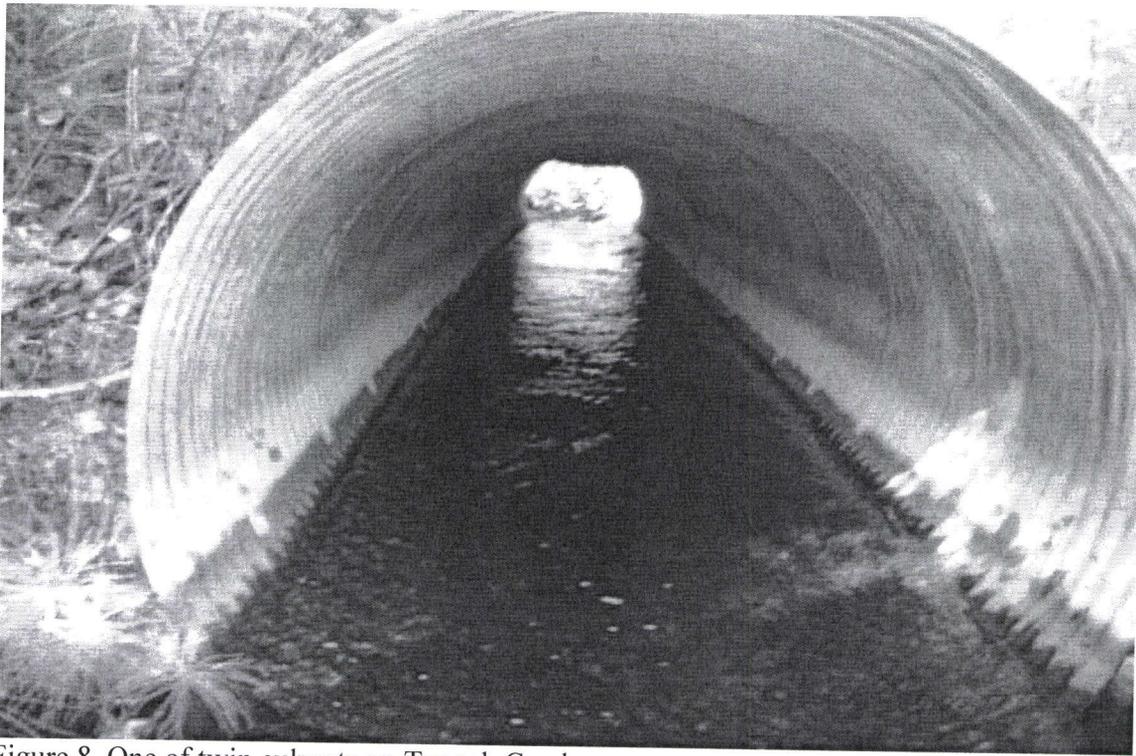
We drove to Road TYO-0011. The road crosses Tyonek Creek which flows through twin ADF&G Culverts TYCS1-TY008 (Figure 8). I observed 5 juvenile coho salmon about 500 feet below the culvert outlet in pool habitat. The juvenile coho salmon will be nominated for addition to the Anadromous Waters Catalog. The culverts may not be a barrier to fish passage.

Figure 8. One of twin culverts on Tyonek Creek.

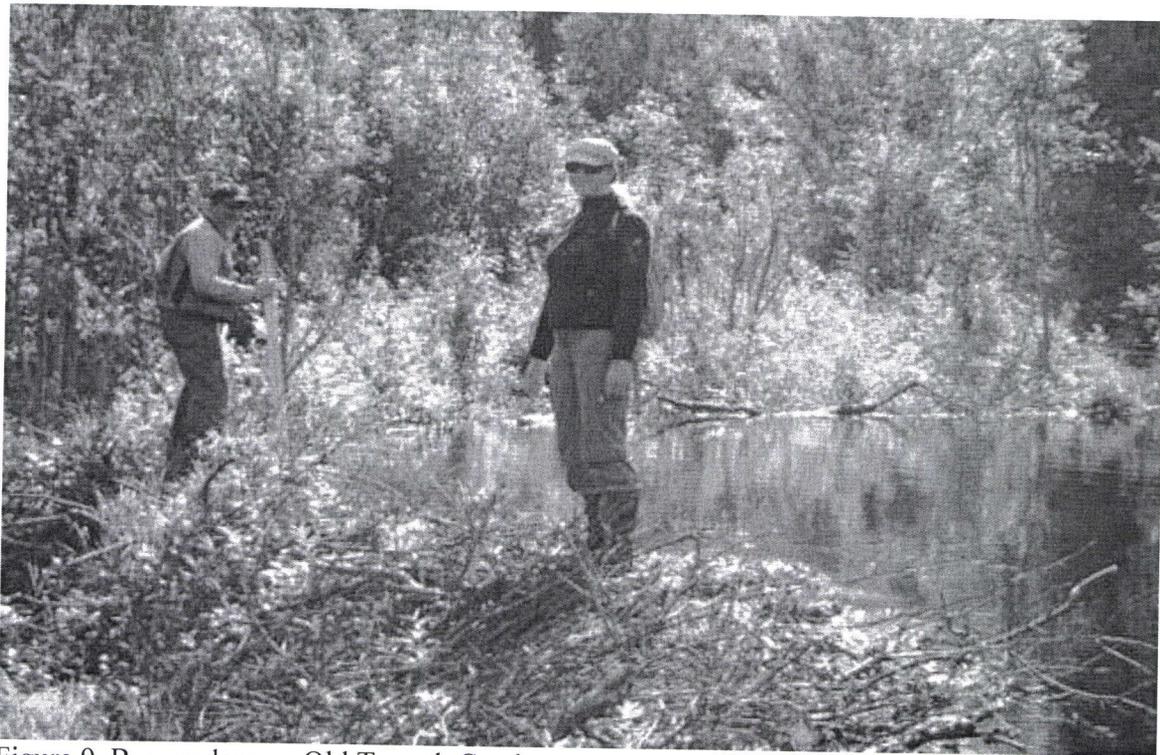
We drove to Road MHT-1002. The road is closed and alder has grown in covering the road. We walked about 1,500 feet to Old Tyonek Creek. A 7-foot high beaver dam is in the location of an old stream crossing (Figure 9). No culvert was located. I observed about 50 juvenile coho salmon in the beaver pond. The juvenile coho salmon will be nominated for addition to the Anadromous Waters Catalog.

Figure 9. Beaver dam on Old Tyonek Creek.

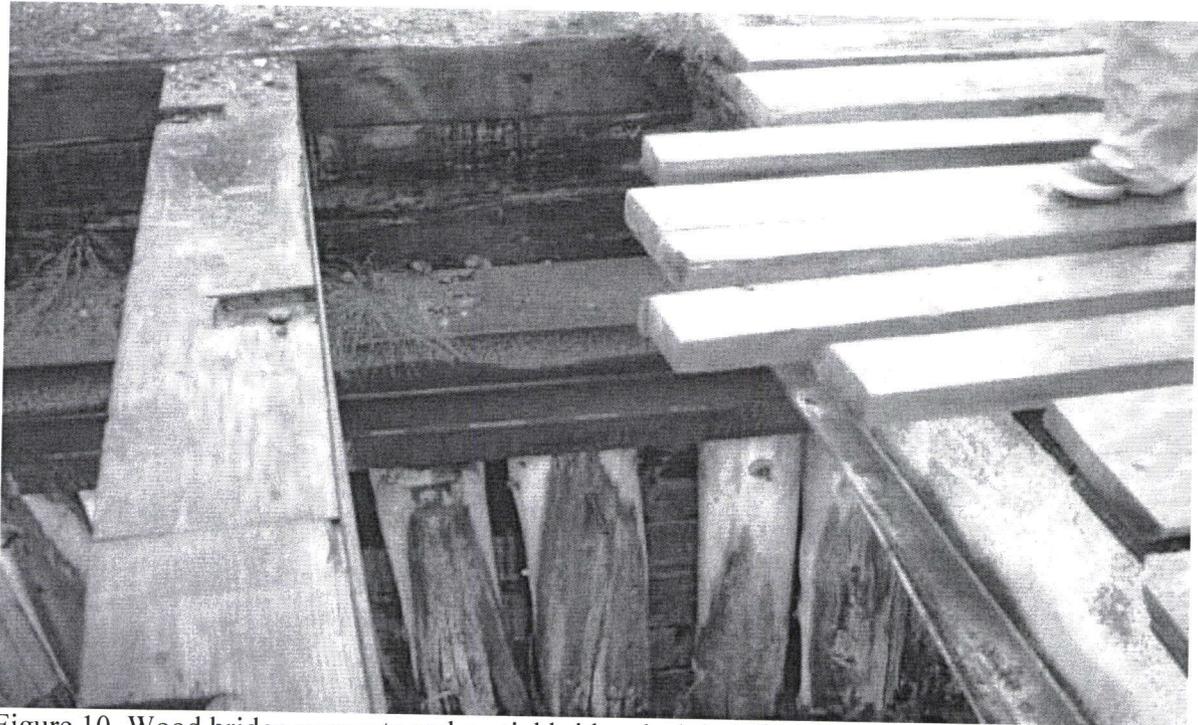
We drove an additional 0.6 miles on Road SOA-1054. We located a 60.5 foot long bridge over Nikolai Creek. The steel bridge is supported by a wood bulkhead (Figure 10). The wood is rotting at ground level. The deck of the bridge has untreated wood beams covering half the bridge width (Figure 10). We did not attempt to cross the bridge with a vehicle. We observed two adult pink salmon below the bridge. The pink salmon will be nominated for addition to the Anadromous Waters Catalog.

Figure 10. Wood bridge supports and partial bridge deck in Nikolai Creek.

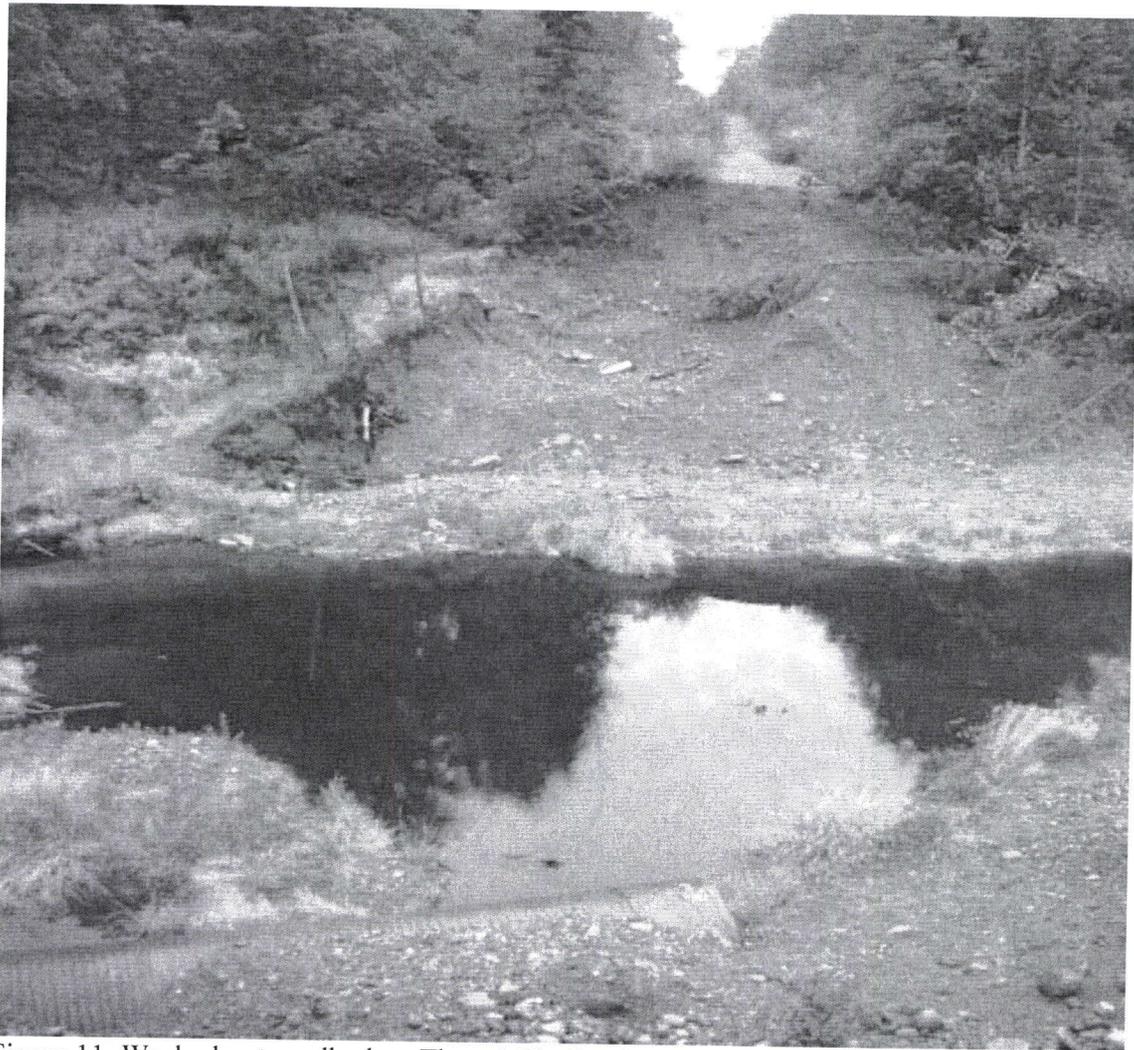
We drove to the site of ADF&G Culvert TYCS1-TY011 located in Three Mile Creek. The 5-foot diameter culvert has failed and about 300 feet of the roadbed has washed into the creek (Figures 11 and 12). The failed roadbed is continuing to erode, discharging sediment into the creek. Three Mile Creek (Stream No. 247-20-10002) is a specified waterbody about 0.5 miles below the road. The ADF&G will require action to be taken to stabilize the roadbed. I sampled the stream about 100 feet above the road and 500 feet below the road. I captured sculpin and stickleback.

Figure 11. Washed out roadbed on Three Mile Creek.

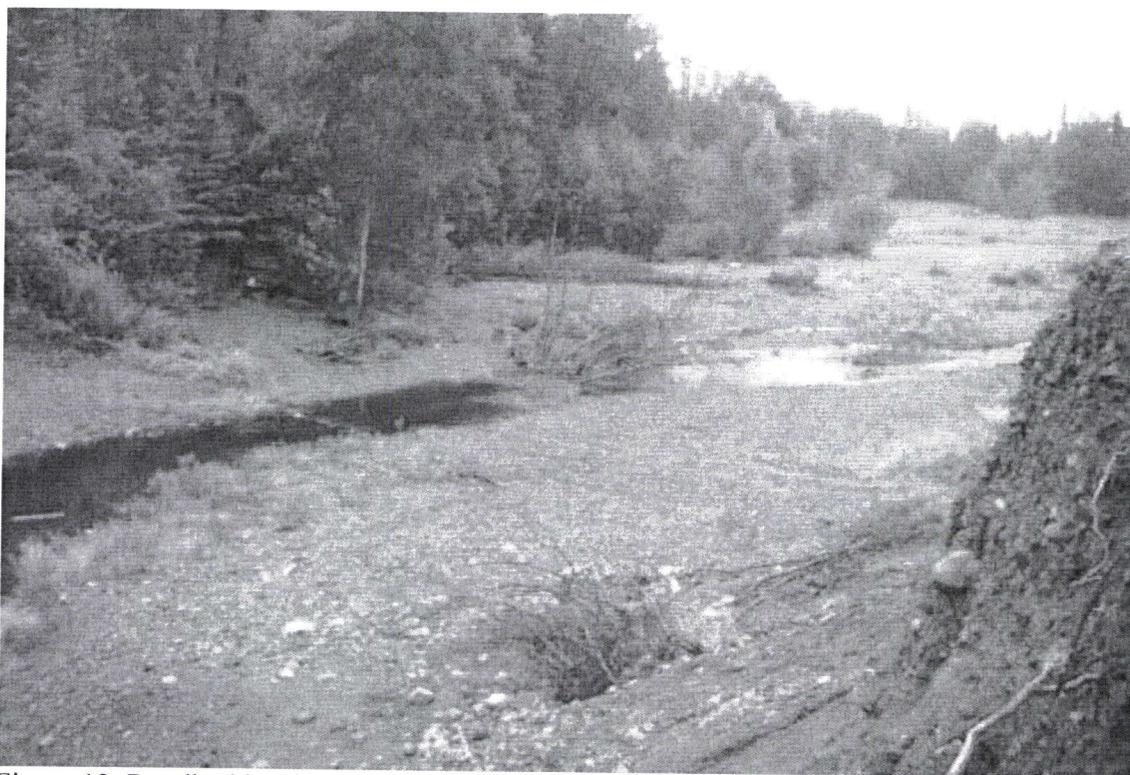
Figure 12. Roadbed in Three Mile Creek.
