Nomination Form
Anadromous Waters Catalog

MEMORANDUM

SUBJECT: August 2012 Tyonek Trip Report

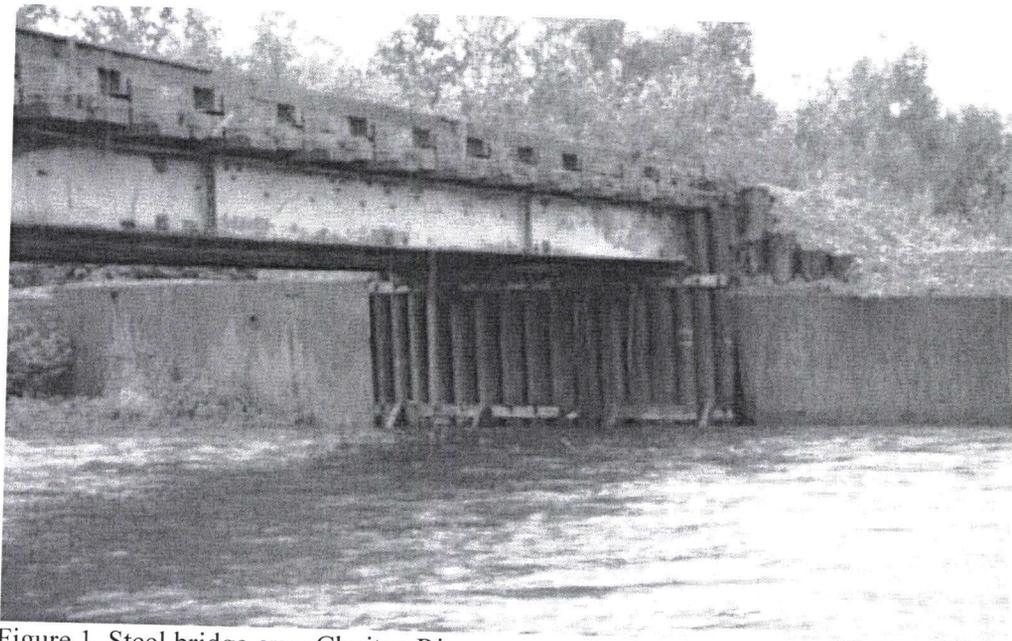
On the afternoon of August 20, Mr. Nudelman, Ms. Alas and I drove from the Beluga Camp to Road TYO-0017. A bridge is located over the Chuitna River (Stream No. 247-20-10010). We inspected a steel bridge supported by old drill casings and sheet pile (Figure 1). An overflow culvert about 8-feet in diameter has been recently installed adjacent to the bridge. I had no site specific concerns with the bridge or culvert.

Figure 1. Steel bridge over Chuitna River.

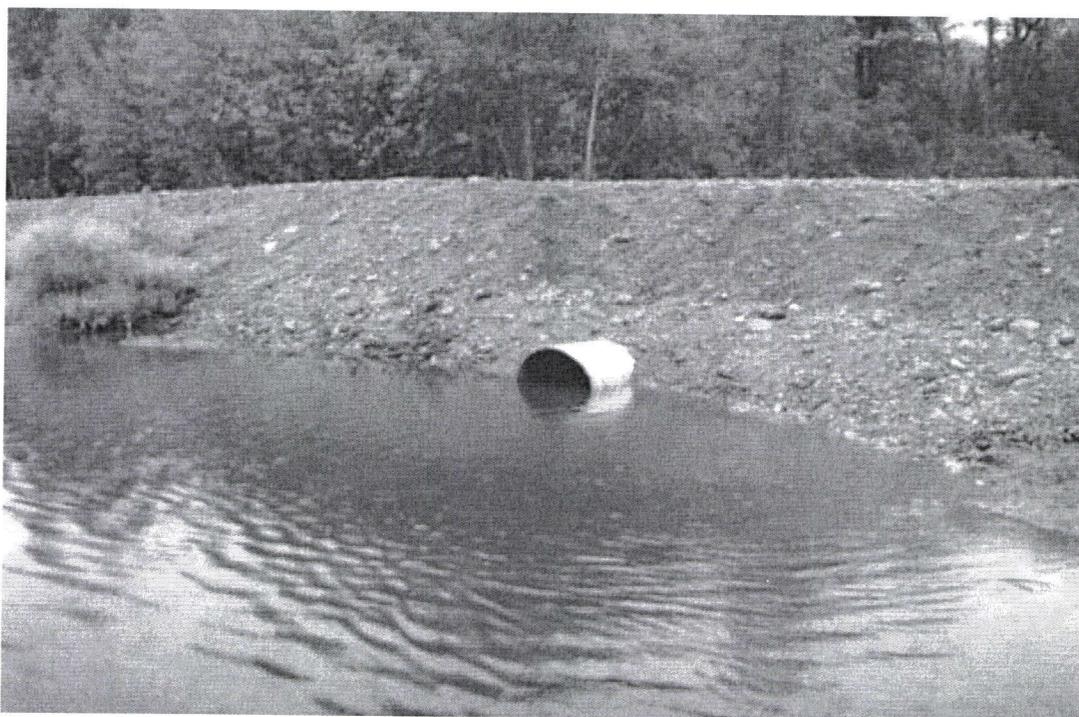
We drove to Road TYO-0015. We set two baited minnow traps in a pond above the road. The pond flows through ADF&G Culvert TYCS1-TY012 into Indian Creek (Stream No. 247-20-10020 (Figure 2)). The traps soaked about three hours. The traps captured stickleback. No other fish were observed. The culvert has structural damage under the road and the diameter is too small to pass fish. The culvert will need to be replaced with a culvert designed for fish passage.

Figure 2. Culvert inlet in Indian Creek.

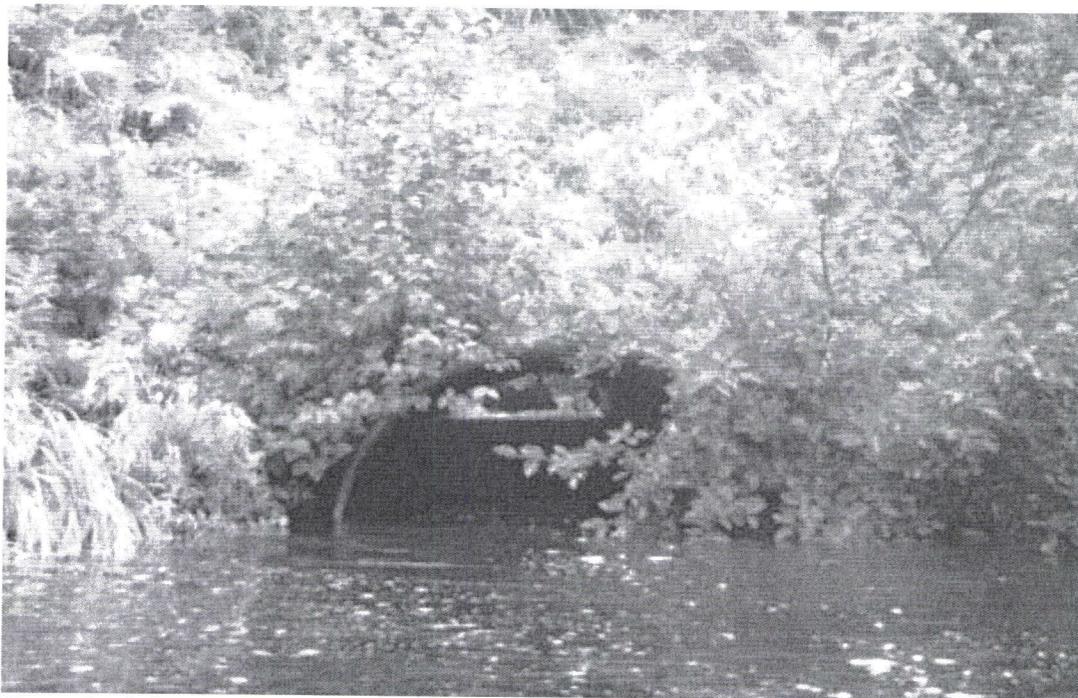
Figure 3. Culvert outlet in Tyonek Creek.

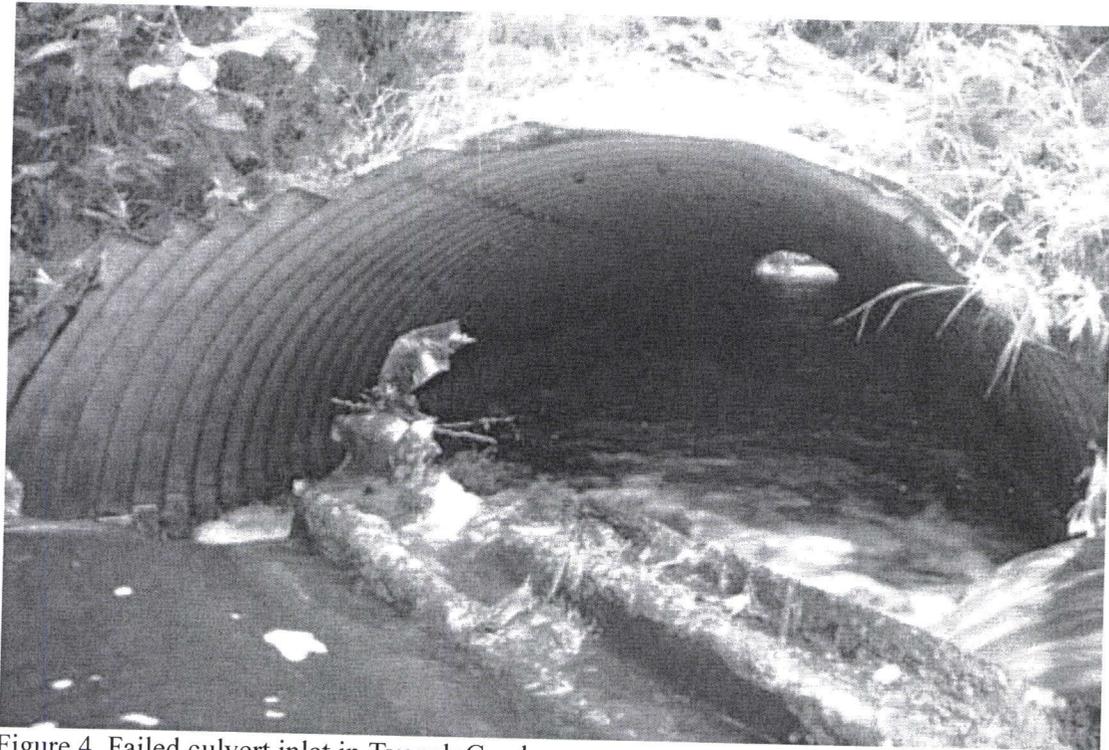
We drove to Road TYO-00013. The road crosses Tyonek Creek (Stream No. 247-20-10040). Tyonek Creek flows through ADF&G Culvert TYCS1-TY014 (Figure 3). The steel culvert invert has folded back into the culvert inlet and is preventing fish passage (Figure 4). The culvert will need the damaged steel removed to restore fish passage.

Figure 4. Failed culvert inlet in Tyonek Creek.

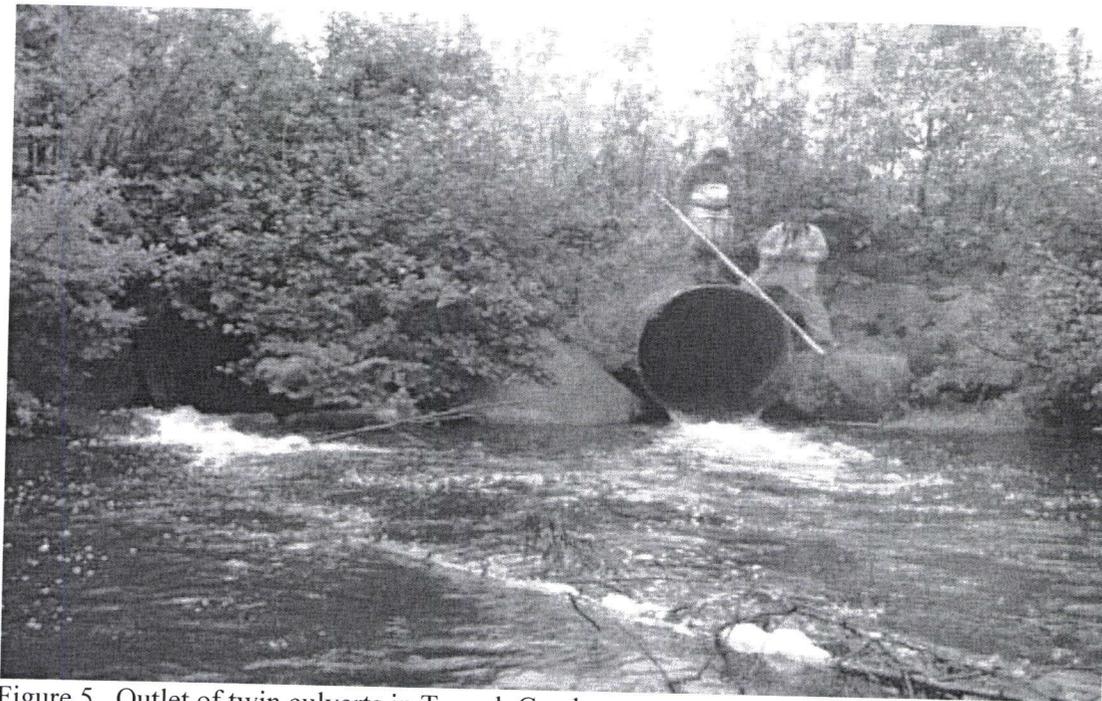
We drove to Road TYO-0006. The road crosses Tyonek Creek. Tyonek Creek flows through ADF&G Culvert TYCS1-TY016 (Figure 5). The twin culverts may be a barrier to fish passage. The ADF&G recommends the culverts are removed and a bridge installed.

Figure 5. Outlet of twin culverts in Tyonek Creek.

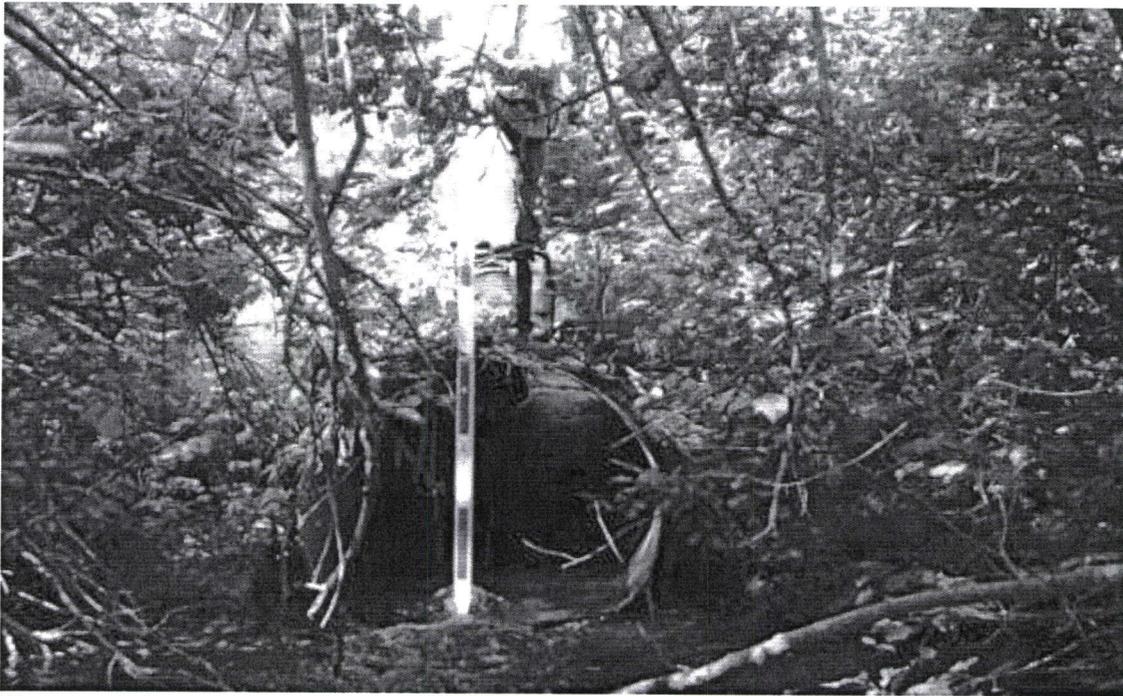
On the morning of August 21, Mr. Nudelman, Mr. Winters, Ms. Alas, and I drove to Road SOA1061. The road crosses an unnamed tributary (Stream No. 247-20-10050-2025) of Old Tyonek Creek. The unnamed tributary flows through ADF&G Culvert TYCS1-TY028 (Figure 6). I observed juvenile coho salmon about 200 feet above the culvert inlet in pool habitat. The water clarity was excellent. The juvenile coho salmon will be nominated for addition to the Anadromous Waters Catalog. The culvert may be a barrier to fish passage. The ADF&G recommends the culvert is removed and a bridge is installed.

Figure 6. Culvert outlet in unnamed tributary Old Tyonek Creek.

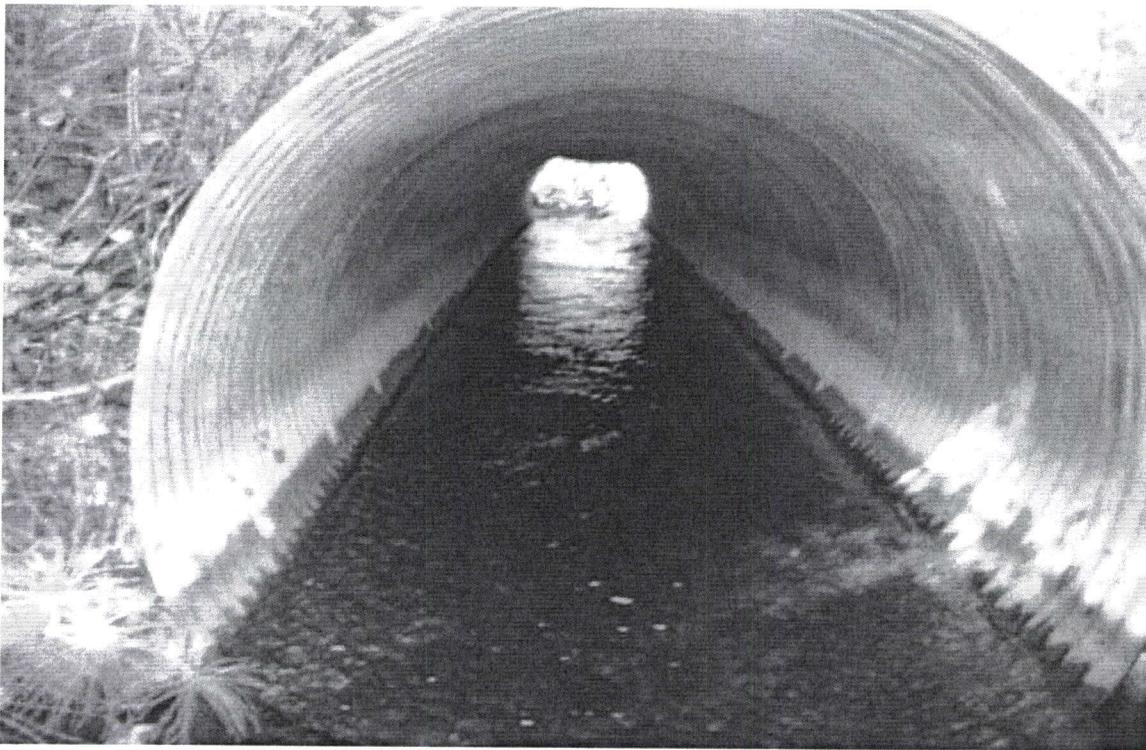
We drove to Road TYO-0011. The road crosses Tyonek Creek which flows through twin ADF&G Culverts TYCS1-TY008 (Figure 8). I observed 5 juvenile coho salmon about 500 feet below the culvert outlet in pool habitat. The juvenile coho salmon will be nominated for addition to the Anadromous Waters Catalog. The culverts may not be a barrier to fish passage.

Figure 8. One of twin culverts on Tyonek Creek.

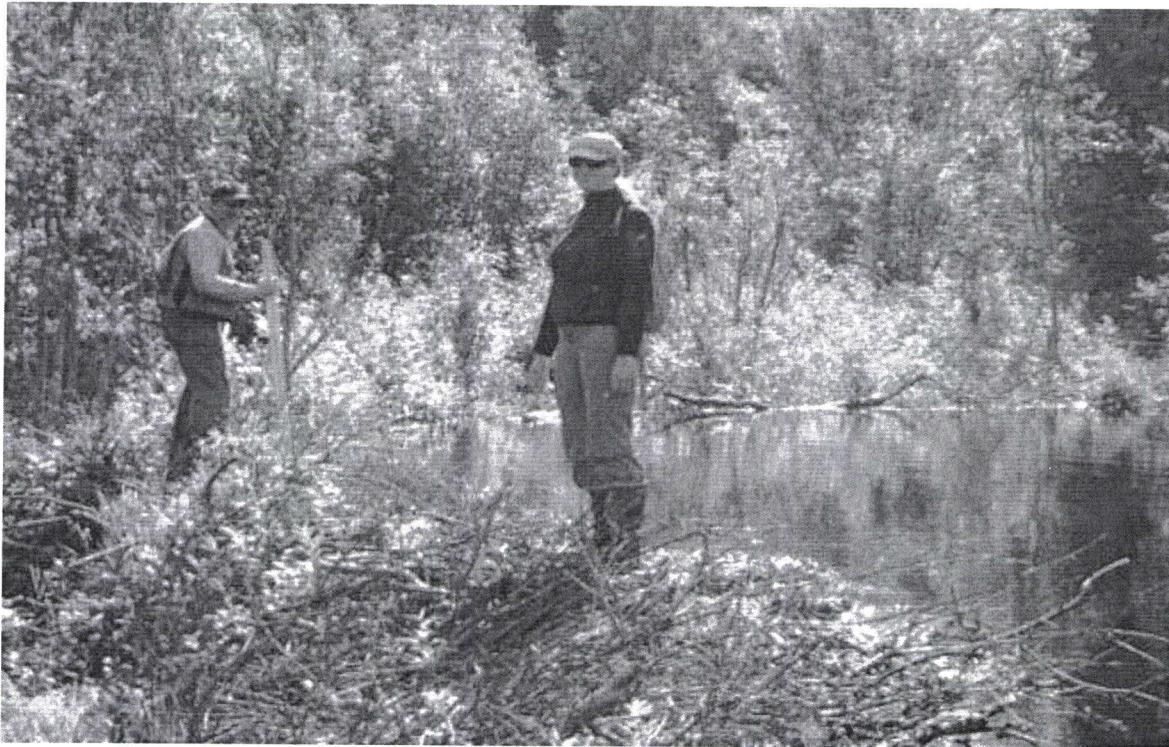
We drove to Road MHT-1002. The road is closed and alder has grown in covering the road. We walked about 1,500 feet to Old Tyonek Creek. A 7-foot high beaver dam is in the location of an old stream crossing (Figure 9). No culvert was located. I observed about 50 juvenile coho salmon in the beaver pond. The juvenile coho salmon will be nominated for addition to the Anadromous Waters Catalog.

Figure 9. Beaver dam on Old Tyonek Creek.

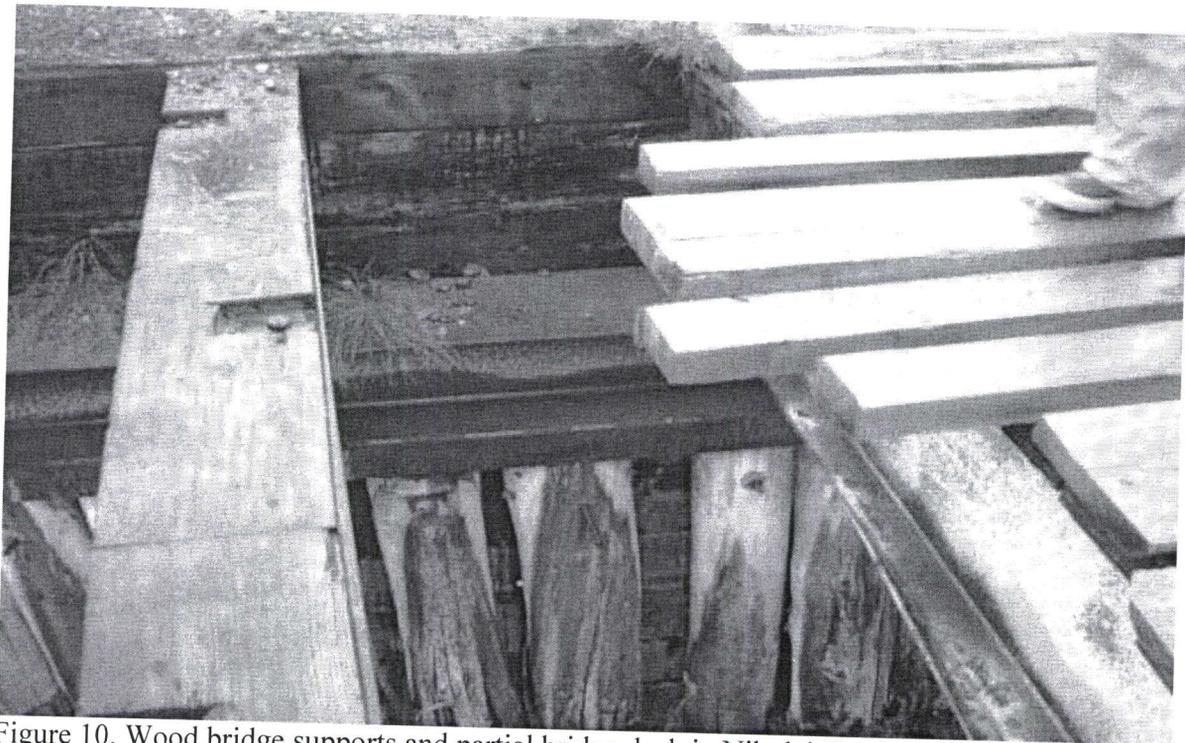
We drove an additional 0.6 miles on Road SOA-1054. We located a 60.5 foot long bridge over Nikolai Creek. The steel bridge is supported by a wood bulkhead (Figure 10). The wood is rotting at ground level. The deck of the bridge has untreated wood beams covering half the bridge width (Figure 10). We did not attempt to cross the bridge with a vehicle. We observed two adult pink salmon below the bridge. The pink salmon will be nominated for addition to the Anadromous Waters Catalog.

Figure 10. Wood bridge supports and partial bridge deck in Nikolai Creek.

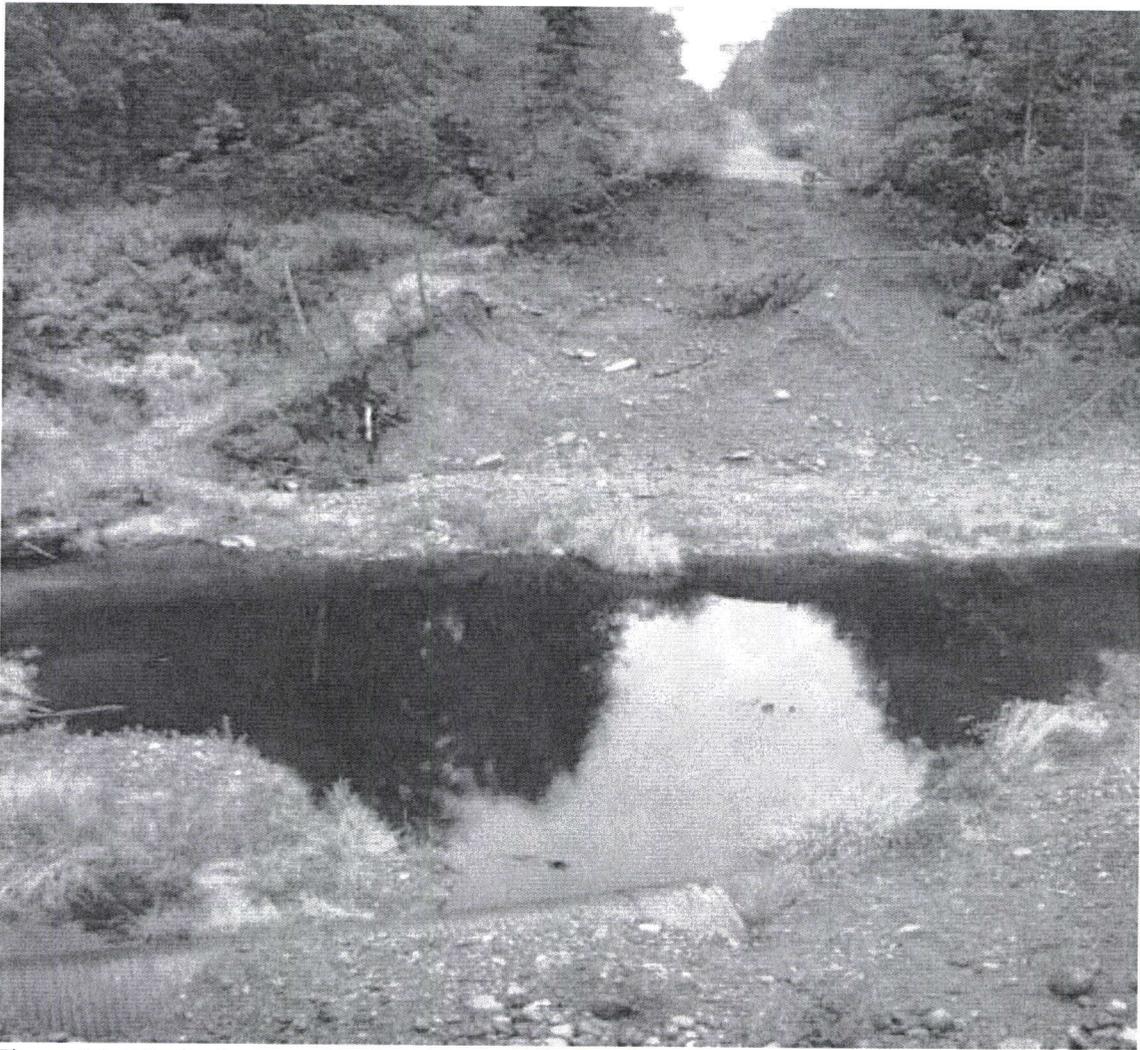
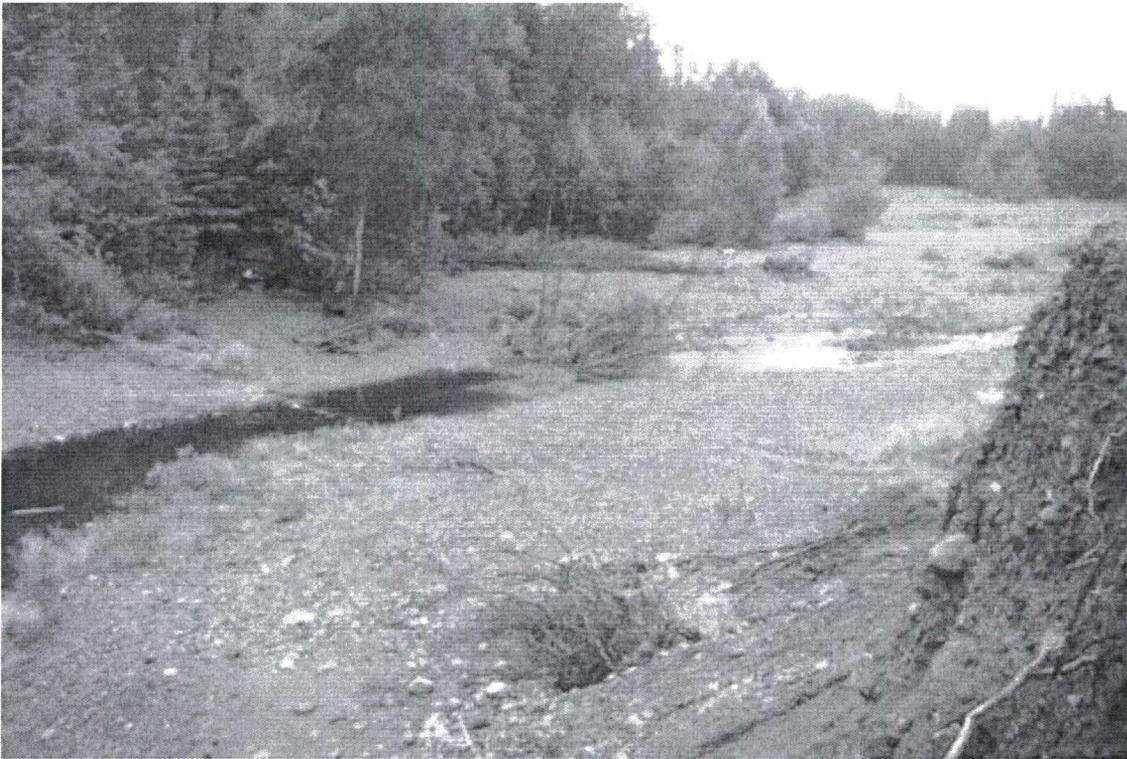
We drove to the site of ADF&G Culvert TYCS1-TY011 located in Three Mile Creek. The 5-foot diameter culvert has failed and about 300 feet of the roadbed has washed into the creek (Figures 11 and 12). The failed roadbed is continuing to erode, discharging sediment into the creek. Three Mile Creek (Stream No. 247-20-10002) is a specified waterbody about 0.5 miles below the road. The ADF&G will require action to be taken to stabilize the roadbed. I sampled the stream about 100 feet above the road and 500 feet below the road. I captured sculpin and stickleback.

Figure 11. Washed out roadbed on Three Mile Creek.

Figure 12. Roadbed in Three Mile Creek.
