Nomination Form
Anadromous Waters Catalog

Region Southcentral USGS Quad(s) Tyonek A-4
 Anadromous Waters Catalog Number of Waterway 247-20-10050-2025
 Name of Waterway Unnamed Tributary Old Tyonek Creek USGS Name Local Name
 Addition Deletion Correction Backup Information

MEMORANDUM

SUBJECT: August 2012 Tyonek Trip Report

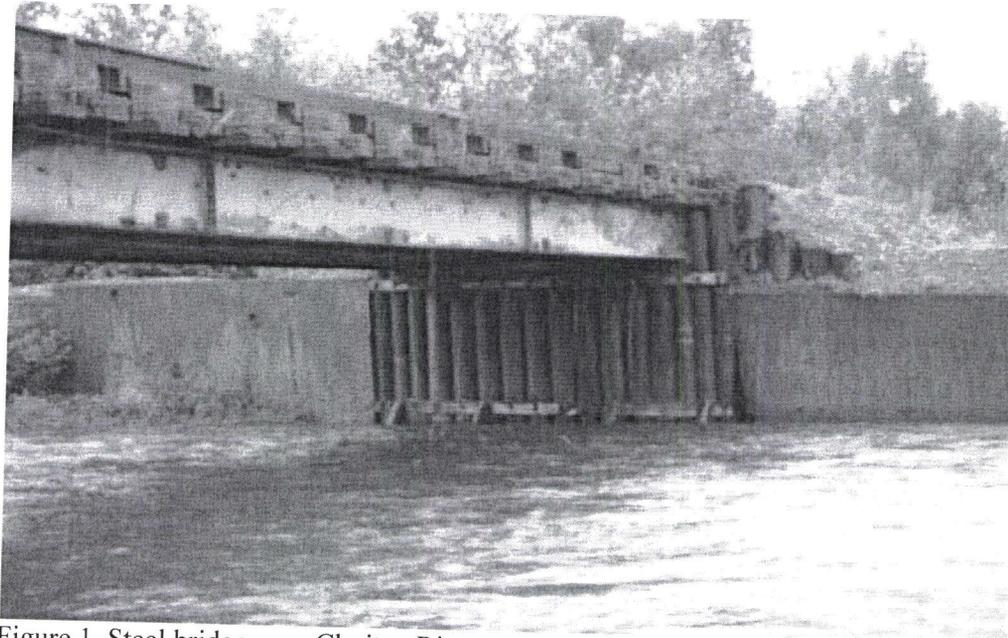
On the afternoon of August 20, Mr. Nudelman, Ms. Alas and I drove from the Beluga Camp to Road TYO-0017. A bridge is located over the Chuitna River (Stream No. 247-20-10010). We inspected a steel bridge supported by old drill casings and sheet pile (Figure 1). An overflow culvert about 8-feet in diameter has been recently installed adjacent to the bridge. I had no site specific concerns with the bridge or culvert.

Figure 1. Steel bridge over Chuitna River.

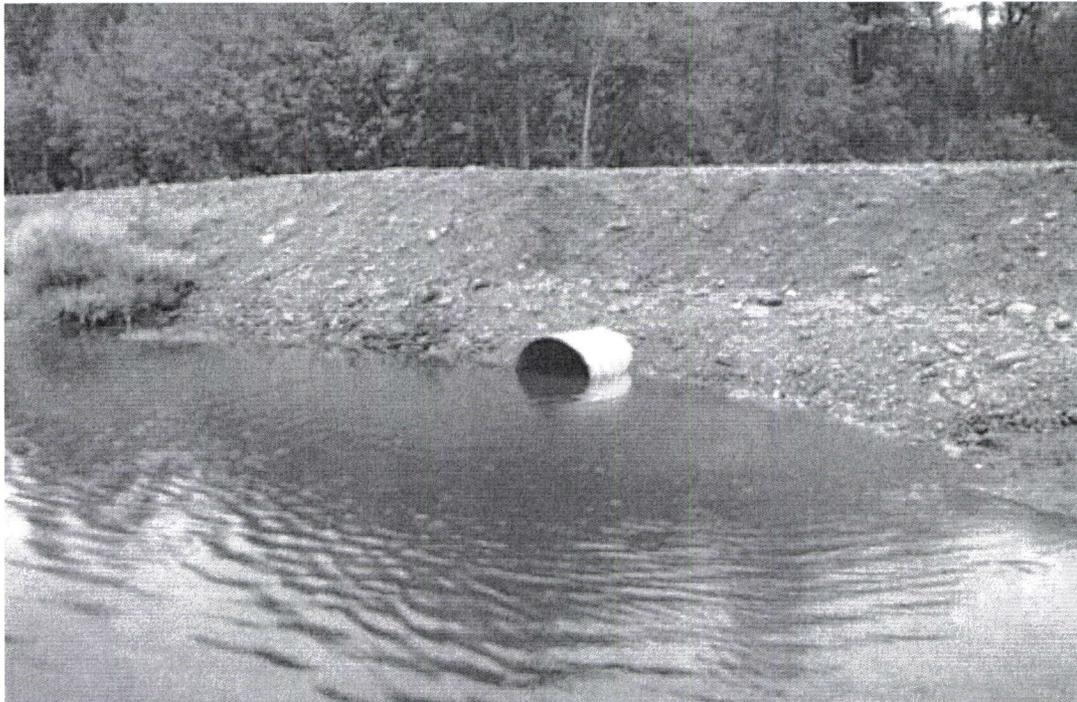
We drove to Road TYO-0015. We set two baited minnow traps in a pond above the road. The pond flows through ADF&G Culvert TYCS1-TY012 into Indian Creek (Stream No. 247-20-10020 (Figure 2)). The traps soaked about three hours. The traps captured stickleback. No other fish were observed. The culvert has structural damage under the road and the diameter is too small to pass fish. The culvert will need to be replaced with a culvert designed for fish passage.

Figure 2. Culvert inlet in Indian Creek.

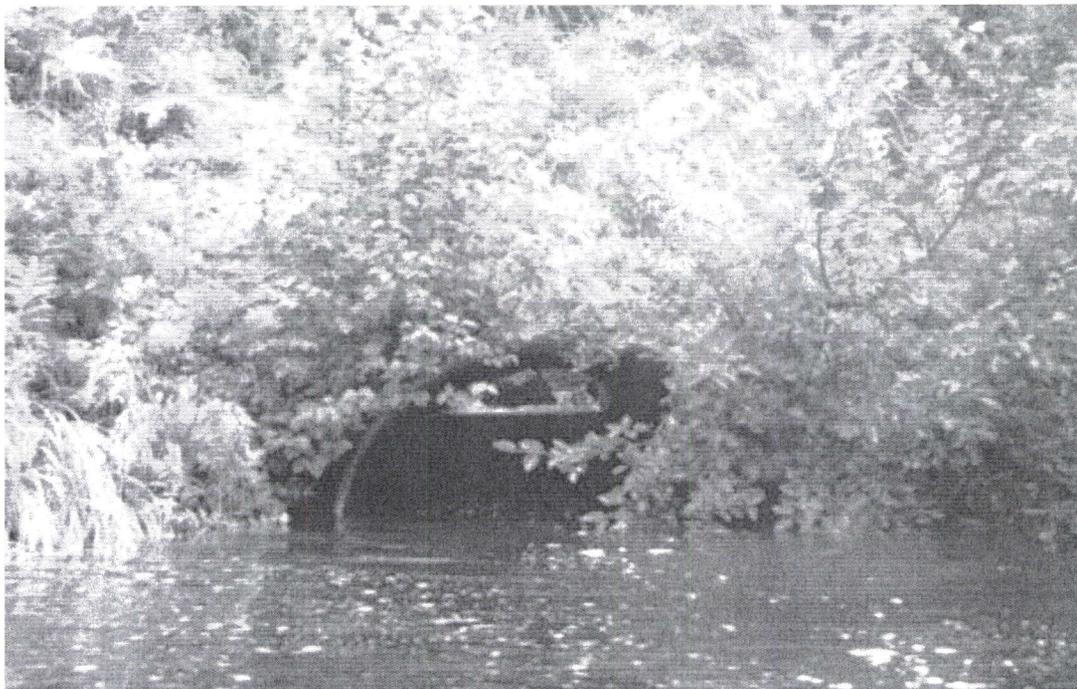
Figure 3. Culvert outlet in Tyonek Creek.

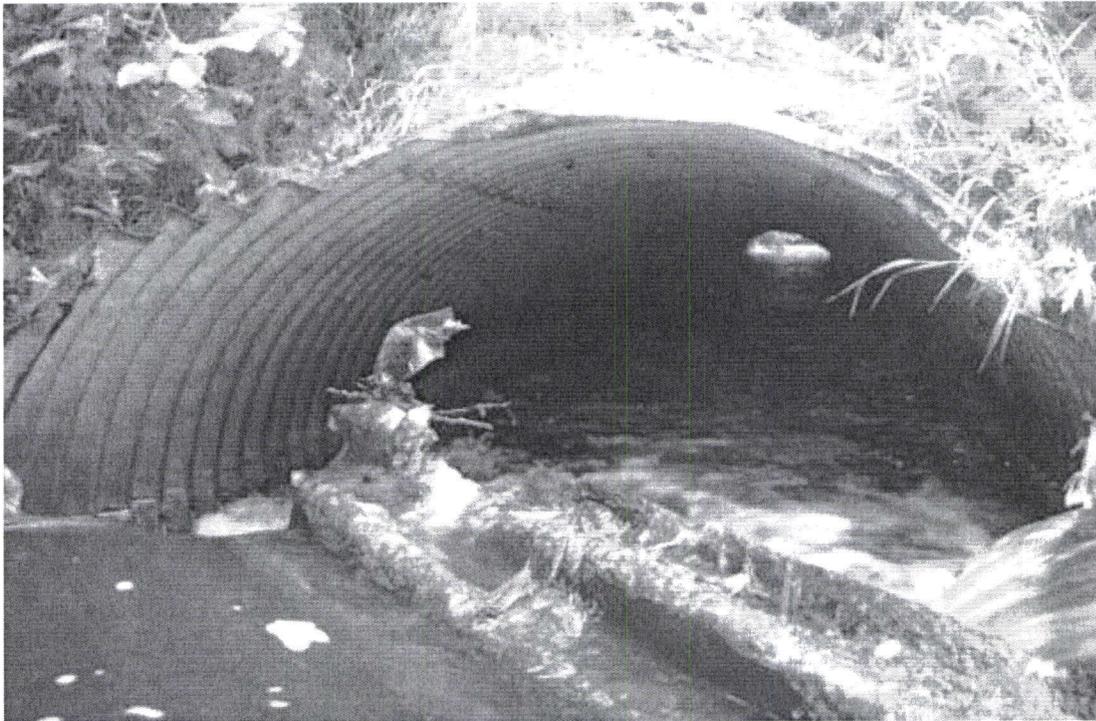
We drove to Road TYO-00013. The road crosses Tyonek Creek (Stream No. 247-20-10040). Tyonek Creek flows through ADF&G Culvert TYCS1-TY014 (Figure 3). The steel culvert invert has folded back into the culvert inlet and is preventing fish passage (Figure 4). The culvert will need the damaged steel removed to restore fish passage.

Figure 4. Failed culvert inlet in Tyonek Creek.

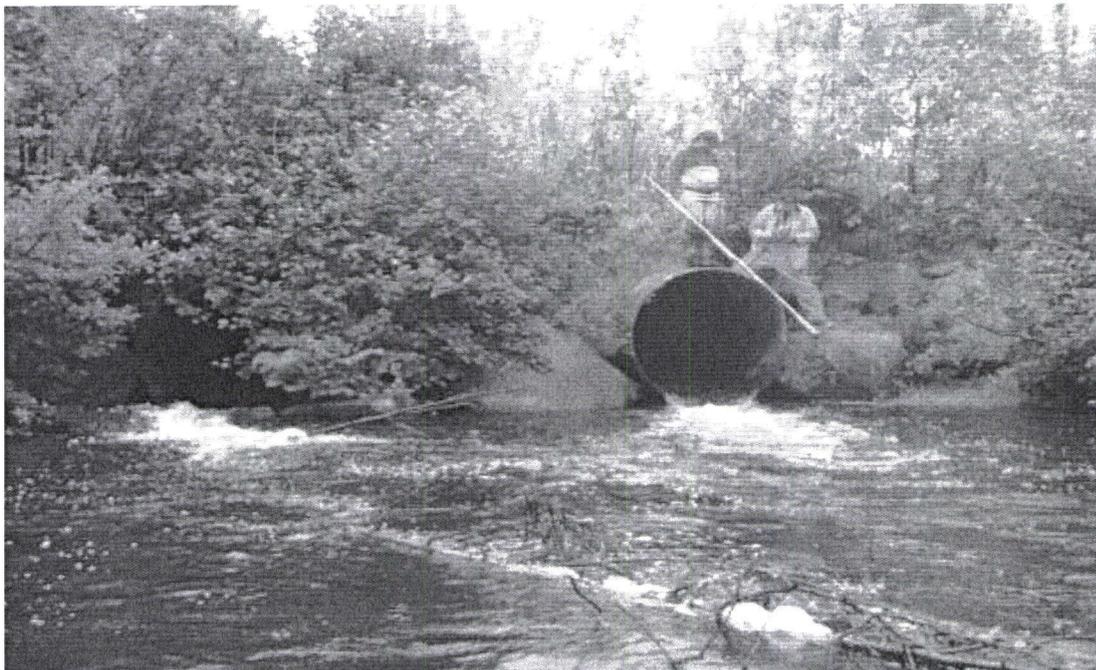
We drove to Road TYO-0006. The road crosses Tyonek Creek. Tyonek Creek flows through ADF&G Culvert TYCS1-TY016 (Figure 5). The twin culverts may be a barrier to fish passage. The ADF&G recommends the culverts are removed and a bridge installed.

Figure 5. Outlet of twin culverts in Tyonek Creek.

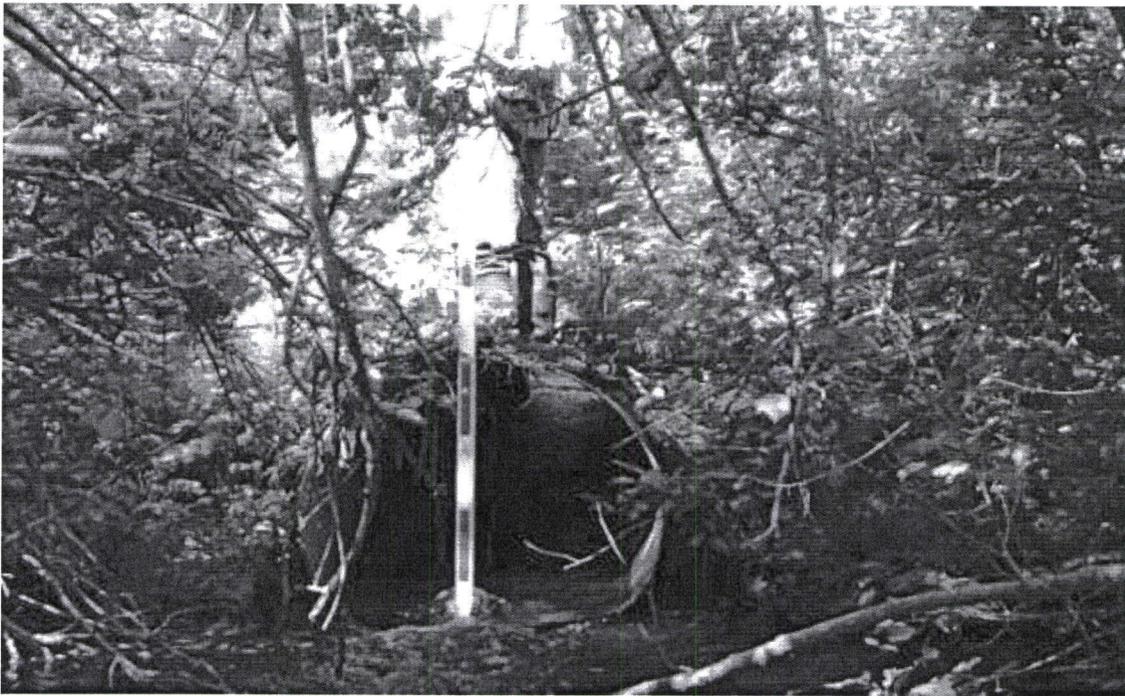
On the morning of August 21, Mr. Nudelman, Mr. Winters, Ms. Alas, and I drove to Road SOA1061. The road crosses an unnamed tributary (Stream No. 247-20-10050-2025) of Old Tyonek Creek. The unnamed tributary flows through ADF&G Culvert TYCS1-TY028 (Figure 6). I observed juvenile coho salmon about 200 feet above the culvert inlet in pool habitat. The water clarity was excellent. The juvenile coho salmon will be nominated for addition to the Anadromous Waters Catalog. The culvert may be a barrier to fish passage. The ADF&G recommends the culvert is removed and a bridge is installed.

Figure 6. Culvert outlet in unnamed tributary Old Tyonek Creek.

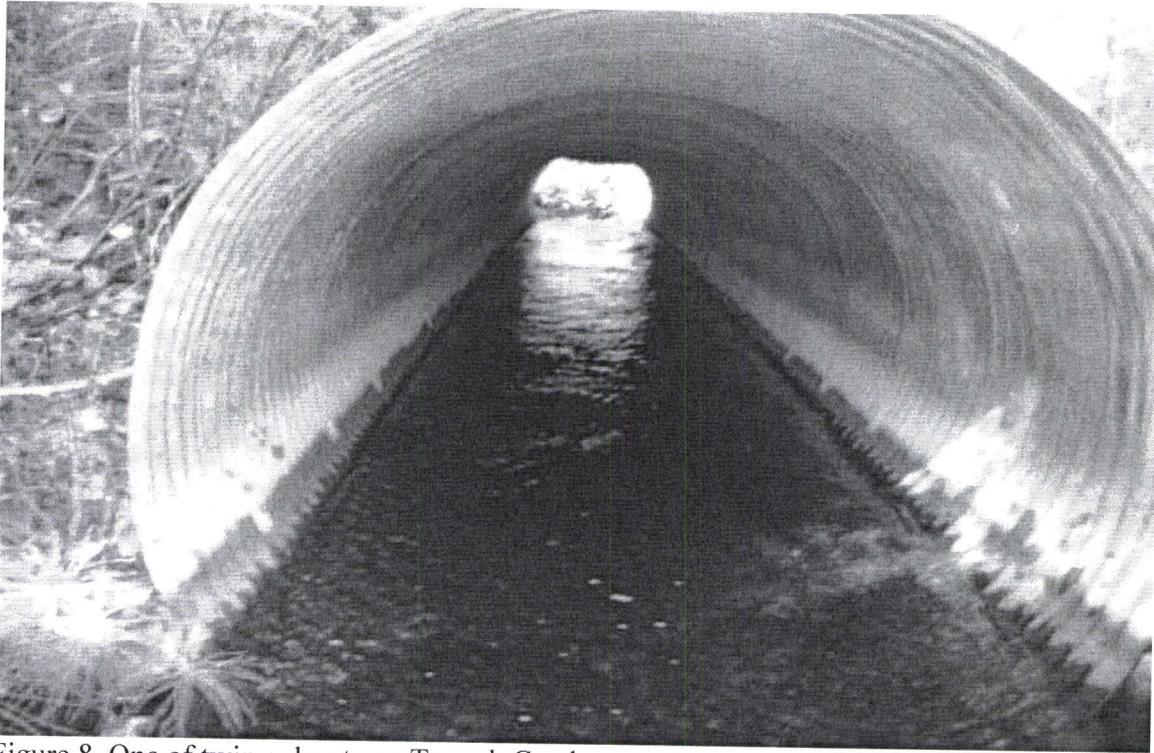
We drove to Road TYO-0011. The road crosses Tyonek Creek which flows through twin ADF&G Culverts TYCS1-TY008 (Figure 8). I observed 5 juvenile coho salmon about 500 feet below the culvert outlet in pool habitat. The juvenile coho salmon will be nominated for addition to the Anadromous Waters Catalog. The culverts may not be a barrier to fish passage.

Figure 8. One of twin culverts on Tyonek Creek.

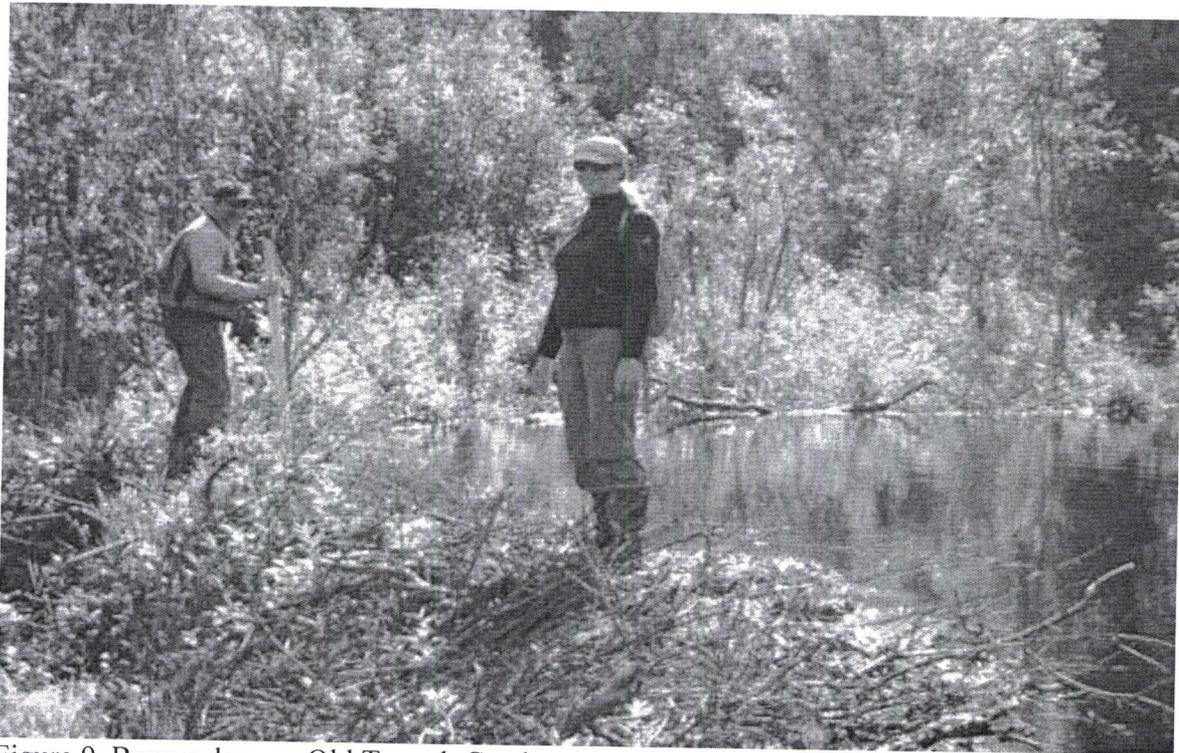
We drove to Road MHT-1002. The road is closed and alder has grown in covering the road. We walked about 1,500 feet to Old Tyonek Creek. A 7-foot high beaver dam is in the location of an old stream crossing (Figure 9). No culvert was located. I observed about 50 juvenile coho salmon in the beaver pond. The juvenile coho salmon will be nominated for addition to the Anadromous Waters Catalog.

Figure 9. Beaver dam on Old Tyonek Creek.

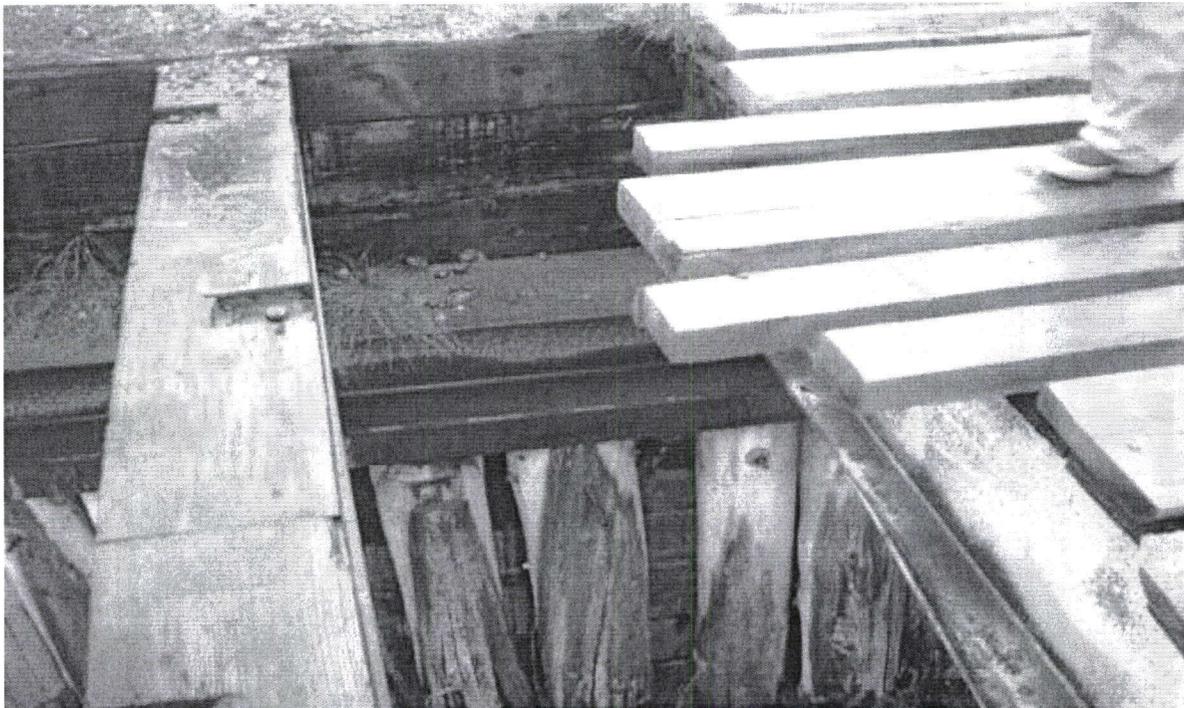
We drove an additional 0.6 miles on Road SOA-1054. We located a 60.5 foot long bridge over Nikolai Creek. The steel bridge is supported by a wood bulkhead (Figure 10). The wood is rotting at ground level. The deck of the bridge has untreated wood beams covering half the bridge width (Figure 10). We did not attempt to cross the bridge with a vehicle. We observed two adult pink salmon below the bridge. The pink salmon will be nominated for addition to the Anadromous Waters Catalog.

Figure 10. Wood bridge supports and partial bridge deck in Nikolai Creek.

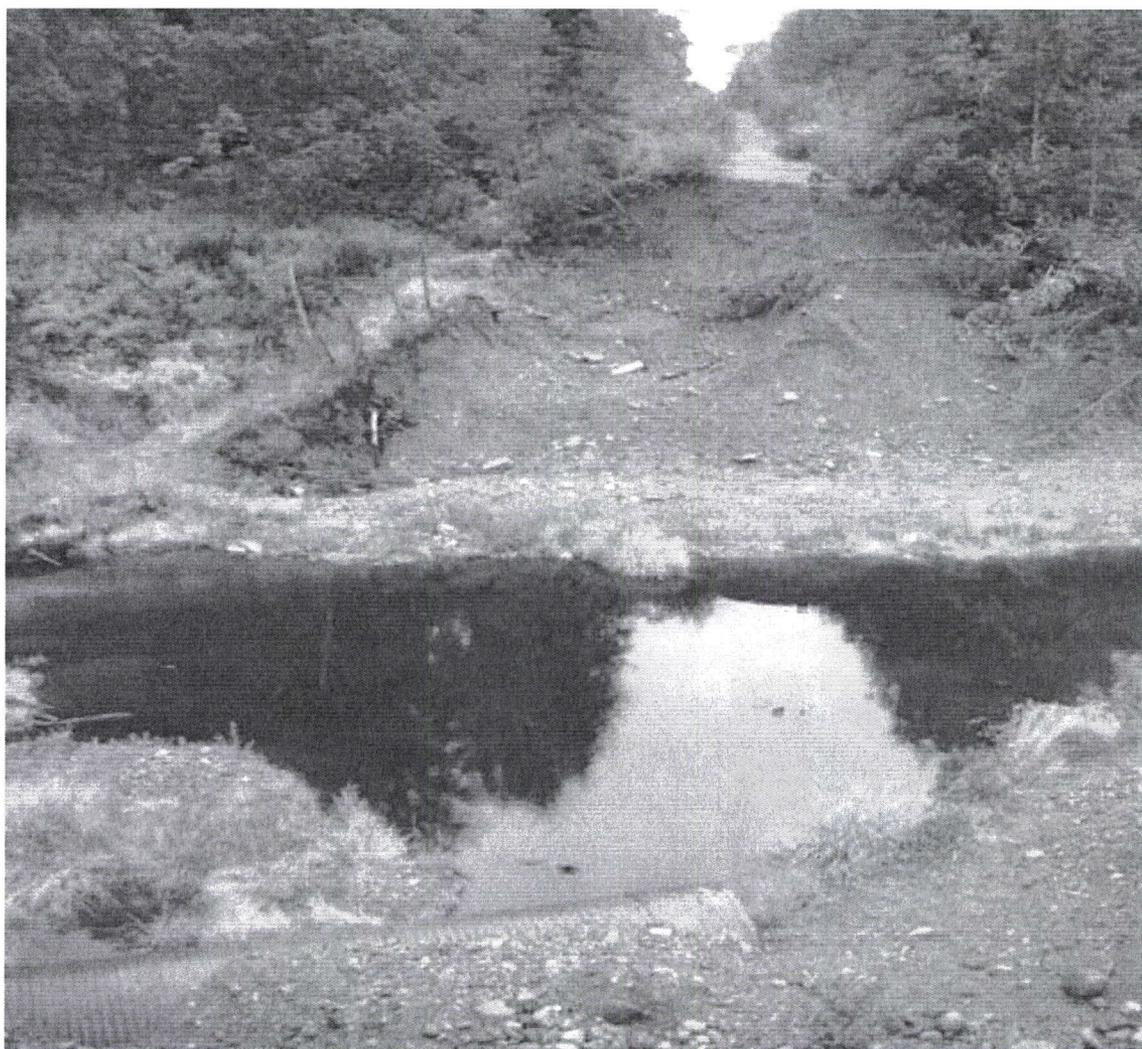
We drove to the site of ADF&G Culvert TYCS1-TY011 located in Three Mile Creek. The 5-foot diameter culvert has failed and about 300 feet of the roadbed has washed into the creek (Figures 11 and 12). The failed roadbed is continuing to erode, discharging sediment into the creek. Three Mile Creek (Stream No. 247-20-10002) is a specified waterbody about 0.5 miles below the road. The ADF&G will require action to be taken to stabilize the roadbed. I sampled the stream about 100 feet above the road and 500 feet below the road. I captured sculpin and stickleback.

Figure 11. Washed out roadbed on Three Mile Creek.

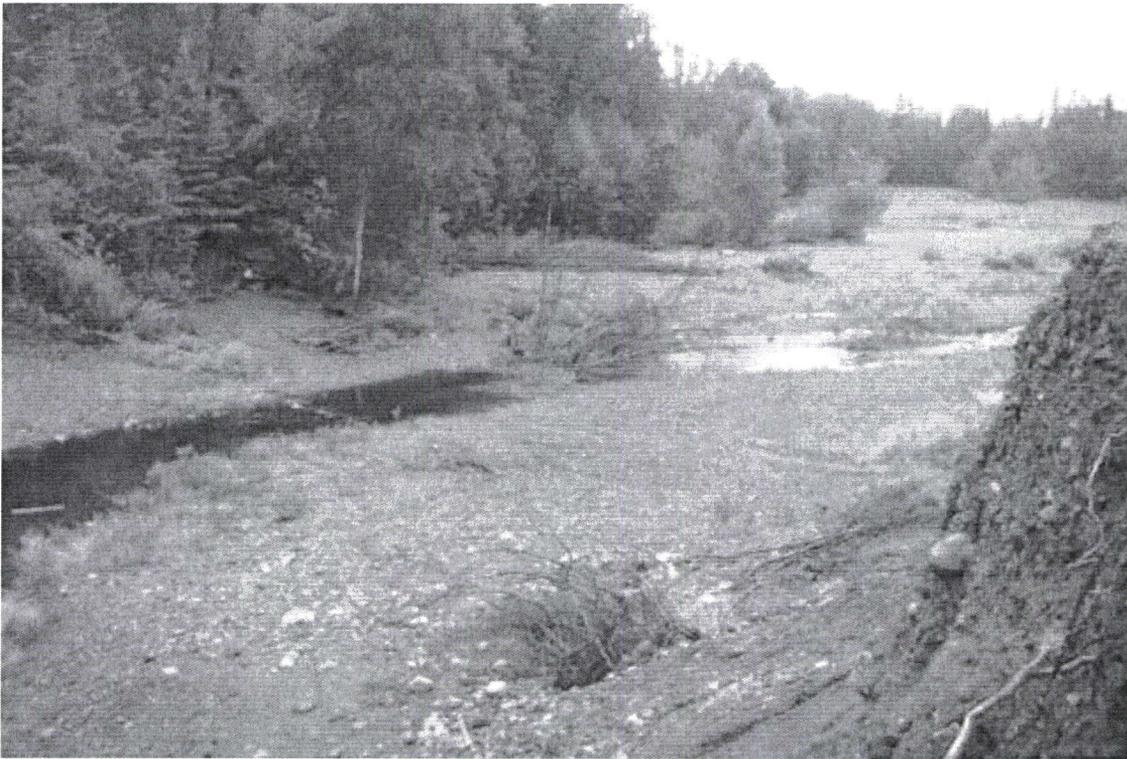
Figure 12. Roadbed in Three Mile Creek.
