State of Alaska  
Department of Fish and Game  
Division of Sport Fish

Nomination Form  
Anadromous Waters Catalog

SUBJECT: July 2014 RCS Seldovia Trip Report

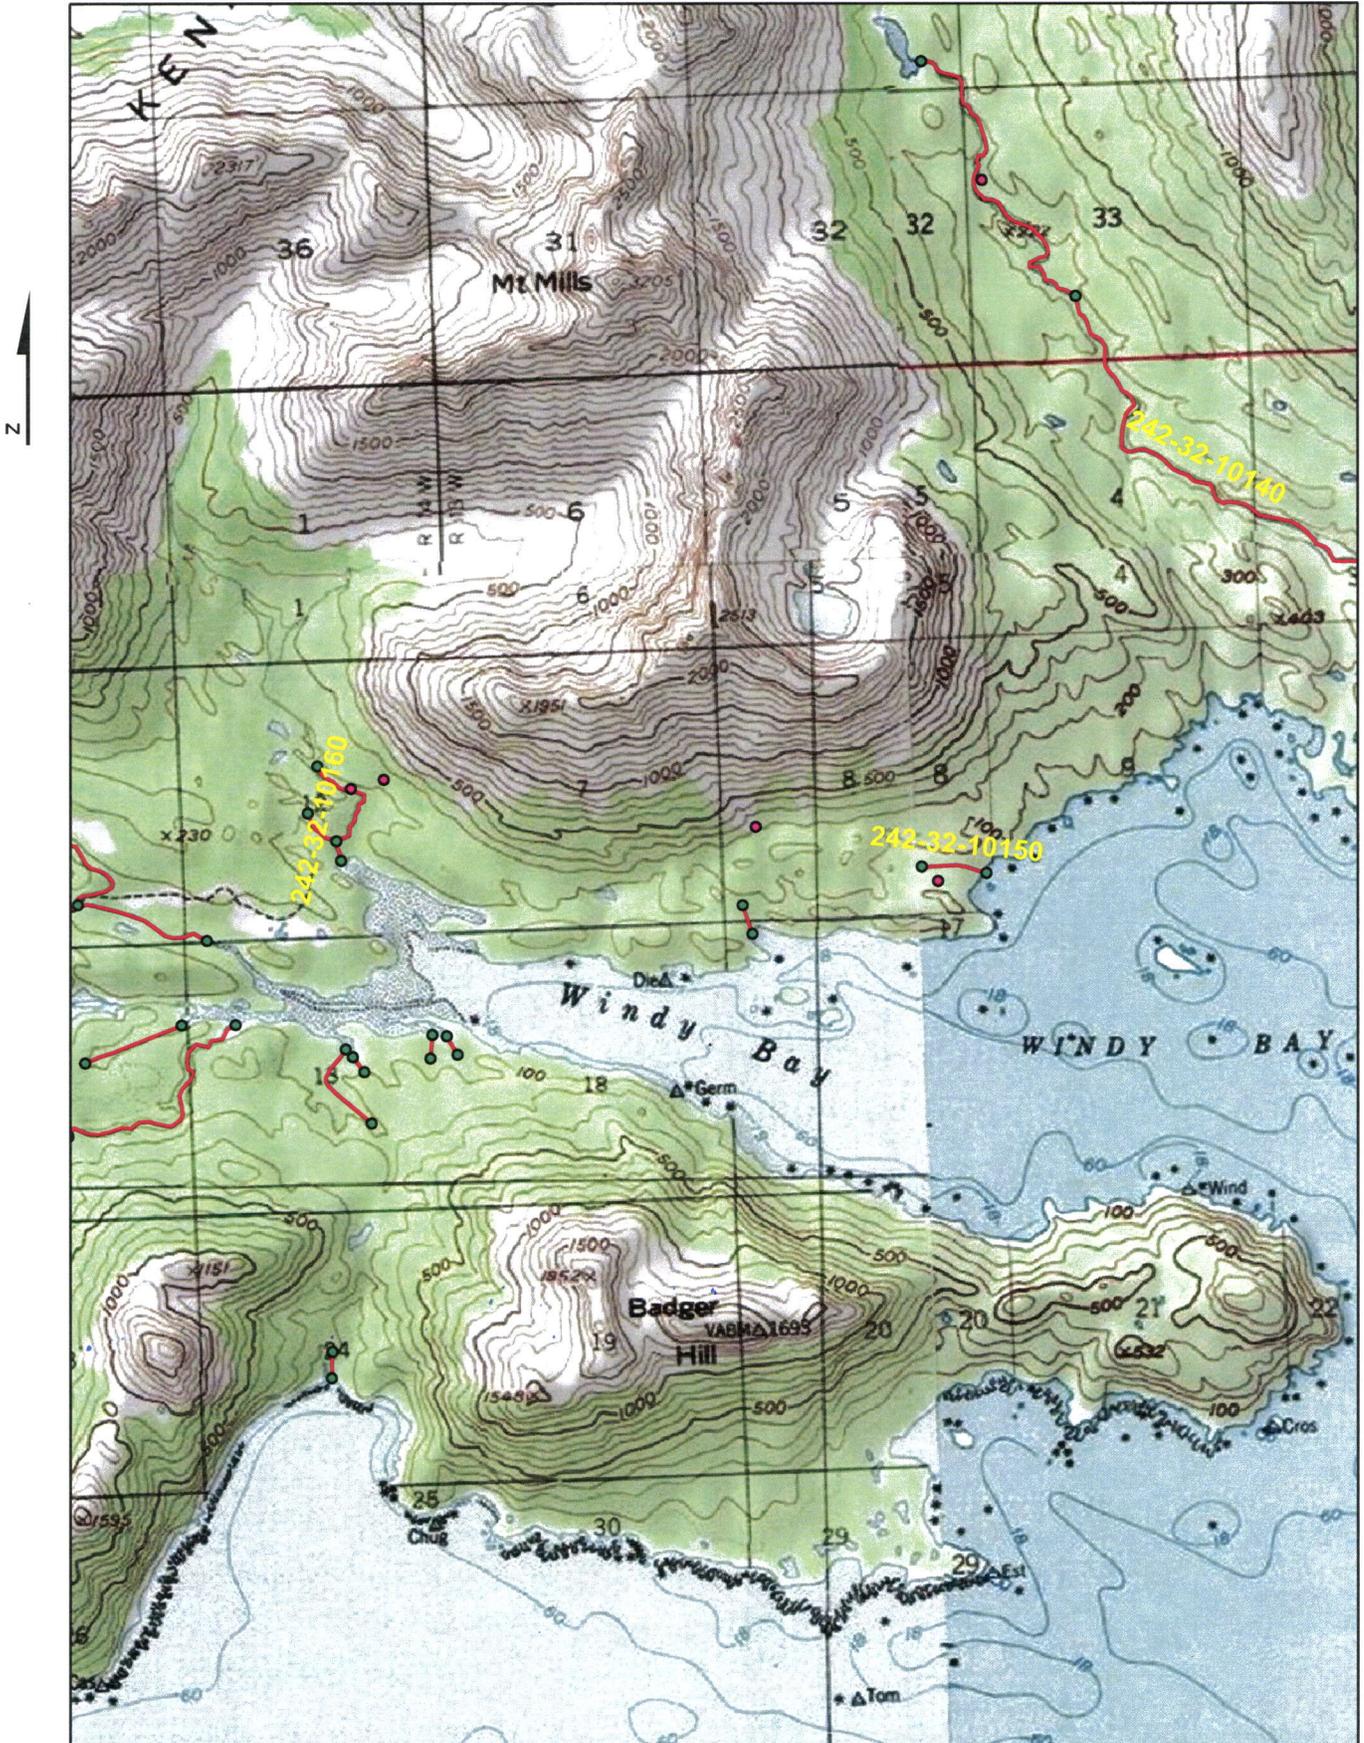
Figure 1

I observed adult pink salmon spawning in Stream No. 242-32-10160 during FRPA road condition survey (Figures 1 and 2). See July 21-25, 2014 Trip Report.

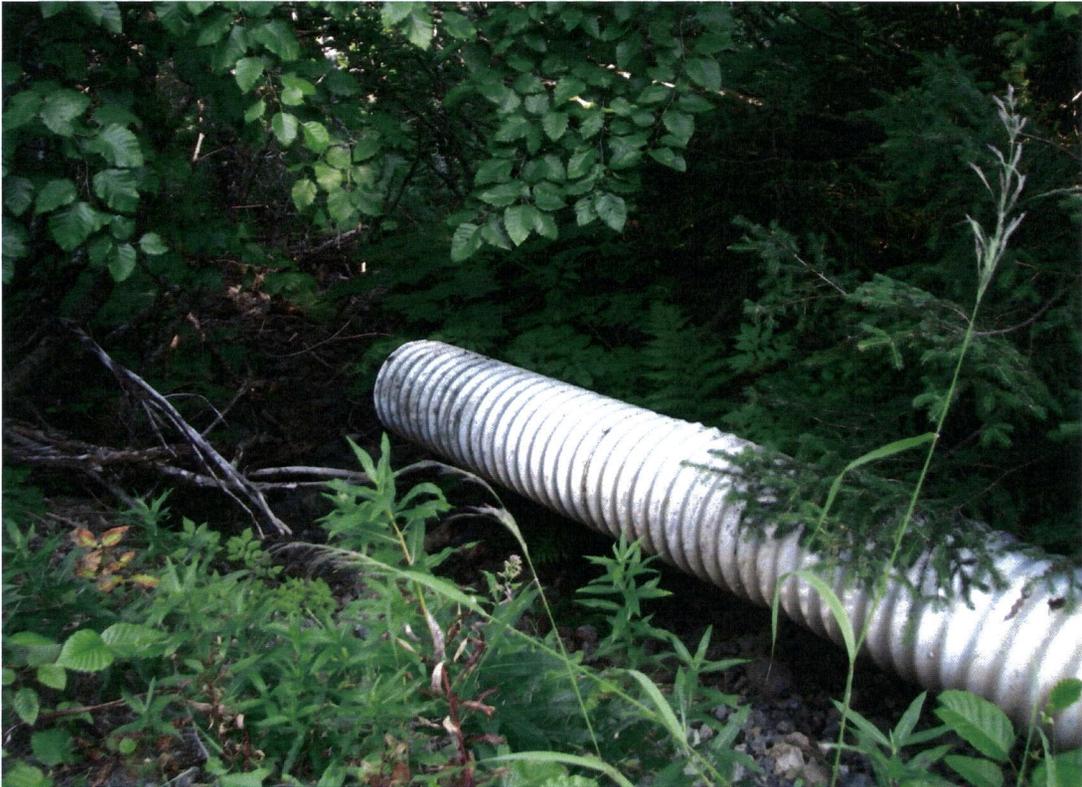
While walking back to the truck, we used a hand held GPS to document the location of culverts located on the State of Alaska road. We observed an 18-inch diameter culvert that was located in a non-fish bearing stream (Figure 1). About 8 feet of pipe extended beyond the downstream side of the road embankment. The stream gradient below the culvert was about 40%. A barrier was located directly above the culvert. We walked about 600 meters along the road and observed a railroad car steel tank that was used to convey a non-fish bearing stream under the road (Figure 2). The culvert diameter was about 6 feet. The stream gradient was about 35%. We walked an additional 220 meters to a 42-inch diameter culvert located in a non-fish bearing stream (Figure 3). At the time of our site visit, the stream was dry. We walked about 200 meters to Stream No. 241-16-10040-2020. Twin steel culverts were exposed in the roadbed (Figure 4). The stream has flanked the culverts and no longer flows through the culverts (Figure 5). About 50 feet above the road, I observed a possible barrier to fish passage (Figure 6). The Anadromous Waters Catalog indicates the stream is specified for pink salmon an additional 1 kilometer above the

Figure 1. An 18-inch diameter culvert located in a non-fish bearing stream.

barrier. The ADF&G recommends the stream above the barrier be sampled for the presence of fish to determine if the specified reach should be reduced to the barrier. We walked about 300 meters and located where Jakolof Creek has washed away the road. Because of the washout vehicle traffic is limited to ATVs. ATVs must cross Jackolof Creek to use the road.

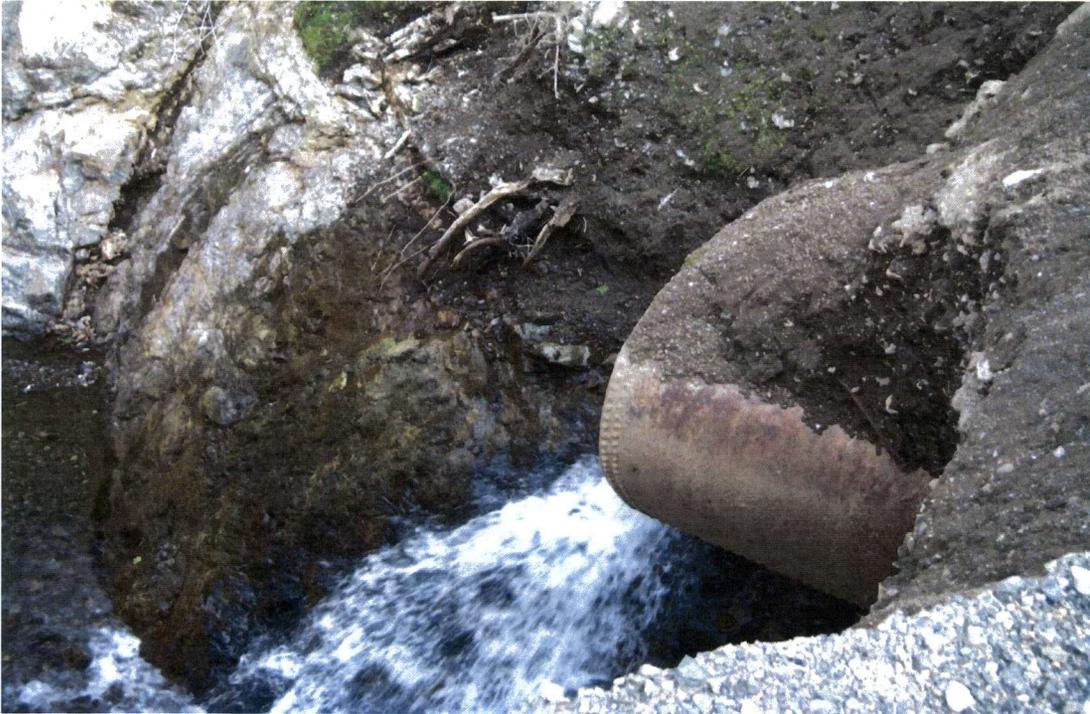
Figure 2. A railroad car steel tank located in a non-fish bearing stream under the state road.

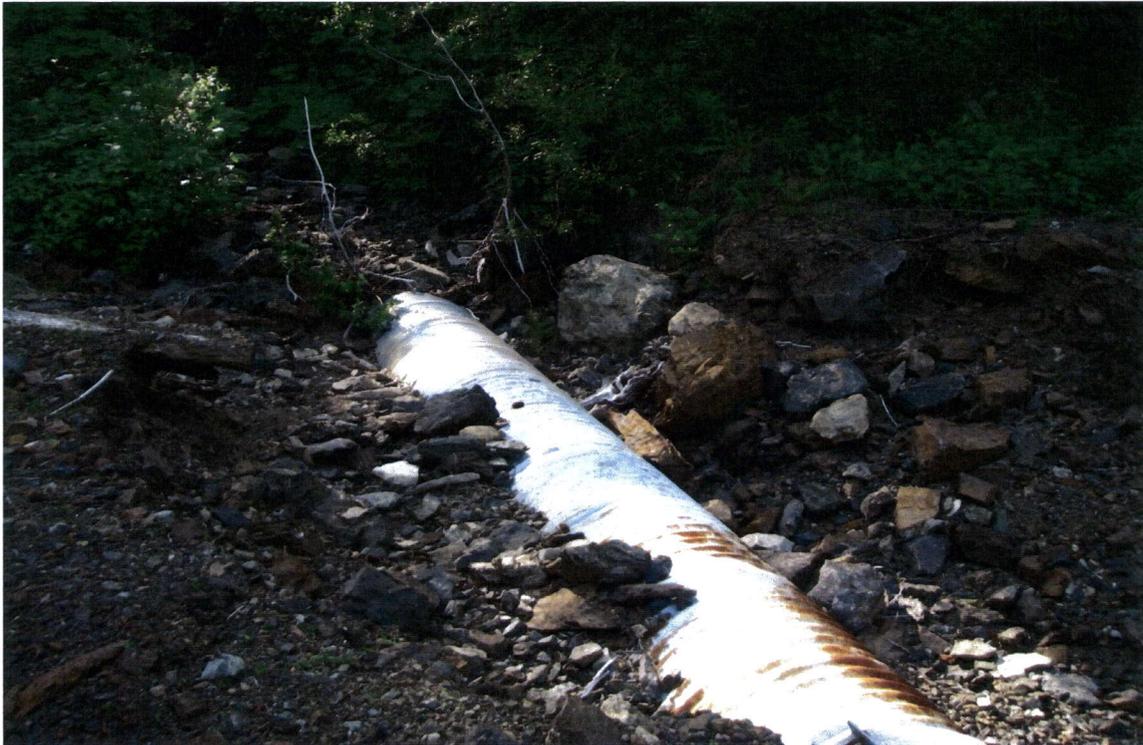
Figure 3. A 42-inch diameter culvert located in a non-fish bearing stream.

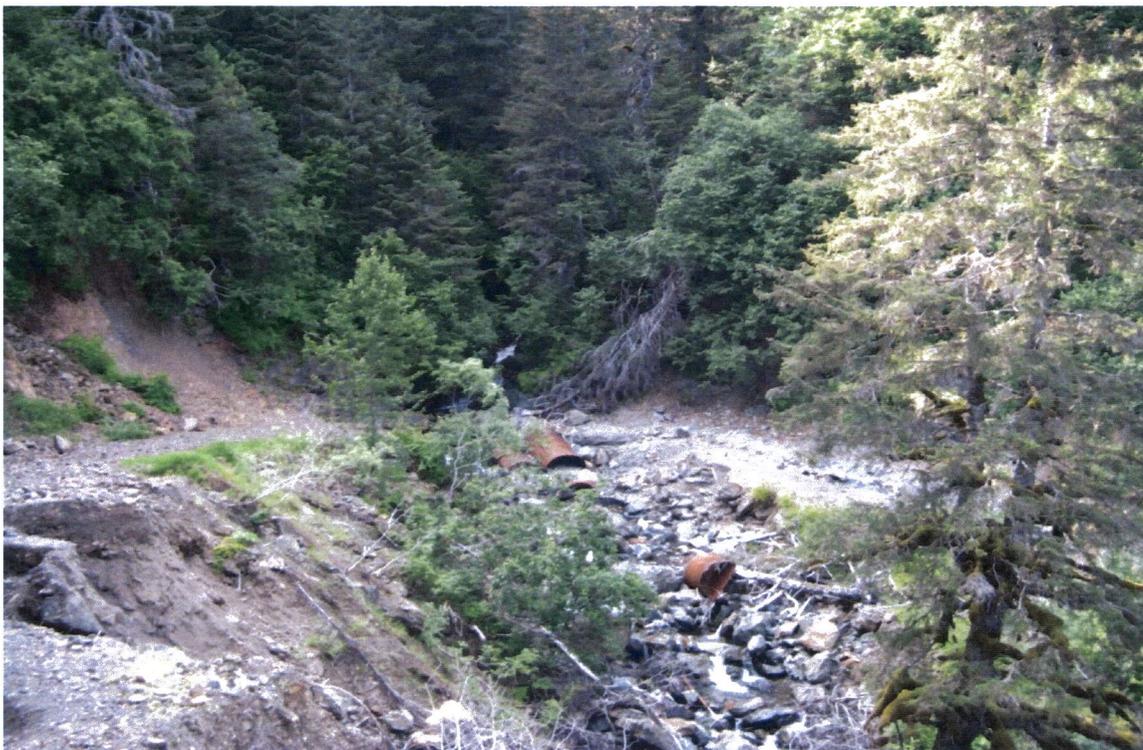
Figure 4. Twin culverts located in Stream No. 241-16-10040-2020.

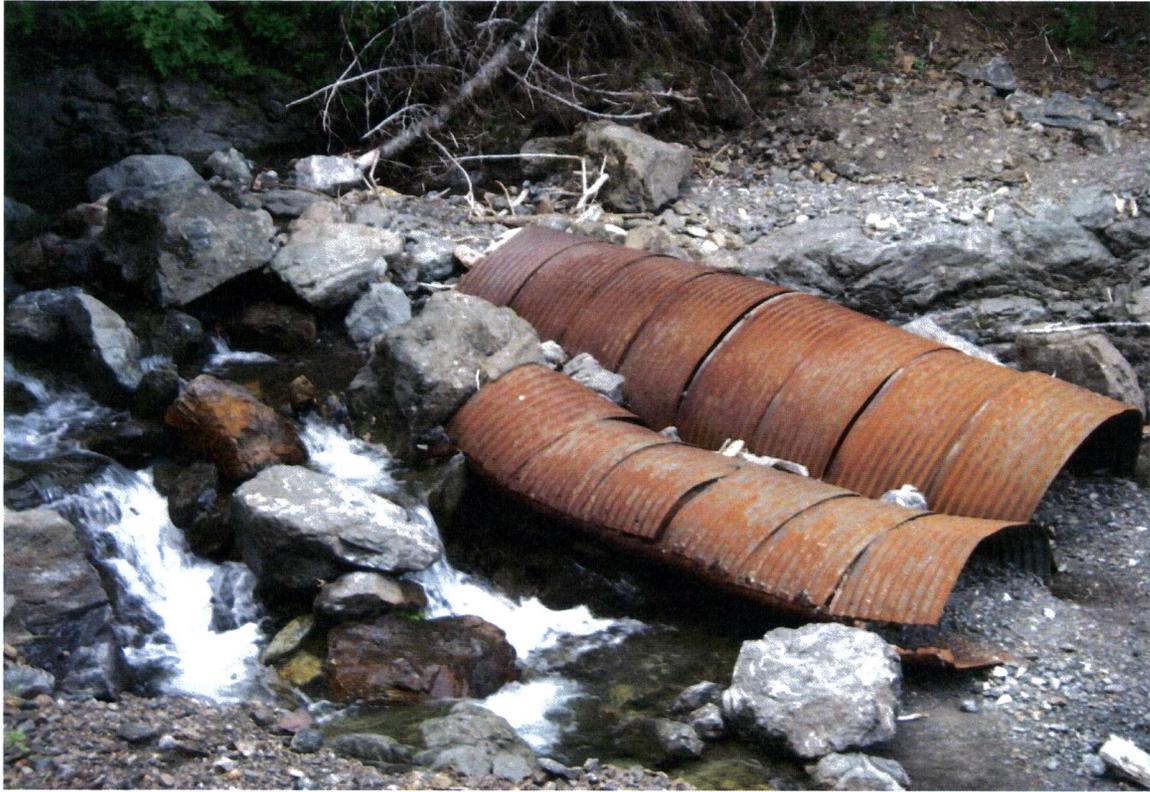
Figure 5. Twin culverts located in Stream No. 241-16-10040-2020.

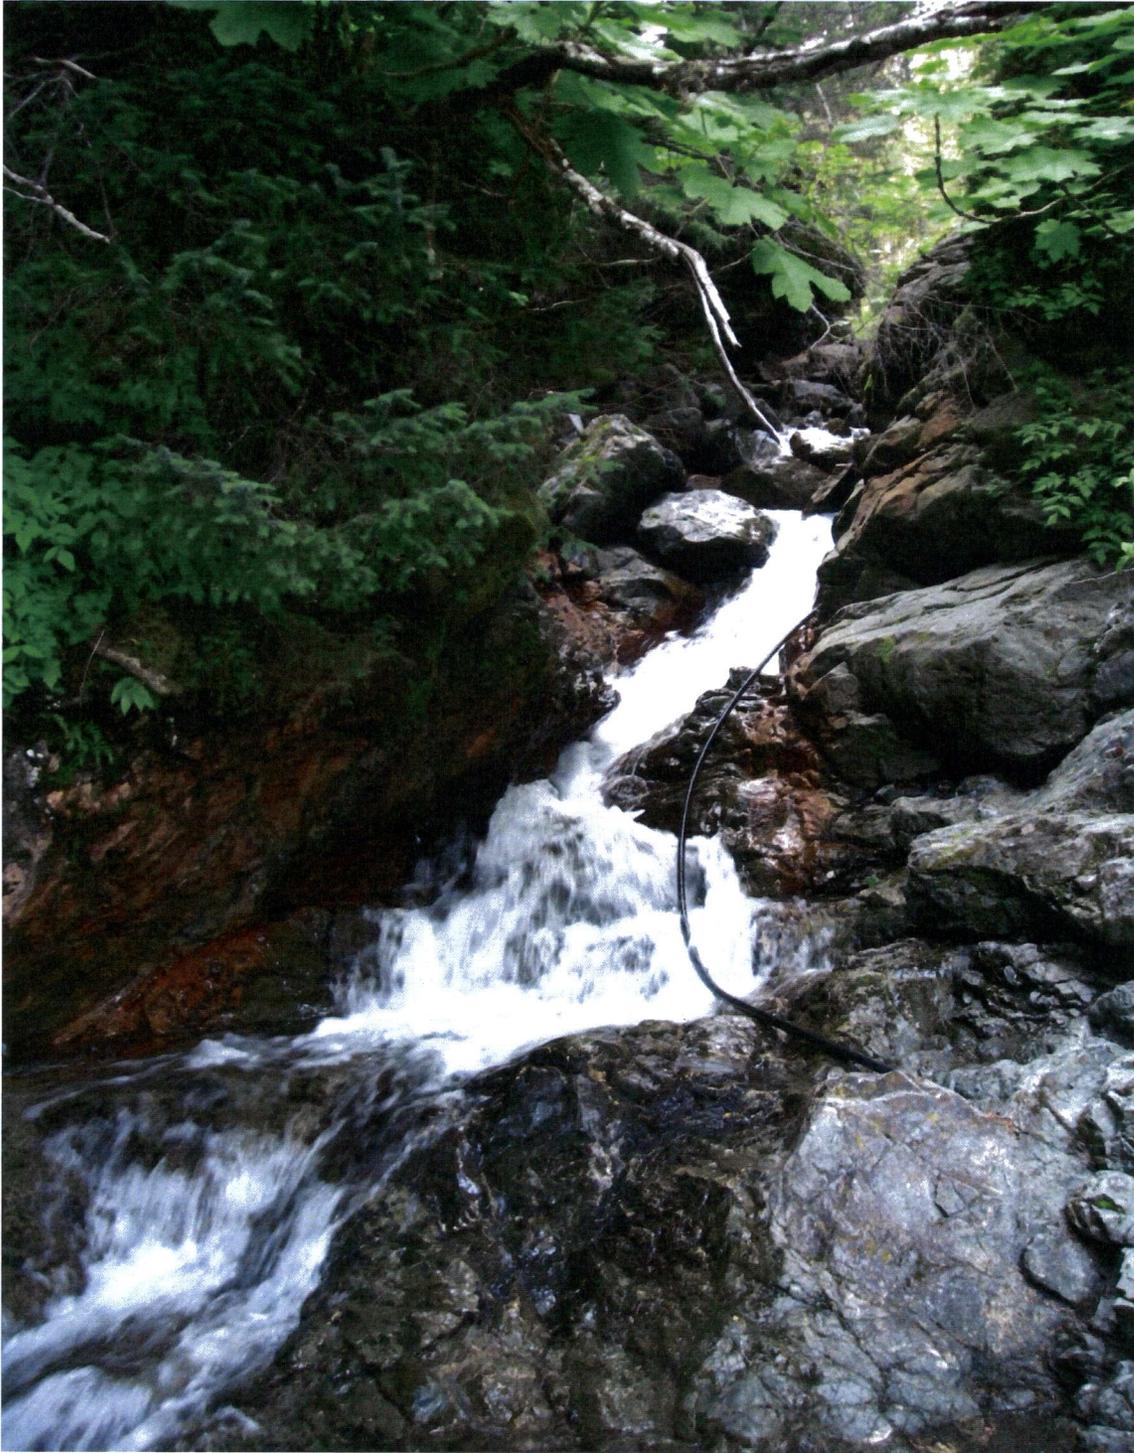
Figure 6. Possible barrier above state road in Stream No. 241-16-10040-2020.

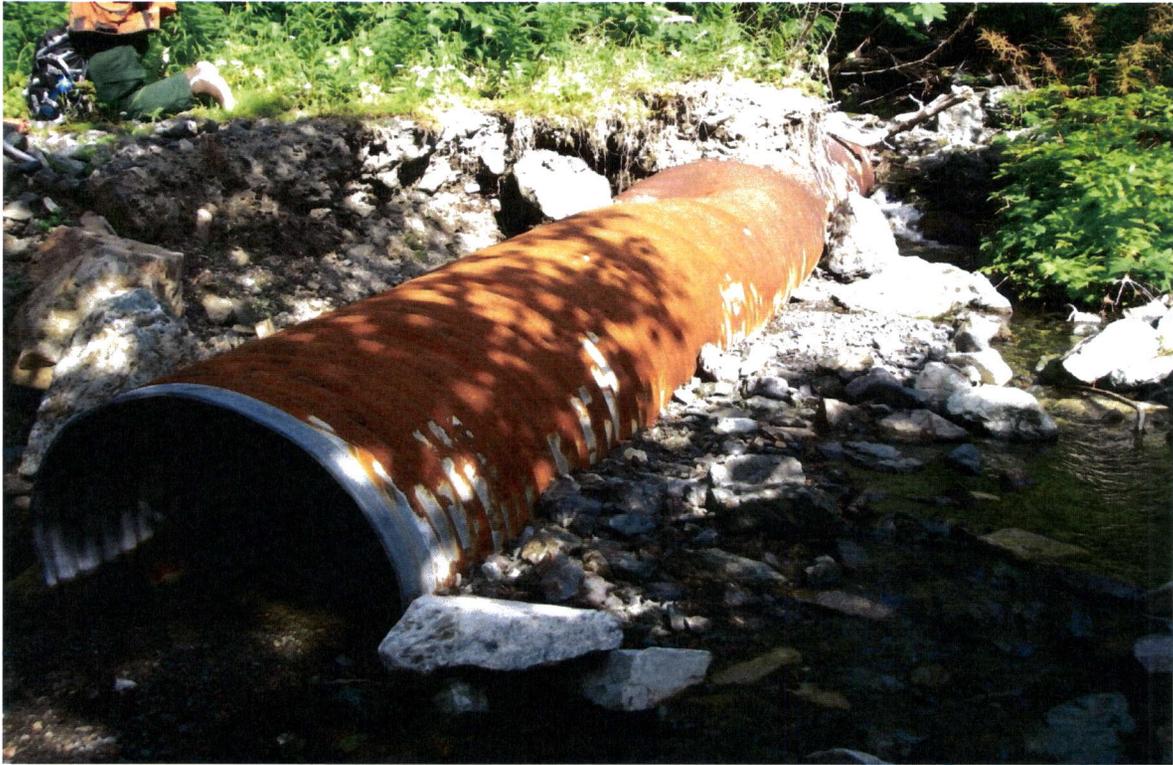
Figure 7. A 36-inch diameter culvert located in Road PGC-0004.

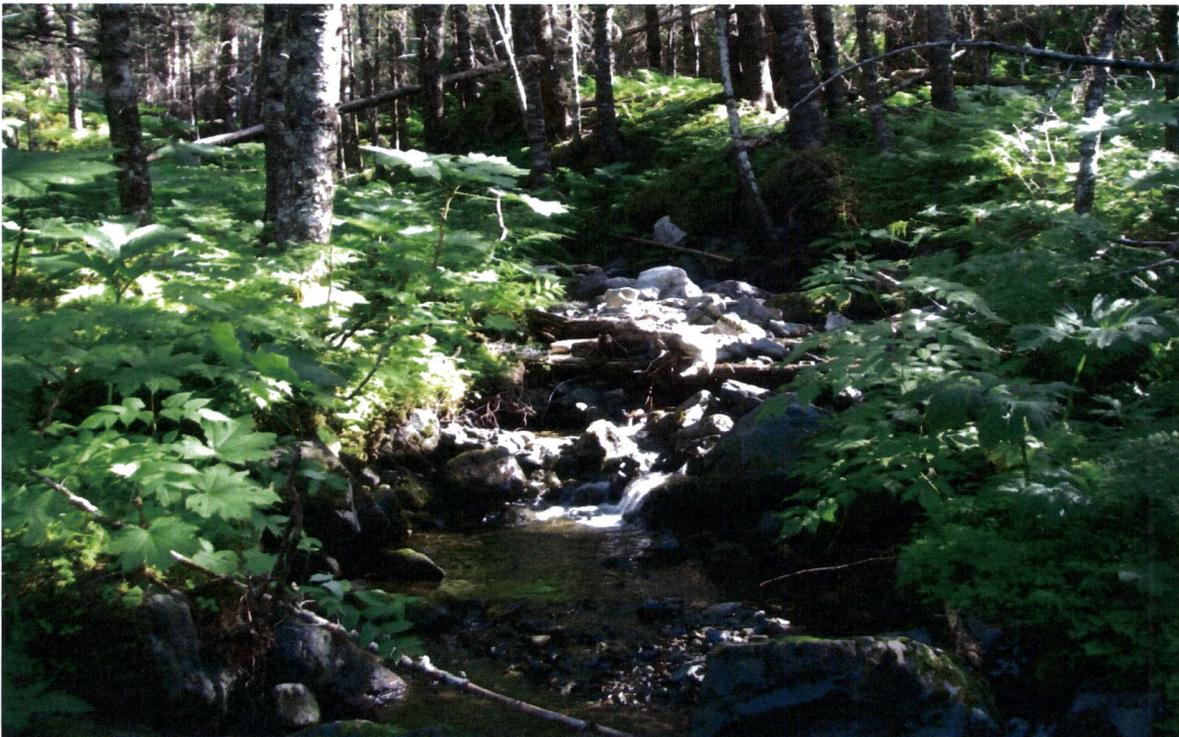
Figure 8. Stream below a 36-inch diameter culvert located in Road PGC-0004.

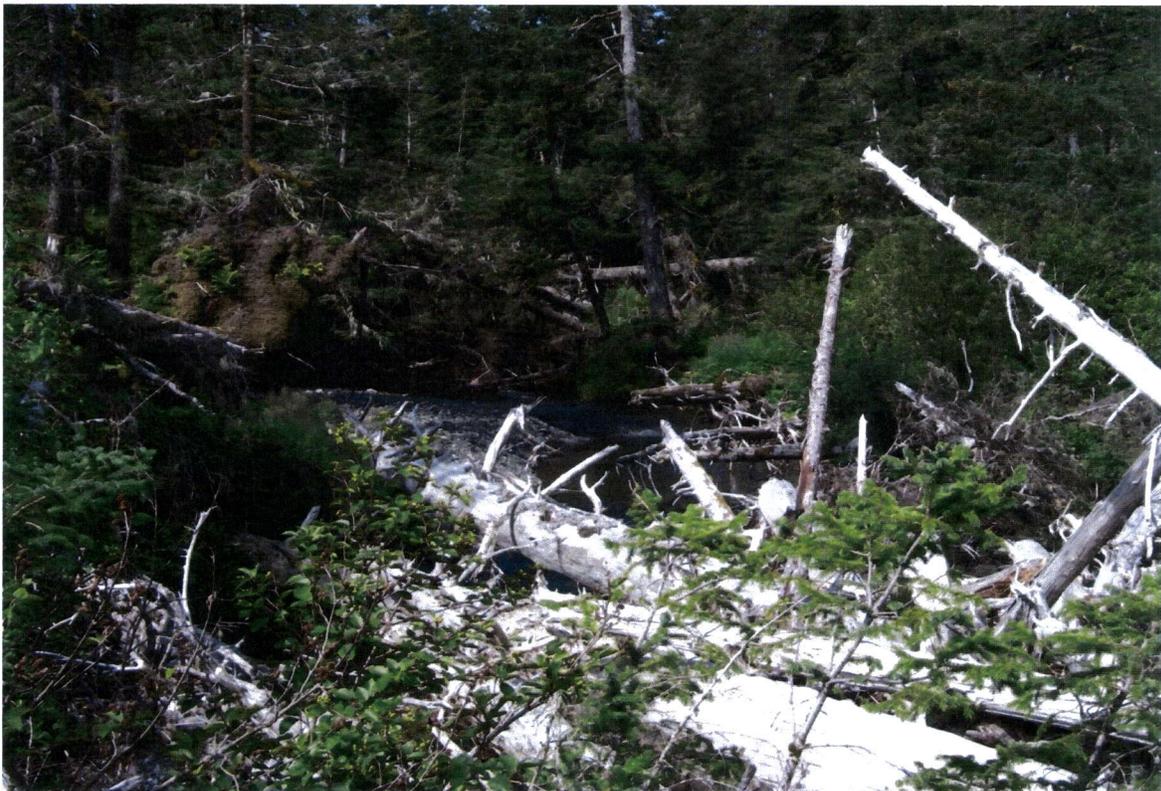
Figure 10. Log jam located upstream of a failed bridge over Stream No. 242-32-10160.

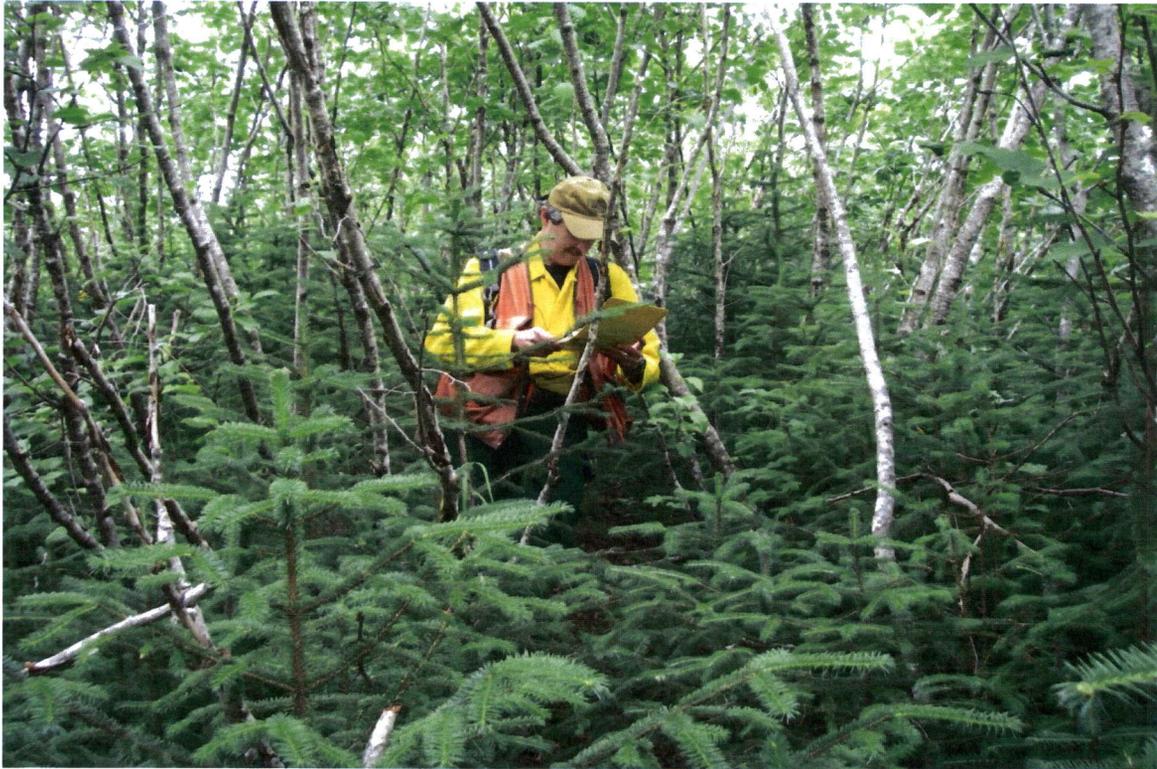
We returned to the helicopter and flew to a spur road off Road PGC-0081. The spur road was overgrown with alder and spruce (Figure 11). We located a log bridge over Stream No. 242-32-10150. The ADF&G will require the log bridge be removed. The location of the stream in the Anadromous Waters Catalog is in the wrong location. The correct stream location will be nominated for update in the Anadromous Waters Catalog.

Figure 11. Overgrown spur road off Road PGC-0081.

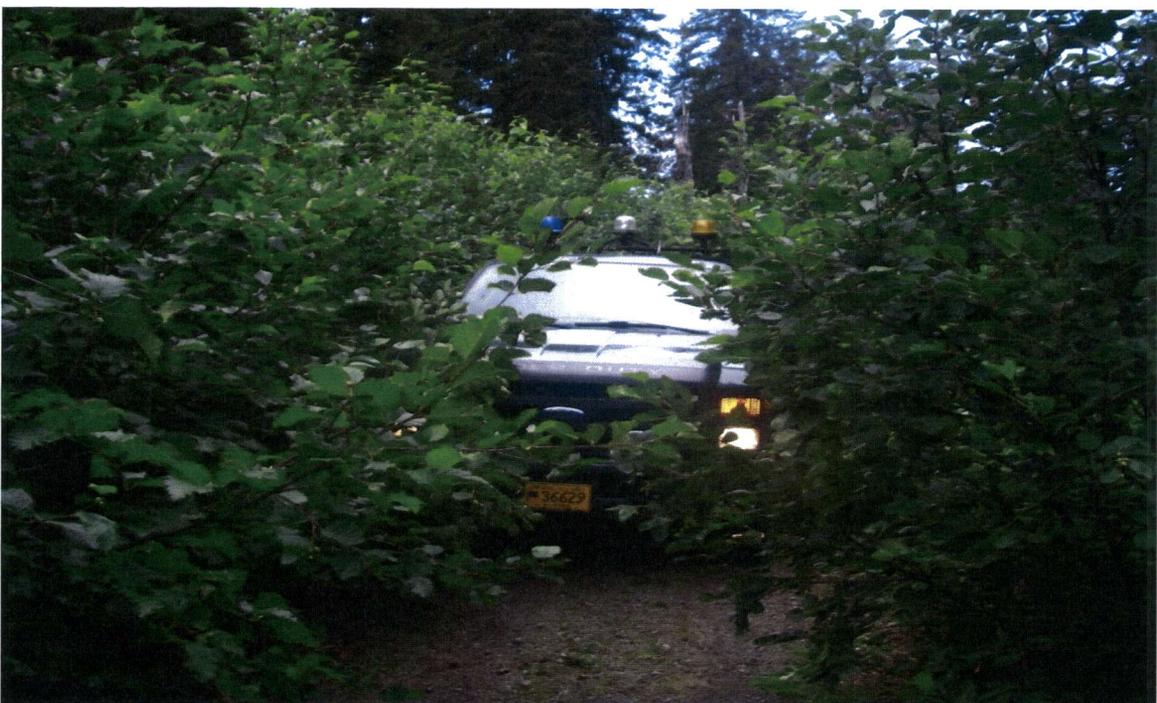
On the afternoon of July 23, we drove to Roads SNA-0012 and SNA-0014, and SNA-0031. The roads were overgrown with alder preventing vehicle use (Figure 12). On Road SNA-0031 we located two log bridges over dry stream channels. We walked up an abandoned spur road to Road SNA-0012 and located a failed log bridge over Stream No. 241-16-10040-2013-3009. I observed juvenile coho salmon in the stream channel. The ADF&G will require the bridge be removed. We located a perched 15-inch diameter culvert on Road SNA-0012. The culvert is located about 50 meters above the specified reach of Stream No. 241-16-10040-2013-3009-4008. The ADF&G will require the culvert be removed. We located two log bridges on Road SNA-0012. The first bridge was recently installed over a dry stream channel and the second bridge was over Stream No. 241-16-10040-2013-3009. The second bridge was in fair condition. We walked to Road SNA-0014 and located a perched 32-inch diameter culvert about 860 meters

Figure 12. Overgrown Road SNA-0031.

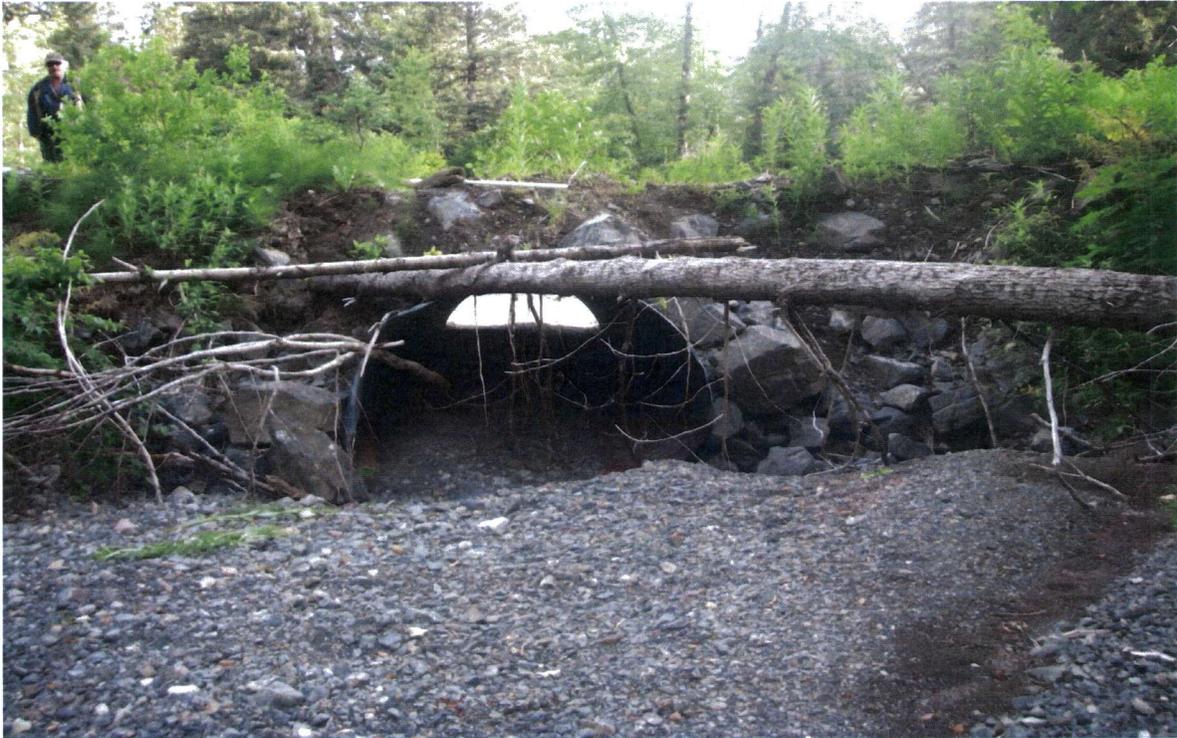
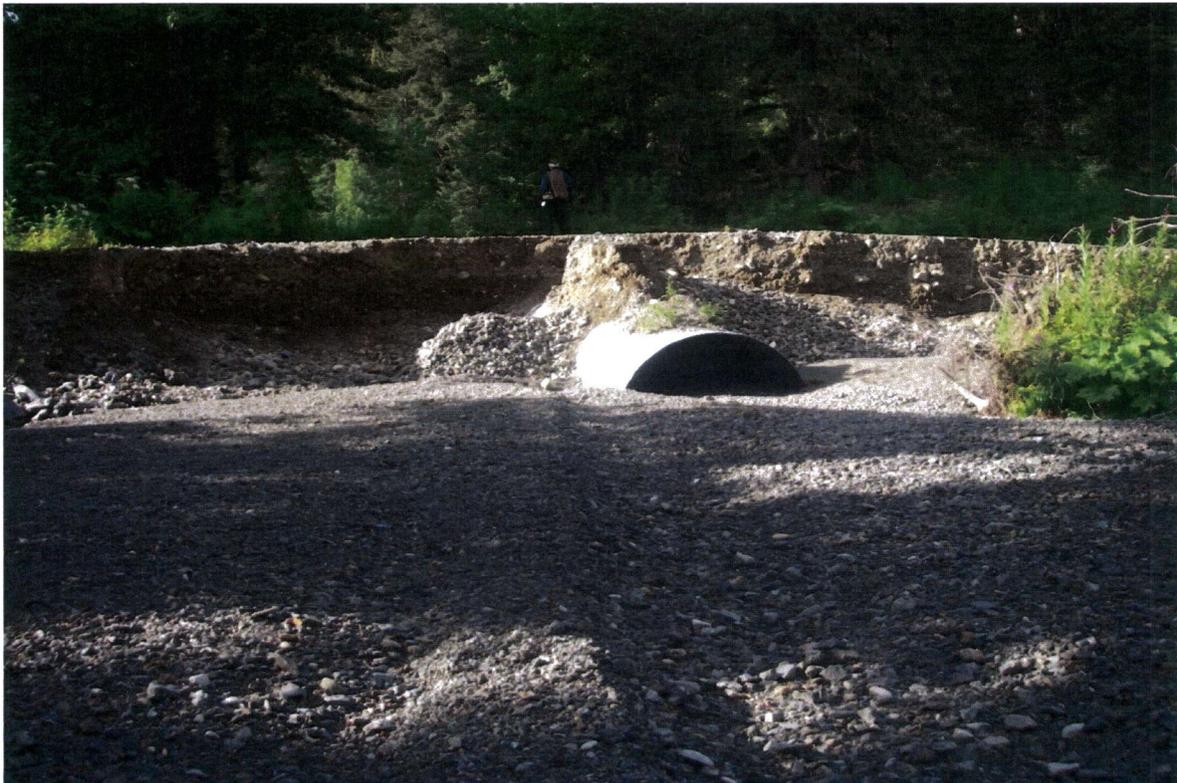
On the morning of July 24, we returned to Road SNA-0012 and surveyed a 7-foot diameter culvert located in Jakolof Creek (Figures 13 and 14). We met with George Oliveira, Alaska Department of Transportation and Public Utilities and he stated stream bedload has aggraded above the culvert causing flooding and damage of the maintained state road. The culvert diameter is inadequate for the hydrology of Jakolof Creek. The culvert does not meet fish passage criteria. The ADF&G will require the culvert be removed and a bridge or culvert designed for fish passage be installed.

Figure 13. Undersized culvert located in Jakolof Creek. Inlet view looking downstream.

Figure 14. Undersized culvert located in Jakolof Creek. Outlet view looking upstream.

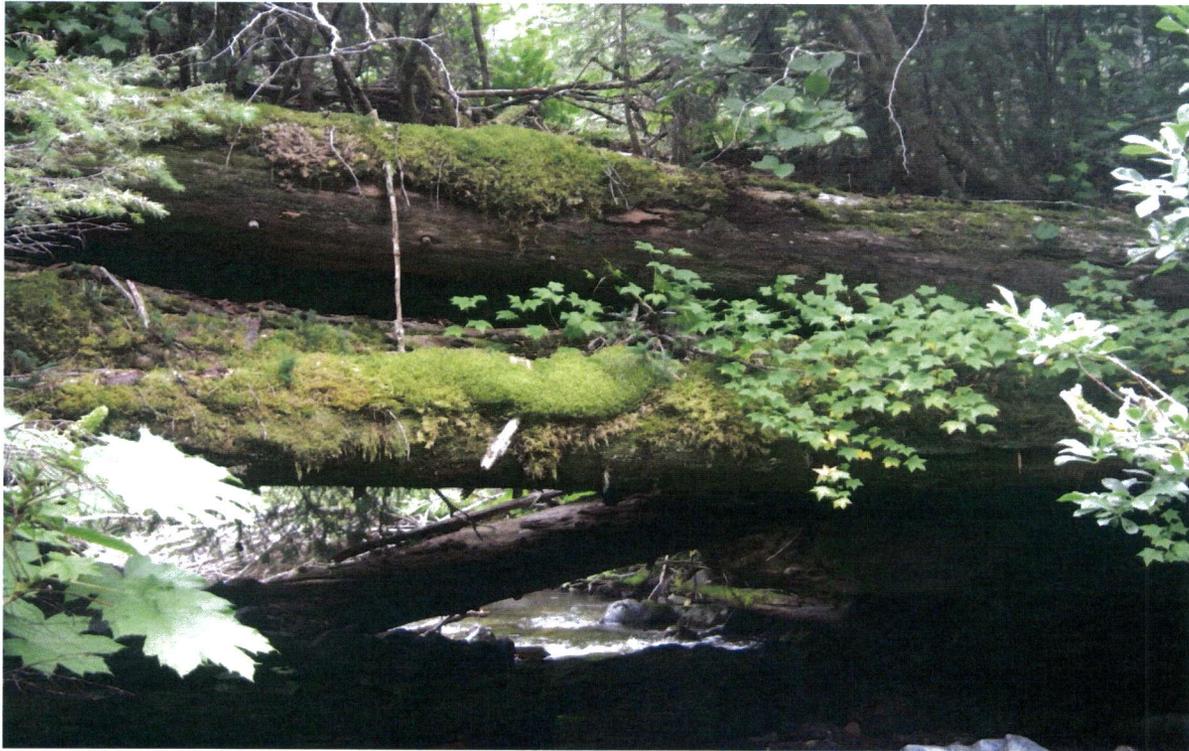
On the afternoon of July 24, we drove to Road SNA-0040 in the Seldovia Bay watershed. We located a 36-inch diameter culvert in a steep highly incised stream channel. I located a barrier about 50 meters below the culvert. No fish were observed. We drove to the end of the maintained road and walked to Road SNA-0041. We located a log bridge over a 5-foot wide stream. The log bridge is failing and in danger of collapsing. It is unknown if fish are present in the stream. We located a log bridge over Stream No. 241-11-10740. The log bridge is failing and in danger of collapsing (Figure 15). The ADF&G will require the log bridges be removed.

Figure 15. Log bridge over Stream No. 241-11-10740. View looking downstream.
