Nomination Form
Anadromous Waters Catalog

Region Southcentral USGS Quad(s) Seldovia B-4
 Anadromous Waters Catalog Number of Waterway 241-16-10040-2013-3009
 Name of Waterway Unnamed Stream Jakolof Bay USGS Name Local Name
 Addition Deletion Correction Backup Information

SUBJECT: July 2014 RCS Seldovia Trip Report

On July 21 to 25, 2014, I joined Joel Nudelman and John Winters, Division of Forestry (DOF), to conduct a joint ADF&G and DOF Forest Resources and Practices Act road condition survey on roads owned by the State of Alaska, Seldovia Native Association (SNA), English Bay Corporation (ENG), and Port Graham Corporation (PGC). Mr. Winters and I arrived in Seldovia at 12:00 p.m. Mr. Nudelman arrived in Seldovia in the late afternoon. The weather conditions were clear and warm becoming cloudy and cool.

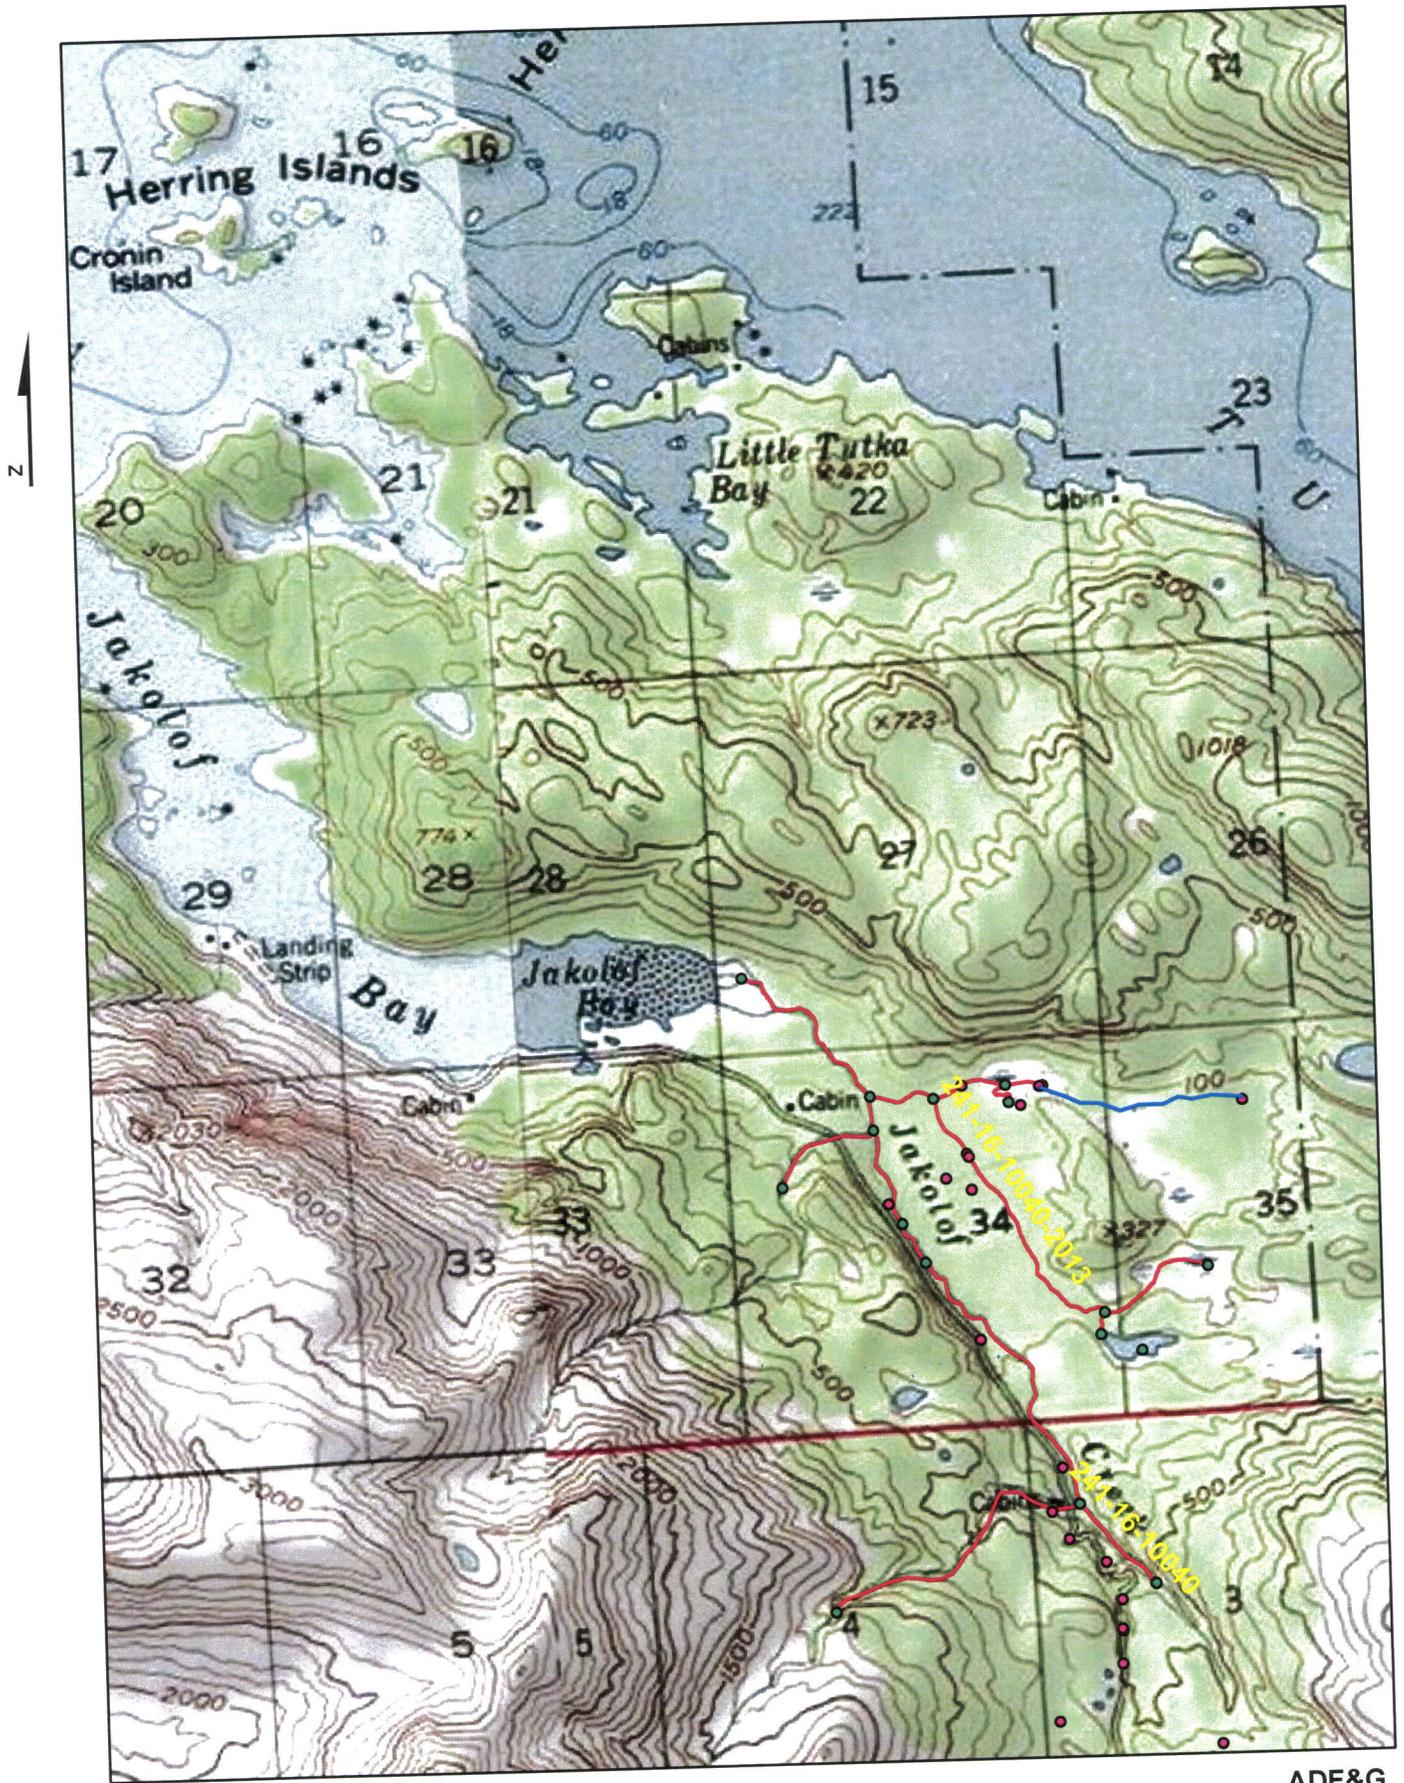
Figure 2

I observed juvenile coho salmon above the specified reach during a FRPA road condition survey (Figures 1 and 2). See July 21-25, 2014 Trip Report.

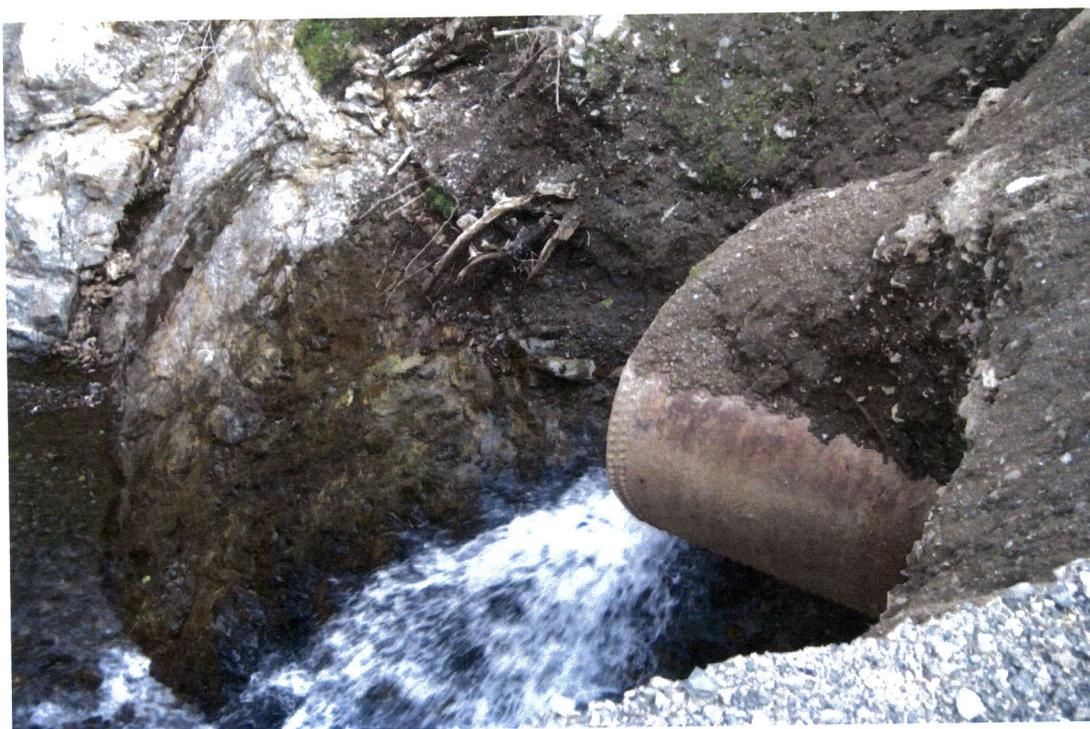
Figure 2. A railroad car steel tank located in a non-fish bearing stream under the state road.

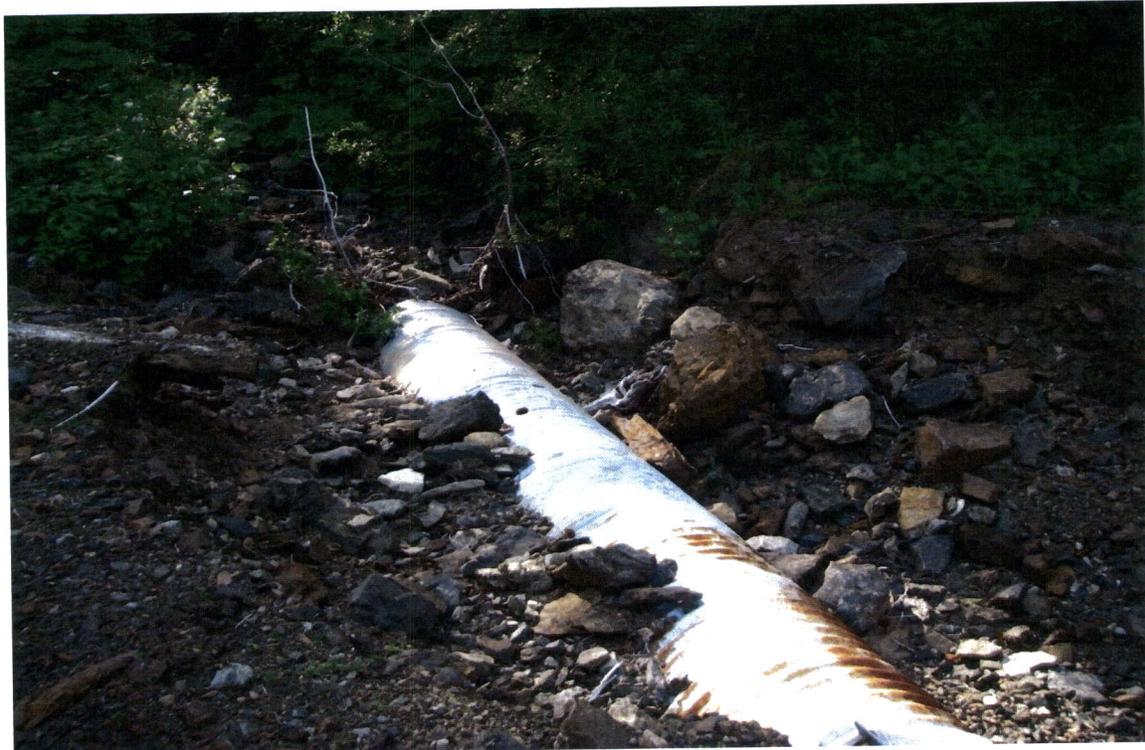
Figure 3. A 42-inch diameter culvert located in a non-fish bearing stream.

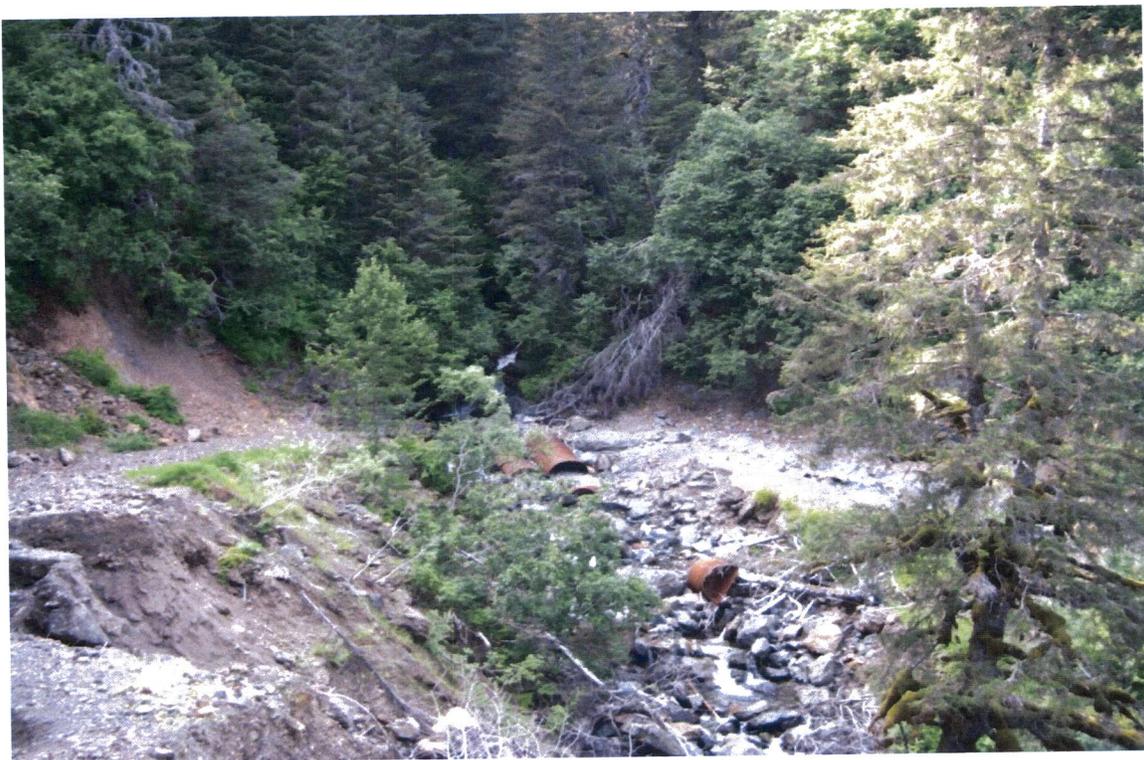
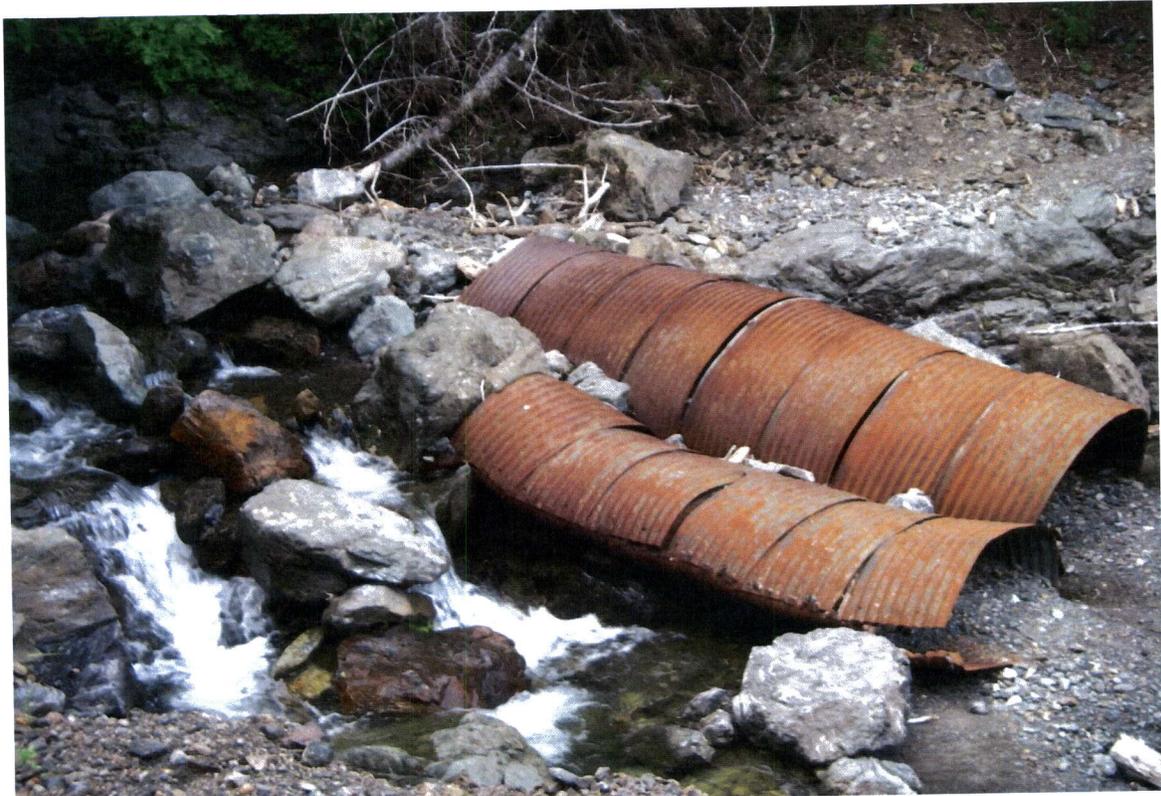
Figure 4. Twin culverts located in Stream No. 241-16-10040-2020.

Figure 5. Twin culverts located in Stream No. 241-16-10040-2020.

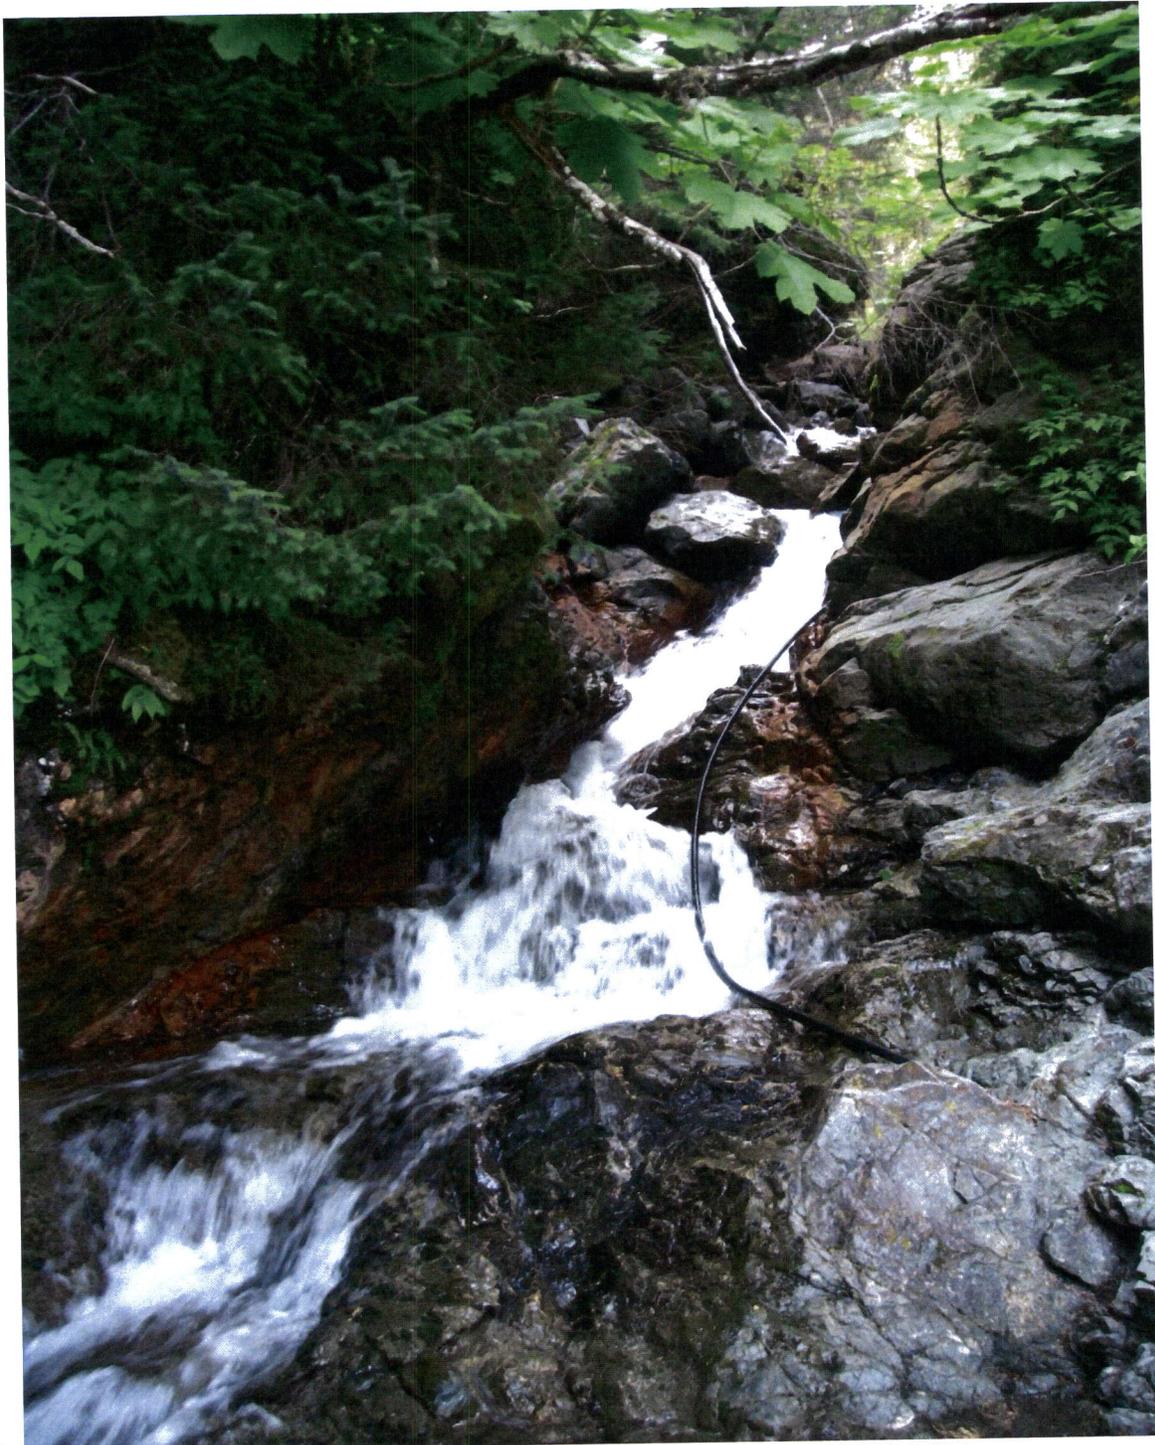
Figure 6. Possible barrier above state road in Stream No. 241-16-10040-2020.

barrier. The ADF&G recommends the stream above the barrier be sampled for the presence of fish to determine if the specified reach should be reduced to the barrier. We walked about 300 meters and located where Jakolof Creek has washed away the road. Because of the washout vehicle traffic is limited to ATVs. ATVs must cross Jackolof Creek to use the road.

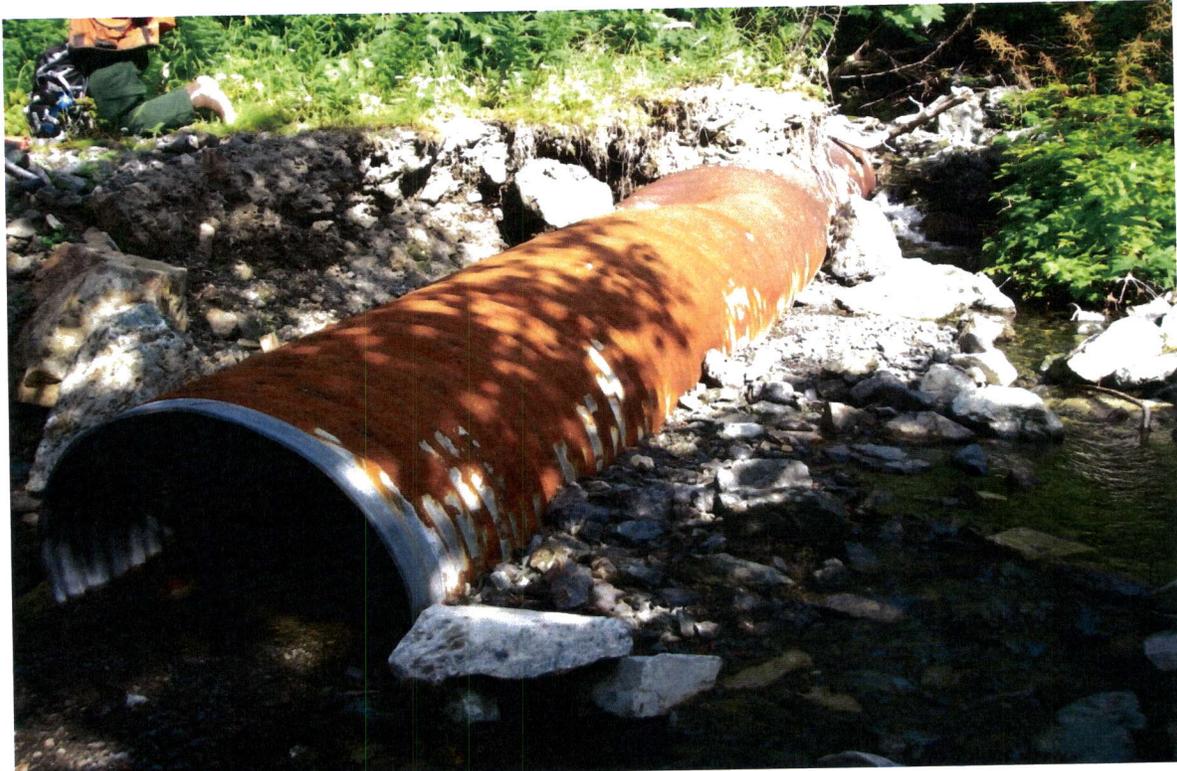
Figure 7. A 36-inch diameter culvert located in Road PGC-0004.

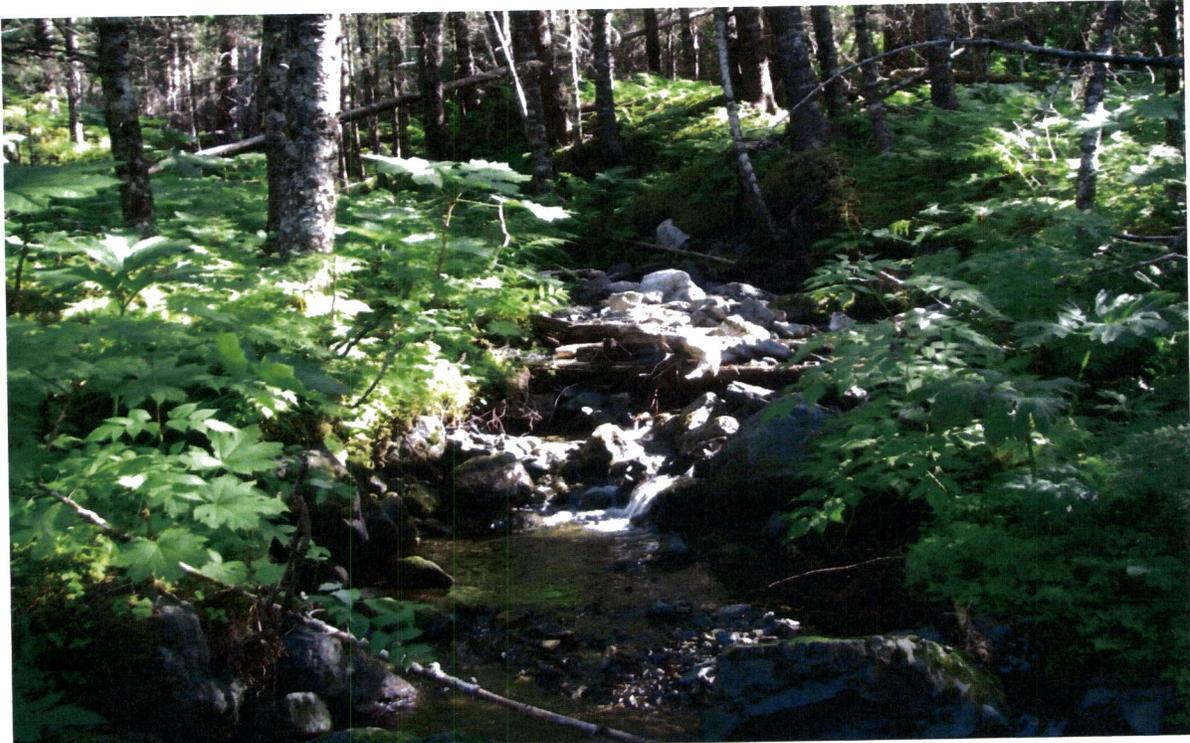
Figure 8. Stream below a 36-inch diameter culvert located in Road PGC-0004.

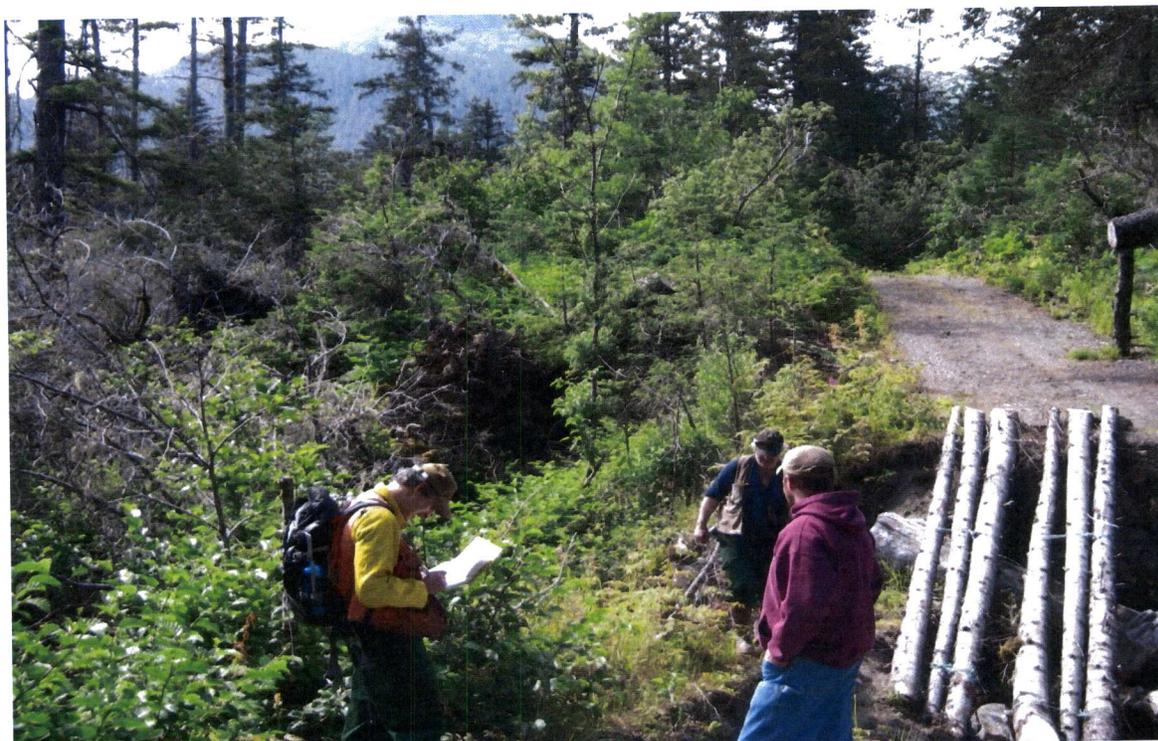
Figure 9. Failed bridge over Stream No. 242-32-10160.

On the morning of July 22, Mr. Nudelman, Mr. Winters, and I used a helicopter to survey roads in the Windy Bay watershed. At about 9:00 a.m. we departed Seldovia and flew up the Jackolof Bay watershed to the Rocky River (Stream No. 242-31-10120) watershed. We flew down the Rocky River attempting to locate roads on land owned by the PGC. Most of the roads in this area were grown over with alder or the Rocky River had covered them with gravel. We flew to Windy Bay and landed on Road PGC-0004. We walked about 680 meters to a 36-inch diameter culvert located in an 8-foot wide stream (Figure 7). I used an electrofisher to sample about 100 meters below the road (Figure 8). No fish were captured or observed. We walked back to the helicopter and walked about 2 kilometers to Road PGC0088. We located a perched 18-inch diameter culvert in a 4-foot wide stream. I sampled below the culvert about 100 meters and captured 20 Dolly Varden. A large pond was located above the culvert. The ADF&G recommend the culvert be removed to restore fish passage. We walked about 217 meters to Stream No. 242-32-10160. A failed log bridge on Road ENG-0055 has fallen into the stream and a log jam has developed upstream of the bridge (Figures 9 and 10). About 75 adult pink salmon were observed spawning near the bridge. The ADF&G will require the bridge be removed.

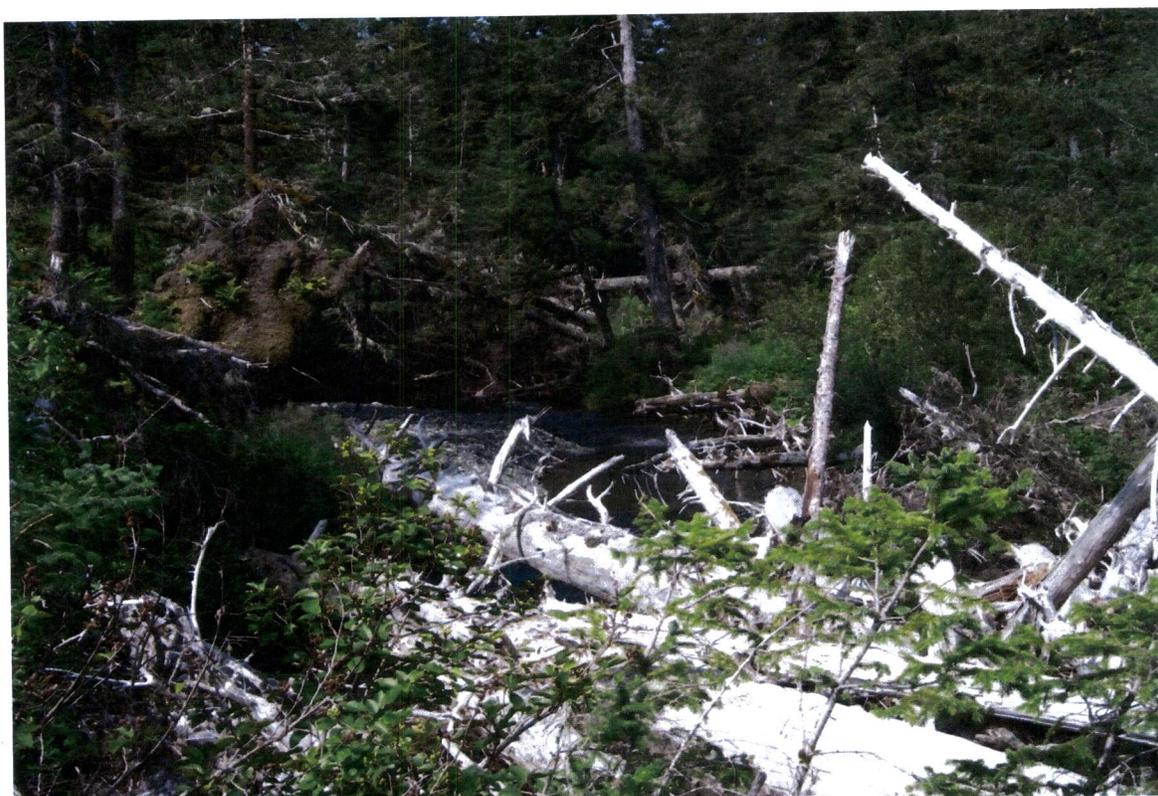
Figure 10. Log jam located upstream of a failed bridge over Stream No. 242-32-10160.

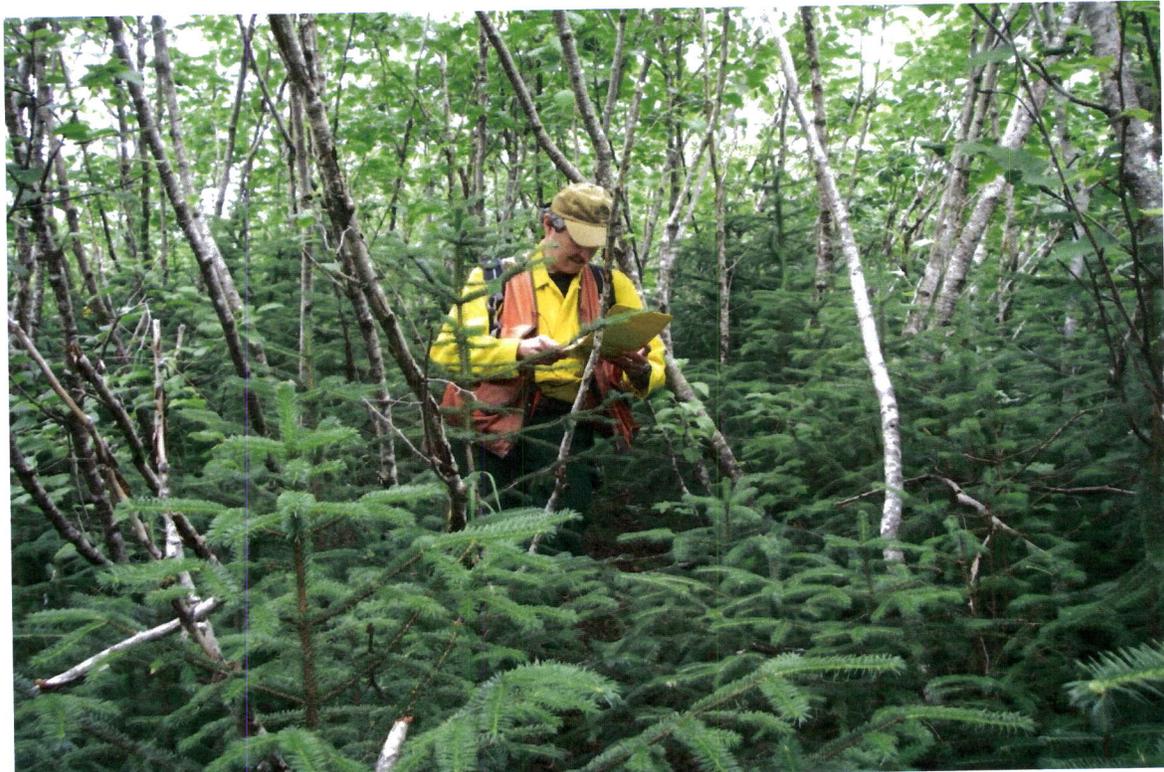
We returned to the helicopter and flew to a spur road off Road PGC-0081. The spur road was overgrown with alder and spruce (Figure 11). We located a log bridge over Stream No. 242-32-10150. The ADF&G will require the log bridge be removed. The location of the stream in the Anadromous Waters Catalog is in the wrong location. The correct stream location will be nominated for update in the Anadromous Waters Catalog.

Figure 11. Overgrown spur road off Road PGC-0081.

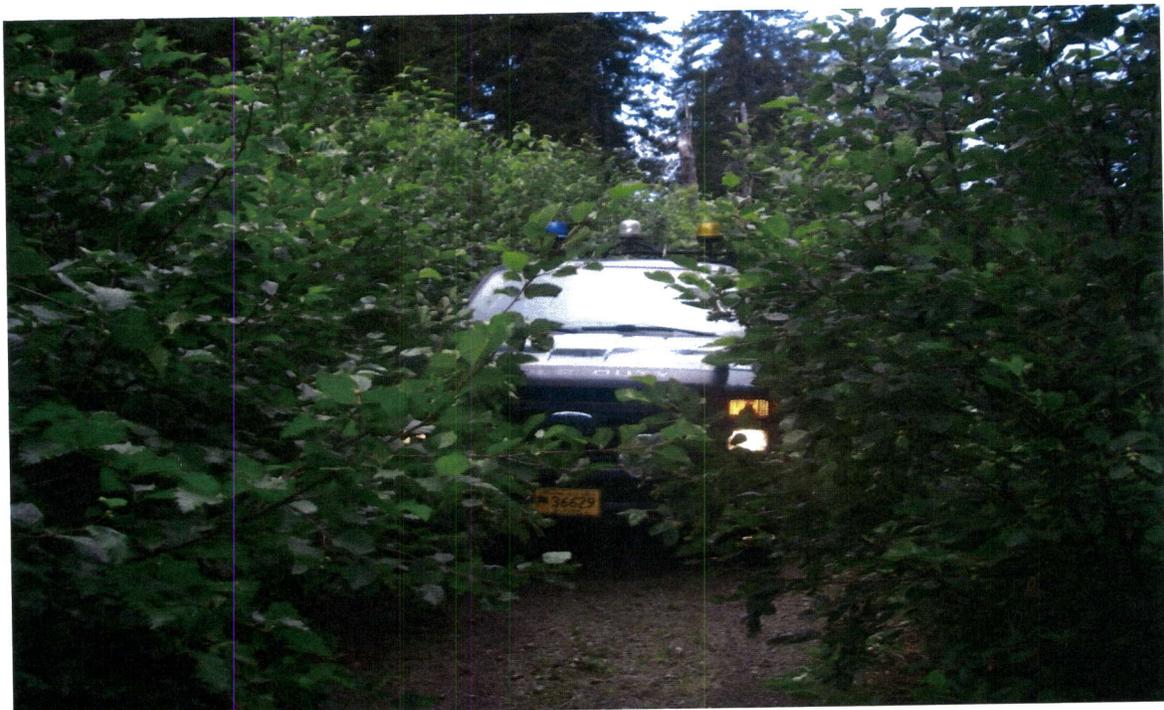
On the afternoon of July 23, we drove to Roads SNA-0012 and SNA-0014, and SNA-0031. The roads were overgrown with alder preventing vehicle use (Figure 12). On Road SNA-0031 we located two log bridges over dry stream channels. We walked up an abandoned spur road to Road SNA-0012 and located a failed log bridge over Stream No. 241-16-10040-2013-3009. I observed juvenile coho salmon in the stream channel. The ADF&G will require the bridge be removed. We located a perched 15-inch diameter culvert on Road SNA-0012. The culvert is located about 50 meters above the specified reach of Stream No. 241-16-10040-2013-3009-4008. The ADF&G will require the culvert be removed. We located two log bridges on Road SNA-0012. The first bridge was recently installed over a dry stream channel and the second bridge was over Stream No. 241-16-10040-2013-3009. The second bridge was in fair condition. We walked to Road SNA-0014 and located a perched 32-inch diameter culvert about 860 meters

Figure 12. Overgrown Road SNA-0031.

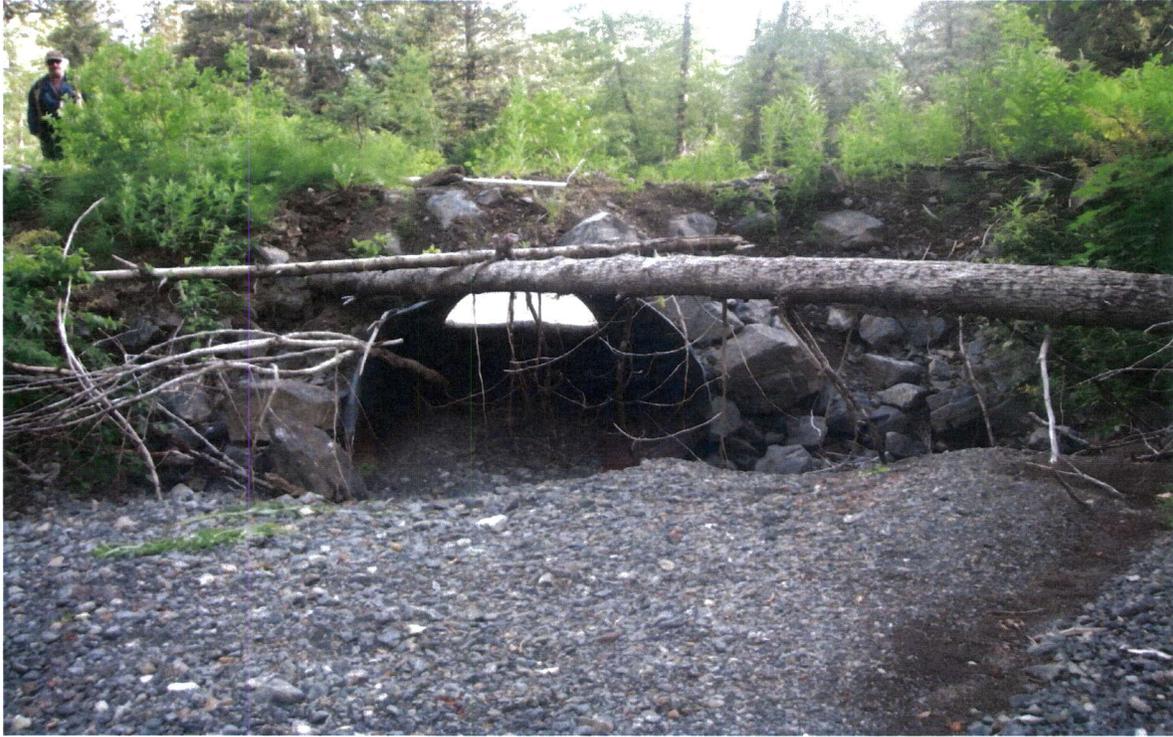
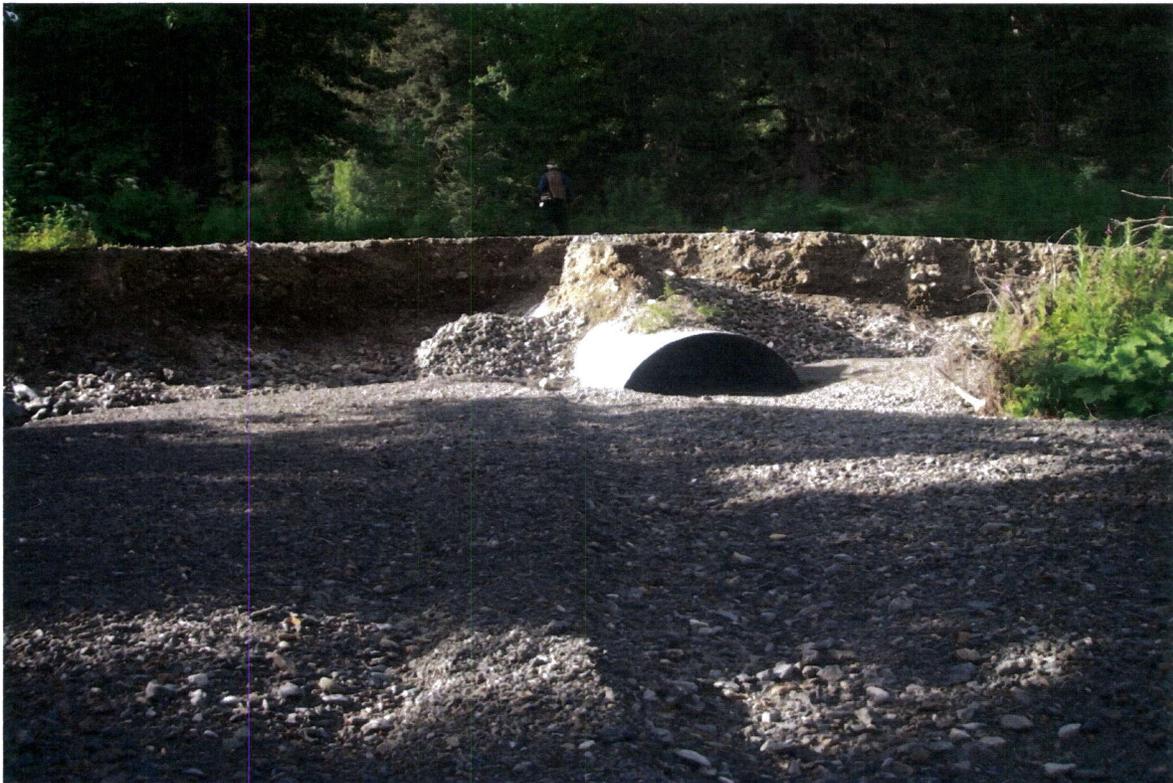
On the morning of July 24, we returned to Road SNA-0012 and surveyed a 7-foot diameter culvert located in Jakolof Creek (Figures 13 and 14). We met with George Oliveira, Alaska Department of Transportation and Public Utilities and he stated stream bedload has aggraded above the culvert causing flooding and damage of the maintained state road. The culvert diameter is inadequate for the hydrology of Jakolof Creek. The culvert does not meet fish passage criteria. The ADF&G will require the culvert be removed and a bridge or culvert designed for fish passage be installed.

Figure 13. Undersized culvert located in Jakolof Creek. Inlet view looking downstream.

Figure 14. Undersized culvert located in Jakolof Creek. Outlet view looking upstream.

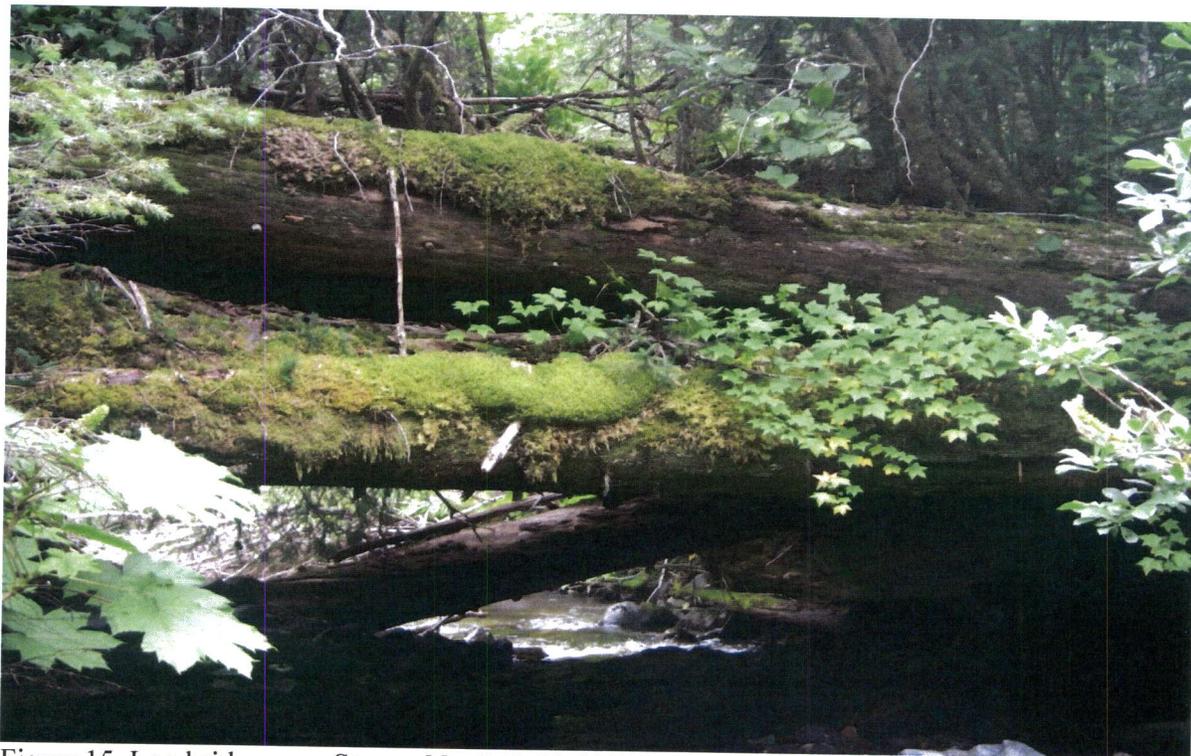
On the afternoon of July 24, we drove to Road SNA-0040 in the Seldovia Bay watershed. We located a 36-inch diameter culvert in a steep highly incised stream channel. I located a barrier about 50 meters below the culvert. No fish were observed. We drove to the end of the maintained road and walked to Road SNA-0041. We located a log bridge over a 5-foot wide stream. The log bridge is failing and in danger of collapsing. It is unknown if fish are present in the stream. We located a log bridge over Stream No. 241-11-10740. The log bridge is failing and in danger of collapsing (Figure 15). The ADF&G will require the log bridges be removed.

Figure 15. Log bridge over Stream No. 241-11-10740. View looking downstream.
