Nomination Form  
Anadromous Waters Catalog

Anadromous Waters Catalog Number of Waterway 111-50-10070-2004-3002-4007

### MEMORANDUM

SUBJECT: Glacier Highway and  
Trailhead (Amalga to Eagle  
Beach) Site Visit

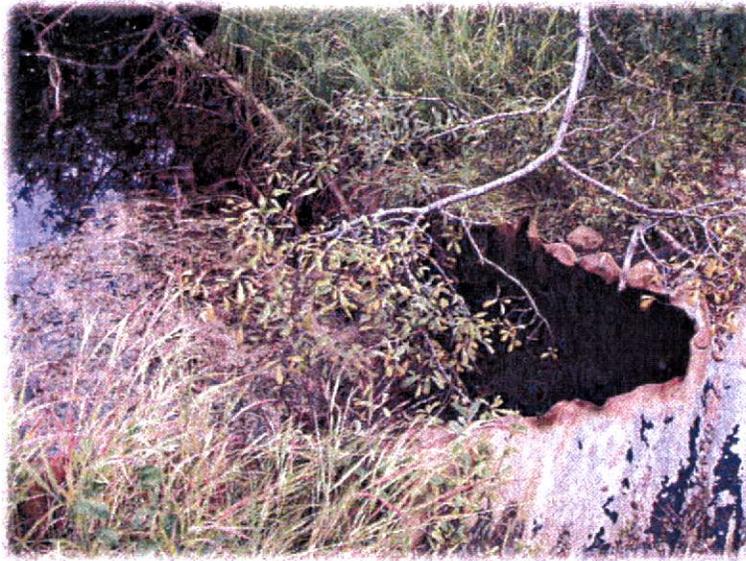
Pipes 115-121 (FH09-I-0025 through FH09-I-0029) have a significant amount of water in them, but no visible flow (Photo 1). Glenn proposes to dig a diversion ditch parallel to the stream and divert water into that ditch while the culvert is replaced, then divert the water back into the stream.

*Photo 1: Upstream end of culvert 120*

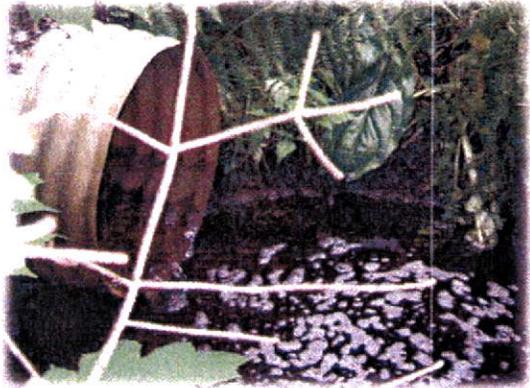
Pipe 137b (FH09-I-0033) is downstream of 137a on Tonsgard Road. This pipe is slightly perched on the outlet (photo 2) and spawned out chum salmon were visible both upstream and downstream of the culvert (photo 3). Glenn stated that a diversion ditch would be used for this culvert replacement. I recommend that as little of the streambed above and below the culvert be disturbed as possible due to the high probability of eggs in the gravel. **It would be ideal to wait until spring (after the fry are out of the gravels) for replacement of this culvert.**

*Photo 2: Outlet of 137b*

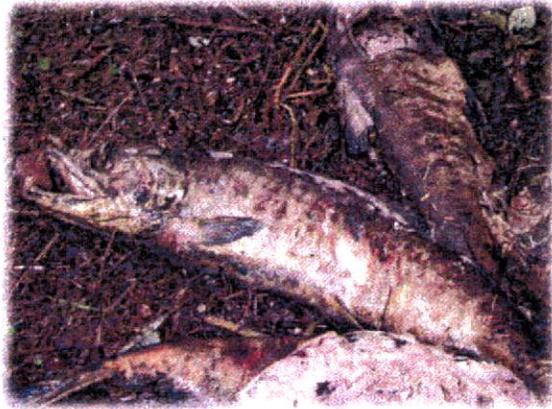
*Photo 3: dead chum downstream of 137b*

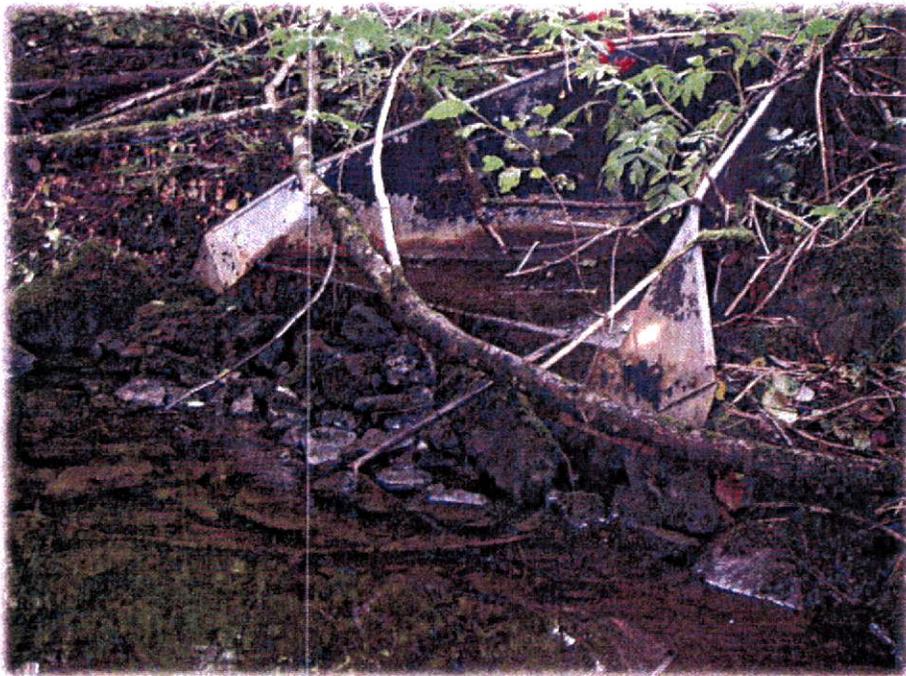
Pipe 145 (FH09-I-0034) is quite perched on the outlet (photo 4) and is a barrier to upstream migration of fish. There were adult chum (both alive and dead) in the large plunge pool while none were visible upstream of the culvert. The plans for this site include filling the plunge pool with scour materials. **While the culvert could be replaced in the fall if necessary, adding material to the plunge pool would kill all eggs in the gravels and should not be done until the fry outmigrate in the spring.**

*Photo 4: Outlet of 145*
