DEPARTMENT OF FISH AND GAME DIVISION OF HABITAT

MEMORANDUM

SUBJECT: Glacier Highway and
Trailhead (Amalga to Eagle
Beach) Site Visit

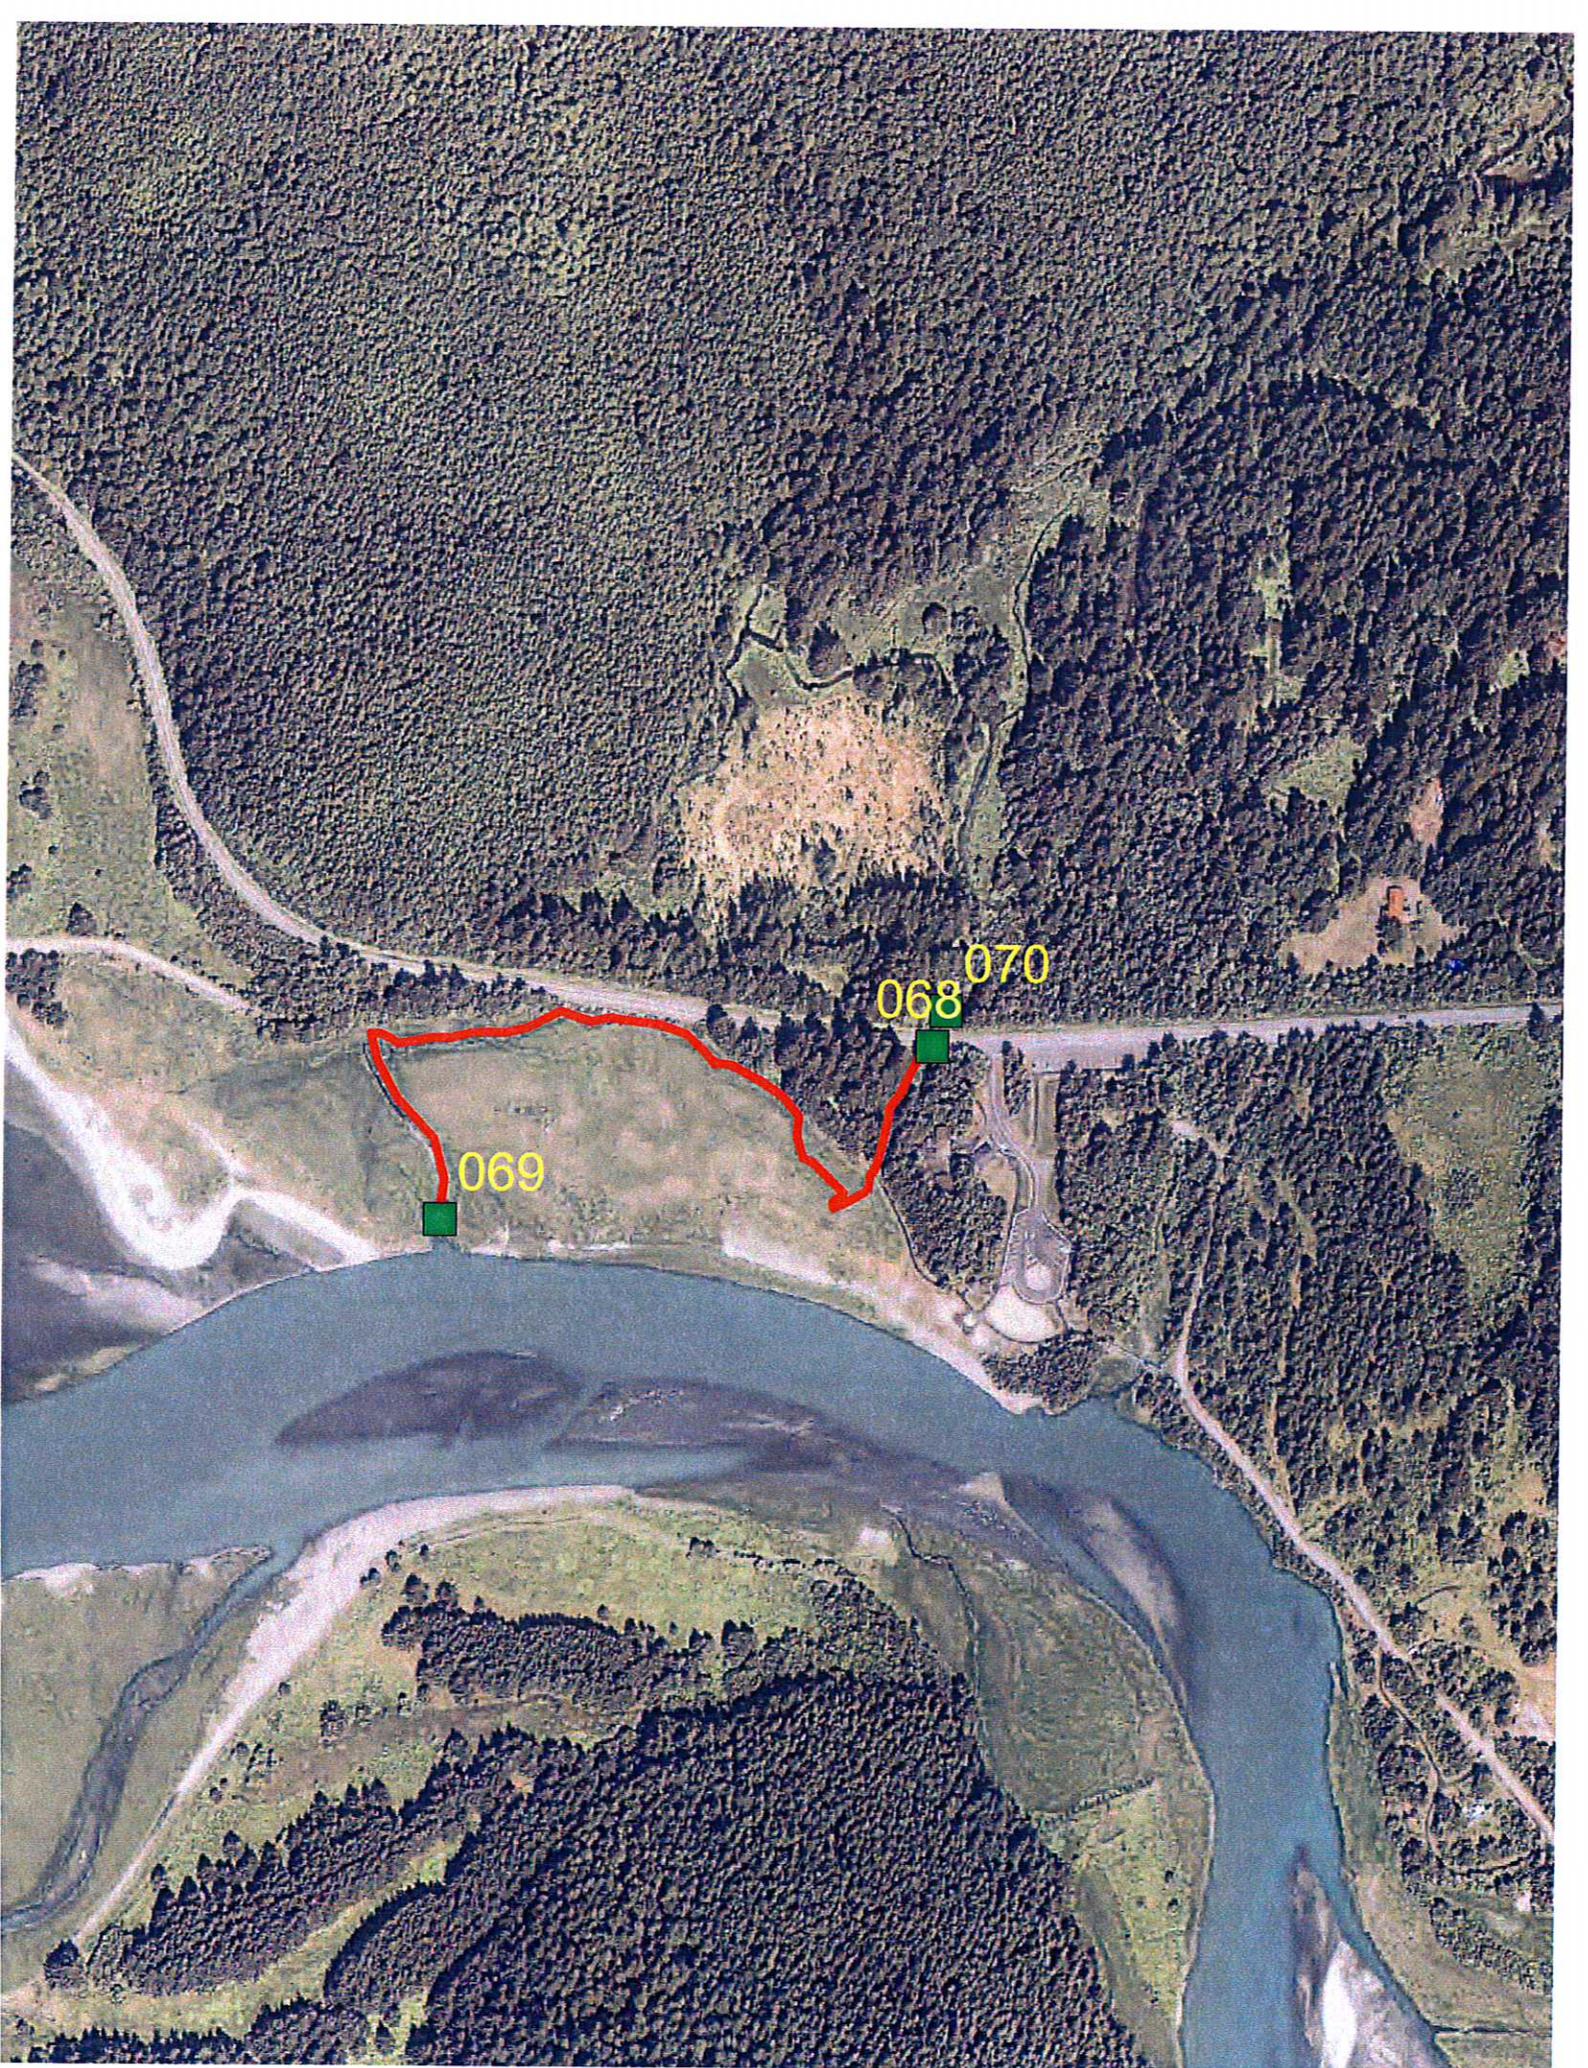
Red line is the stream track

Green squares are waypoints

ADF&G Habitat Division conducted two site visits on 9-30-09 and 10-1-09 to culvert # 146 near Eagle Beach. We have been documenting fish presence on various streams that are involved with the Glacier Highway culvert replacement project. This stream has a very developed channel, however it seems to be tidally influenced. Water was only present near culvert # 146 and near the confluence of Eagle River. We tracked the stream at low tide, multiple fish carcasses were present along the bank.

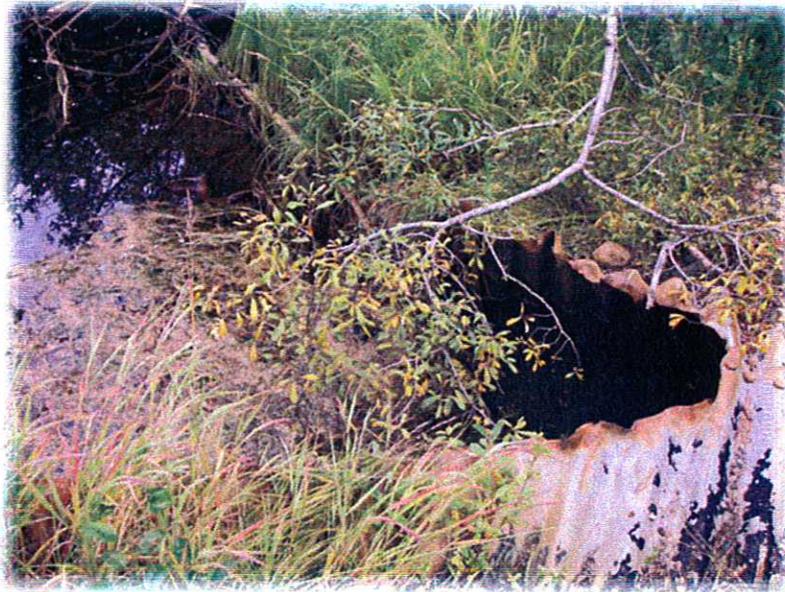
Pipes 115-121 (FH09-I-0025 through FH09-I-0029) have a significant amount of water in them, but no visible flow (Photo 1). Glenn proposes to dig a diversion ditch parallel to the stream and divert water into that ditch while the culvert is replaced, then divert the water back into the stream.

Photo 1: Upstream end of culvert 120

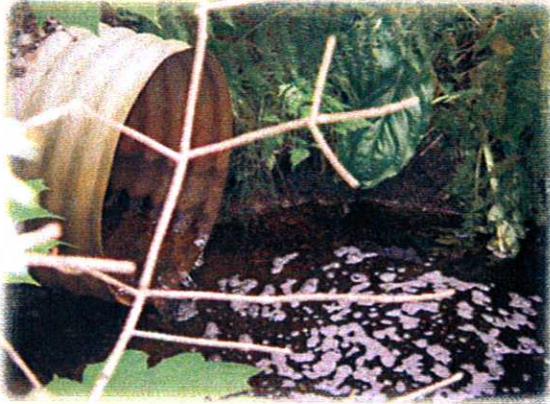
Pipe 137b (FH09-I-0033) is downstream of 137a on Tonsgard Road. This pipe is slightly perched on the outlet (photo 2) and spawned out chum salmon were visible both upstream and downstream of the culvert (photo 3). Glenn stated that a diversion ditch would be used for this culvert replacement. I recommend that as little of the streambed above and below the culvert be disturbed as possible due to the high probability of eggs in the gravel. **It would be ideal to wait until spring (after the fry are out of the gravels) for replacement of this culvert.**

Photo 2: Outlet of 137b

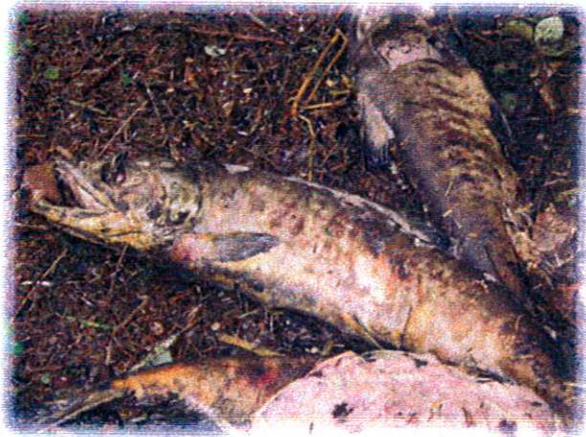
Photo 3: dead chum downstream of 137b

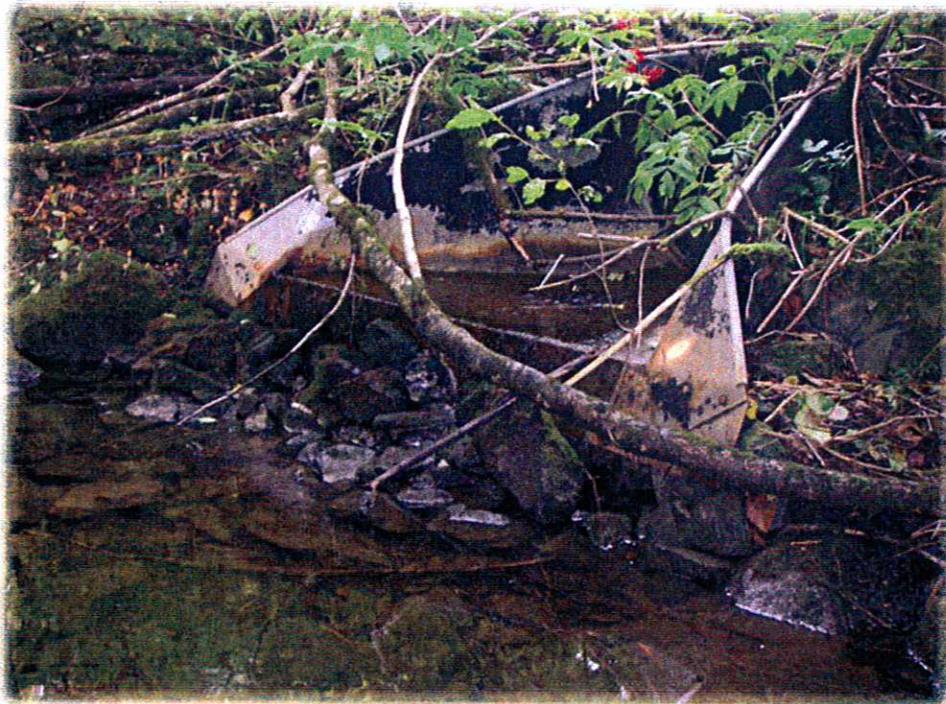
Pipe 145 (FH09-I-0034) is quite perched on the outlet (photo 4) and is a barrier to upstream migration of fish. There were adult chum (both alive and dead) in the large plunge pool while none were visible upstream of the culvert. The plans for this site include filling the plunge pool with scour materials. **While the culvert could be replaced in the fall if necessary, adding material to the plunge pool would kill all eggs in the gravels and should not be done until the fry outmigrate in the spring.**

Photo 4: Outlet of 145
