MEMORANDUM

SUBJECT: Traitors Cove IDT

TRIP REPORT

TRAITORS RIVER SURVEY, 8-24-77

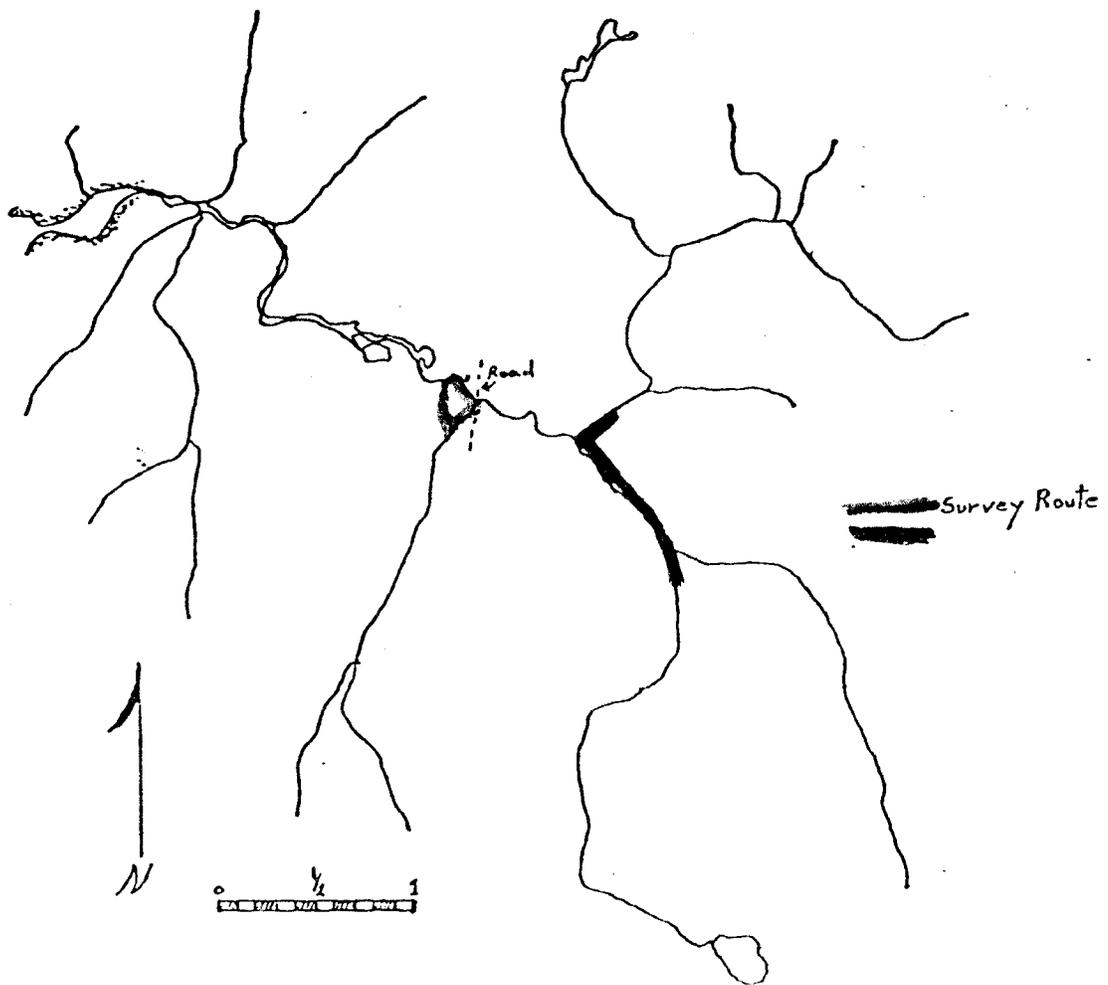
101-90-29
Traitors River

The Traitors River was walked and mapped on the following route (see map). The main stream channel had many rearing pools and a small amount of spawning area. The major part of the streambed was mud and sand with few gravel areas. Banks of the main stream were generally unstable with undercutting of the soil banks along most of the stream. Approximately 500' to the west of where the stream intersects the road a large muskeg area exists and is probably a result of beaver activity in that area.

The fork was surveyed from a 50' to 60' falls down to the main stream channel. This is a distance of approximately 600'. From the falls to about 200' downstream, the banks are bedrock, steep and provide shading to the estuary. The bottom is composed of large boulders which create many pools and small cascades. A minnow trap set for approximately one hour caught a 5" cutthroat. Further downstream the stream becomes braided and develops into two major stream channels, the bottom changes to gravel and sand. Pools develop under blowdown and the channels get narrow in places. The banks become covered with brush and are moderately stable. At the point where the stream reaches the existing road, it is bent toward the mainstream and the two channels join together. Fill for the road appears to have entered the stream at this point and caused the stream to slow down and become very muddy. The bottom is mud from this point to where it meets the main stream. This is the most unstable portion of the fork.

It was also noted that the bridge over the main stream shows erosion on the east bank. During high water levels severe erosion may result due to an unstable mud bank.
