# Appendix F: Haines

## Guide to direct fieldwork for cataloging anadromous water bodies in Southeast Alaska

## HAINES STREAM SURVEYS

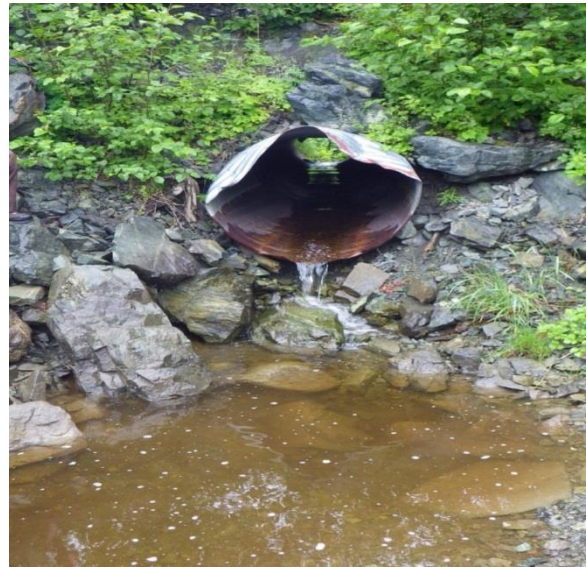
Figure 1.–Culvert filled with debris, restricting flow (WPT# 7).

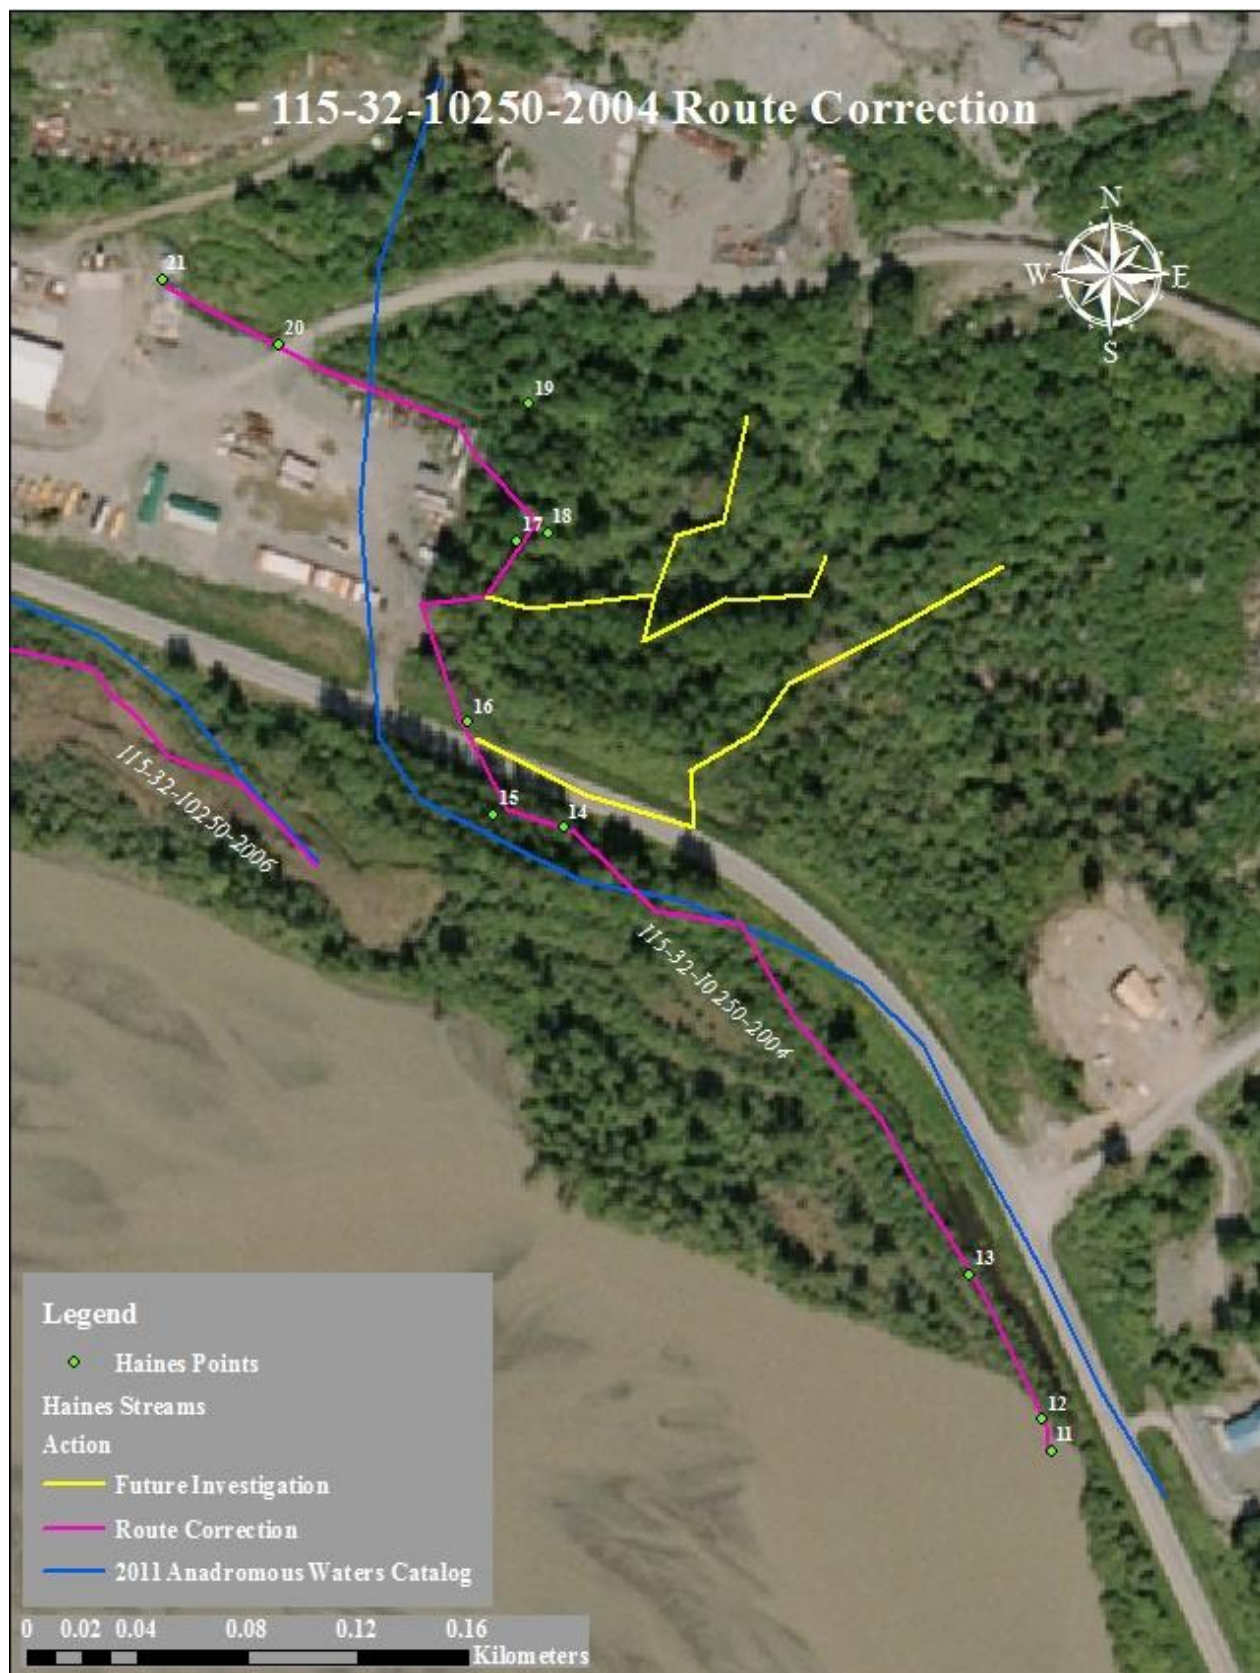
Figure 1.—115-32-10250-2004 route correction map.

**Findings:** We surveyed this cataloged stream using a backpack electrofisher and a GPS (Table 1). We found that the upper and lower limits of Stream No. 115-32-10250-2004 were found to differ from the AWC. The stream takes a more sinuous path before meeting the Chilkat River. The stream's upper extent is below a steep rocky hillside in the parking area of Southeast Roadbuilders. The stream empties into the Chilkat River at a different location than is illustrated in the current AWC.

**Recommendations:** Correct the current route in the Anadromous Waters Catalog (Figure 1).

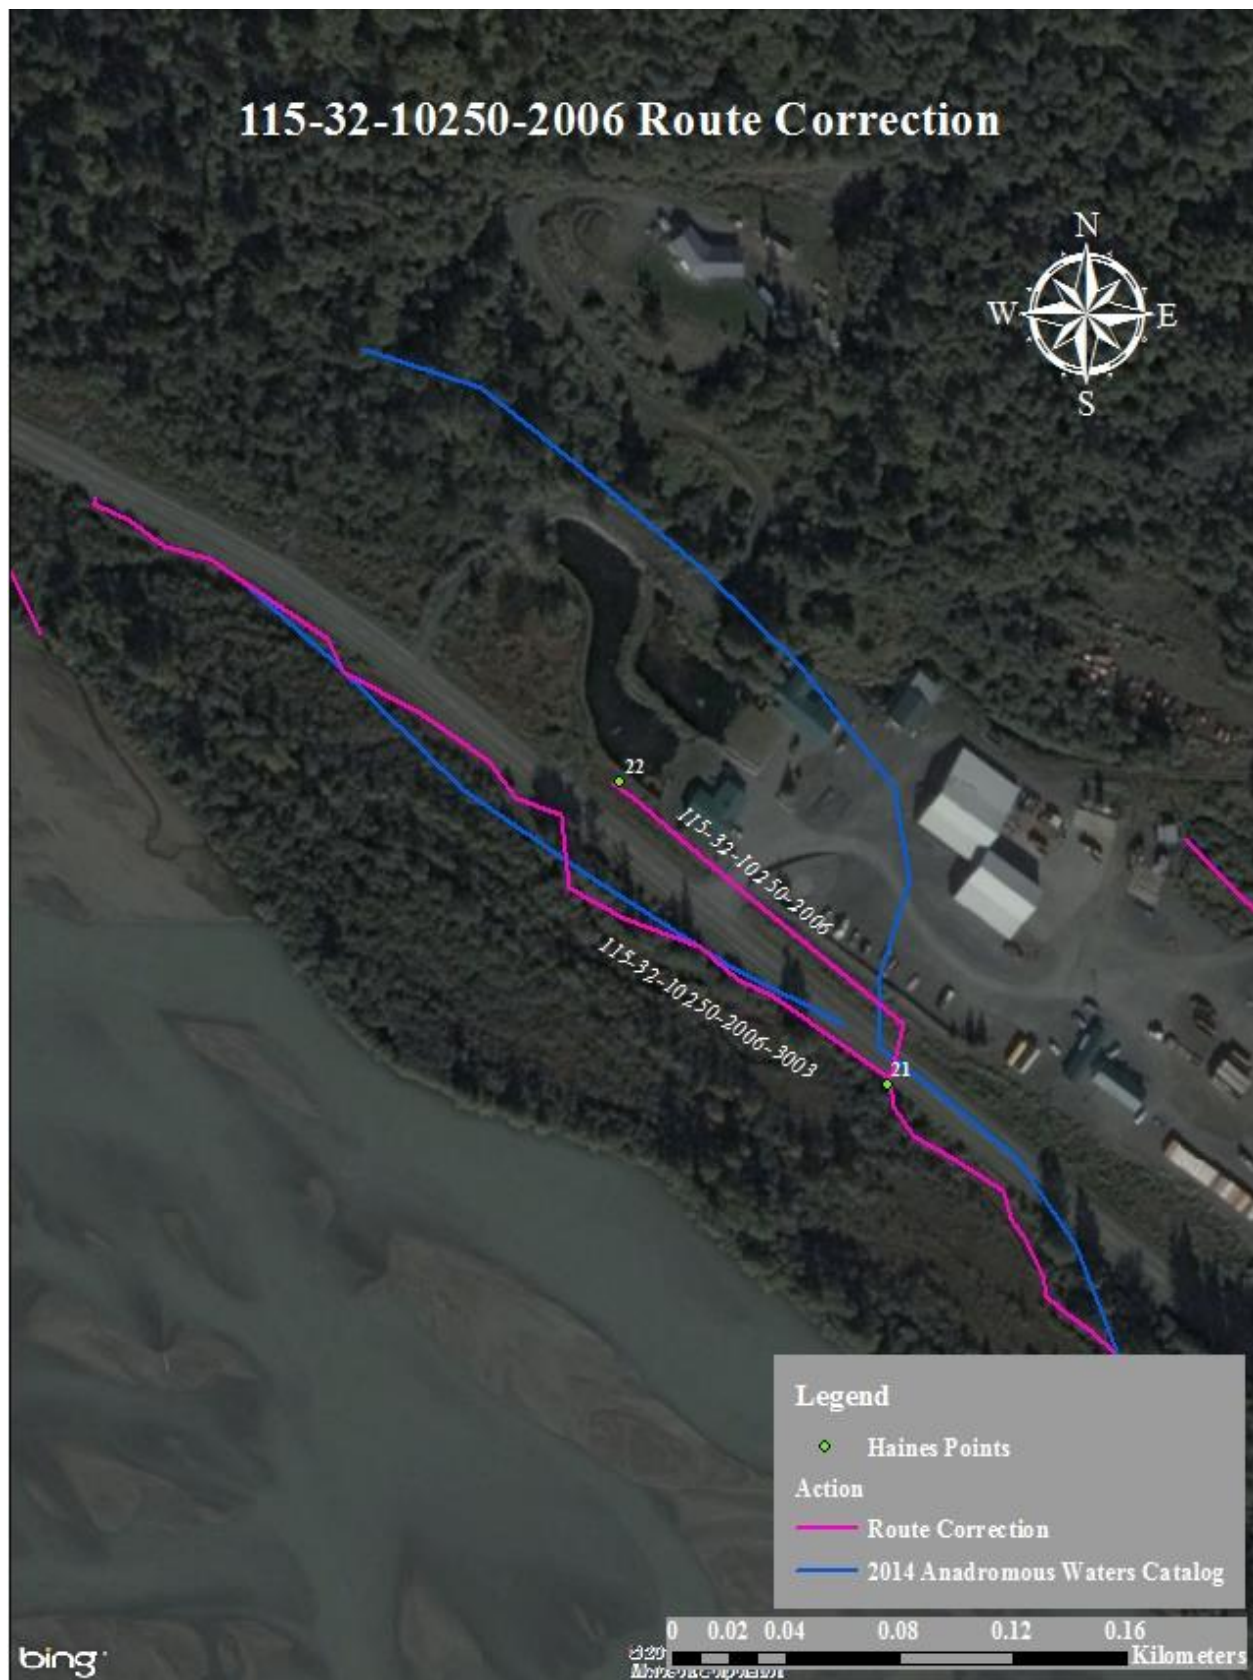
Figure 1.-115-32-10250-2006 route correction map.

**Findings:** We conducted a foot survey of this cataloged stream using a GPS (Table 1). We found that this stream splits and flows through a culvert under the Haines Highway near Southeast Roadbuilders. It does not flow through the parking lot and above the constructed ponds. It becomes a roadside ditch that terminates at a small dam at the base of the ponds.

**Recommendations:** Update the route of this stream to reflect the field verified course (Figure 1).

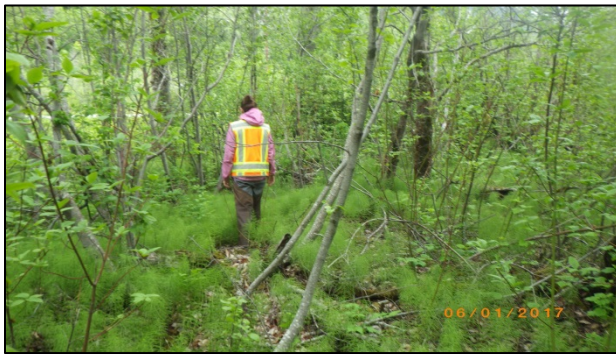
**Findings:** We surveyed the area of the cataloged stream using a GPS and observed organic detritus covered by silt and a few isolated pools generally measuring less than 3 feet diameter, no defined stream channel (Figures 1, 2). Though we searched, we did not visually observe fish in the shallow (< 6 inch) pools.

Figure 1.—115-32-10250-2008-3005 area, no defined stream channel present.

**Recommendations:** Delete the stream since water flow is dependent on Chilkat River overflow, not a separate water source (Figure 3).

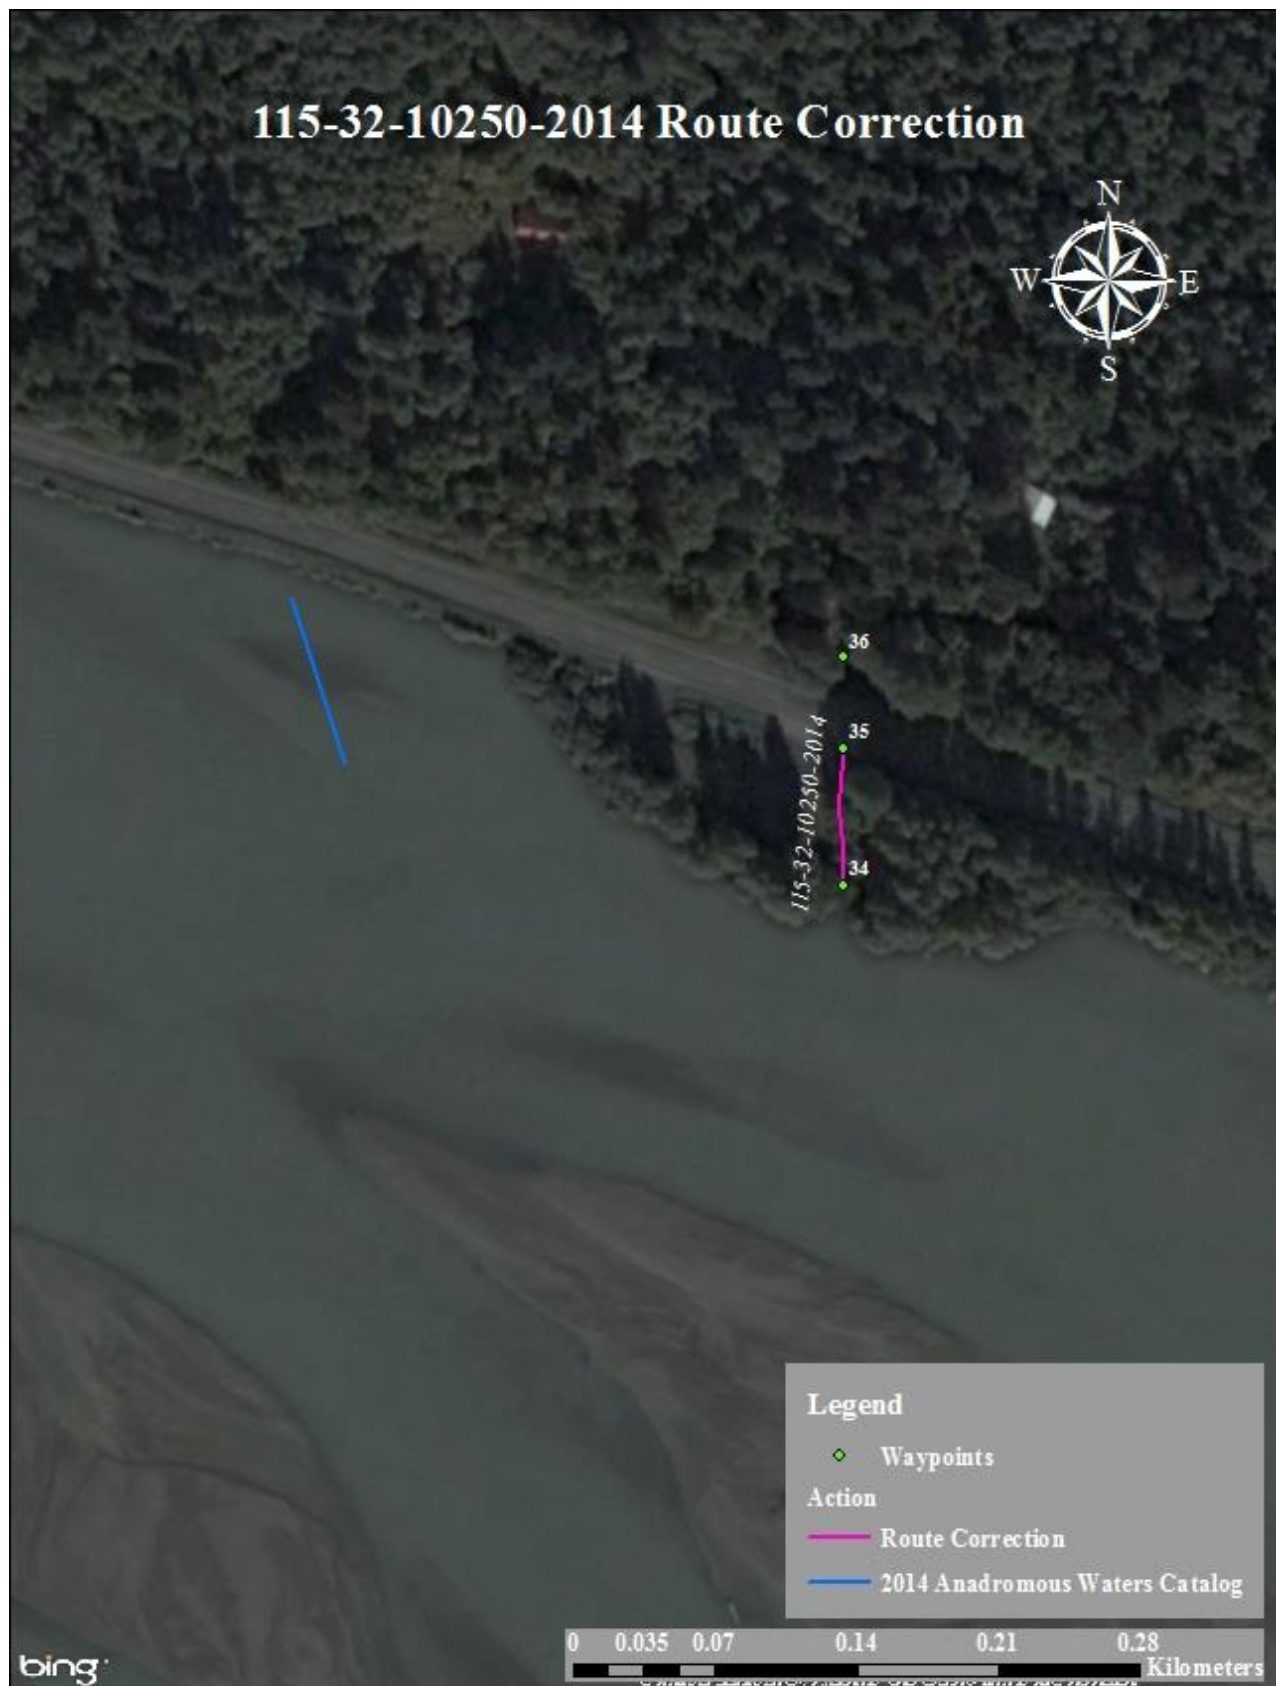
Figure 1.—115-32-10250-2014 route correction map.  
Haines

**Findings:** We conducted a route survey on this stream (Table 1) and found it to be inaccurately mapped in the AWC.

**Recommendations:** Correct the stream arc to reflect field-verified route in the Anadromous Waters Catalog (Figure 1).

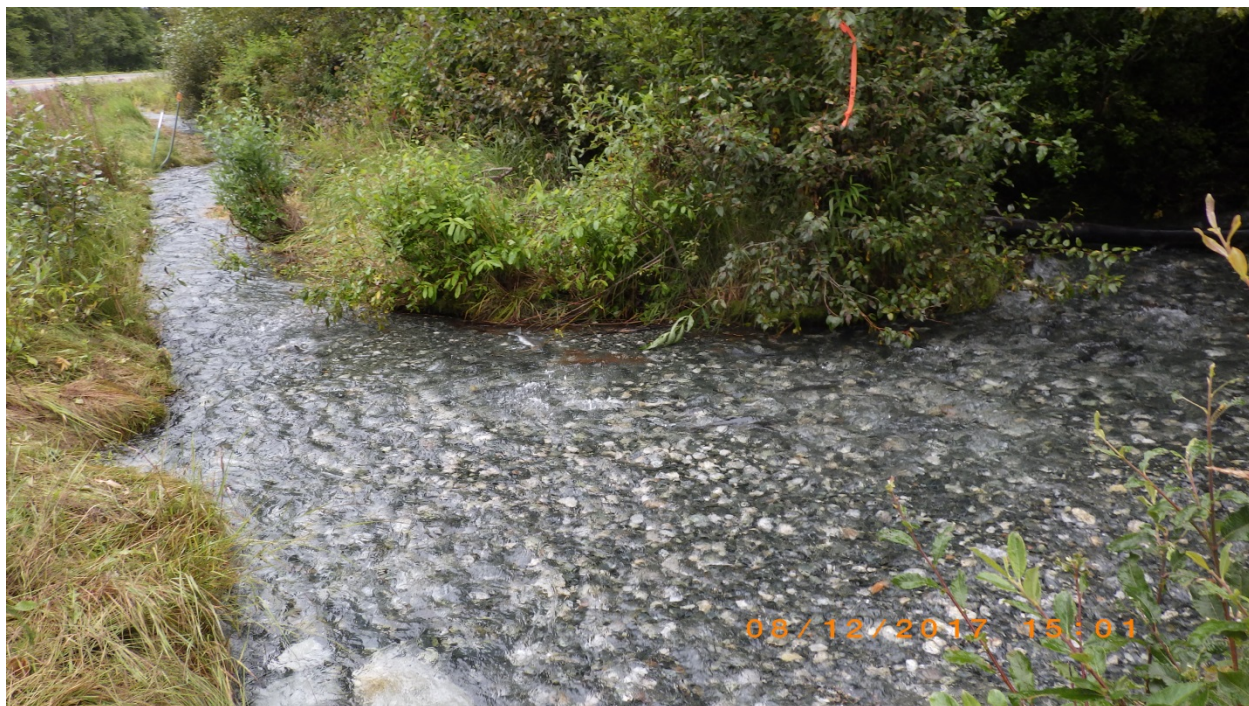
**Findings:** We surveyed this stream with a GPS (Table 1). We found that stream 115-32-10250-2042 is a distributary of 115-32-10250-2040. Stream 115-32-10250-2040 splits at WP 1088, the majority of the flow goes east while some flows west (Figures 1, 2). During our survey, we observed dozens of adult pink salmon spawning throughout both branches of this stream.

Figure 1.-Channel splits at WP 1088.

**Recommendations:** Correct the route of this stream to include this channel in the Anadromous Waters Catalog.

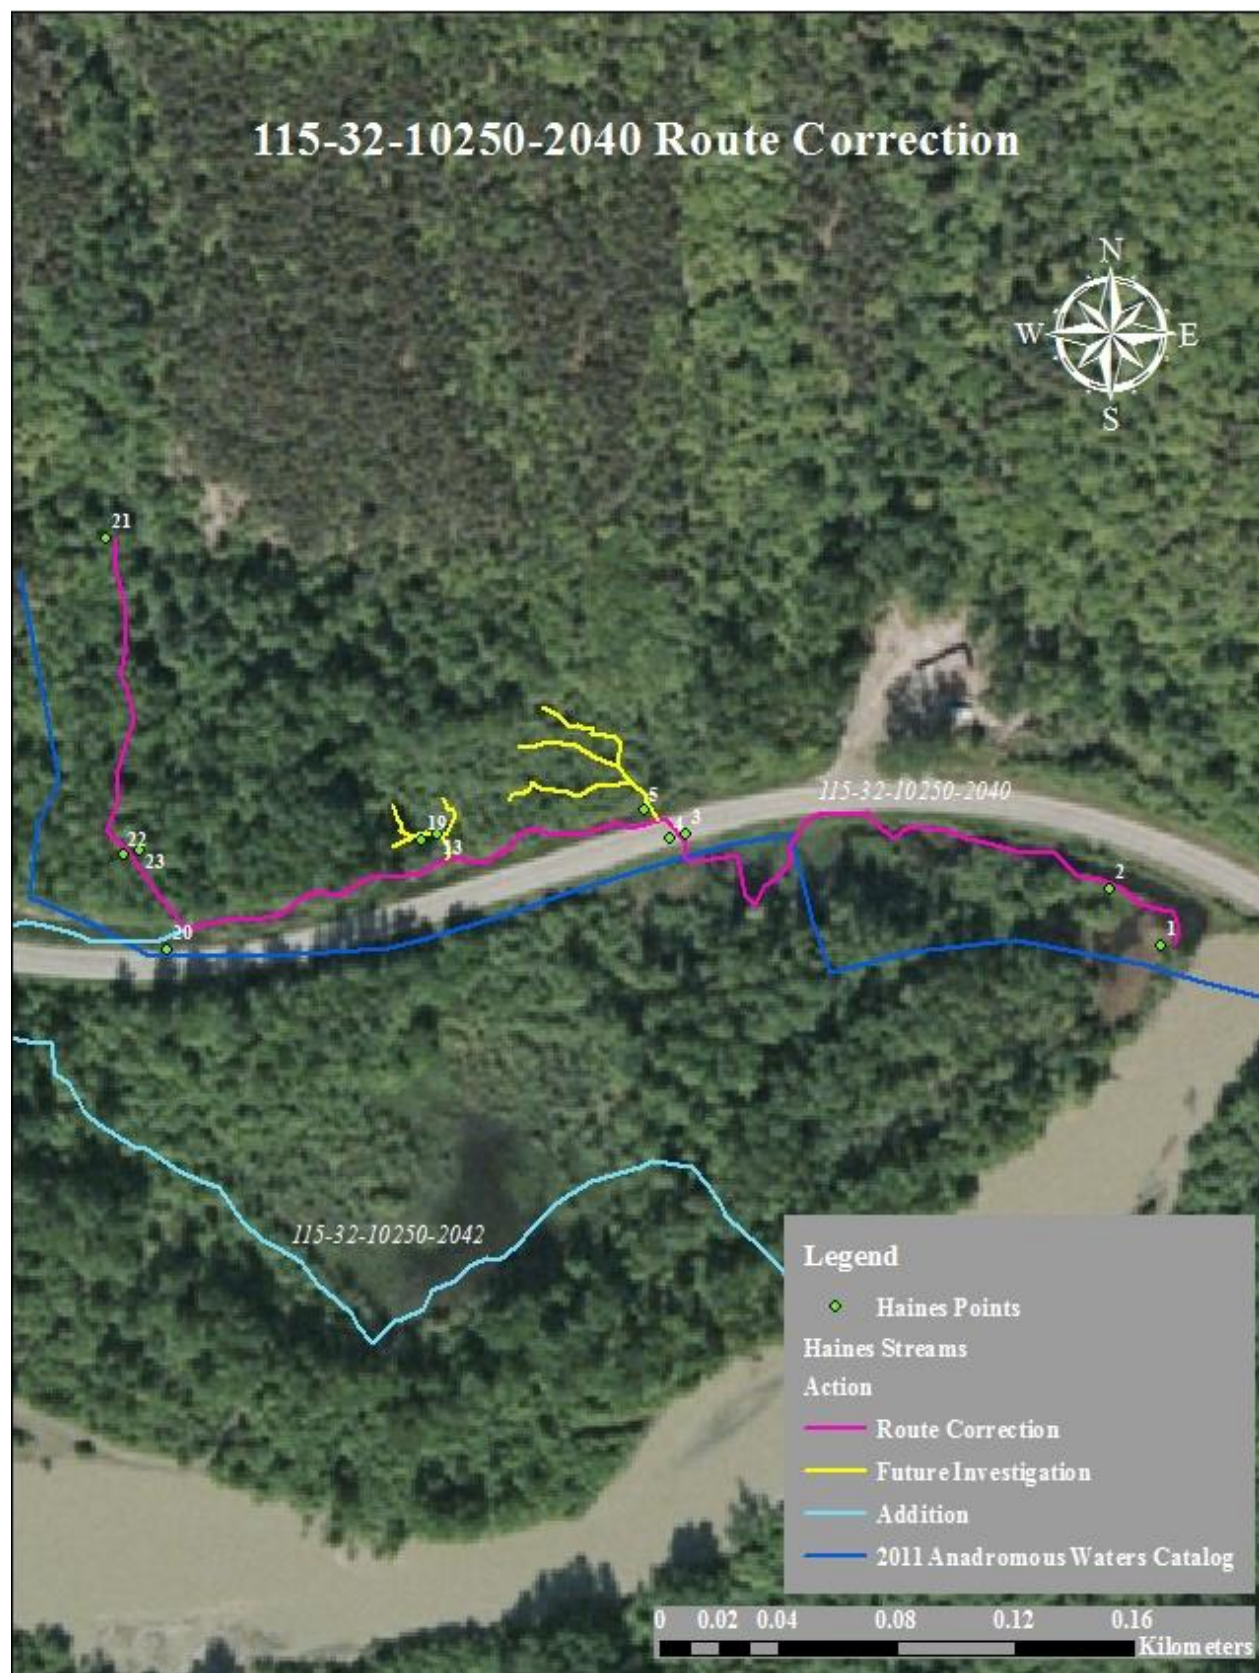
Figure 1.—115-32-10250-2040 route correction map.  
Haines

**Findings:** We surveyed this stream using a handnet and a GPS (Table 1). We found that the stream takes a more sinuous path before emptying into the Chilkat River than what is shown in AWC. This stream's upper anadromous extent ends at a waterfall flowing from the mountainside. The stream flows to the highway where it splits, creating two separate streams; one side flowing along the highway before passing through a culvert and into a side channel of the Chilkat River; the second branch flows through a culvert and widens into a marsh before channelizing again and entering the Chilkat side channel.

**Recommendations:** Correct the current route in the Anadromous Waters Catalog (Figure 1).
