**Technical Report No. 08-01**

## **A SURVEY OF STREAM CROSSING STRUCTURES IN THE NORTH SLOPE OILFIELDS**

**by William A. Morris  
and Jack F. Winters**

**February 2008**

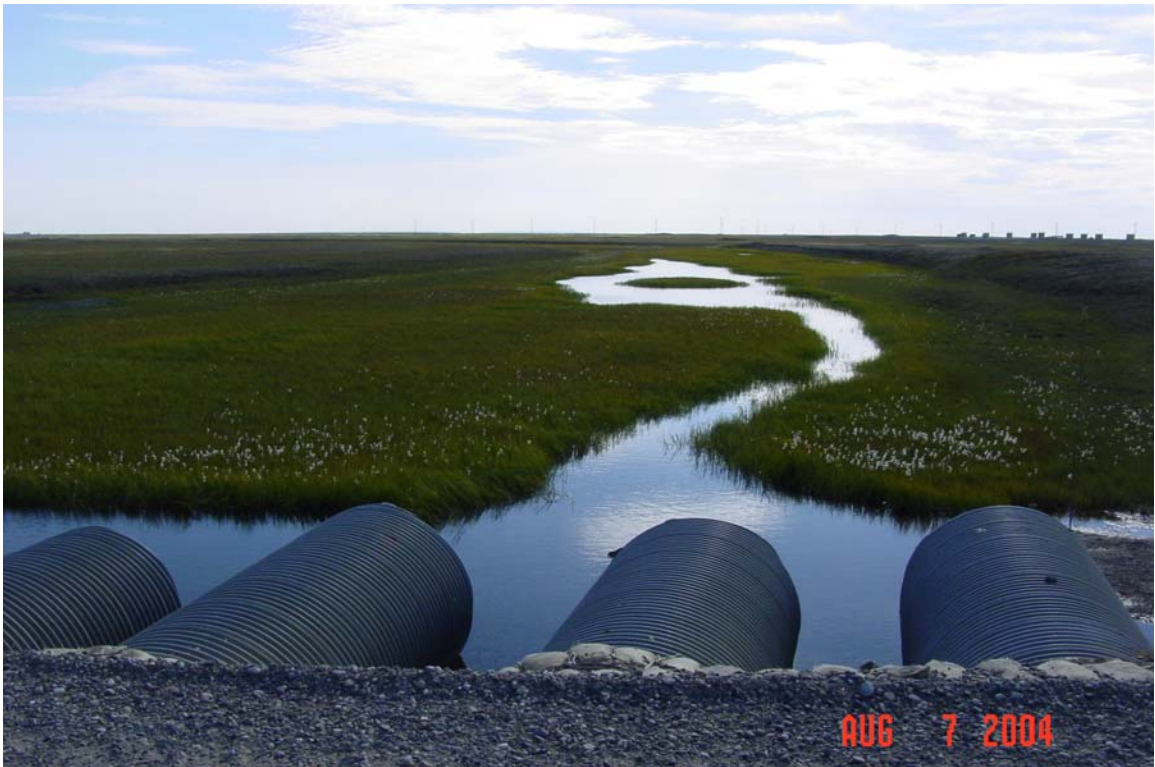
OUTLET: Sand bag armor, gobi mat, significant outwash gravel blocking the stream, minor outlet damage

**Photograph 5. Washout Creek upstream of road.**

REMEDIATION RECOMMENDATIONS: Remove outwash gravels, increase water conveyance through the crossing

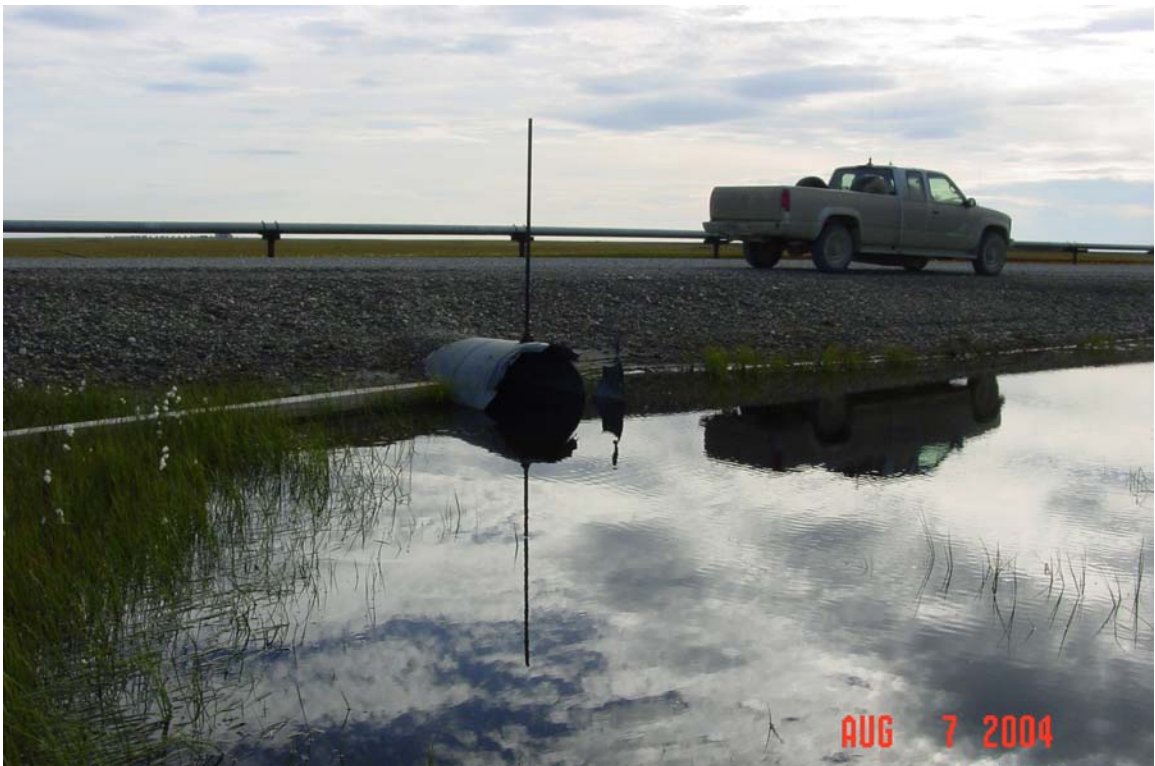
OUTLET: Damage to culvert end, gobi mat armor

**Photograph 11. Duck Island Creek culvert outlet.**

REMEDICATION RECOMMENDATIONS: Increase water conveyance through this crossing

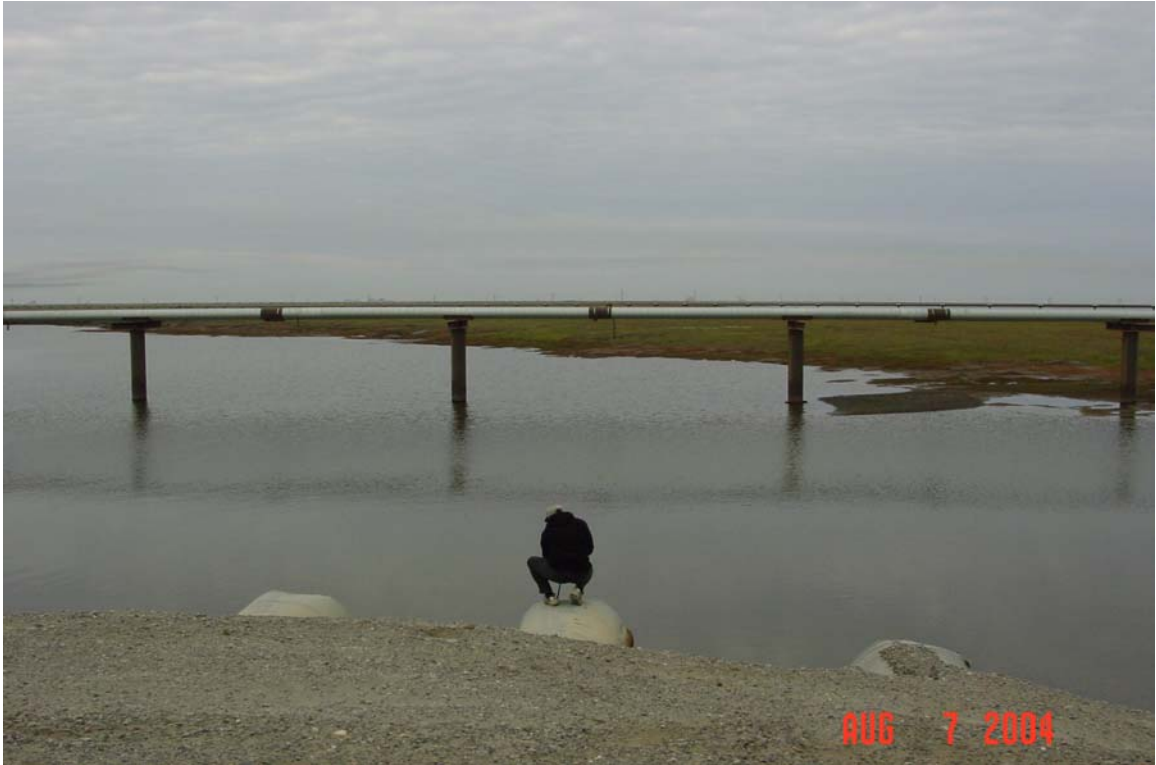
**Photograph 55. LGI Estuary Creek upstream of the road.**

REMEDICATION RECOMMENDATIONS: Repair road damage, increase water conveyance past this location

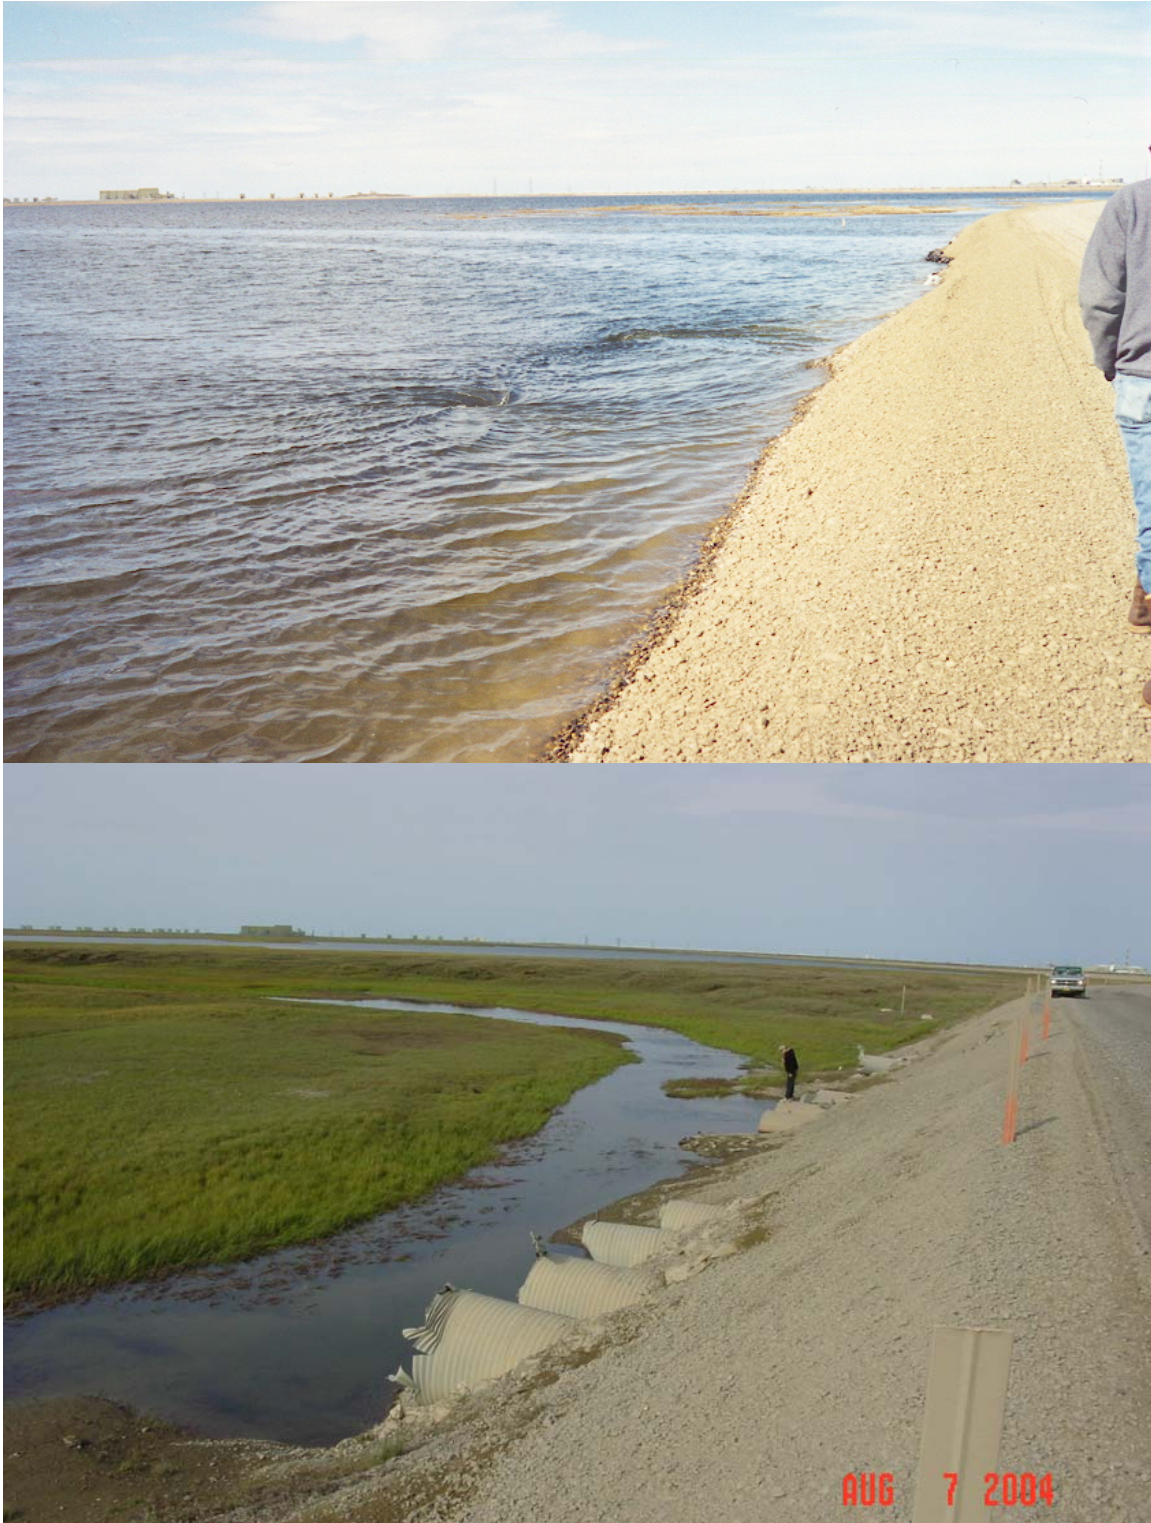
**Photograph 103. Compilation of summer (bottom) vs. breakup(June 20, 2000) (top) flow conditions at the Little Putuligayuk River upstream of the Spine Road. Water is ponded upstream for an extreme distance; minimally, water is ponded to the Drill Site 14 pad nearly 1 mile to the west. This condition occurs most years during breakup; this is not an isolated event.**

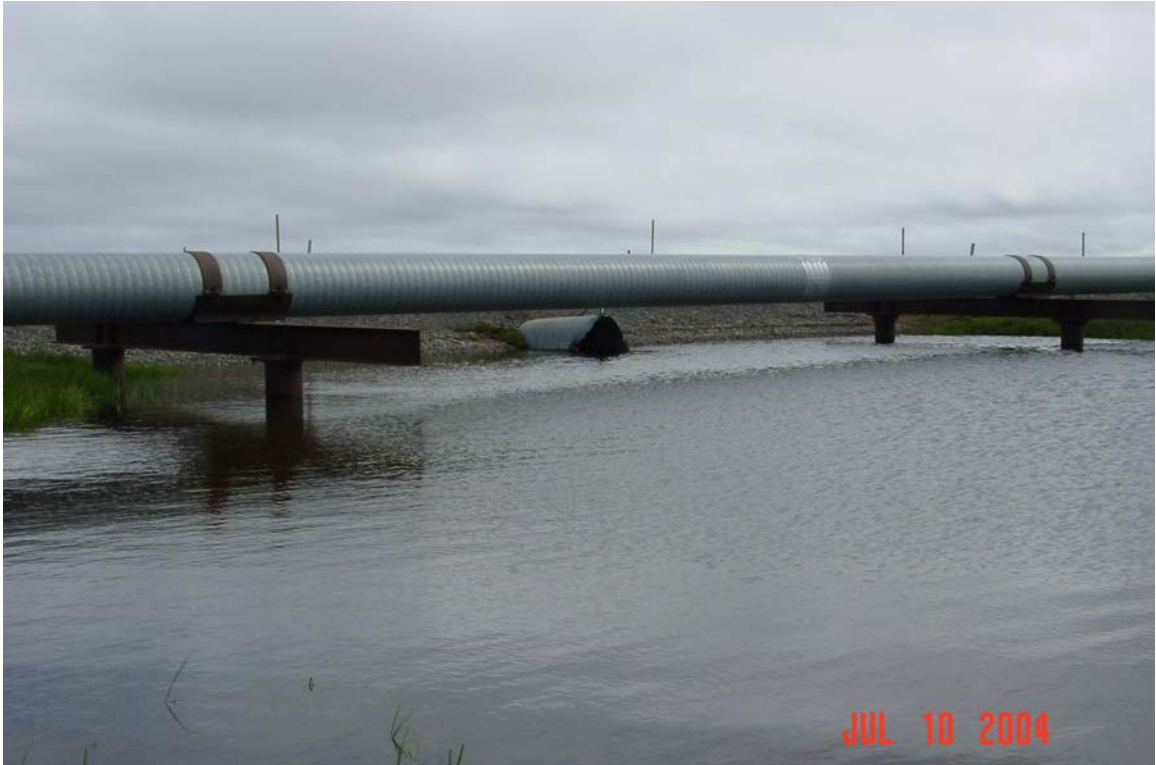
**Photograph 116. Fawn Creek culvert inlet. Minimal inlet damage.**

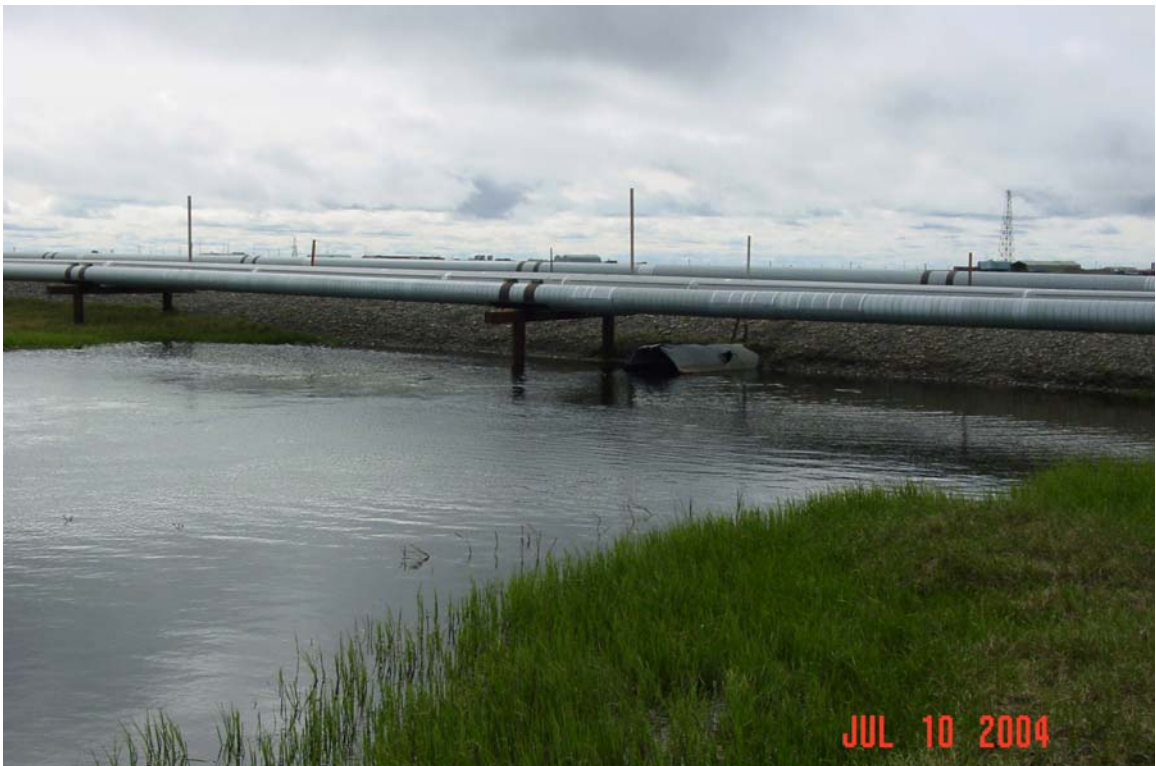
**Photograph 117. Fawn Creek culvert outlet. Some damage to culvert can be seen.**

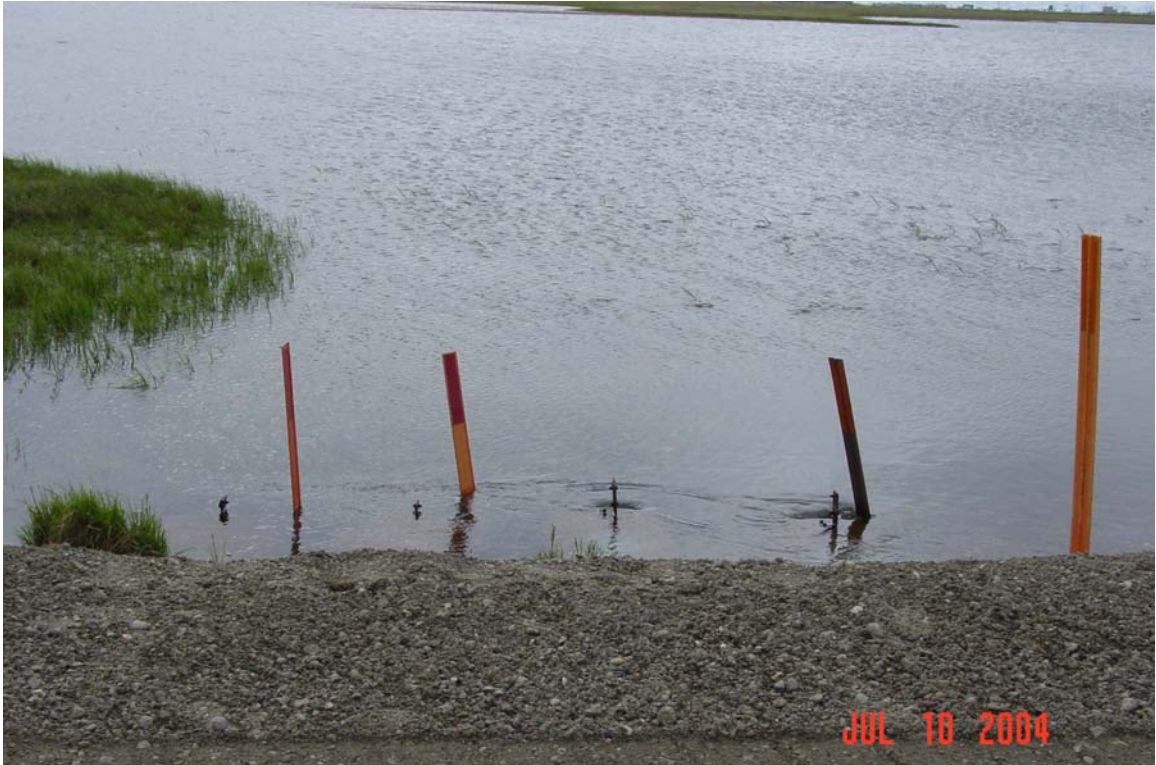
**Photograph 118. Fawn Creek upstream of the F-Pad to E-Pad Road. Water is ponded upstream and culverts are submerged; whirlpools at inlets indicate excessive velocity is likely.**

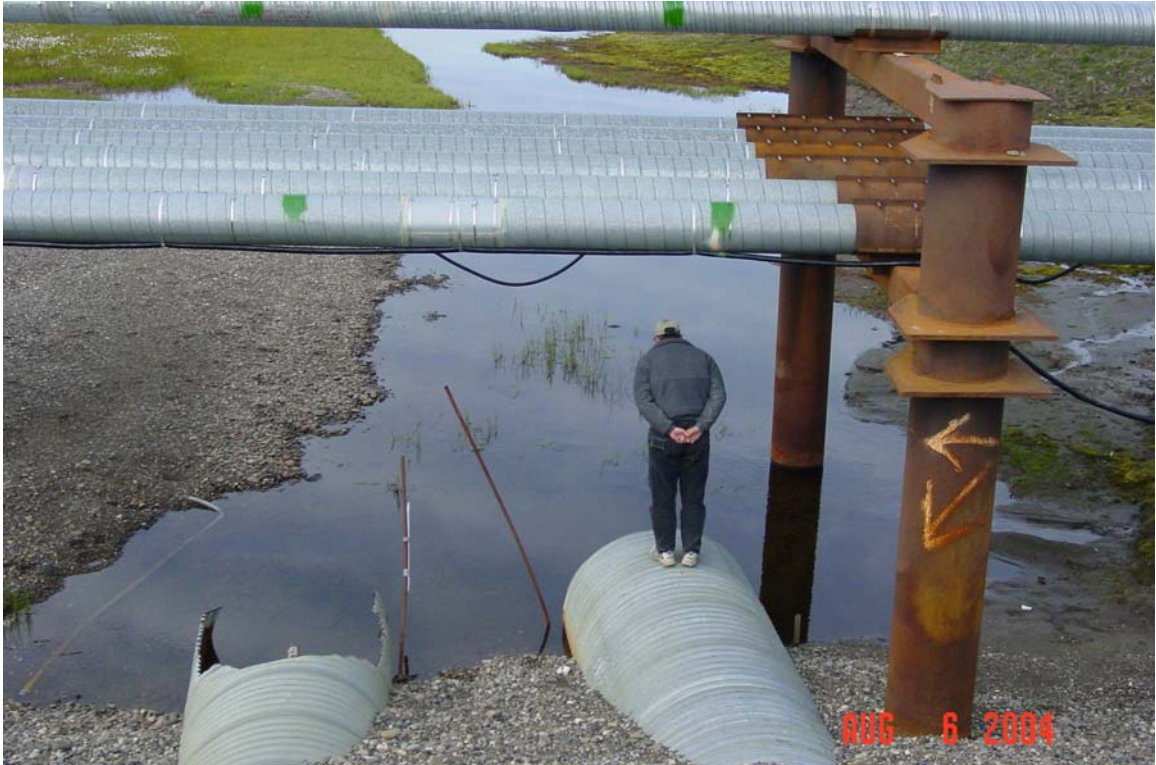
**Photograph 132. Leach Creek downstream of the R Pad Road. Significant gravel outwash and debris is in the stream channel and on the stream banks.**

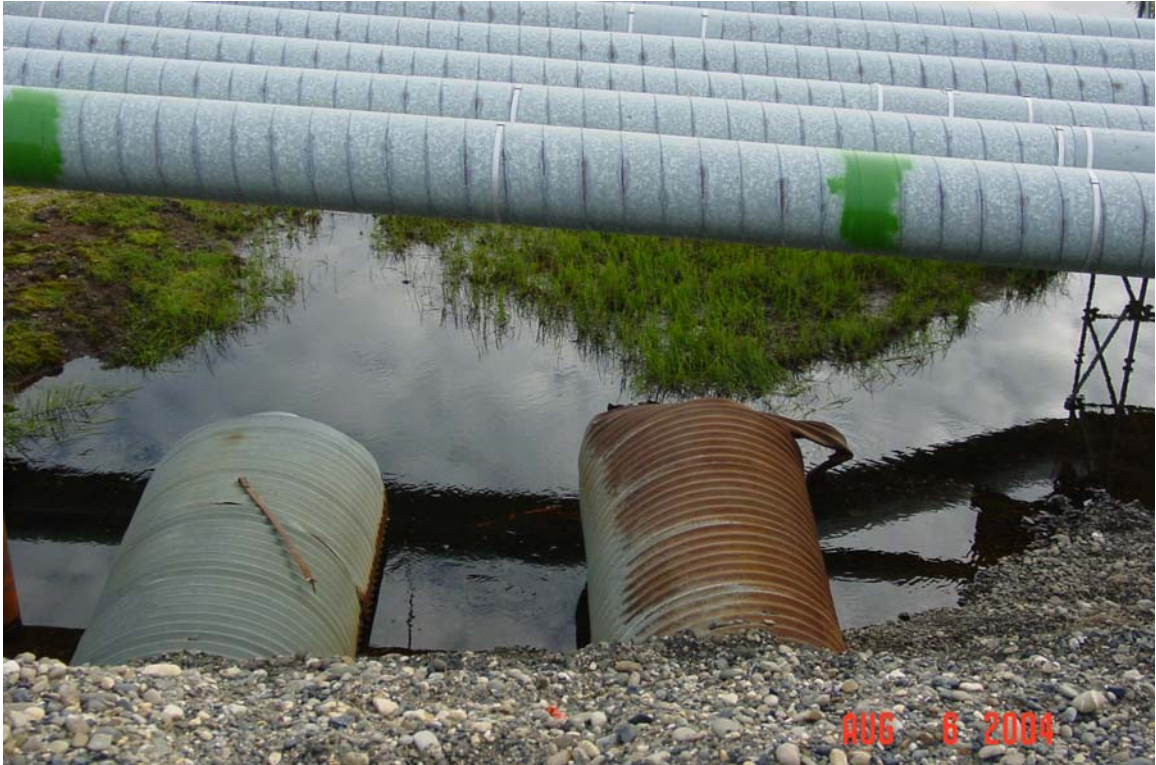
**Photograph 133. Misaligned and damaged Leach Creek culvert inlets at the R Pad Road.**

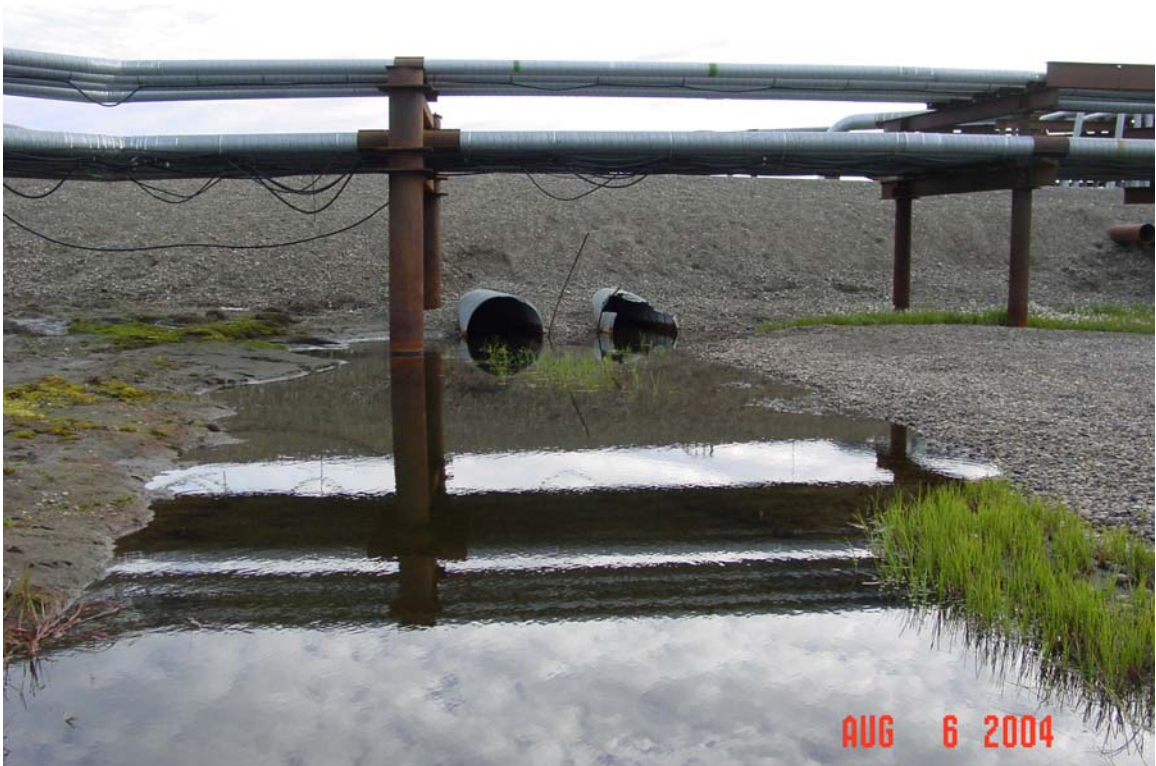
**Photograph 134. Leach Creek damaged culvert outlets and outwash gravel.**

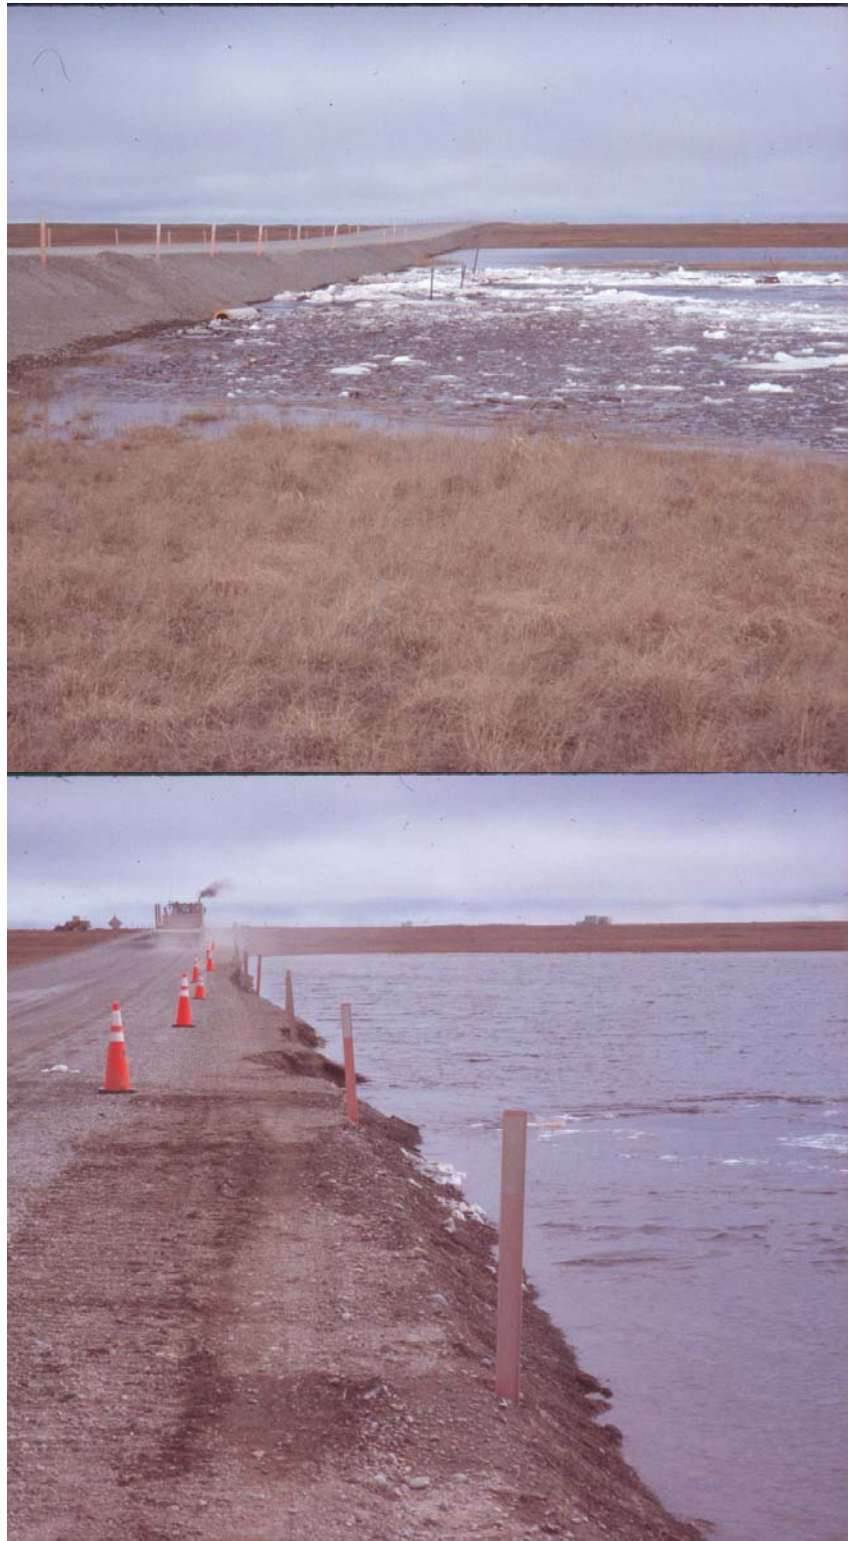
**Photograph 148. Smith Creek at Spine road at the upstream side of crossing during break-up, June 9, 2005 (top) and June 10, 2005 (bottom). Flow is significantly impeded, road erosion is occurring and ice is jamming at the crossing.**

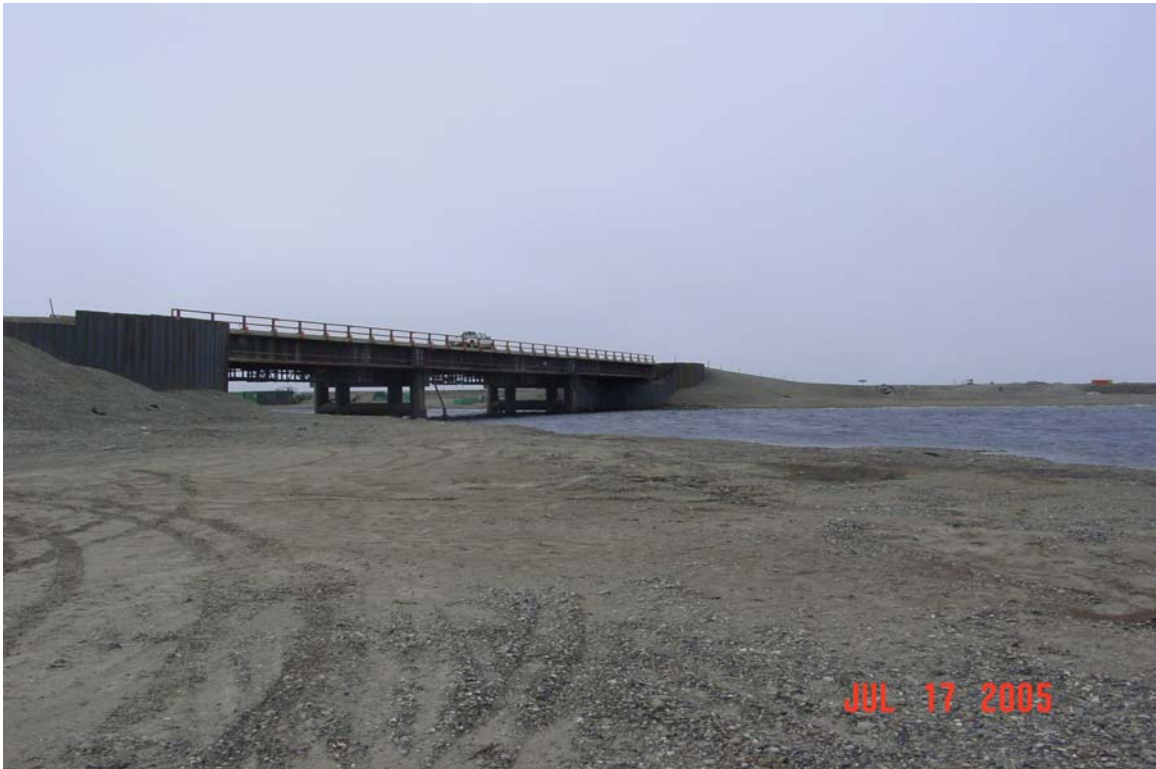
**Photograph 186. Kugaruk River Central Channel bridge final repair with sheet pile abutments.**

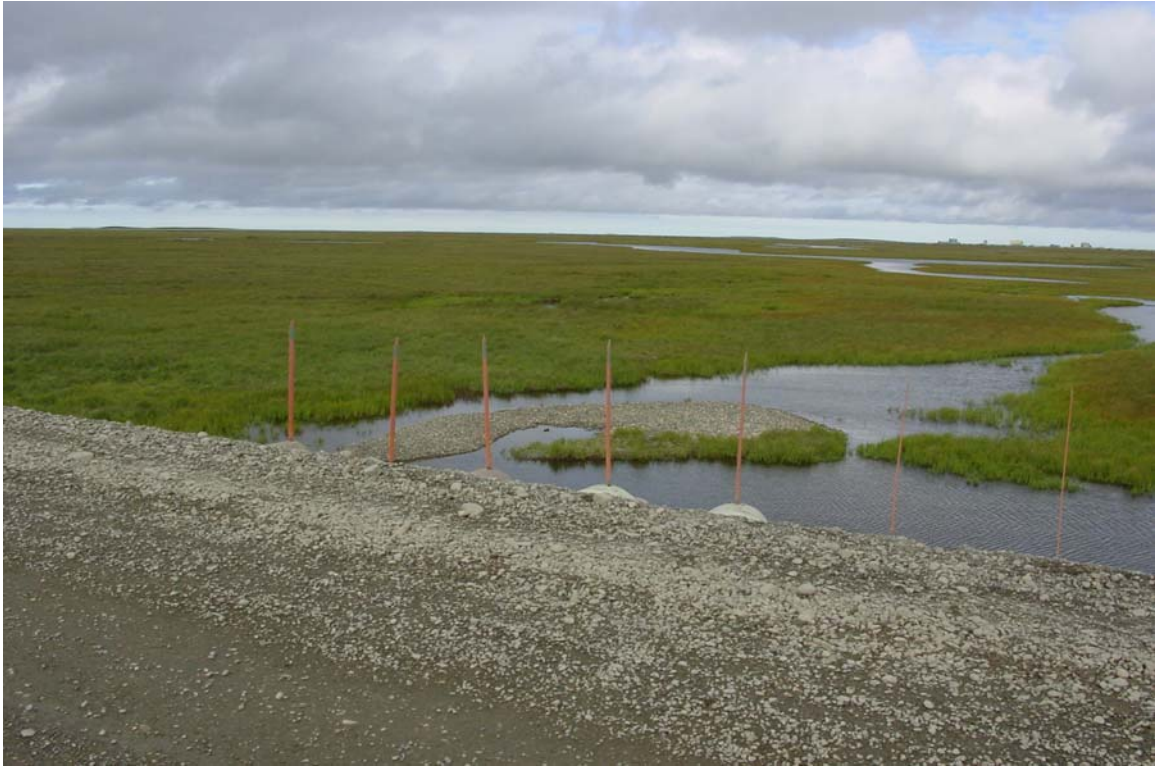
**Photograph 223. West Fork West Fork Central Creek downstream of the Spine Road between Drill Site 1 D and CPF-1 with scour pools and outwash gravels, August 8, 2006.**

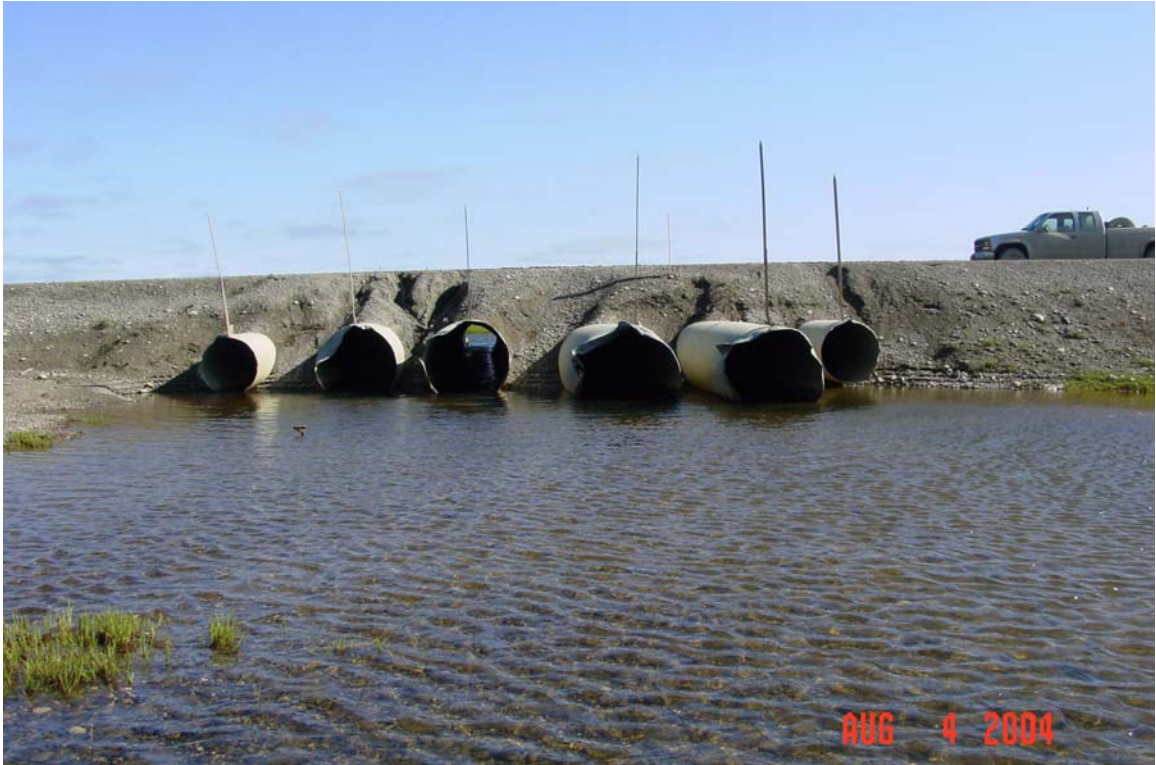
**Photograph 292. West Fork Ugnuravik River culvert inlet damage, road prism erosion, and a high water mark about 1 foot above the inlets.**

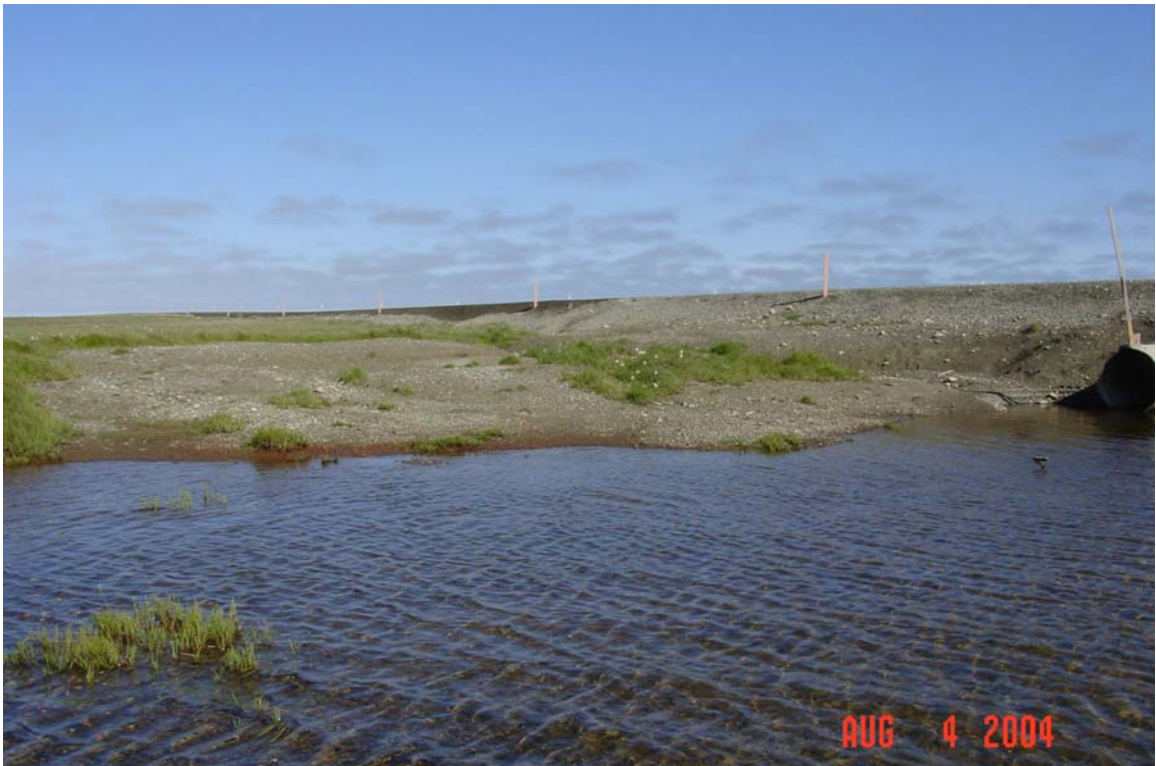
**Photograph 293. Outwash gravels downstream of the culvert battery.**

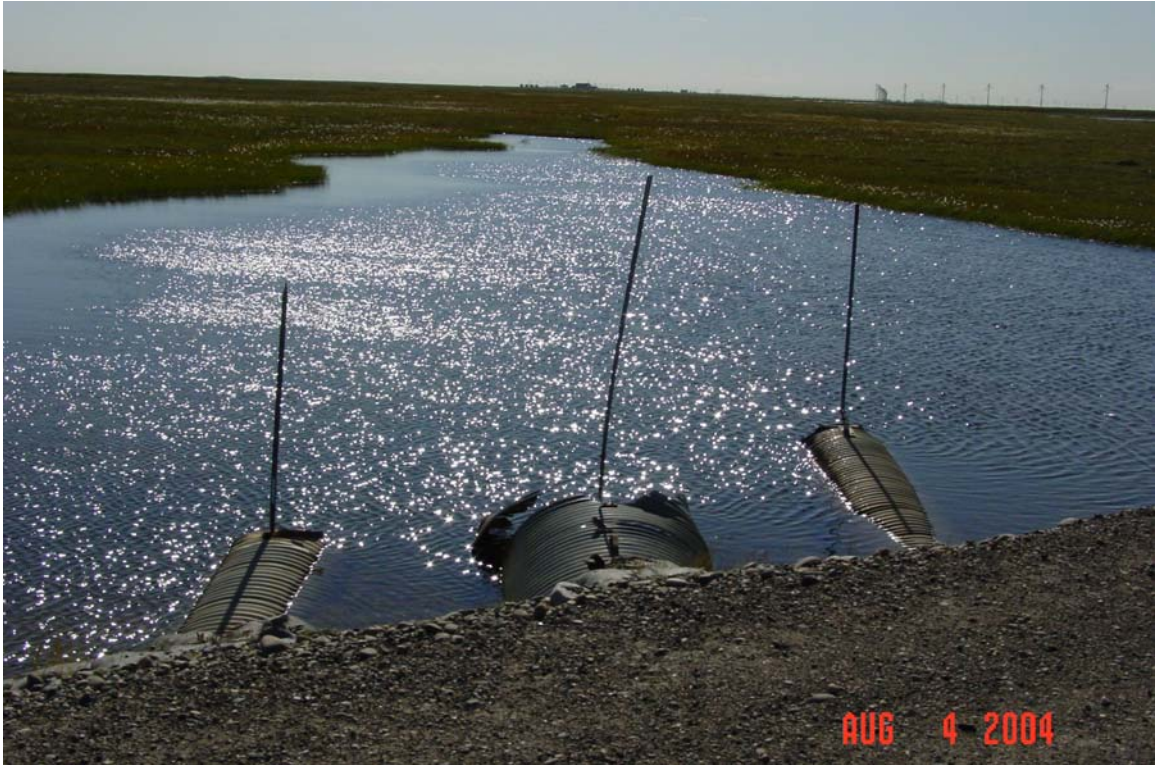
**Photograph 296. Caribou Creek upstream of the access road at Drill Site 3B. Damaged inlets.**

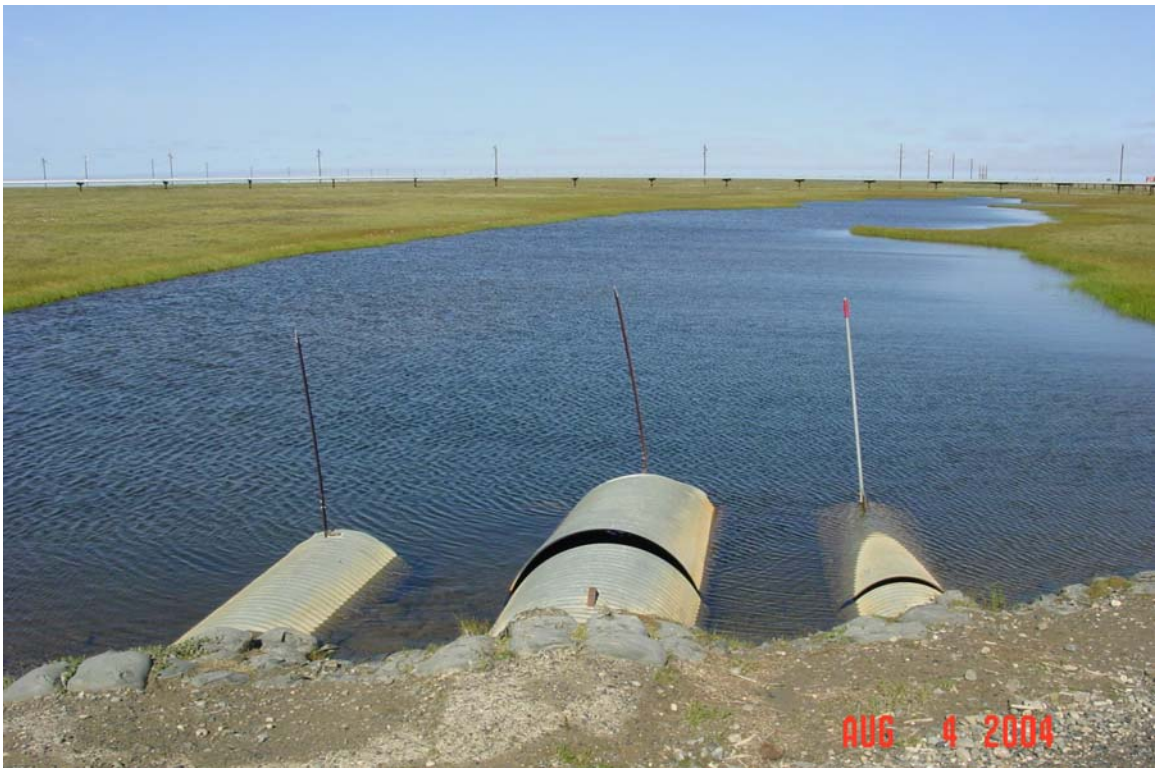
**Photograph 297. Caribou Creek downstream of the access road at Drill Site 3B. Broken outlets.**

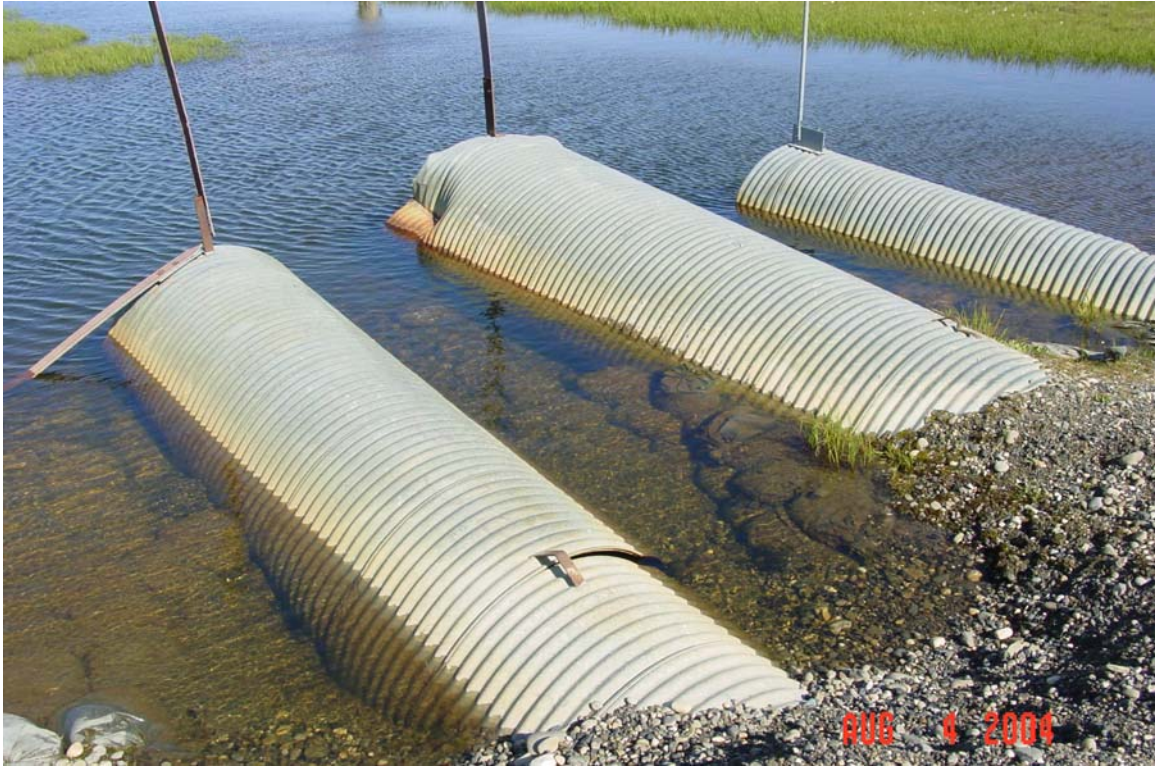
**Photograph 304. Kalubik Creek tributary (East Fork Nowhere Creek) culvert outlets that are excessively long, damaged and split.**

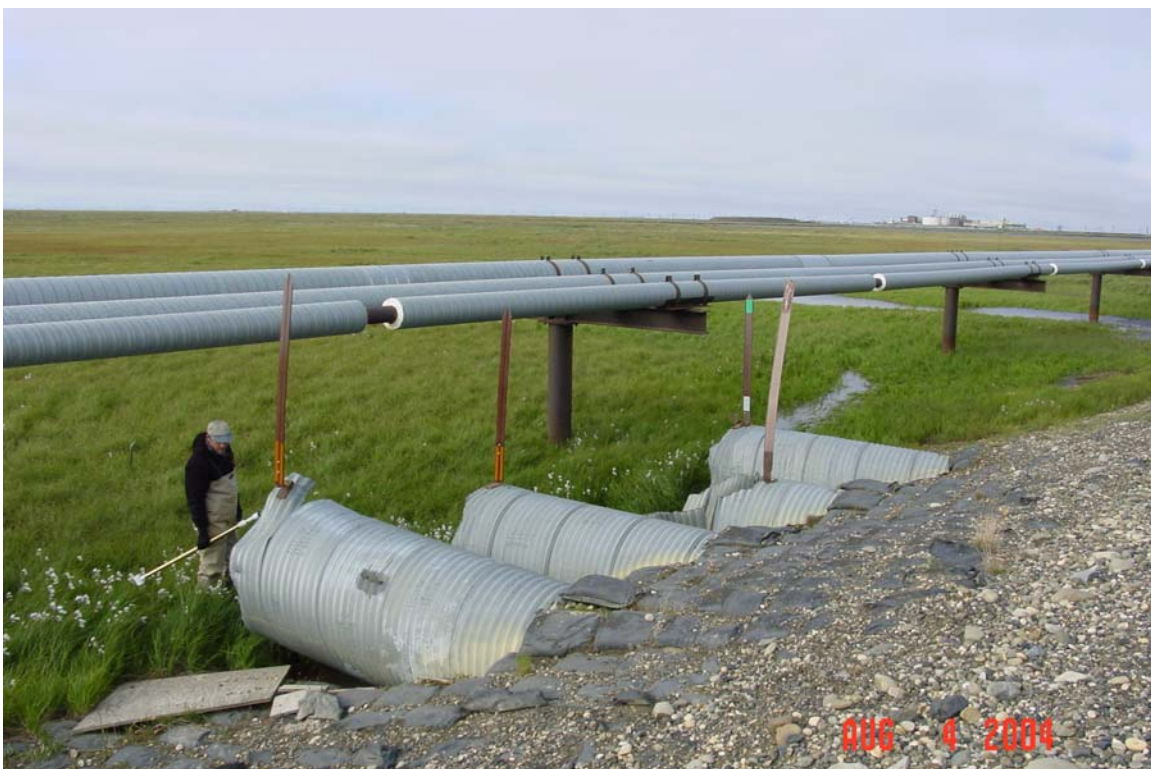
**Photograph 363. West Fork Ugnuravik River culvert inlets. Note the stream approaching from the right, and the perched and damaged inlets.**

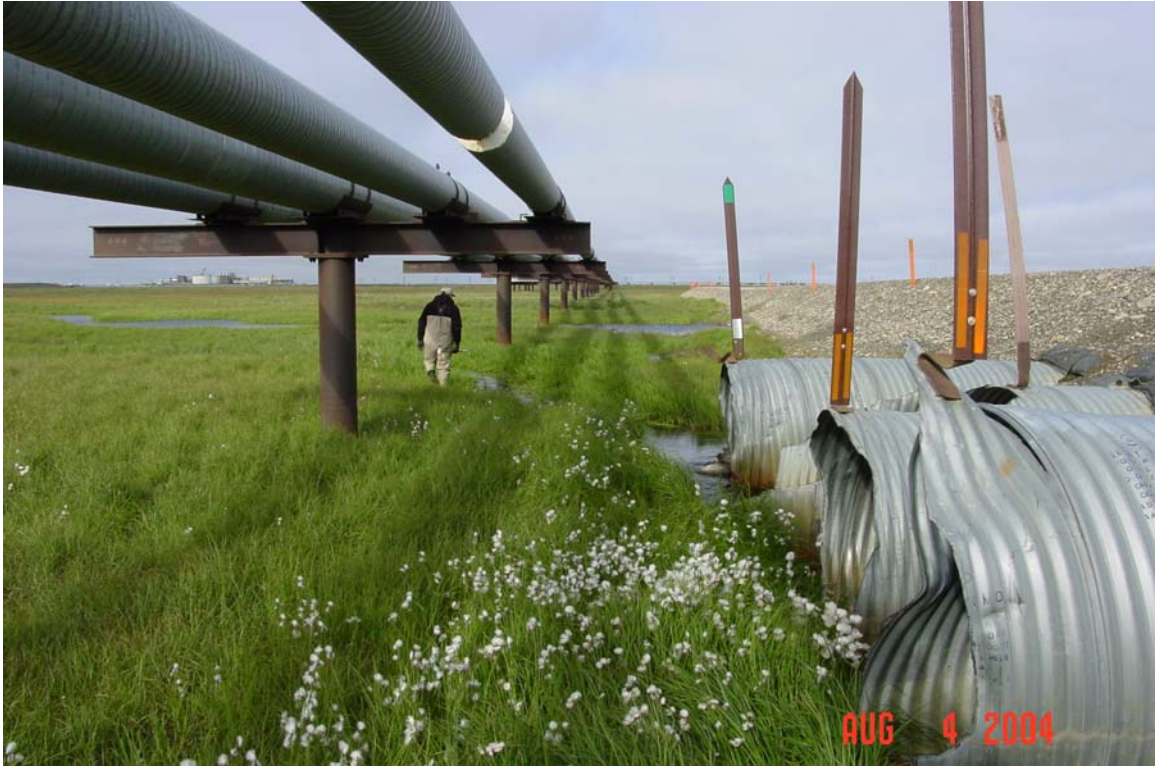
**Photograph 364. West Fork Ugnuravik River damaged culvert inlets.**
