**A SURVEY OF RECREATIONAL OFF-ROAD VEHICLE (ORV)
STREAM CROSSINGS ALONG TRAILS ORGINATING FROM
THE NABESNA ROAD IN WRANGELL-ST. ELIAS NATIONAL
PARK AND PRESERVE**

February 2009

Alaska Department of Fish and Game
Division of Habitat

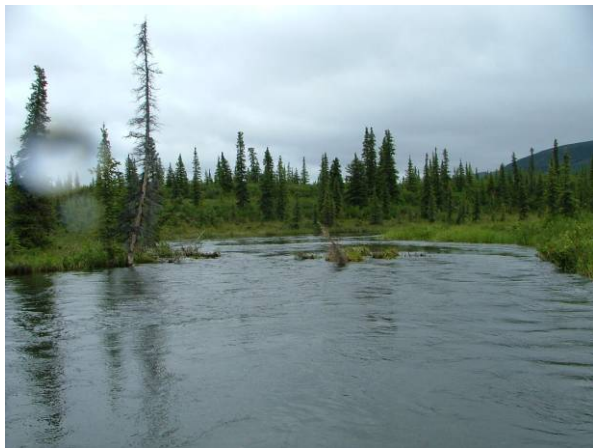
Upstream view from crossing CL-3.

Precipitation levels for the field season were higher than average. Most streams were at or just below bankfull, making it difficult to accurately and thoroughly assess the condition of the crossing due to decreased visibility and difficulty collecting the data because of high and fast flows. We recommend that the following crossings be re-surveyed at low flows: CL-3, LCS1, and the inundated area on the Tanada Lake Trail (Table 1).

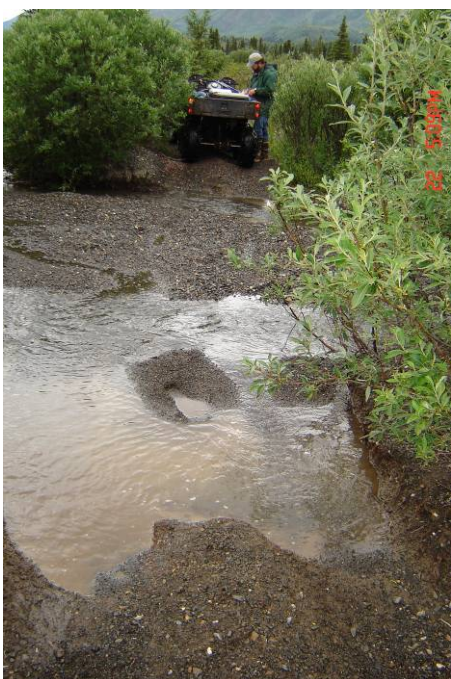
Right bank. Notice shoe print in the soft substrate.

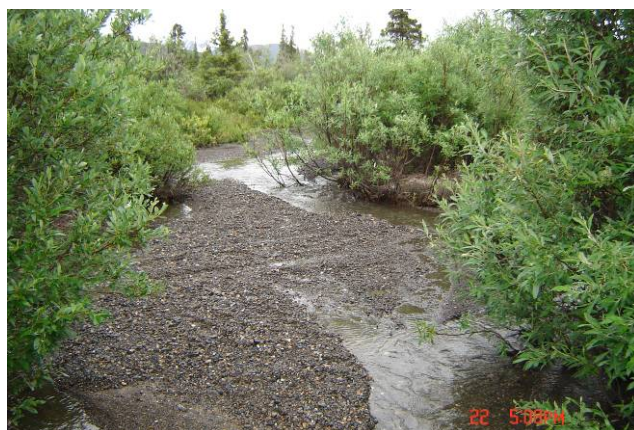
Upstream view from crossing SC-7.

We examined 7 crossings along this trail, which is within the Nabesna River watershed. All crossings were in good condition with the exception of SC-7 which was very soft with fines being released with disturbance (Table 1).

DATE: 7/22/08 **TIME:** 5:04 pm **STATION NO.** SC-7 **HABITAT :** Riffle **WATER COLOR:** Clear
WATERBODY NAME/DESCRIPTION: Unnamed tributary to Chalk Creek (no fish data for this tributary but Chalk Creek supports round whitefish and grayling near the Nabesna Road)
GPS LATITUDE: 62° 32.323 **GPS LONGITUDE:** 143° 05.988
RIPARIAN VEGETATION: Functional, but some degradation at both bank approaches
WATERBODY TYPE: stream **FLOODPLAIN:** flat **STREAM MORPHOLOGY:** B **H₂O STAGE:** 3
WATERBODY SLOPE: 3.5 % **BANKFULL WIDTH:** 20 (ft.) **FLOODPLAIN WIDTH:** 200 (ft.)
SUBSTRATE (%): Bedrock ____ Boulder ____ Cobble ____ Gravel _70_ Sand _30_ Silt/Clay ____ Organic ____
COMMENTS: Substrate here is very soft (very fine gravels and sand) and releases a lot of fines when disturbed.
SURVEY METHOD: ☐ Visual Ground ☐ Visual Plane ☐ Visual Helicopter ☐ Net ☒ Trap ☐ Electroshocker
TRAP ID: SCT005 **TRAP CATCH:** 0 **TRAP IN:** 12:16 pm **TRAP OUT:** 5:05 pm **TOTAL TRAP TIME:** 5 hours

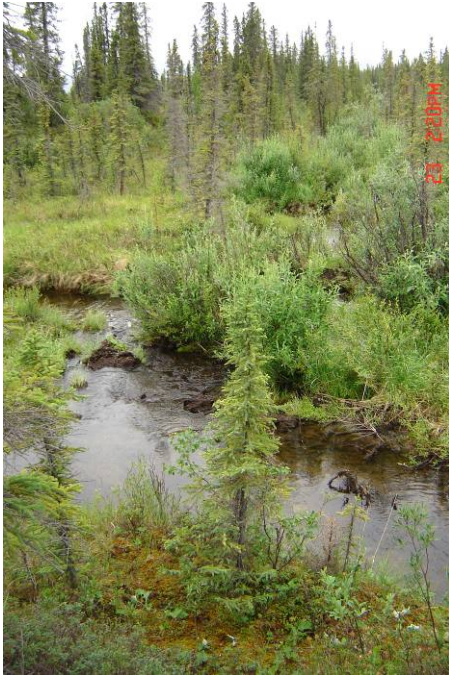
Downstream view from SLT-1.

We surveyed three crossings along this trail, which is in the Slana River watershed. All crossings except for SLT-2 suffered from one or more impacts (Table 1). Crossing SLT-1 and SLT-3 were severely degraded. At each site there were three cuts perpendicular to the stream from ORV use, each cut less than 25-50 ft. apart. These cuts are causing rutting in the streambed as the substrate is somewhat soft and altering water flow which allows water to overflow into the ruts during high flows.

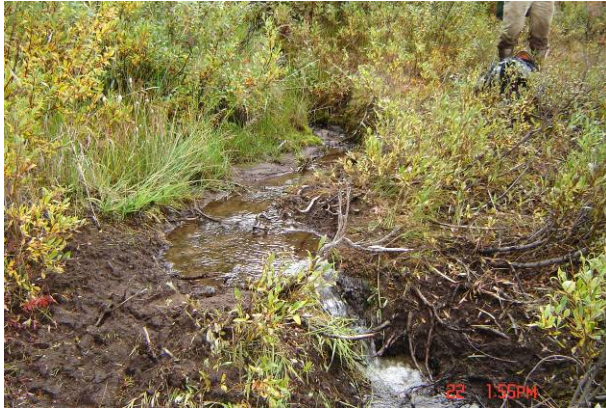
Upstream view from crossing TLT-6.

COMMENTS: Crossing very soft and with multiple tracks running through it. Additional crossing only 50 feet away from this one and in similar condition.

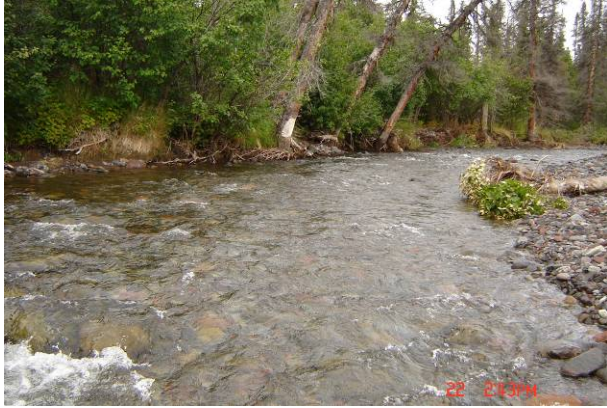
Upstream view from crossing TLT-7.

COMMENTS: This crossing could be an impediment to passage for juveniles, if present. Additional crossing only 50 feet away from this one and in similar condition, but without the potential passage issue.

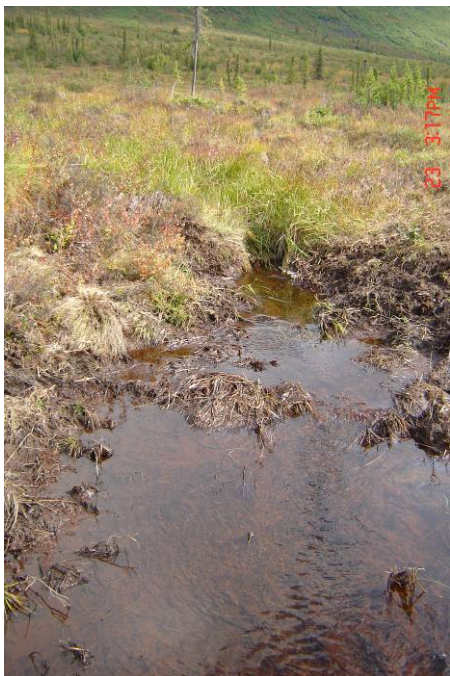
Upstream view from crossing TLT-12.

COMMENTS: Drains through a wetland and into Tanada Creek where there is sockeye spawning habitat. The crossing, which is located approximately 1500 feet from the creek, is degraded and may contribute to water quality issues and have potential negative impact to spawning habitat.

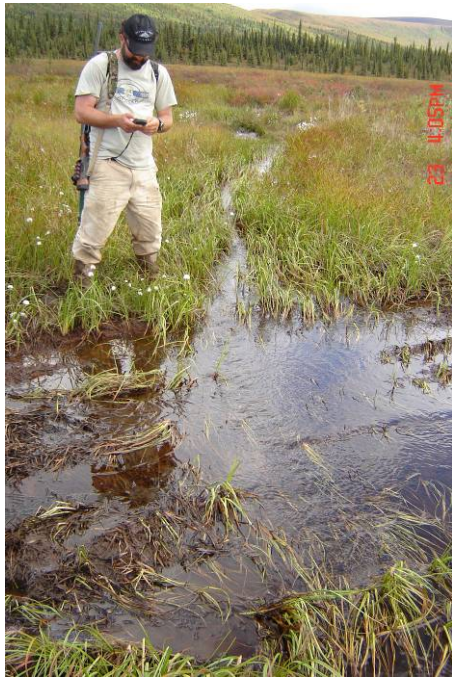
Upstream view from crossing TLT-13.

COMMENTS: Stream runs through a wetland, into the crossing and then channels into Tanada Creek where there is sockeye spawning habitat. The crossing, which is located approximately 400 feet from the creek, is degraded and may contribute to water quality issues and have potential negative impact to spawning habitat.

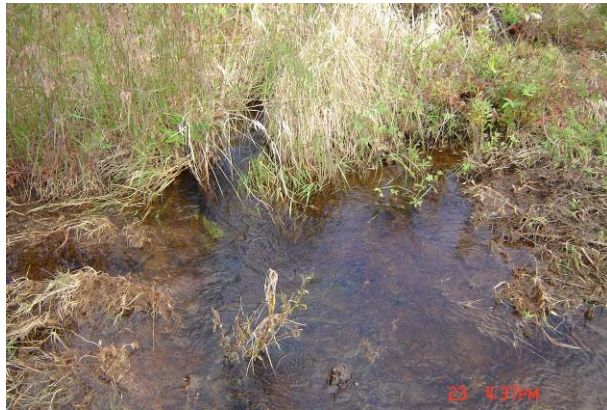
Upstream view from crossing TLT-14.

We examined 7 crossings along this trail, which is in the Copper River watershed. Most of the crossings along this trail had some rutting on the approaches and weakened banks. TLT-14 was significantly degraded and was impassable. Crossing TLT-6 had significant drop which was creating a barrier to juvenile fish passage. Crossings TLT-5, TLT-8, TLT-9, TLT-10, TLT-11, TLT-12, TLT-13, and TLT-14, were also degraded by one or more impacts (Table 1).

COMMENTS: Crossing very degraded and located within 1500 ft. of Tanada Lake. Not possible to cross with high water conditions and unsure about ability to cross with lower water levels. Current conditions contribute to water quality issues.

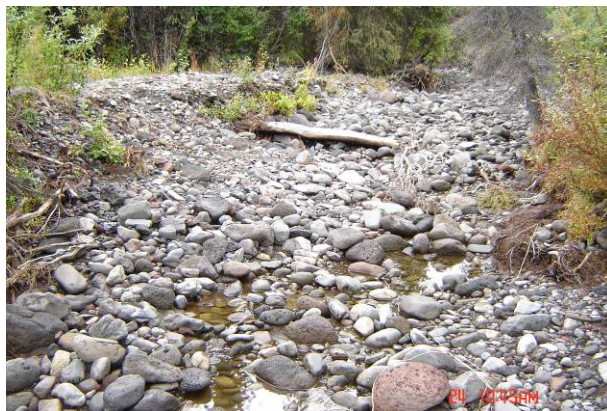
Upstream view from crossing TLT-15.

DATE: 8/24/08 **TIME:** 10:41 am **STATION NO.** TLT-15 **HABITAT :** Riffle **WATER COLOR:** Clear
WATERBODY NAME/DESCRIPTION: Unnamed tributary to Tanada Lake (no fish data available for this tributary but it leads to Tanada Lake which is cataloged as sockeye spawning. Tanada Lake also supports burbot, grayling and slimy sculpin).
GPS LATITUDE: 62° 26.375 **GPS LONGITUDE:** 143° 20.998 **RIPARIAN VEGETATION:** Functional
WATERBODY TYPE: stream **FLOODPLAIN:** flat **STREAM MORPHOLOGY:** B **H₂O STAGE:** 1
WATERBODY SLOPE: 4 % **BANKFULL WIDTH:** 30 (ft.) **FLOODPLAIN WIDTH:** 60 (ft.)
SUBSTRATE (%): Bedrock ___ Boulder _30_ Cobble _50_ Gravel _20_ Sand ___ Silt/Clay ___ Organic ___
COMMENTS: Partially degraded left bank.
