Fish Passage Assessment and Culvert Inventory on the King Cove and Cold Bay Road Systems

December 2018

Alaska Department of Fish and Game

FISHERY DATA SERIES NO. 18-28

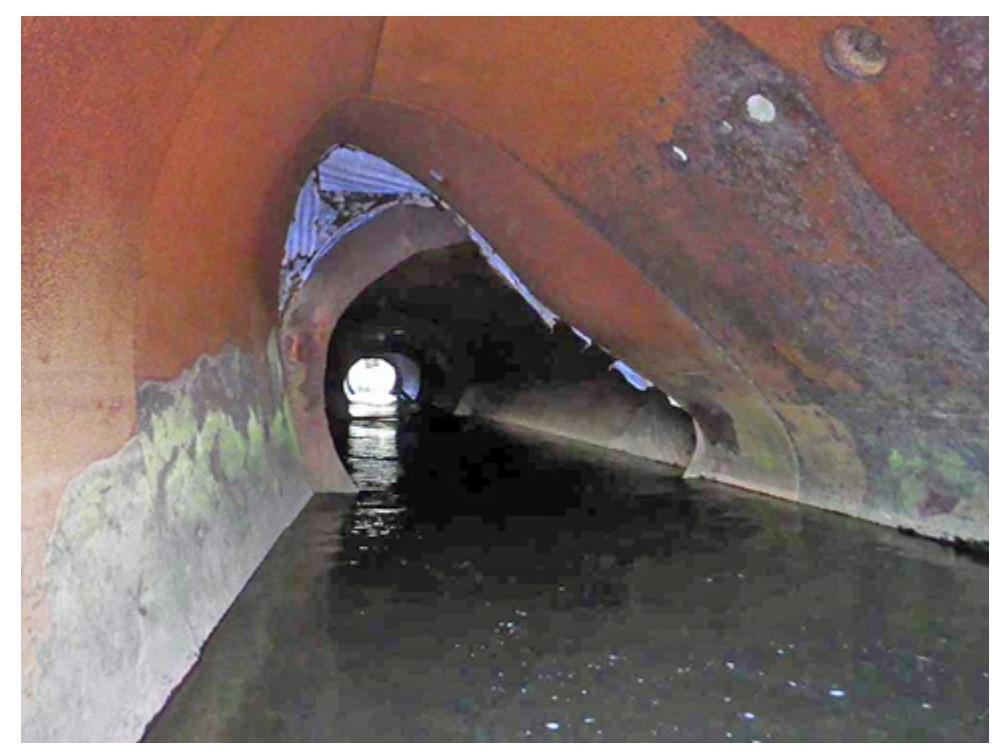
Assessments showed that 1 culvert met the project's standards for being embedded (ADF&G Fish Passage Matrix, Figure 3). Additionally, 1 site was found to be backwatered, 3 were found to potentially have tidal influence, and 2 culverts (sites 30103336 and 30103337) were found to have structures that could be considered baffling. Sites 30103336 and 30103337 are constructed out of old 8 foot diameter fuel tanks laid end to end with the inlet and outlet opens cut to create a large lip at the openings (Tables 13-16, Figure 7).

Figure 7.–Site 30103336, internal view of culvert looking upstream from outlet and showing the internal connection between tank sections and the created baffling.

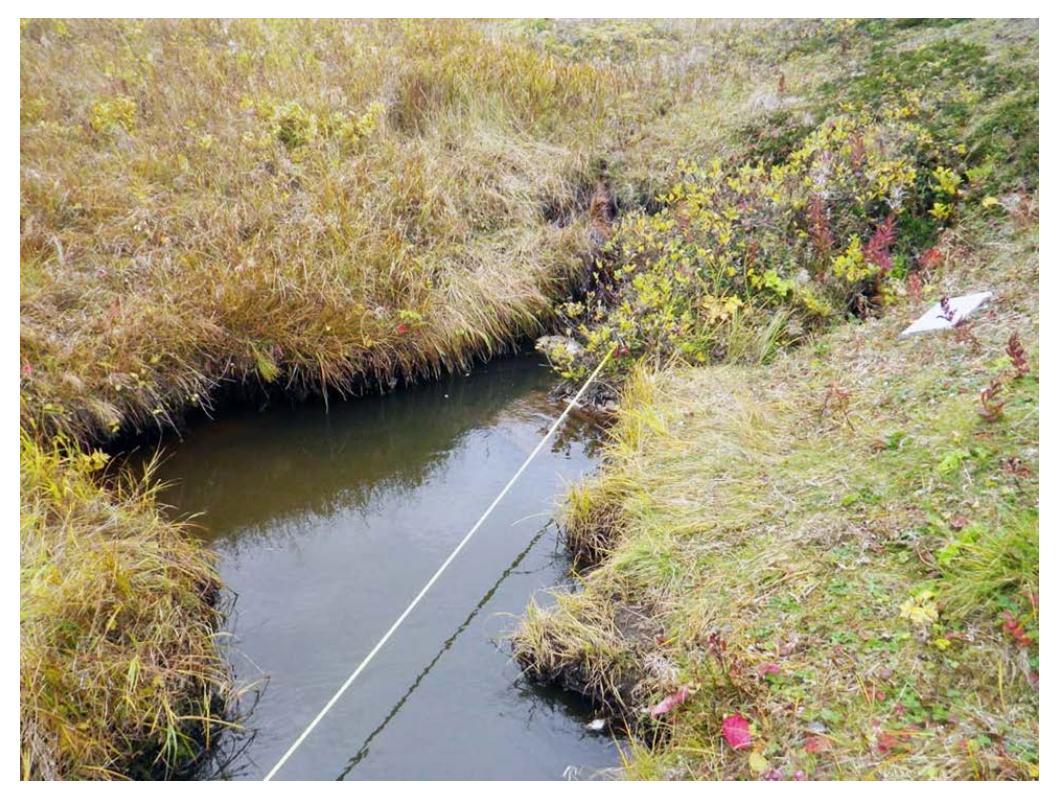
At the time of assessment, the inlet was bent downward and partially separated. Water was being funneled around the invert, which was submerged, and entering the culvert at the point of separation (Figures 10 and 11). Above the culvert is 3 miles of AWC-documented stream habitat and over 62 acres of lake habitat. The assessment crew also observed adult sockeye and coho salmon, juvenile coho salmon, and threespine stickleback below the culvert, but no fish were observed or captured above. Damage to the inlet appears to be blocking any upstream movement.

Figure 10.–Site 30103341, unnamed tributary to Trout Creek on the airport runway light access road, damaged inlet.

It is recommended that this culvert be replaced with a stream simulation culvert to restore unimpeded access to upstream spawning areas and allow juvenile salmonids and resident fish seasonal movement.

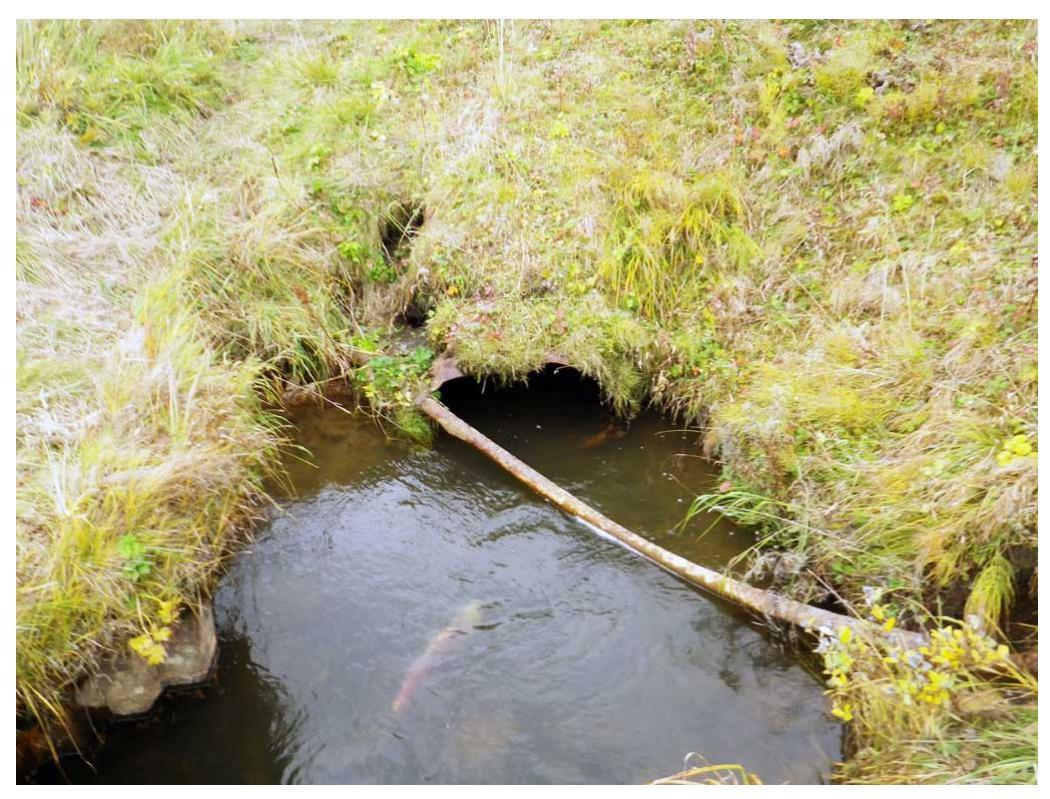
Figure 11.–Site 30103341, unnamed tributary to Trout Creek on the airport runway light access road, outlet. *Note*: Adult sockeye salmon below outlet.

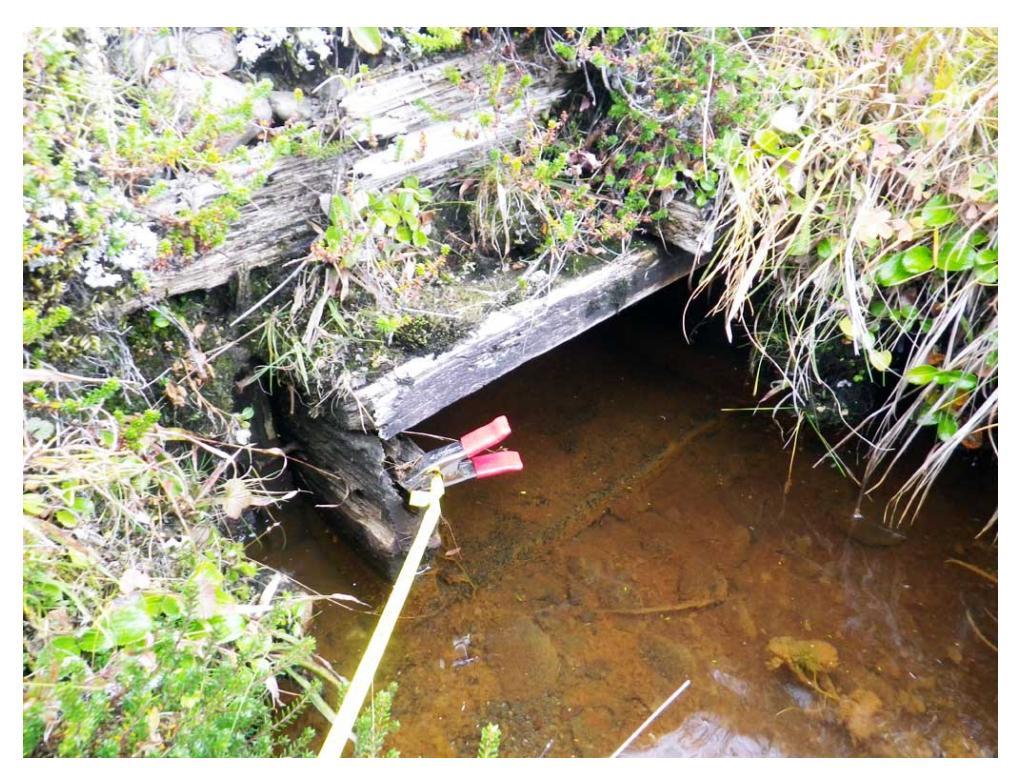
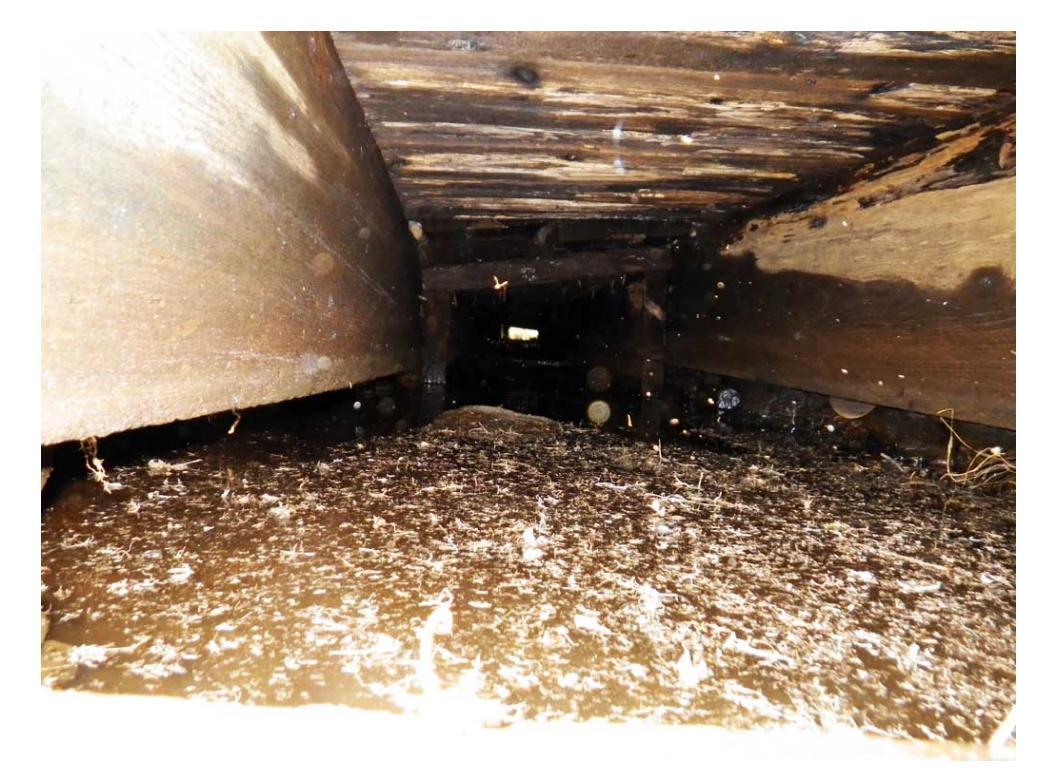
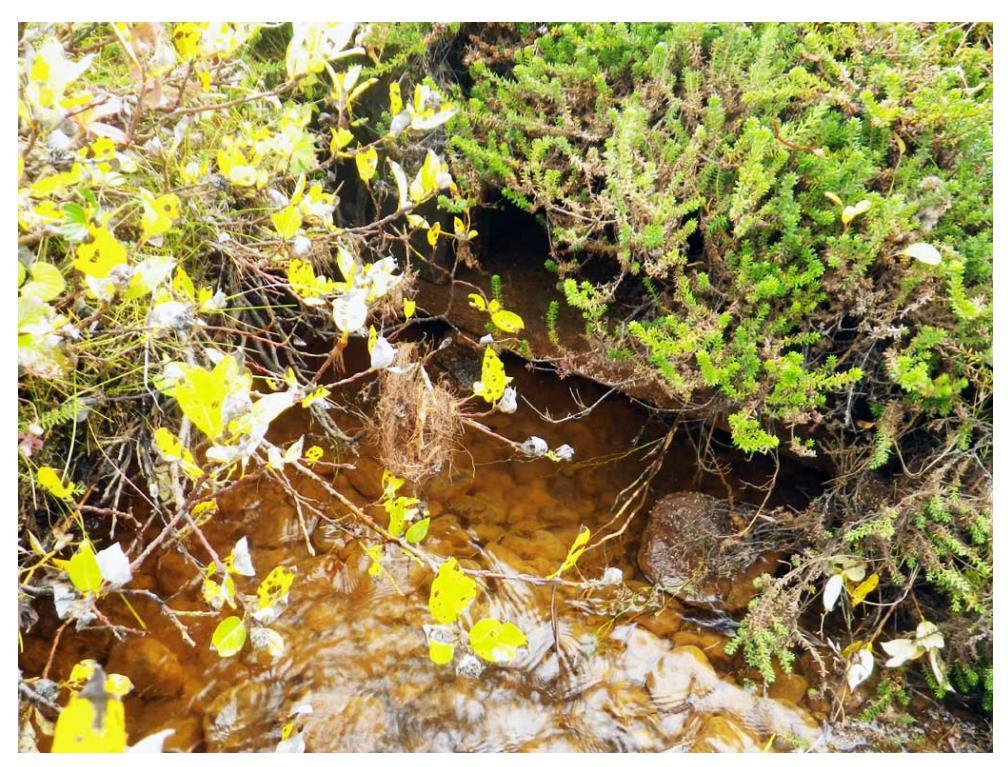
The creek is small, averaging 1.2 feet wide at OHW, but it had excellent habitat consisting of undercut banks, small pools, and riffles. Satellite imagery shows that this creek extends about another 0.3 miles upstream and drains multiple kettle ponds. During the assessment one juvenile coho salmon was caught upstream, nine juvenile coho salmon were caught downstream, and small unidentified fish were observed in the upstream kettle ponds. At the time of assessment this creek was not included in the AWC but was nominated and accepted in 2015 (ADF&G 2015).

Figure 12.–Site 30103339, inlet.

Figure 13.–Site 30103339, looking upstream inside the culvert from outlet.

Figure 14.–Site 30103339, outlet.

It is recommended that this crossing be either removed and the road decommissioned or replaced with a stream simulation culvert.

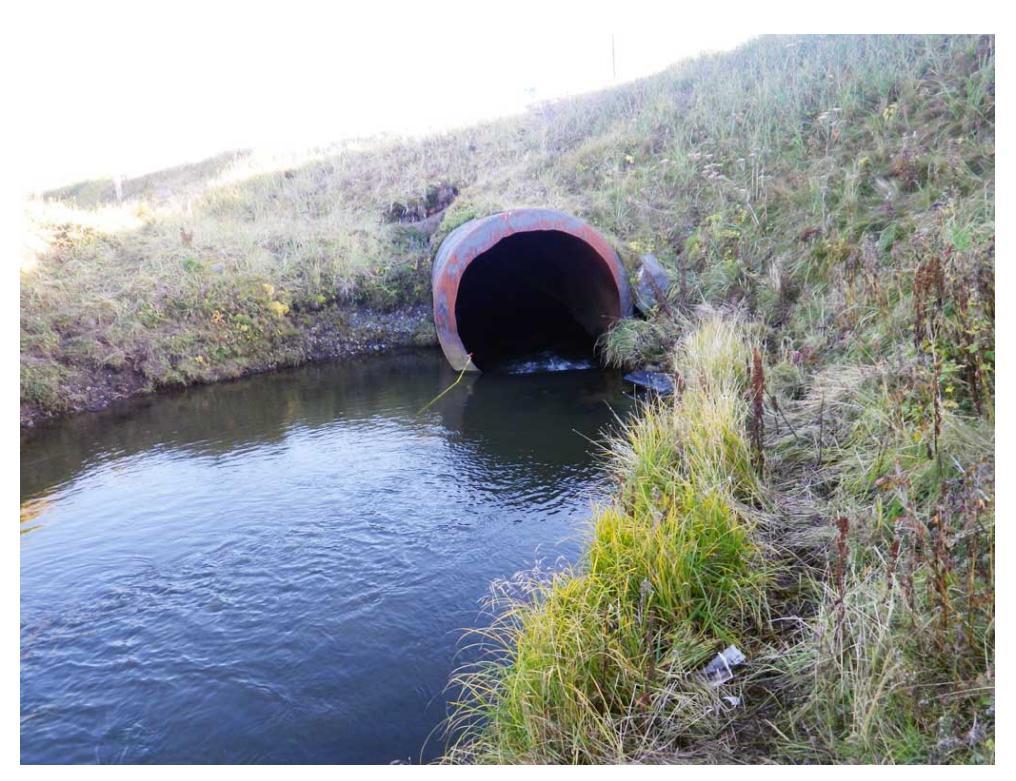
Figure 15.–Site 30103336, inlet.

This site is located on Grant Point Road on the north side of Cold Bay. This site consists of five 8 to 9-foot diameter fuel tanks that were installed in the 1980's to replace a failing bridge (M. Miller, ADF&G, Sport Fish Biologist, Anchorage, personal communication) (Figure 9). The tank ends had been cut out and the tanks placed end to end. The way the openings were cut left about a 1 to 2-foot-high lip between sections that act like baffles. The cut-out pieces from the tanks were used as wing walls for the outlet. Overall length of the culvert is 156 feet. Upstream OHW measurements averaged 23.3 feet, and the pipes constrict the stream with a ratio of 0.37. There is a noticeable hydraulic inlet perch. This creek has been cataloged as supporting sockeye, coho, chum, and pink salmon runs and resident three spine stickleback and Dolly Varden char (Figures 15-18). This culvert shares its outlet pool with site 30103337 (Stream No. #283-34-10300-2008) with the outlet located downstream about 20 feet.

It is recommended that this site be replaced along with site 30103337 with a bridge or large stream simulation culvert.

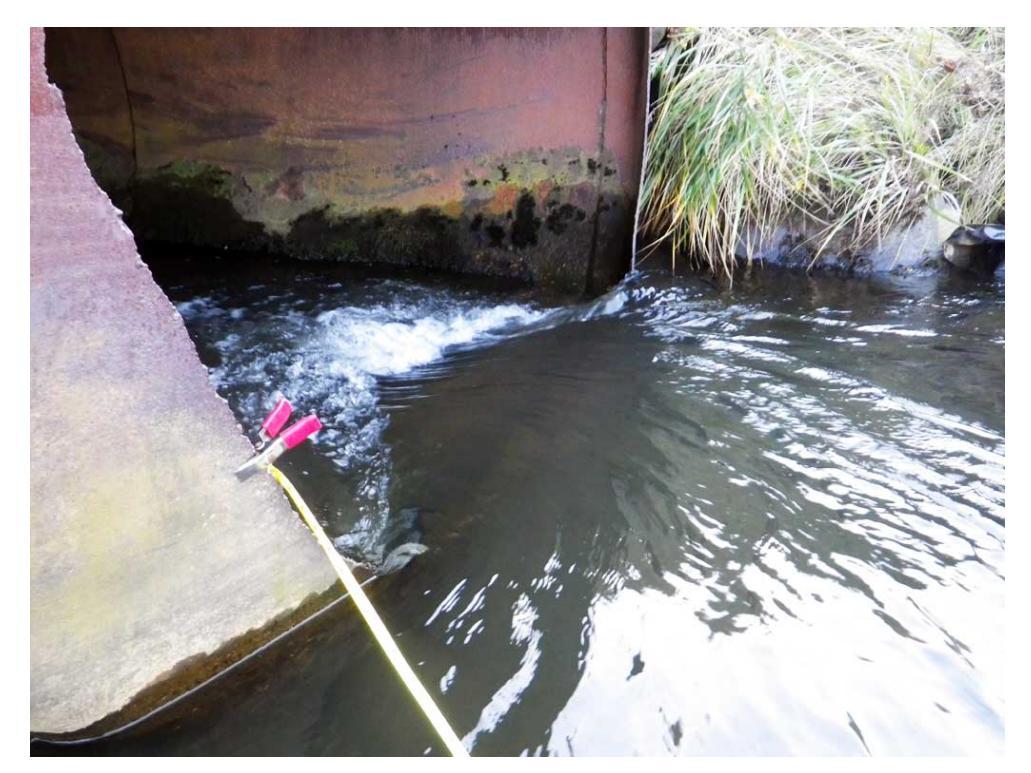
Figure 16.–Site 30103336, stream constriction at inlet creating a hydraulic jump, inlet.

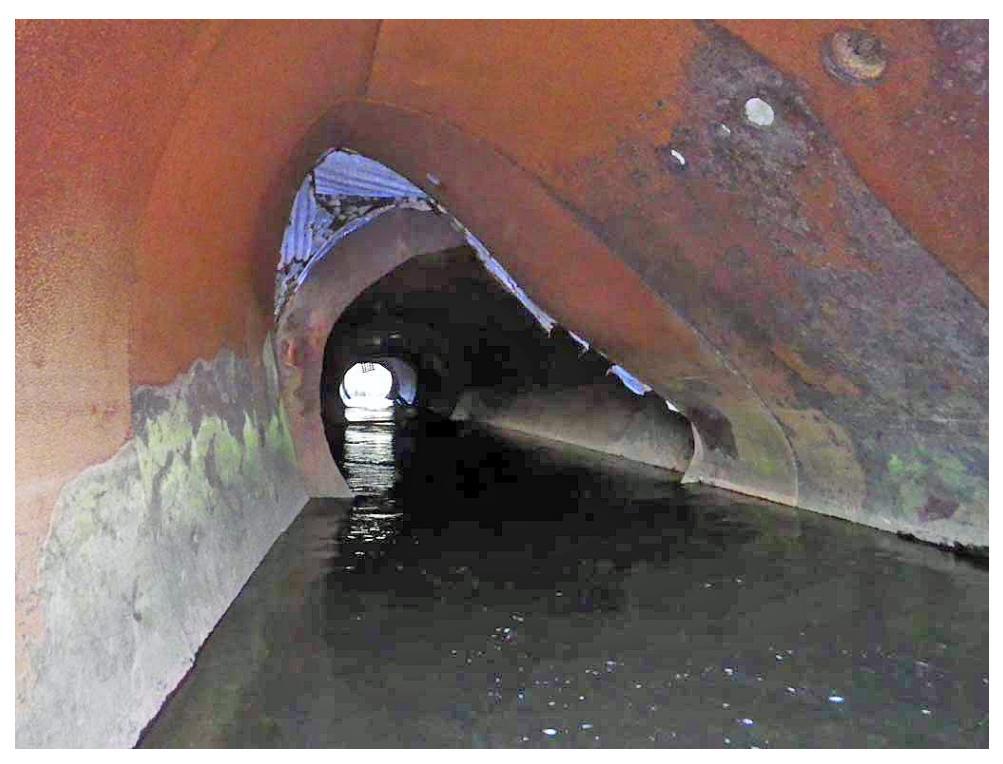
Figure 17.–Site 30103336 inside culvert looking upstream from outlet showing internal structural problems and internal baffles from tank lips.

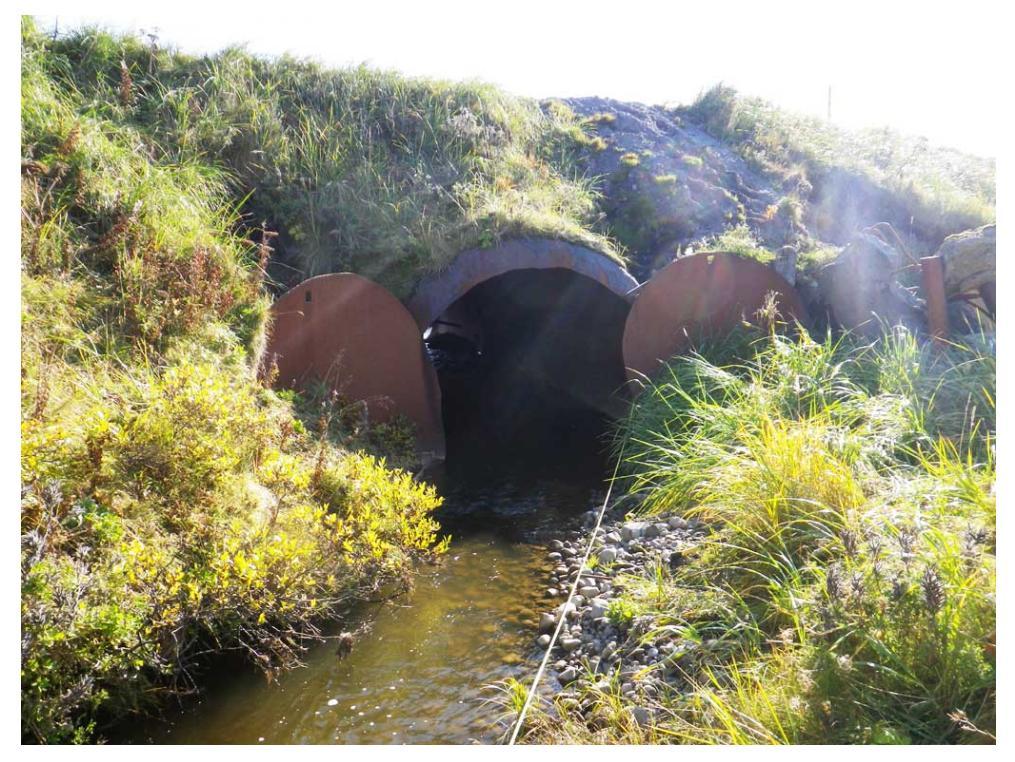
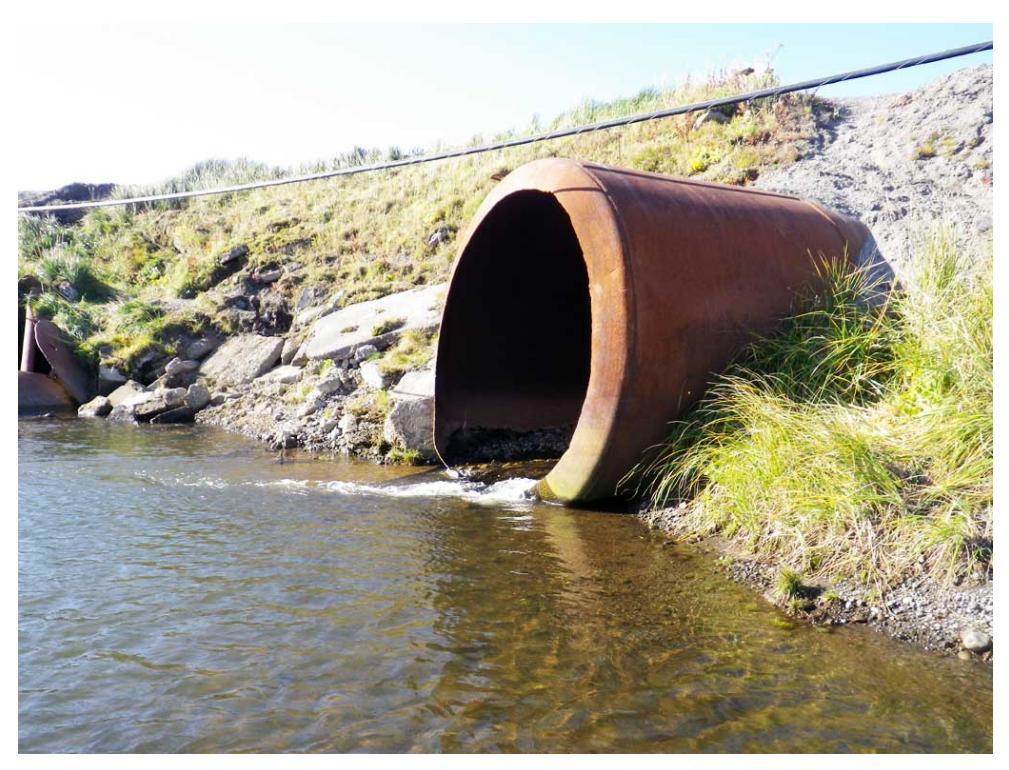
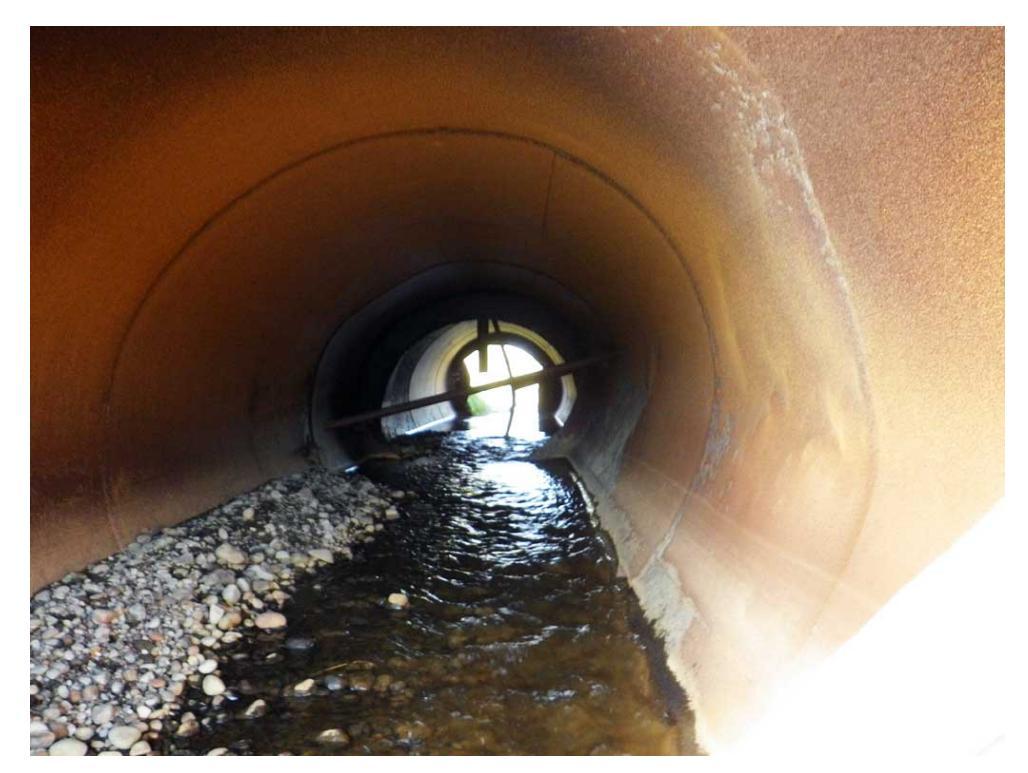
This site is about 0.40 miles downstream from site 30103341 and converges with Trout Creek (AWC #293-34-10300) directly downstream of the culvert outlet (Figure 9). It was constructed of old fuel tanks in the same manner as Site 30103336. The culvert is 78 feet long and about 8 feet in diameter. It is perched at the outlet (Figures 19–21). This stream is considerably smaller than Trout Creek with an average OHW of 8.23 feet. We caught 1 juvenile coho salmon and 1 juvenile Dolly Varden char upstream, as well as threespine sticklebacks up- and downstream. There were also adult coho salmon observed milling below the culvert.

Figure 19.-Site 30103337, inlet with metal wingwalls.

Figure 20.–Site 30103337, outlet showing outfall.

Figure 21.–Site 30103337, looking upstream inside culvert from outlet.

It is recommended that this site be replaced in conjunction with site 30103336 with a bridge or stream simulation culvert.

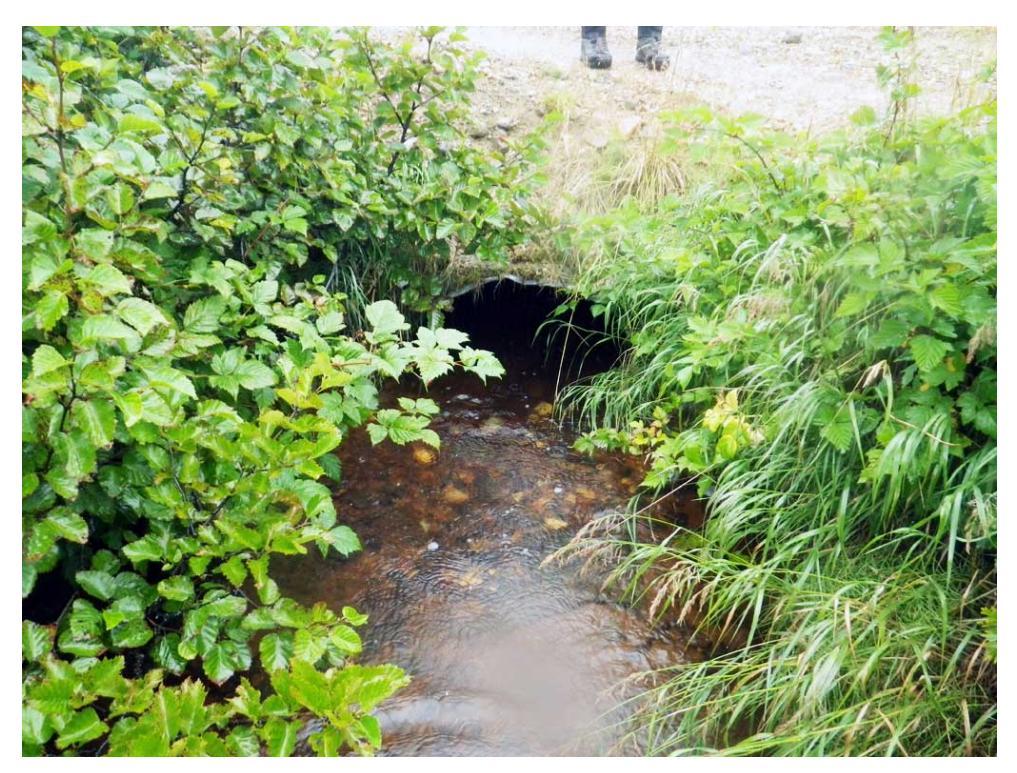
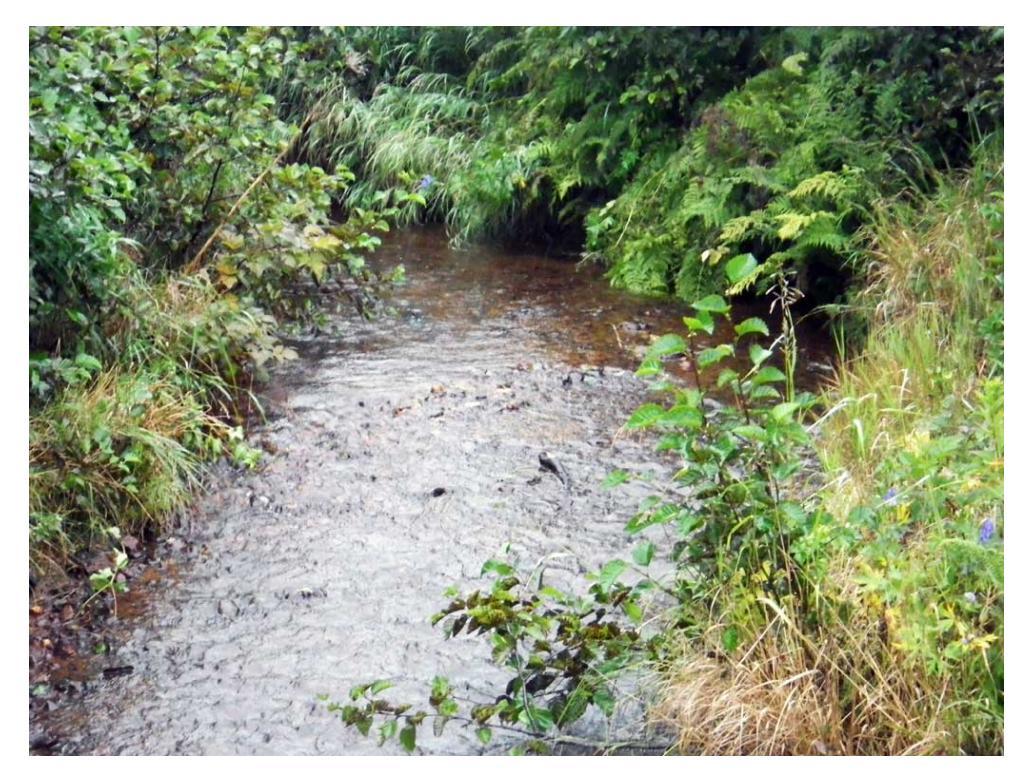
This site is about 500 feet upstream from site 30103441 (Figure 22). This creek has been cataloged for pink, coho, and chum salmon and Dolly Varden char. Cataloged anadromy extends 500 feet upstream beyond the crossing and satellite imagery shows an additional half mile of potential habitat upstream above the end of anadromy. Assessment crews noted that the culvert was undersized for the creek but were unable to access the inlet or upstream habitat because of the airport security fence. Adult pink salmon were observed above and below the culvert. The project recommends replacement with a stream simulation type culvert (Figures 23 and 24).

Figure 23.–Site 30103444, outlet.

Figure 24.–Site 30103444, upstream channel with adult pinks.

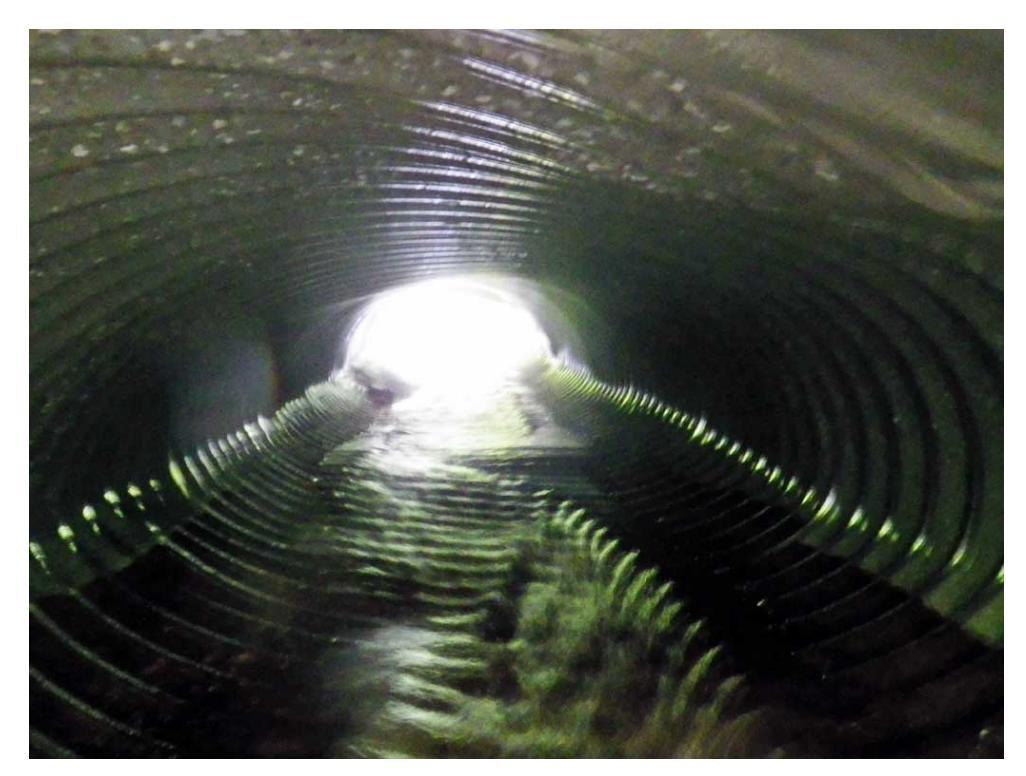
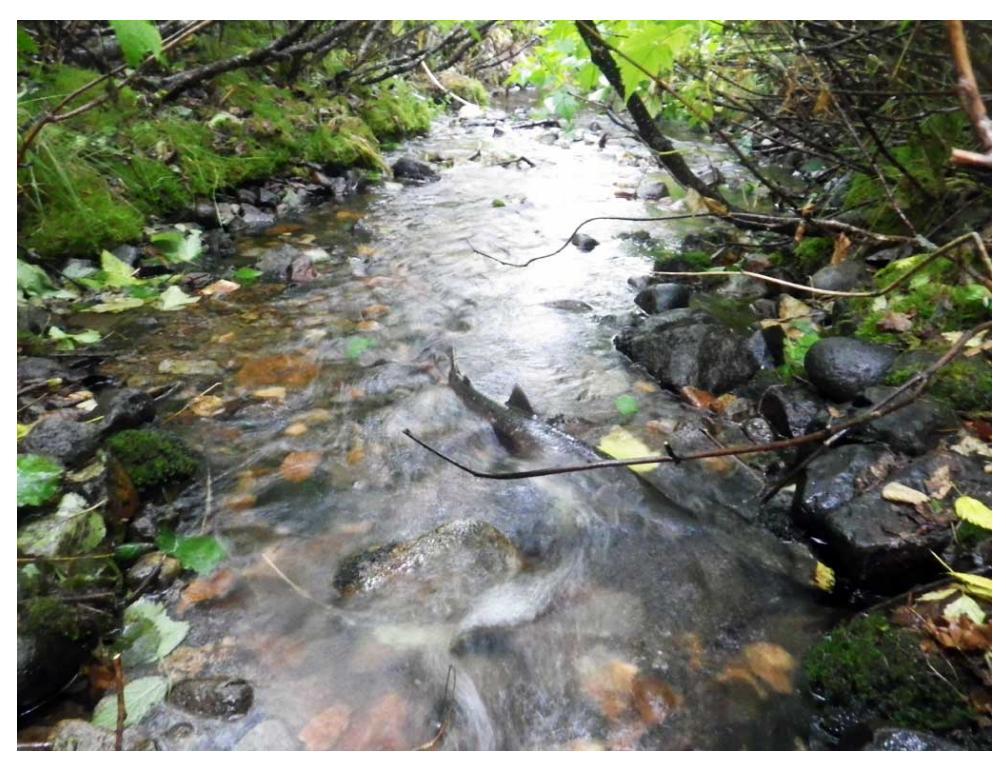
This site is about 550 feet upstream from site 30103442. The stream in documented for pink salmon and is a tributary to a known coho and chum salmon stream about 1000 feet downstream (Figure 22). The assessment crew was unable to access the culvert inlet or upstream habitat due to a security fence but noted that the culvert appeared to be a potential gradient barrier and that it had inadequate water depth for adult passage. Adult pink salmon were observed downstream of the culvert. The stream is cataloged for pink salmon for a few hundred feet above the crossing, but satellite imagery shows about a half mile of estimated upstream habitat. The project recommends replacement with a stream simulation type culvert (Figures 25 and 26).

Figure 25.-Site 30103443, looking upstream inside culvert from outlet.

Figure 26.-Site 30103443, downstream habitat with adult pink salmon.

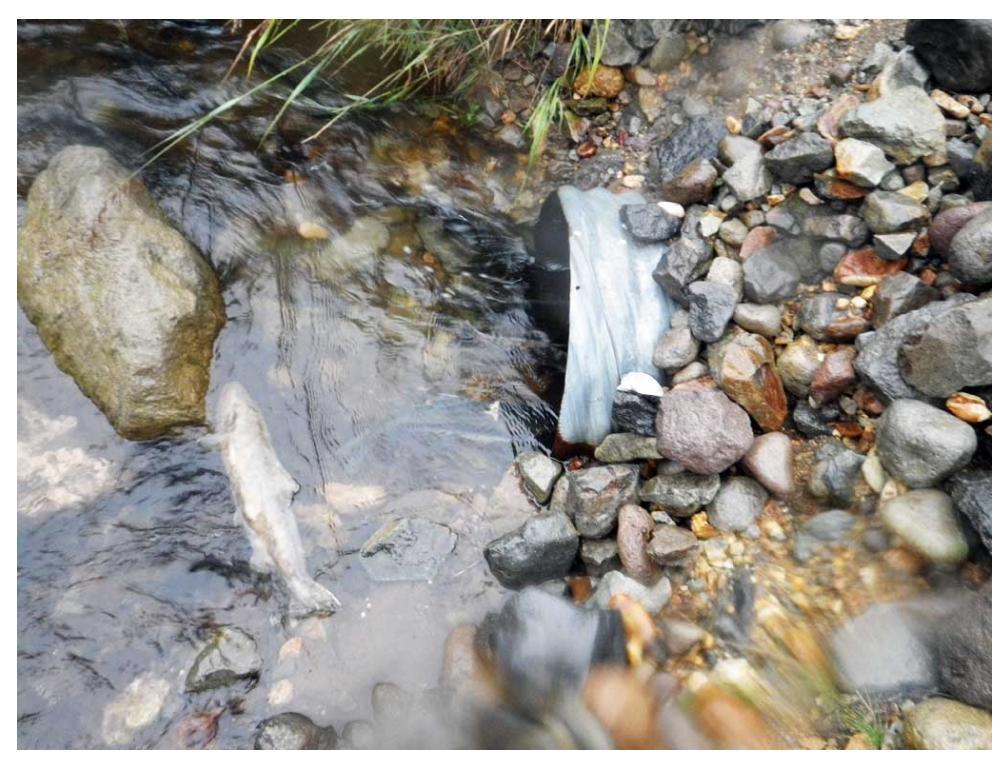
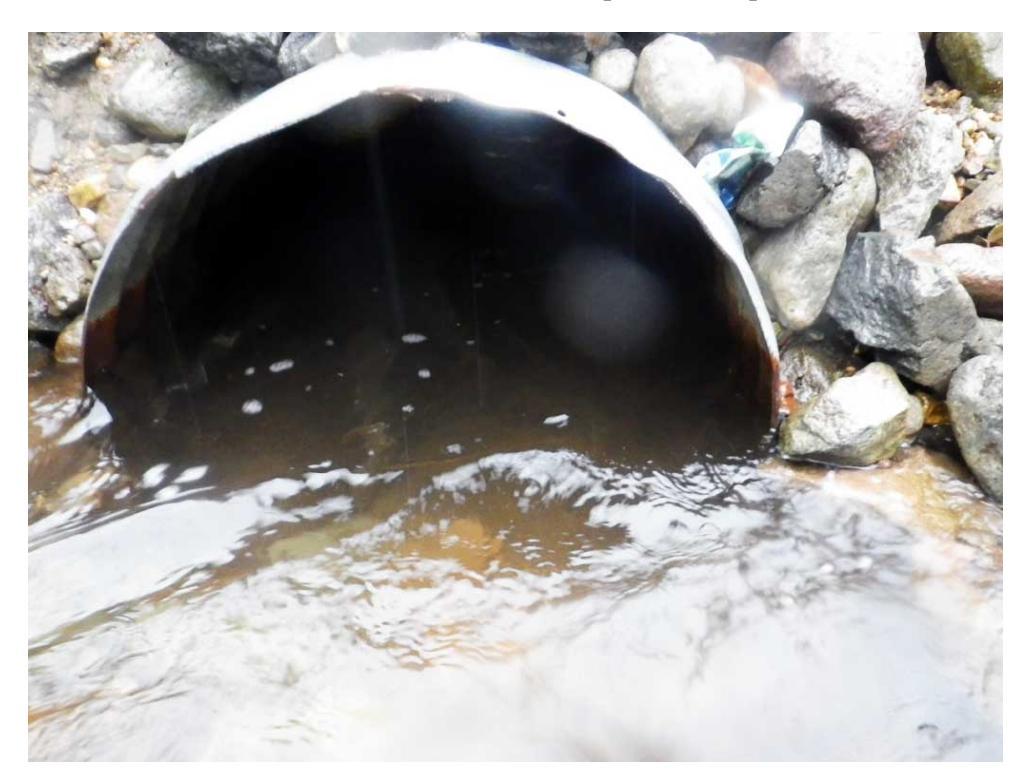
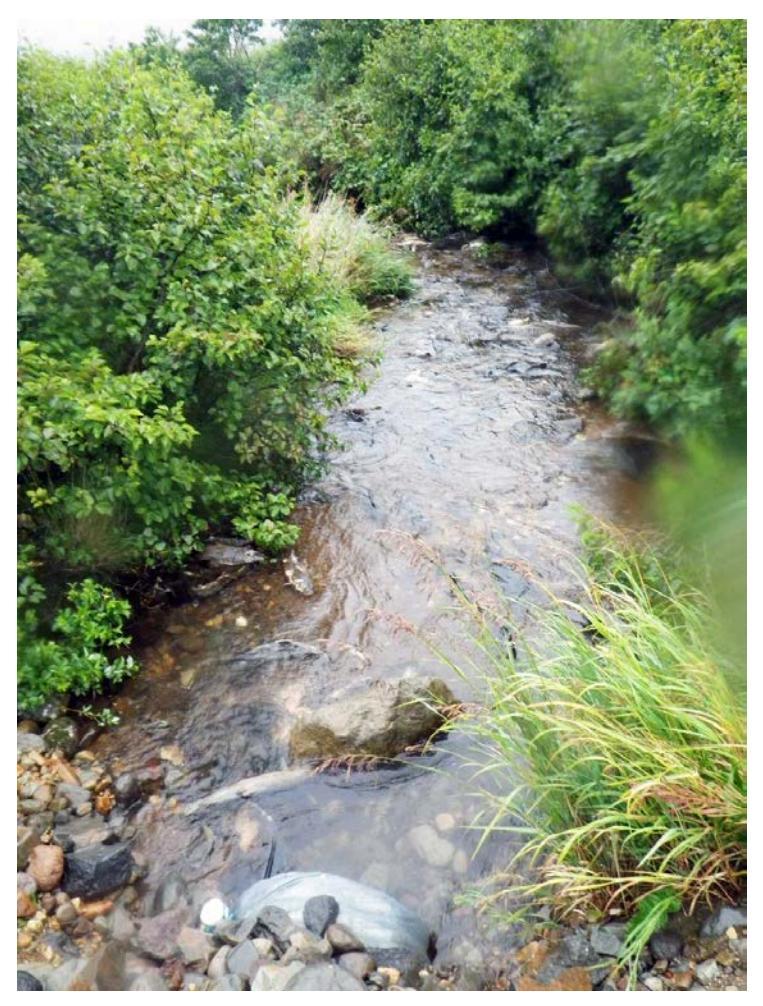
This site is about 400 feet upstream from site 30103442 and merges with a small tributary (AWC #283-42-10500-2001-3025-4020-5013) about 300 feet downstream (Figure 22). Stream is documented for pink salmon another 200 feet above site and the assessment crew encountered many spawning pink salmon during assessment. Satellite imagery shows an estimated 0.88 miles of potential habitat upstream above the current uppermost point of anadromy, and it has been documented for coho and chum salmon downstream. The airport security fence prevented the assessment crew from assessing culvert inlet and upstream habitat. The culvert is undersized, and the site is severely constricted. The project recommends replacement with a stream simulation type culvert (Figures 27–29).

Figure 27.-Site 30103445, culvert outlet side view with spawned-out pink salmon.

Figure 28.–Site 30103445, culvert outlet from directly downstream.

Figure 29.-Site 30103445, above culvert outlet looking downstream.

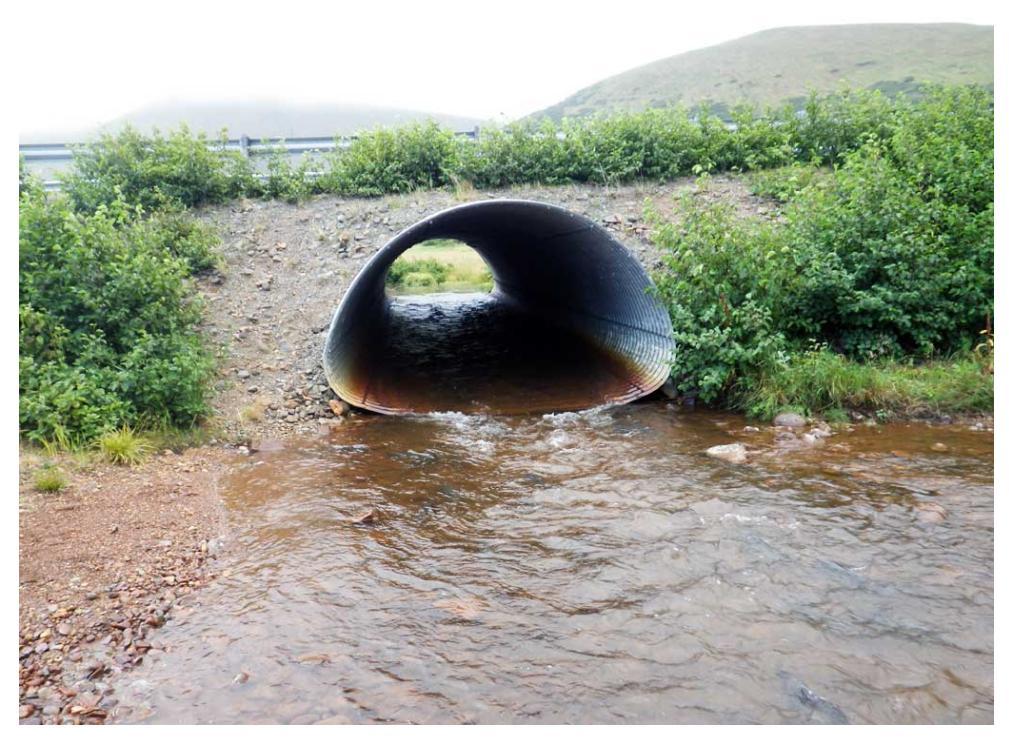
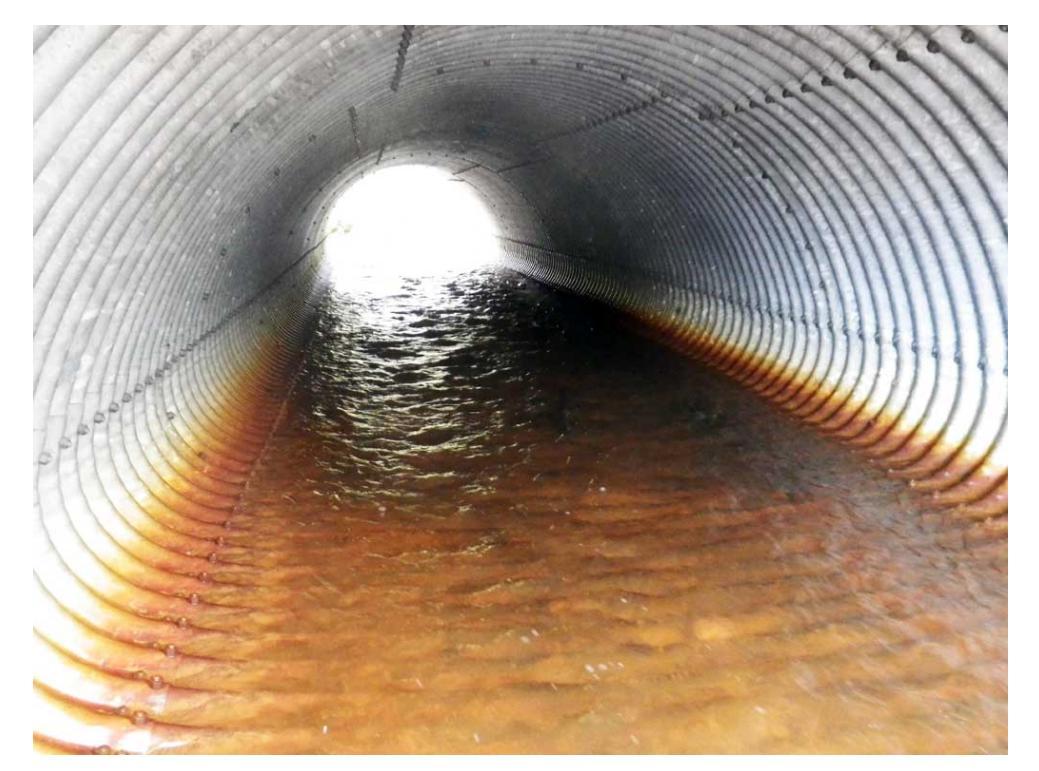
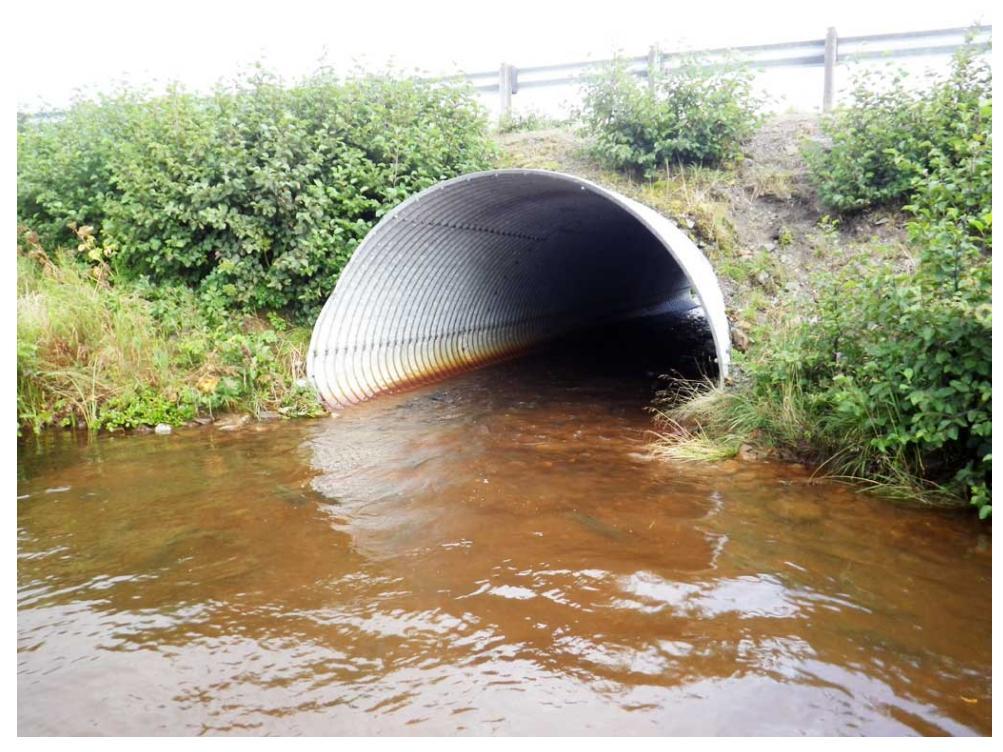
Site is located on Airport Road about 4 miles north of the city center and a quarter mile from the airport (Figure 22). A large number of adult spawning pink and chum salmon were observed to move through or attempt to move through this culvert at the time of survey.

The stream is cataloged for pink salmon 0.33 miles above culvert and was nominated for chum by project staff. Satellite imagery shows approximately 0.9 miles of stream habitat above the crossing. The culvert was somewhat undersized, had an outfall of 0.19 inches at time of assessment, and was observed to be partially impassable to adult fish after a rain event due to high water velocities. Additionally, low water levels may not allow for adequate water depth through culvert for fish passage. The project recommends replacing with a stream simulation type culvert in the long term; in the short term, a correctly installed grade control structure installed downstream may backwater the inlet and improve passage (Figures 30–33).

Figure 30.-Site 30103446, culvert outlet showing outfall.

Figure 31.–Site 30103446, interior of culvert showing water level and rust line.

Figure 32.–Site 30103446, culvert inlet.

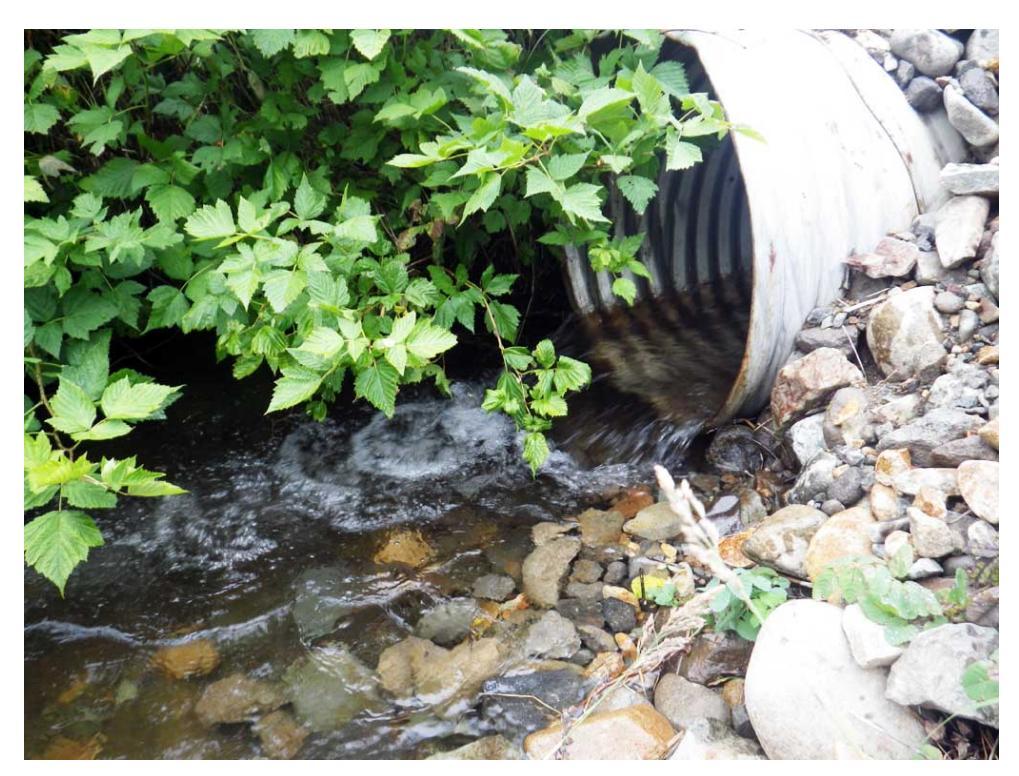
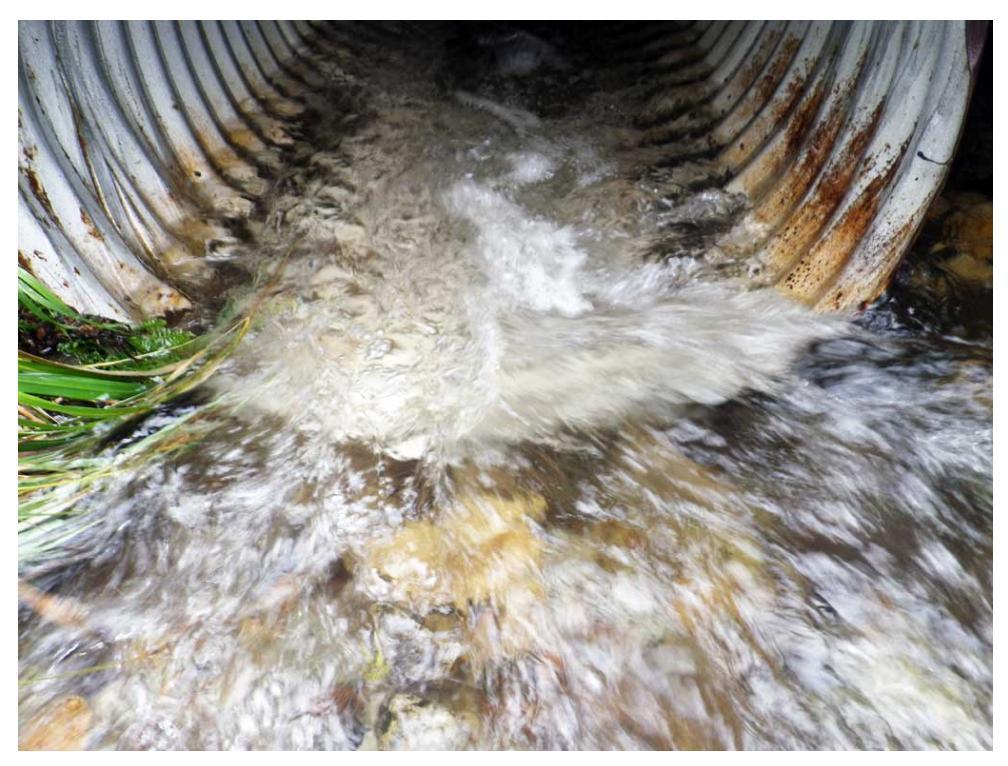
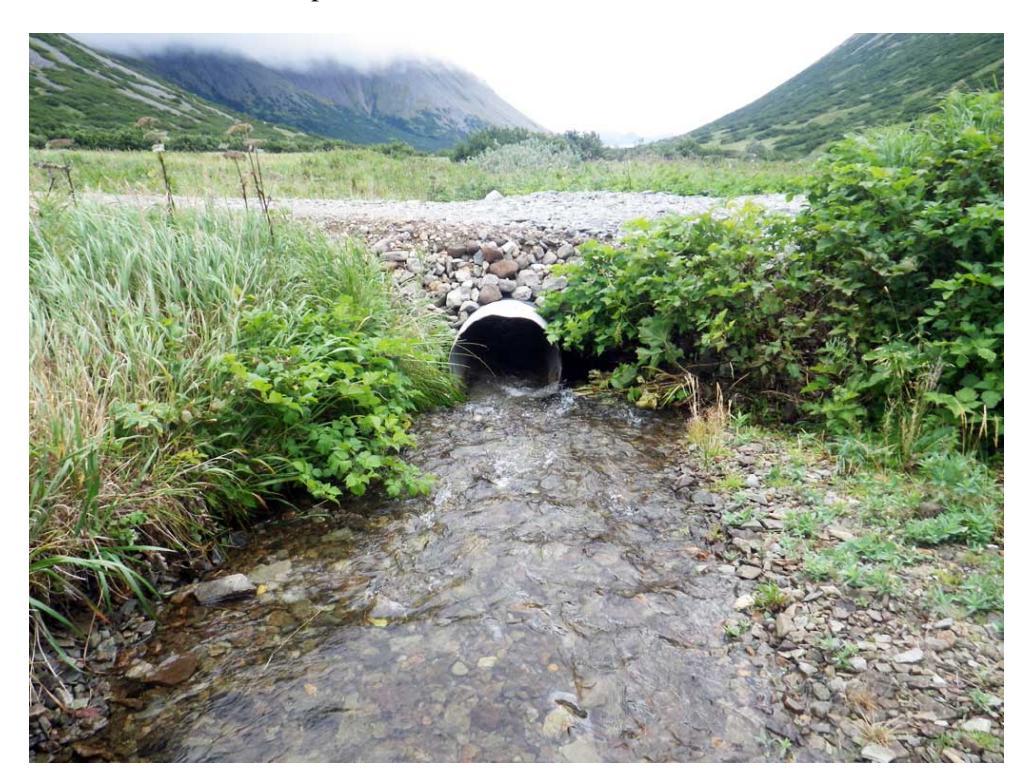
Site is on the shooting range off Airport Road about 3 miles from King Cove (Figure 33). The stream is cataloged in the AWC for chum and pink salmon about 0.3 miles downstream of this culvert. Assessment crews observed fish at the site, most likely Dolly Varden char. Satellite imagery shows about another half mile of potential habitat upstream. Recommend replacement with a stream simulation culvert (Figures 34-36).

Figure 34.-Site 30103448, culvert outlet showing outfall.

Figure 35.–Site 30103448, inlet perch.

Figure 36.–Site 30103448, constricted culvert inlet.
