Fish Passage Assessment and Culvert Inventory on the King Cove and Cold Bay Road Systems

December 2018

Alaska Department of Fish and Game

FISHERY DATA SERIES NO. 18-28

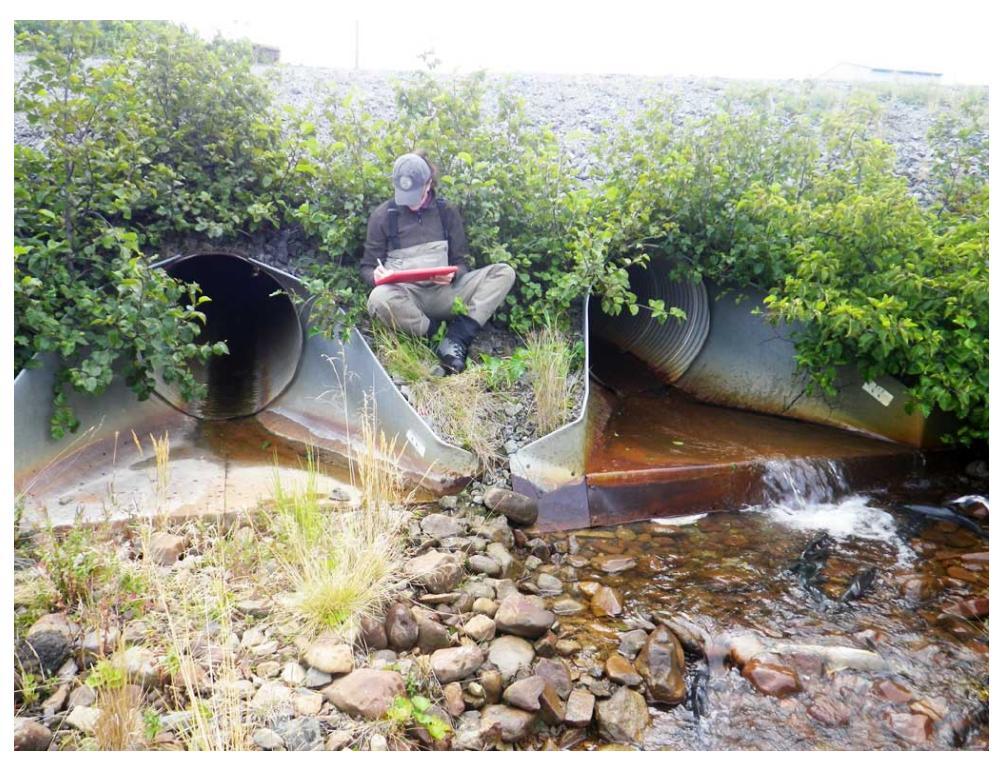
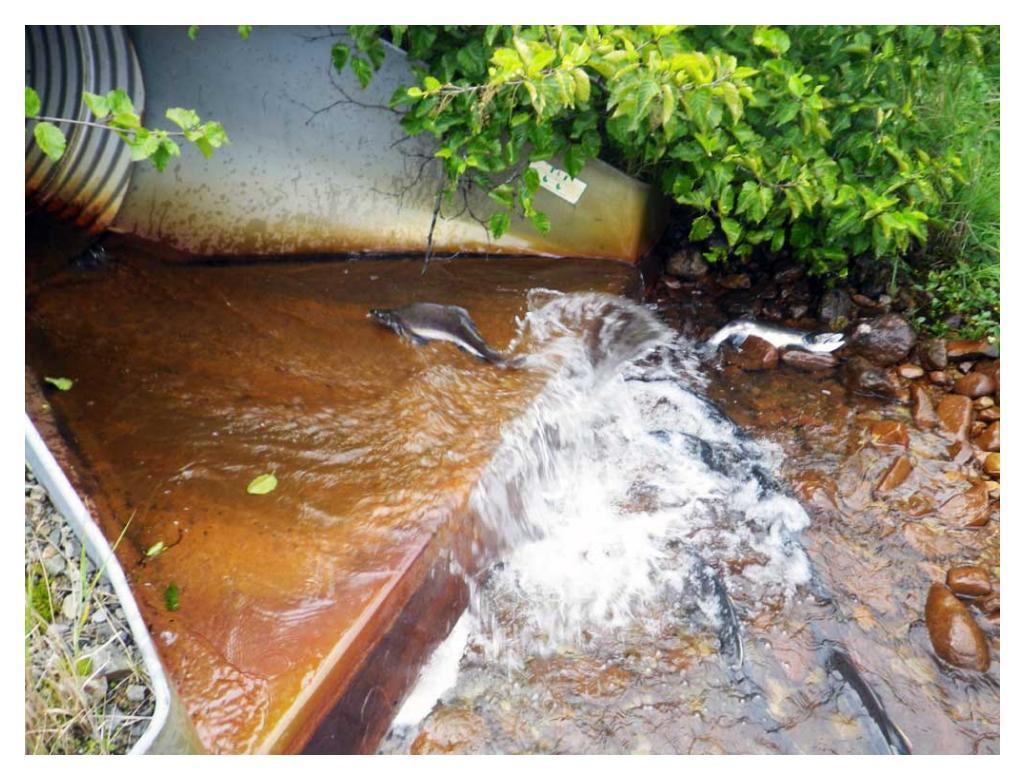
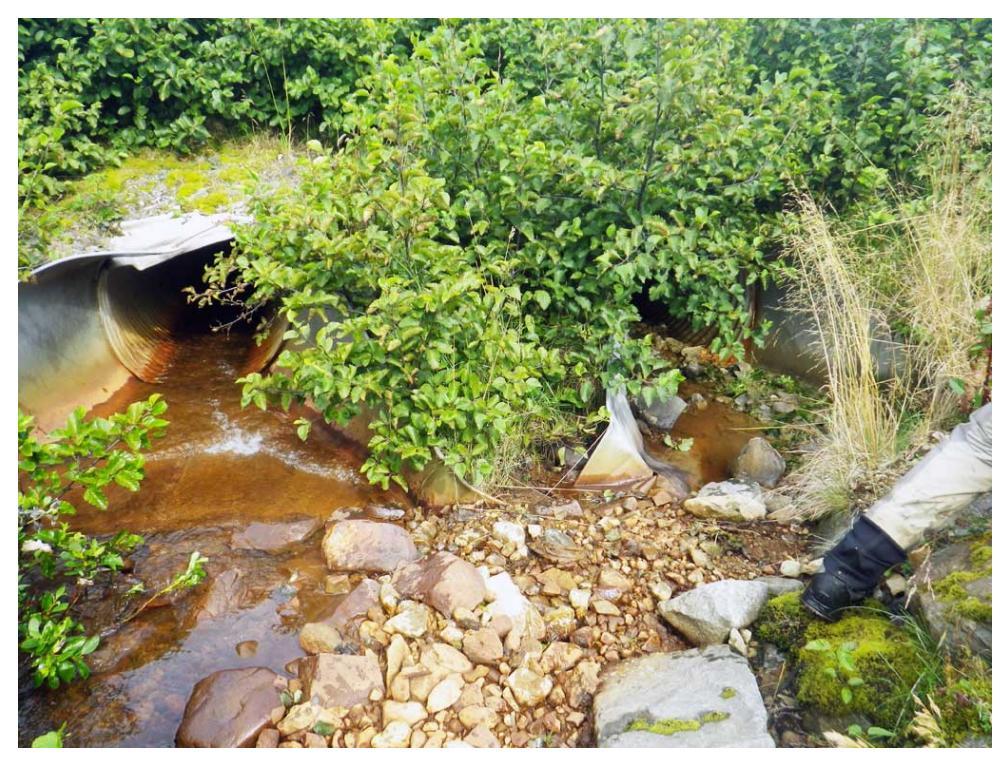
Site is about 1000 feet upstream from the confluence with Ram Creek (AWC # 283-33-10500) and about 950 feet downstream of site 30103460 (Figure 37). The assessment crew observed adult pink salmon and Dolly Varden char up- and downstream from this site. Site consists of 2 culverts, with one capturing all the flow at the time of survey. Culvert has a Red outfall and adult fish were observed leaping to pass through the crossing and stacking up below the culvert. Recommend replacing culverts with a stream simulation culvert (Figures 38–40).

Figure 38.-Site 30103461, outlets showing outfall.

Figure 39.–Site 30103461, outlet of C1 showing outfall and adult pink salmon attempting to transit.

Figure 40.–Site 30103461 culvert inlets.

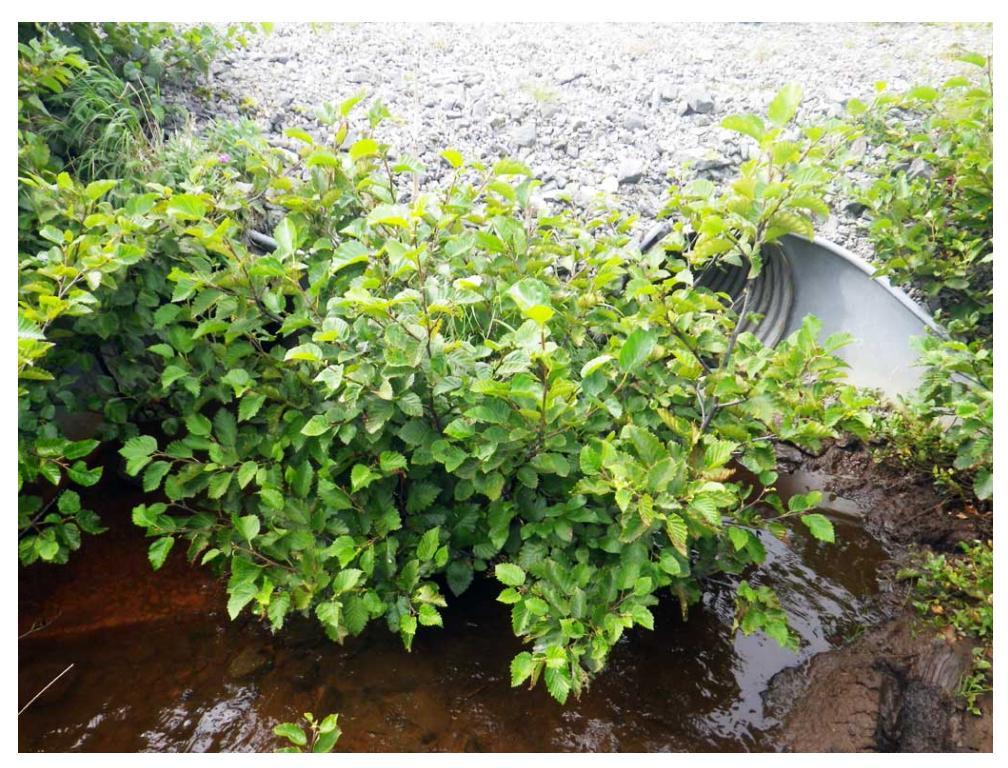
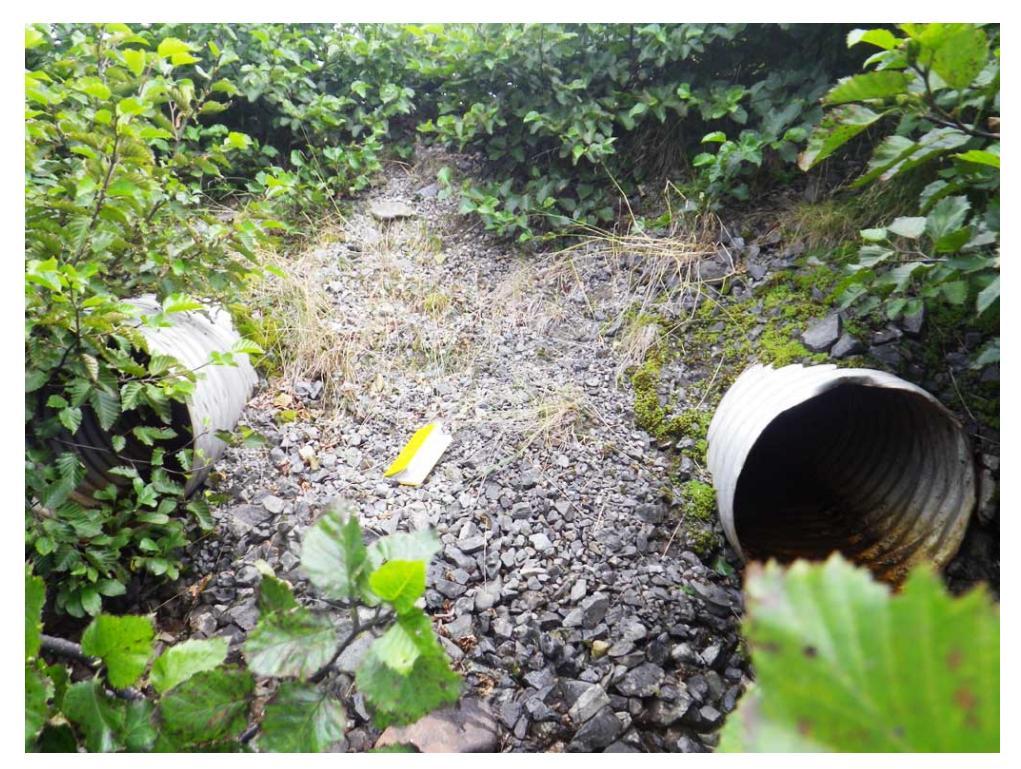
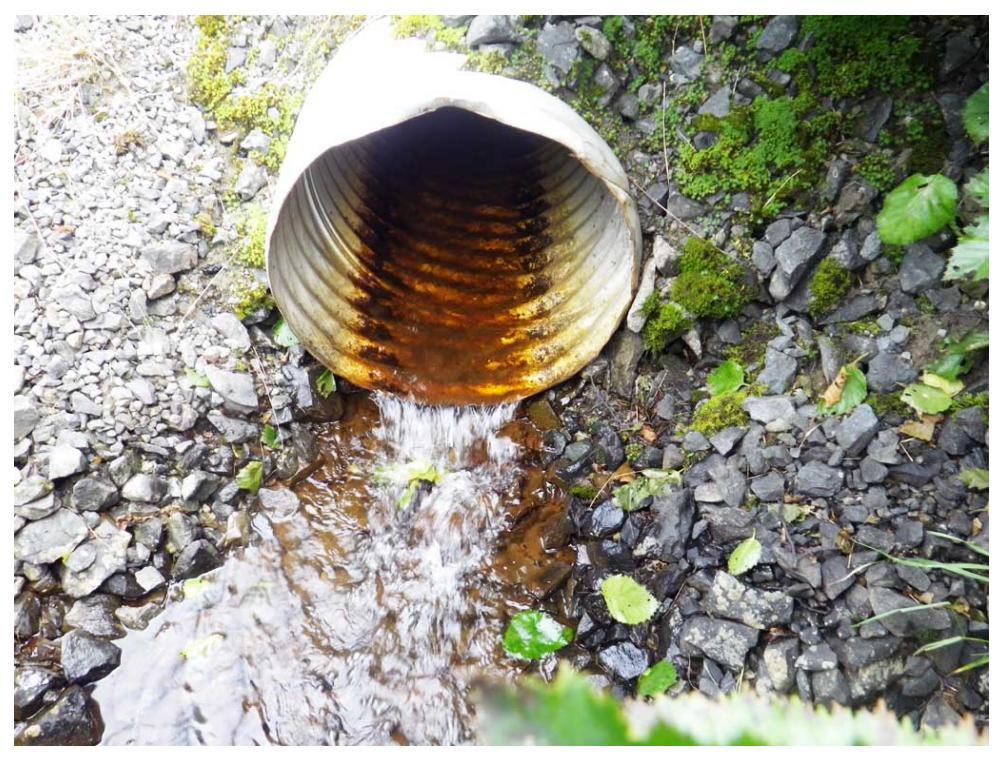
Site is about a quarter mile upstream from site 30103461 and a half mile from the confluence with Ram Creek (Figure 37). Site consists of two culverts with flared inlets. Almost all flow is being directed into the C1 culvert, or the first culvert starting from the left streambank looking downstream. Both culverts have Gray outfall and Red gradients, and the site also has a Gray constriction ratio. The assessment crew observed Dolly Varden char above culvert, adult pink salmon above and below the culvert, and adult pink salmon over 400 feet upstream of the crossing. The project recommends replacing these culverts with a stream simulation culvert (Figures 41–43).

Figure 41.–Site 30103460, culvert inlets, C1 (left hand side) taking almost all flow.

Figure 42.–Site 30103460, culvert outlets.

Figure 43.–Site 30103460, outlet of C1 showing outfall.

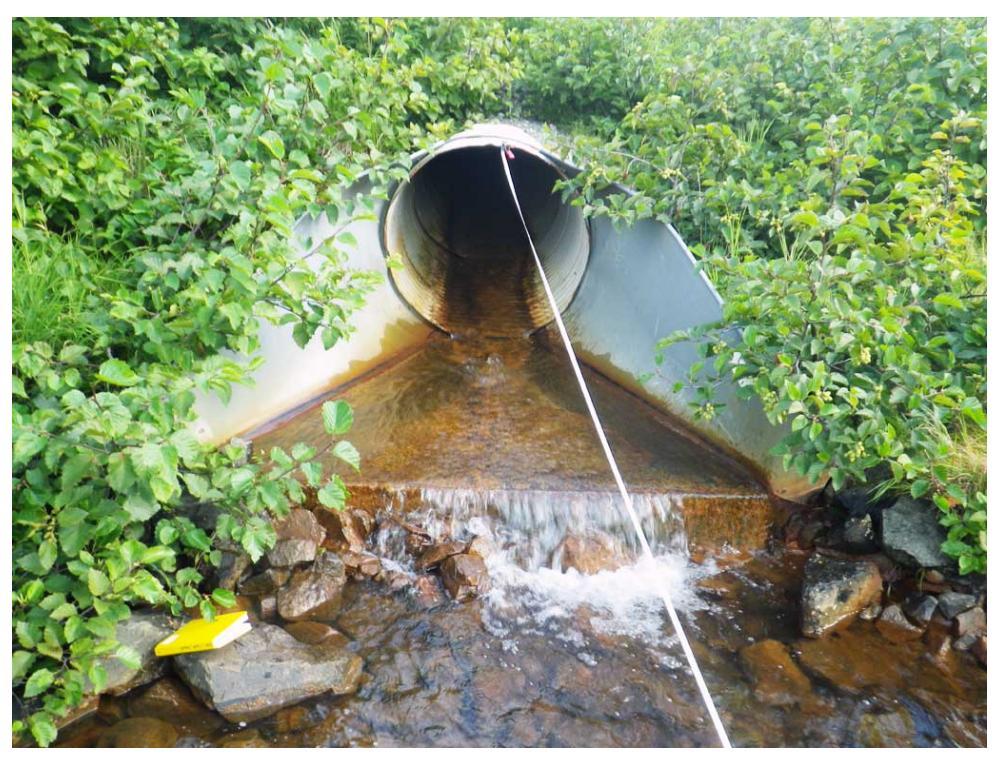
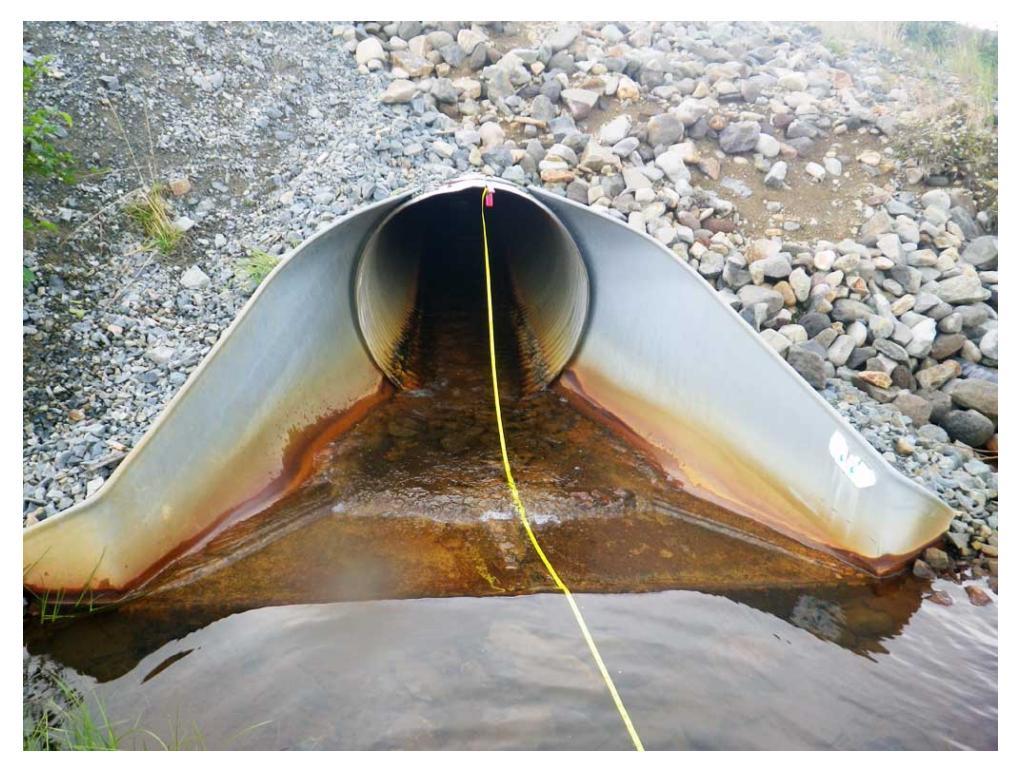
This site is about 700 feet upstream from the confluence with Ram Creek (AWC#283-33-10500) (Figure 37). The creek is documented for pink salmon up to the road crossing. The culvert has a Red outfall and gradient and a Gray constriction ratio. The assessment crew observed fish upstream and downstream of site, likely Dolly Varden char. Creek flows under the new King Cove school about 300 feet downstream of the culvert. The project recommends replacement with a stream simulation culvert (Figures 44–47).

Figure 44.–Site 30103459, flared outlet showing Red outfall.

Figure 45.–Site 30103459, culvert inlet, showing inlet perch.
