# Fish Passage Assessment, Inventory, and Prioritization of Culverts on the Ketchikan, Petersburg, and Wrangell Road Systems, 2013–2016

June 2021

Alaska Department of Fish and Game

### FISHERY DATA SERIES NO. 21-01

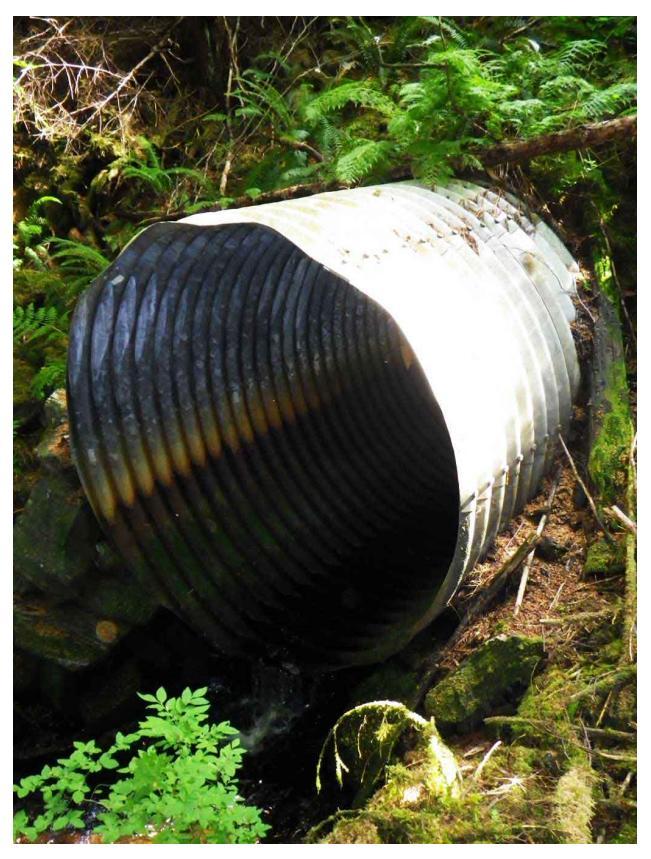
Figure 12.–Site 10103229, North Tongass Highway, Trollers Creek (AWC# 101-90-10705), Ketchikan, culvert outlet.

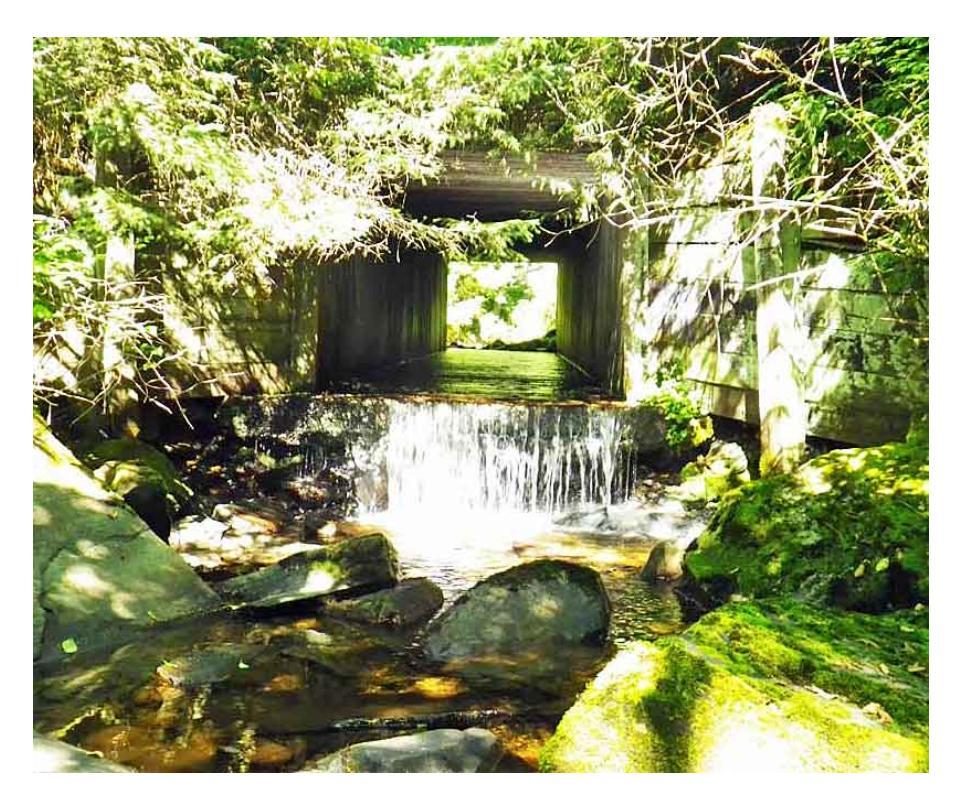
Figure 14.–Site 10103208, South Tongass Highway, unnamed creek (AWC# 101-47-10300), Ketchikan, culvert outlet.

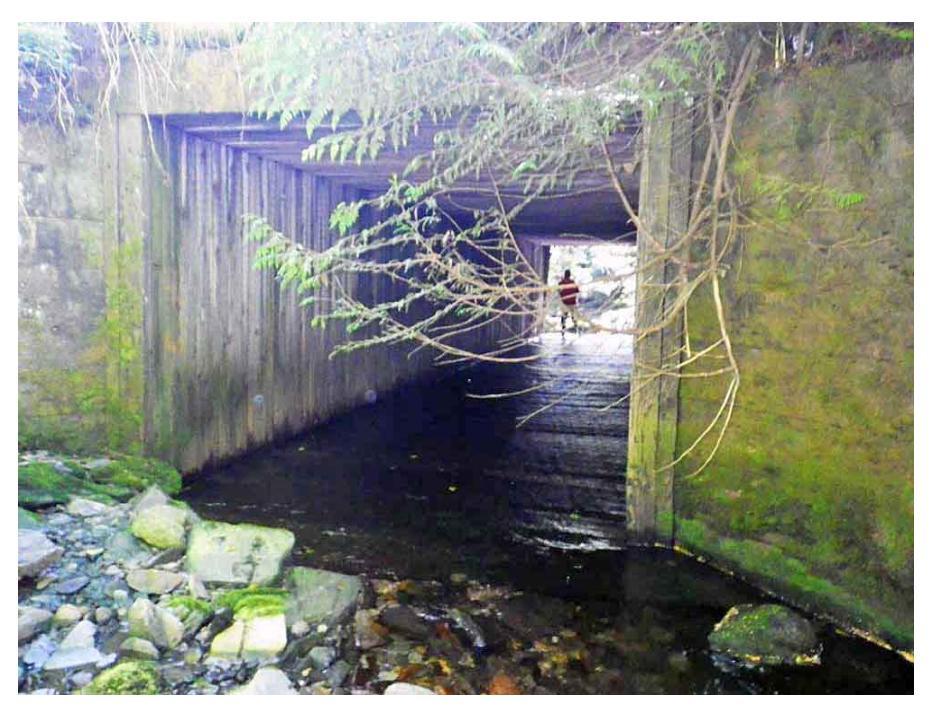
Figure 15.–Site 10103208, South Tongass Highway, unnamed creek (AWC# 101-47-10300), Ketchikan, culvert inlet.

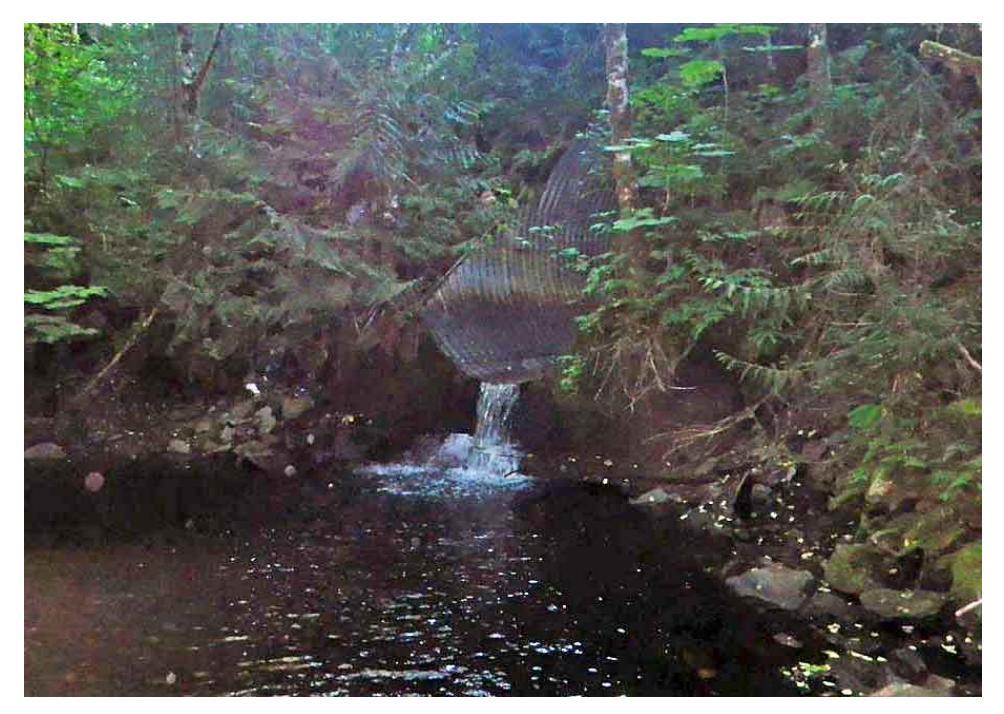
Figure 17.–Site 10103174, Ward Lake Road, unnamed creek, Ketchikan, culvert outlet.

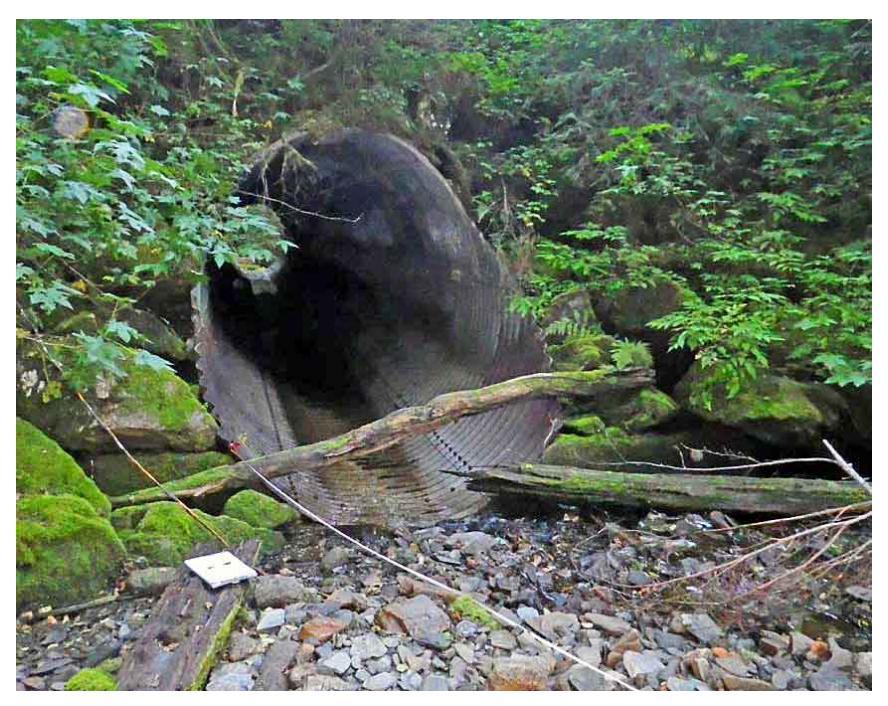
Figure 18.-Site 10103174, Ward Lake Road, unnamed creek, Ketchikan, culvert inlet.

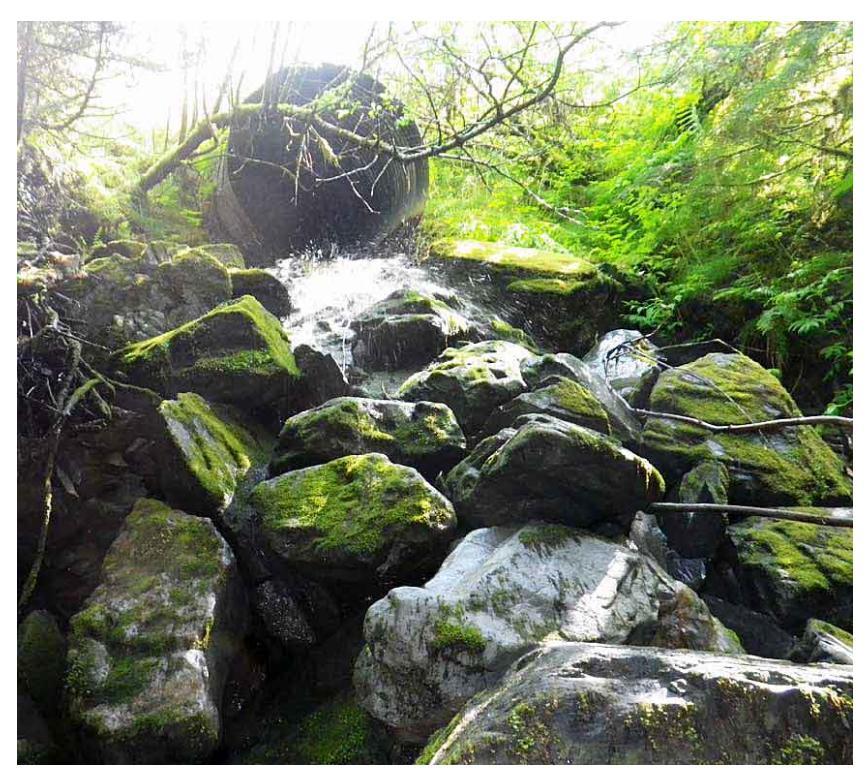
Figure 20.–Site 10203301, Mitkof Highway, Letti Creek (AWC# 106-44-10070), Petersburg, outlet showing outfall onto riprap barrier.

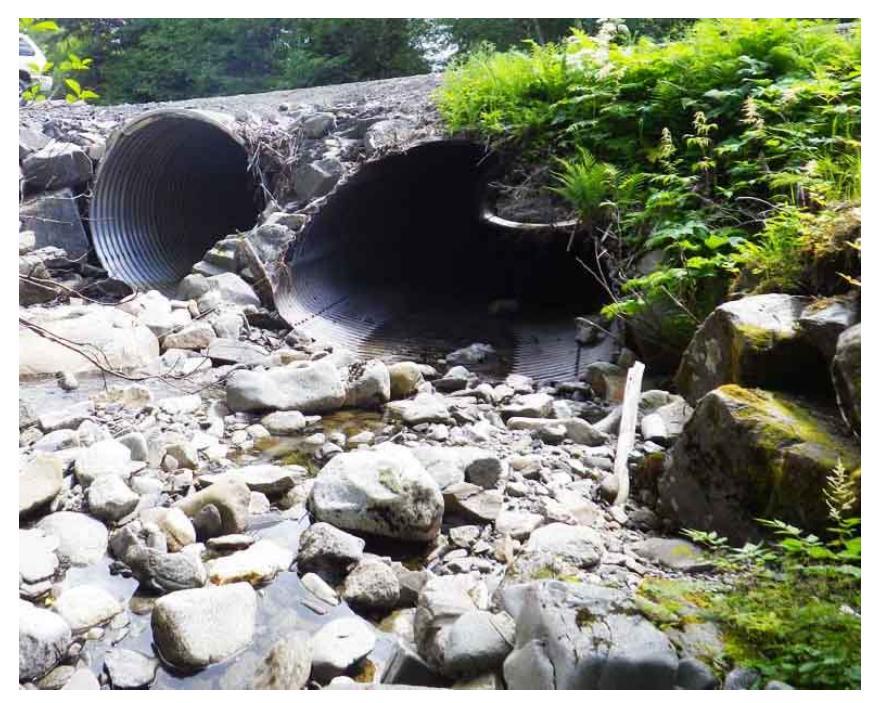
Figure 22.–Site 10203133, Mitkof Highway, unnamed creek (AWC Stream #108-40-10600), Petersburg, culvert inlets.

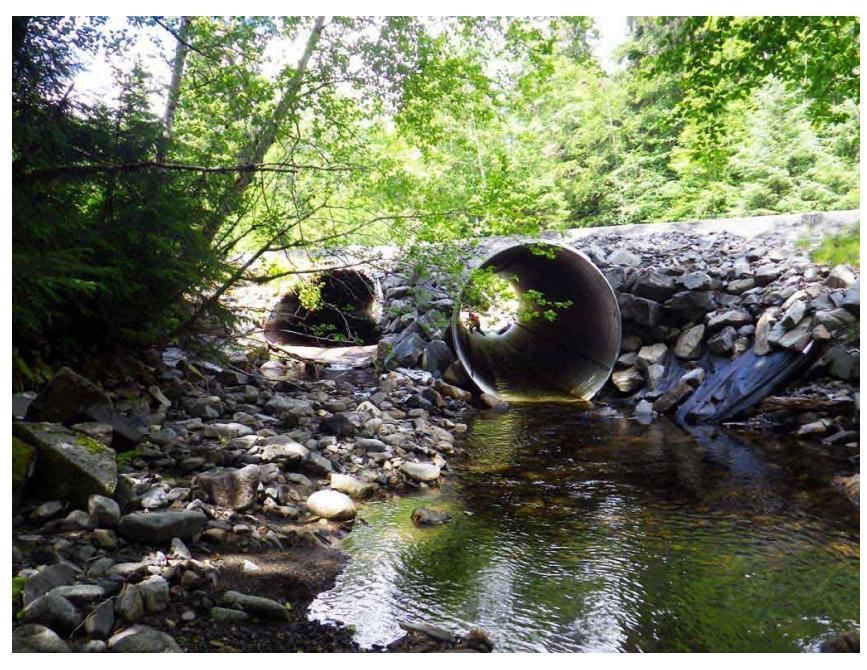
Figure 23.–Site 10203133, Mitkof Highway, unnamed creek (AWC Stream #108-40-10600), Petersburg, culvert outlets.

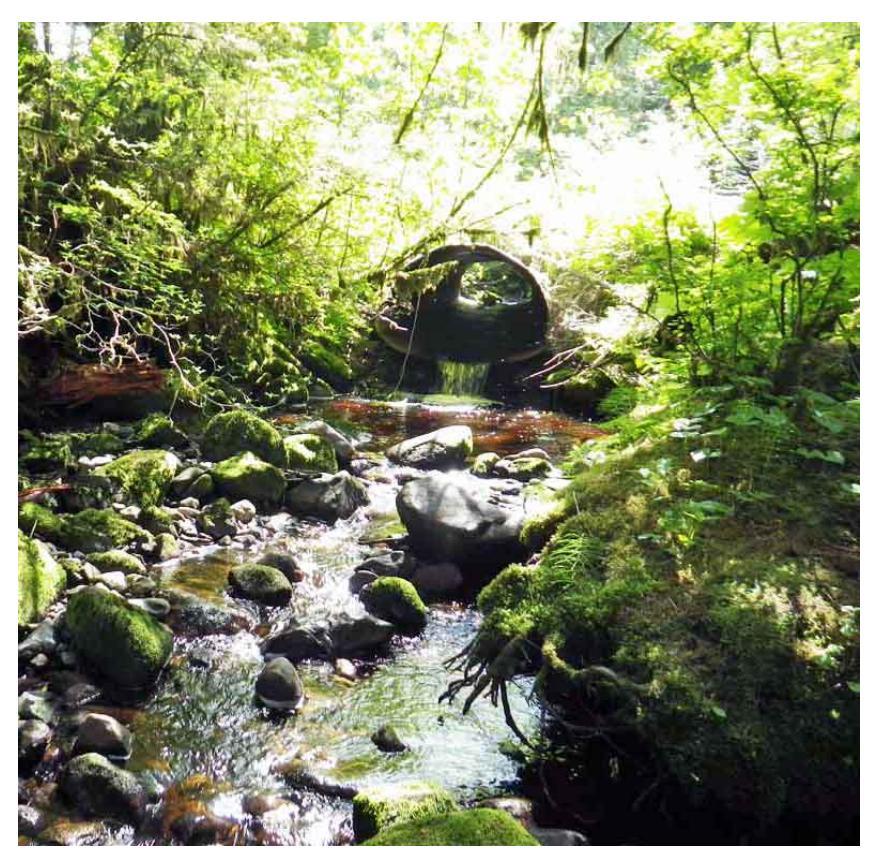
Figure 25.-Site 10203171, Sandy Beach Road, unnamed creek (AWC Stream #108-60-10051), Petersburg, culvert outlet.

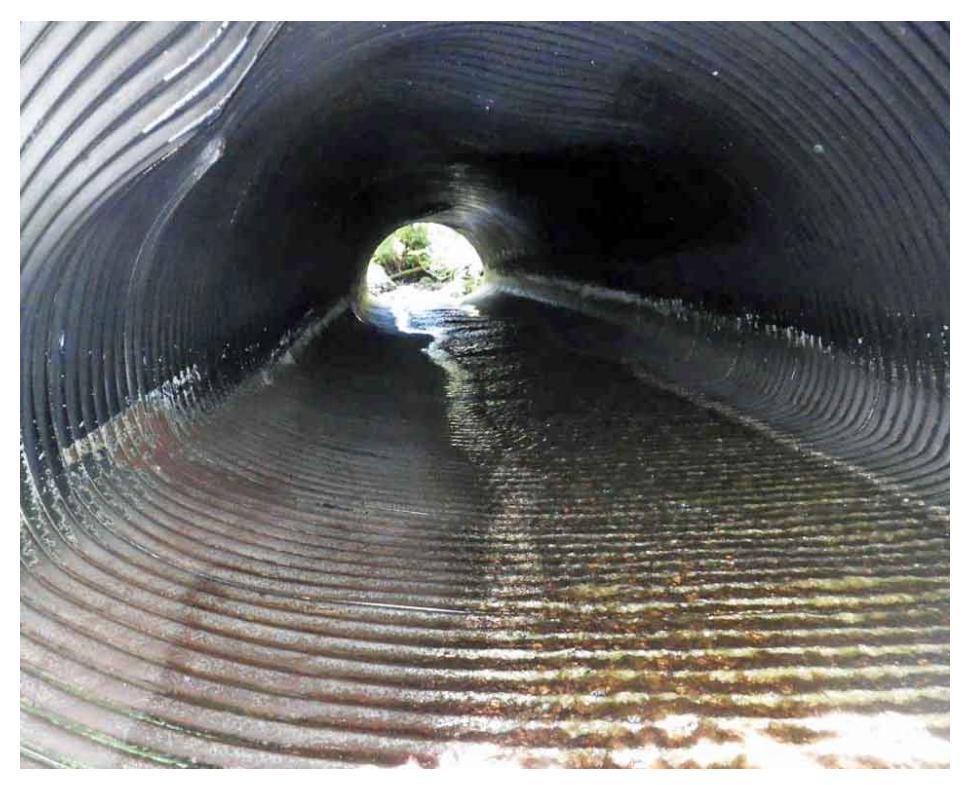
Figure 26.–Site 10203171, Sandy Beach Road, unnamed creek (AWC Stream #108-60-10051), Petersburg, culvert interior.

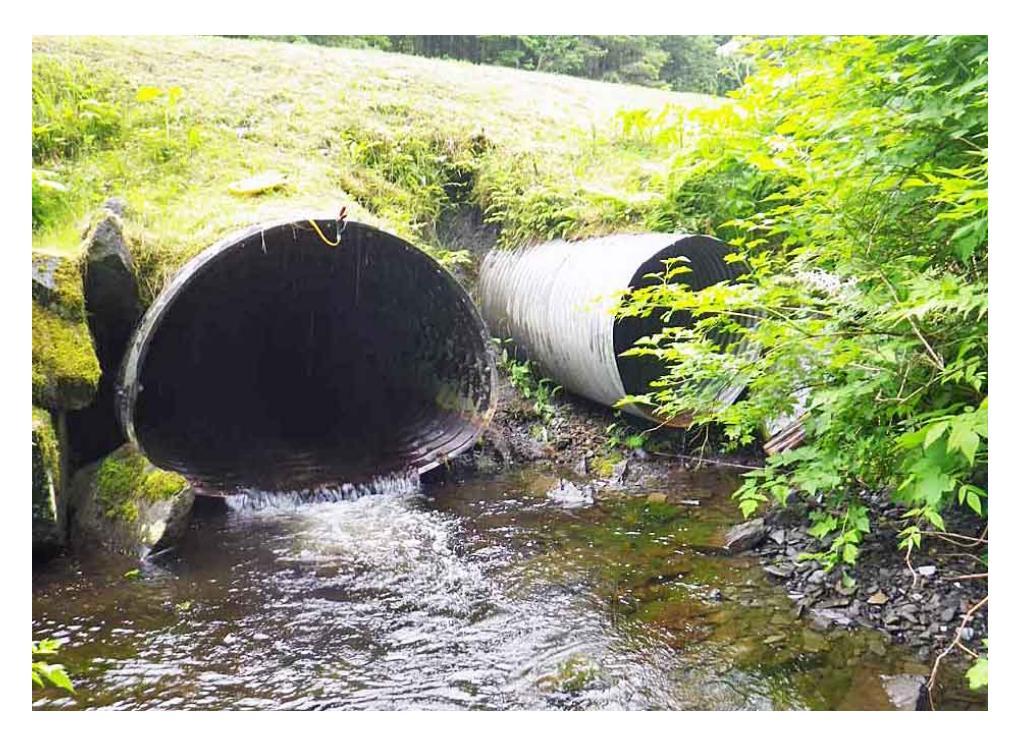
Figure 28.–Site 10203312, Zimovia Highway, Playground Creek (AWC# 108-40-10282), Wrangell, culvert outlets.

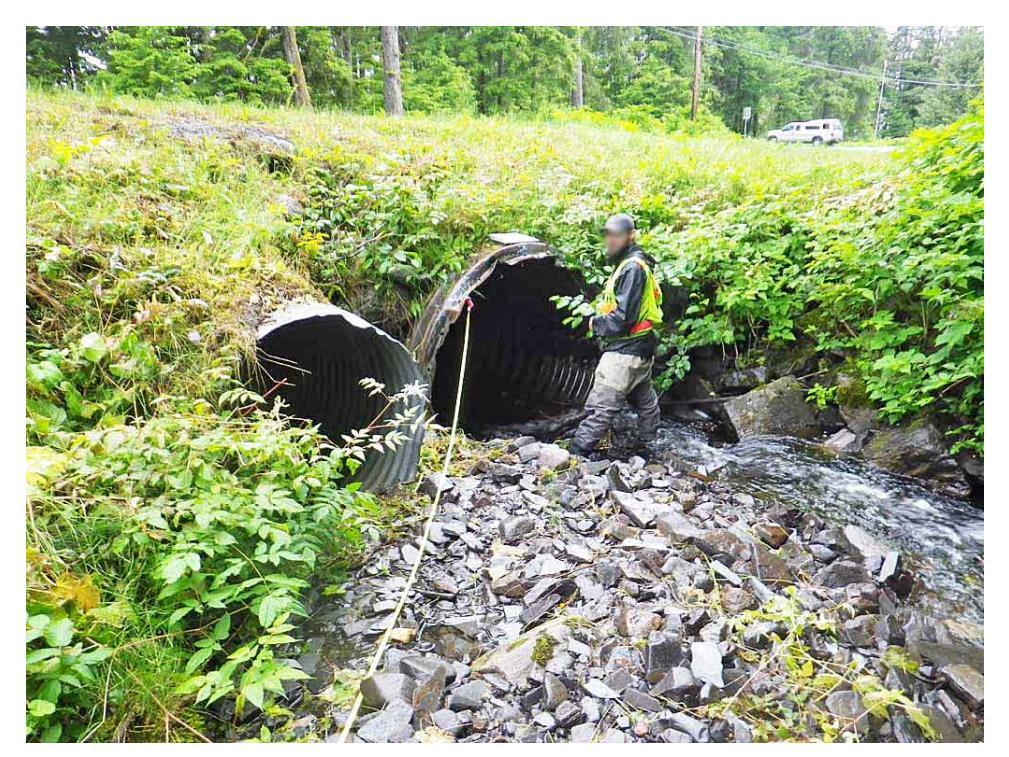
Figure 29.–Site 10203312, Zimovia Highway, Playground Creek (AWC# 108-40-10282), Wrangell, culvert inlets.

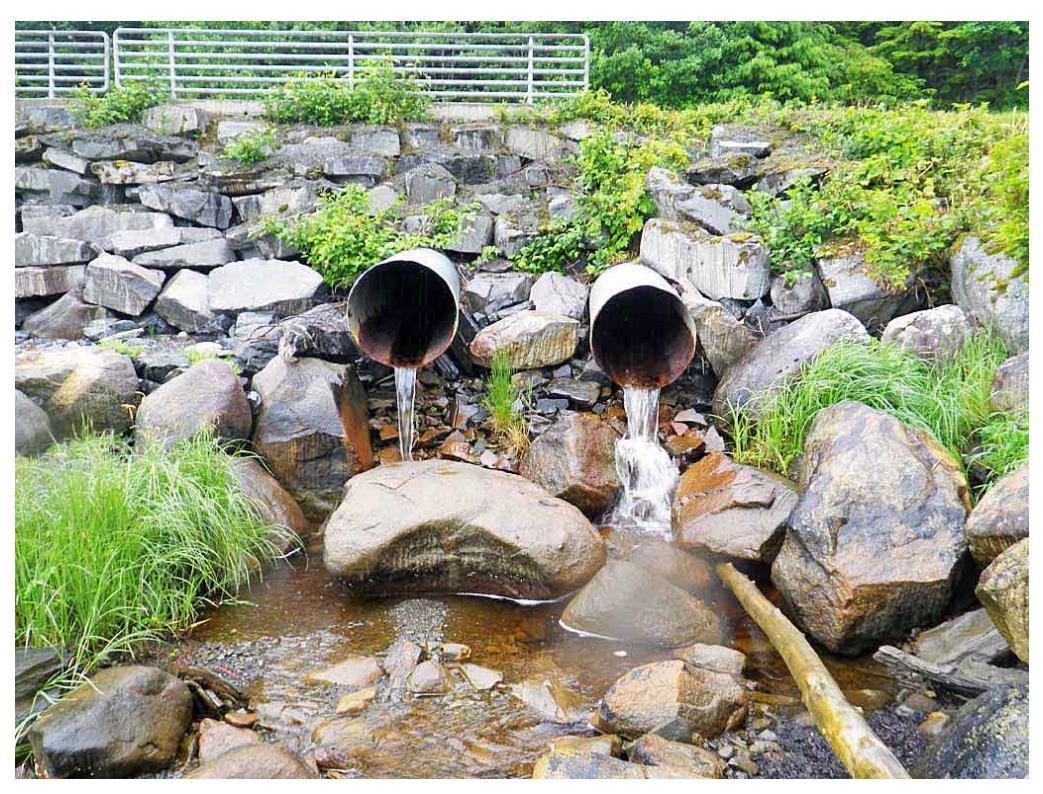
Figure 31.-Site 10203315, Zimovia Highway, unnamed creek (AWC# 108-40-10290), Wrangell, culvert outlets.

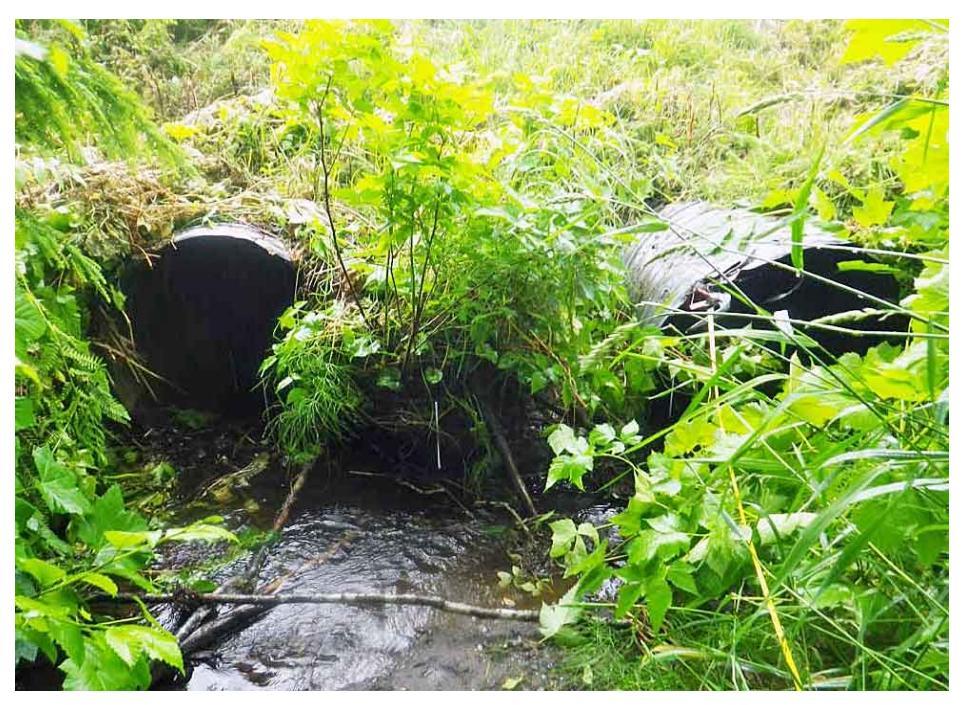
Figure 32.-Site 10203315, Zimovia Highway, unnamed creek (AWC# 108-40-10290), Wrangell, culvert inlets.

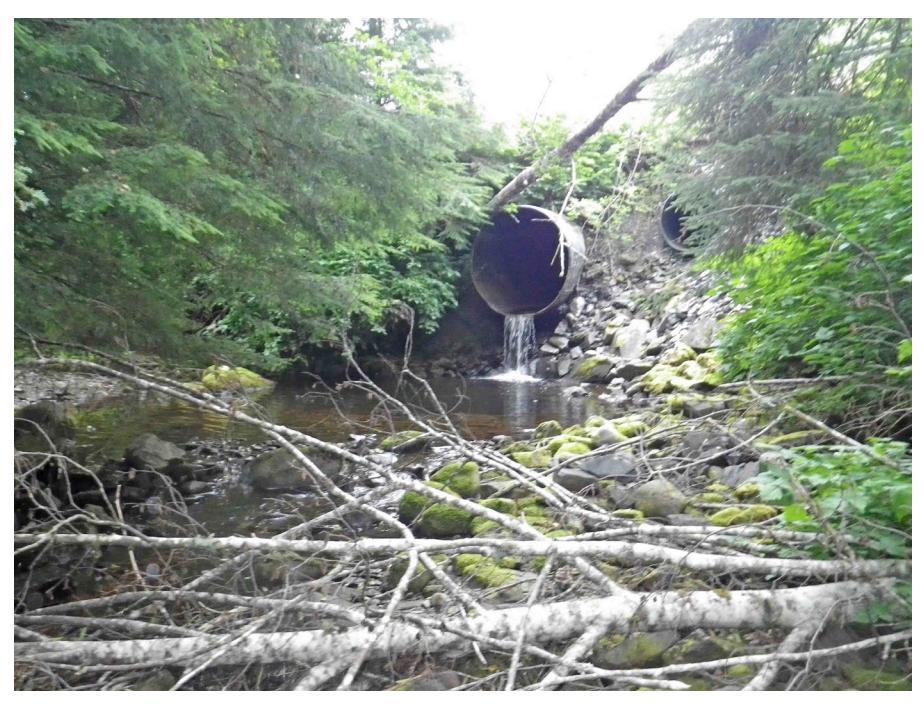
Figure 34.-Site 10203506, Zimovia Highway, unnamed stream, Wrangell, culvert outlet.

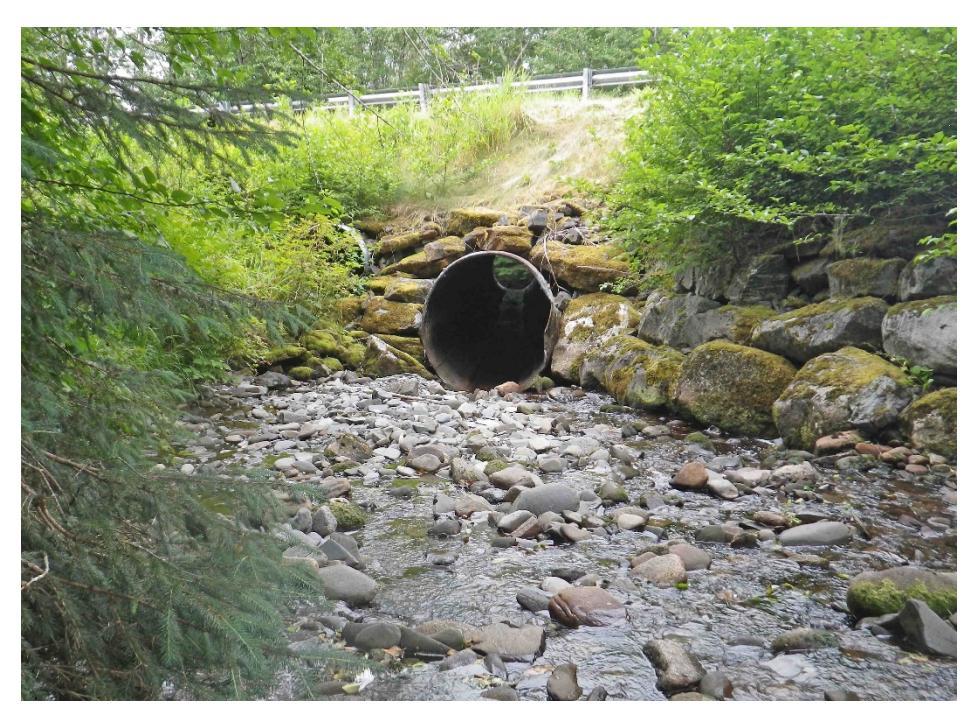
Figure 35.-Site 10203506, Zimovia Highway, unnamed stream, Wrangell, culvert inlet.
