ANNUAL REPORT OF PROGRESS, 1962 - 1963

FEDERAL AID IN FISH RESTORATION PROJECT F-5-R-4

SPORT FISH INVESTIGATIONS OF ALASKA

Project No: F-5-R-4 Title: Salmonoid Rearing and
Migration Study:
Fire Lake System.

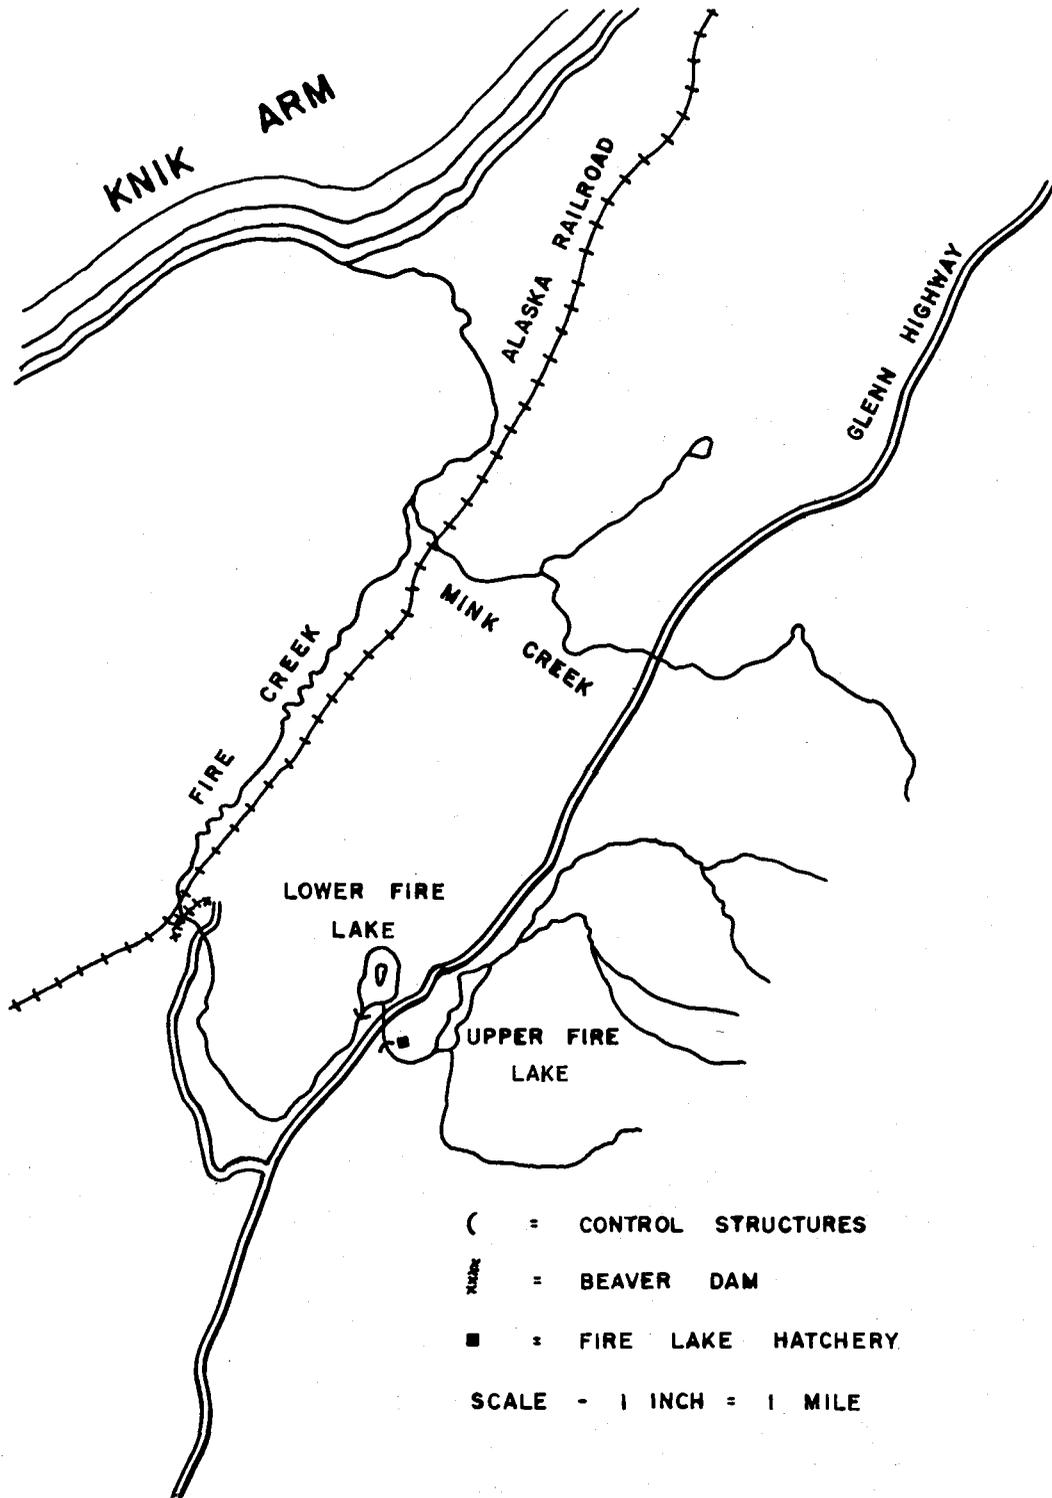
FIGURE 1. FIRE CREEK AND LAKES SHOWING LOCATION OF CONTROL STRUCTURES, IMPASSABLE BEAVER DAM, AND ROAD ACCESS.

On August 3, a survey was conducted of Fire Creek below Lower Fire Lake. A road crossed Fire Creek just above the Alaska Railroad approximately four miles above the mouth. One beaver dam immediately above the railroad culvert forms a barrier to upstream migrant fish. This dam is about four feet high, 100 feet long and backs up approximately 1.5 acres of water. A foot survey was conducted on August 28 in a one-half mile stretch of stream starting approximately two miles above the mouth of Fire Creek. Twenty-five silver salmon were counted in this area with 17 congregated in a pool at the confluence of Mink Creek and Fire Creek. No salmon redds were observed. Lack of man power and time prevented a complete survey.

The beaver dam immediately above the Alaska Railroad should be removed prior to salmon migration.

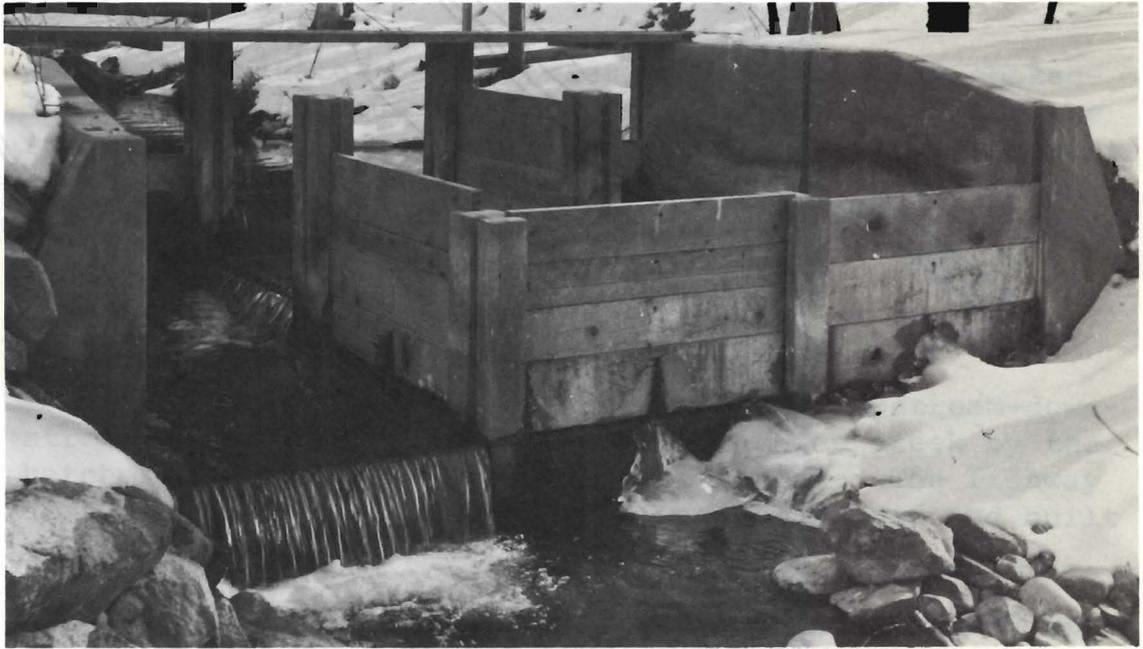
On April 23, work was started on the installation of the upstream-downstream control structure at the hatchery (Figure 1). Heavy fall rains halted construction in the fall of 1961. The facility was completed on May 16, 1962 (Figure 2). The area was cleared of debris, then backfilled and riprapped to prevent soil erosion.

Figure 2. View of the fish trapping facility in Fire Creek next to the Fire Lake Hatchery.

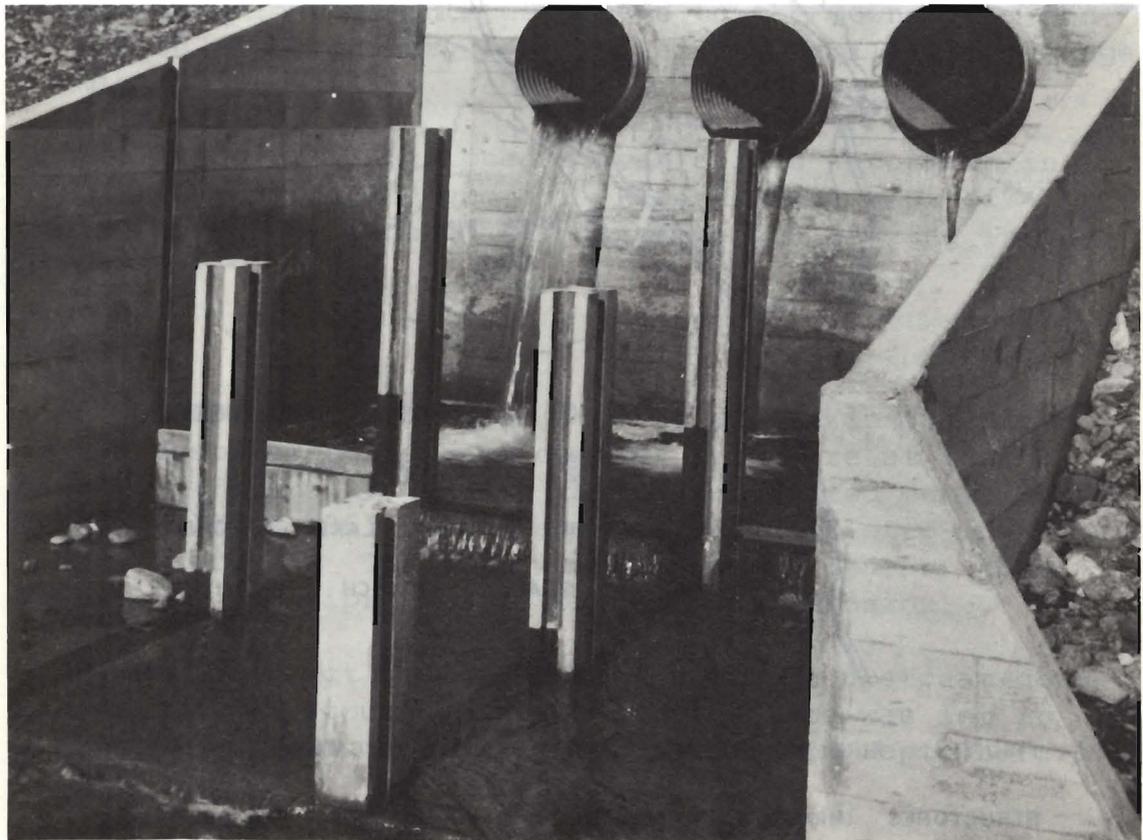
The contract for construction of the upstream-downstream control structure at Lower Fire Lake was let in early July. This facility was completed in September, 1962 (Figure 3).

Figure 3. View of the combination fish ladder and trapping facility at outlet of Lower Fire Lake.

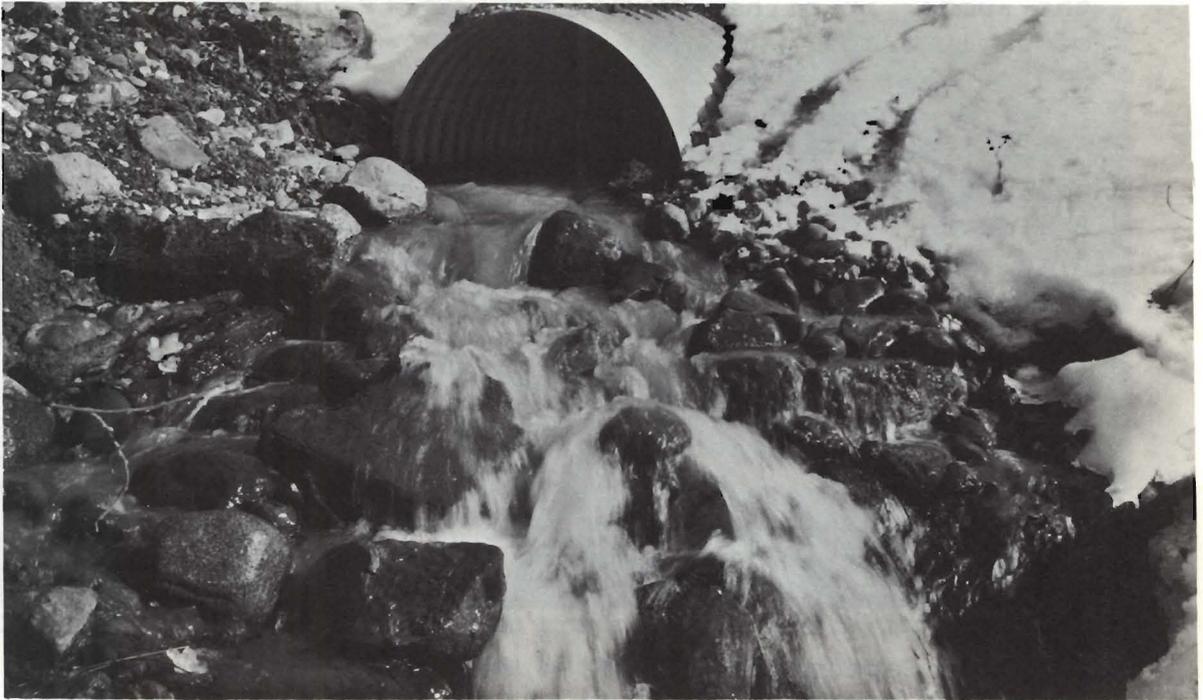
The Fire Lake hatchery road culvert is a partial barrier to upstream migrant fish (Figure 4). The culvert outlet is about two feet above the stream bed, and the creek water cascades down over large rocks making upstream passage difficult. Additional rocks were placed below the culvert to form pools.

Figure 4. View of Fire Lake Hatchery road culvert.

The outlet of the Fire Lake Hatchery road culvert should be remedied to ease the passage of fish.

Minor improvements were made to the downstream end of the 36 inch hatchery road culvert to facilitate passage of migrating fish.
