REVISED ANADROMOUS STREAM CATALOG OF SOUTHEASTERN ALASKA

District 106

Northeast Coast of Prince of Wales Island

Subdistricts 106-30 and 106-10

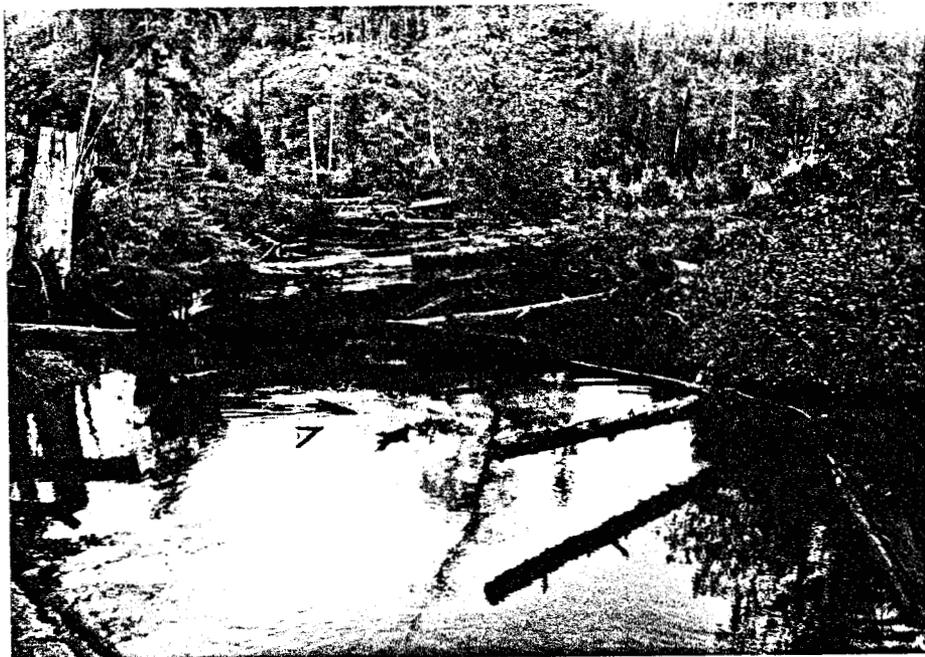
11. Left Fork, Section 15: Upstream view taken from mainline logging road bridge crossing shows a clearcut unit to both banks and copious debris. 20+ adult PS were observed milling in foreground.

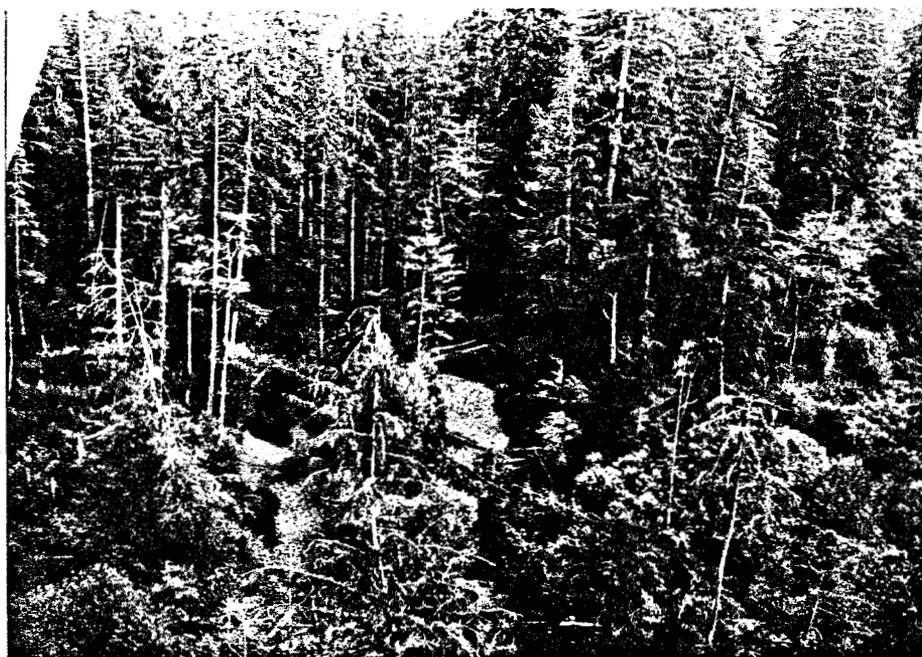
12. Stream leaves unit and enters mature forest cover.

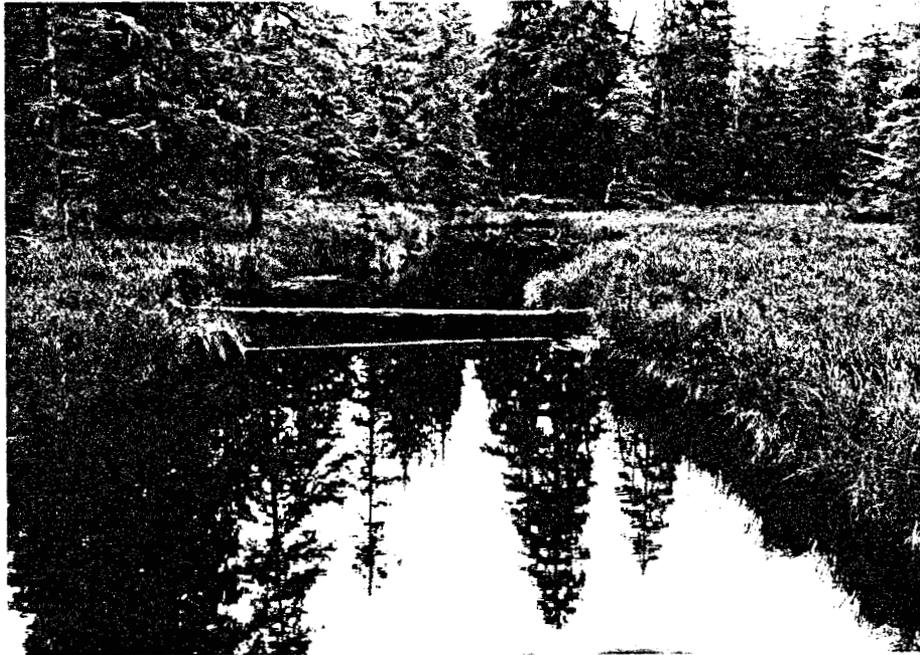
15. Right Fork: Beaver impounded slough-like channel provides excellent rearing habitat; however, no ASA was observed. Dark water hindered observations.

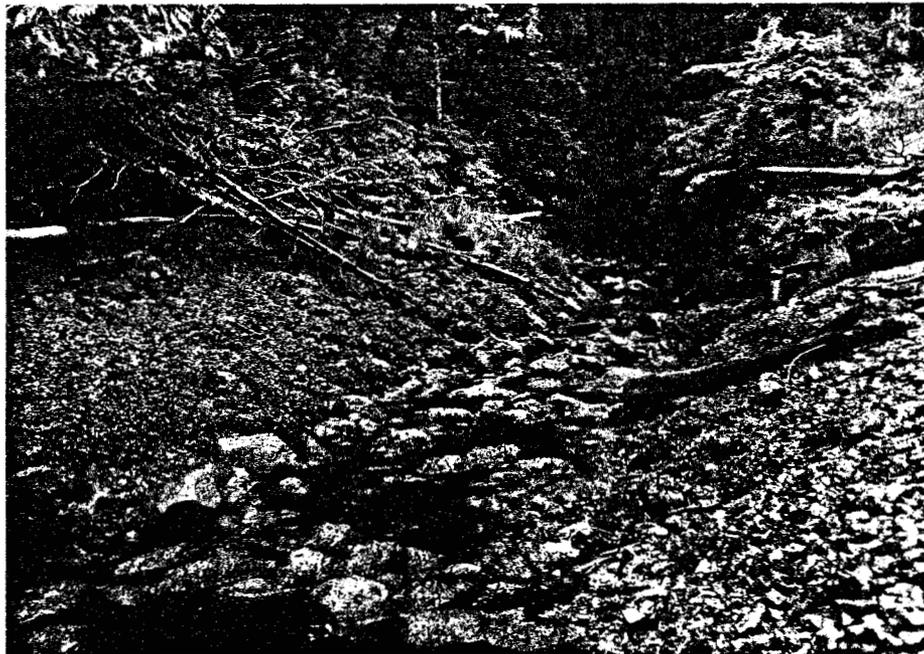
2. Boulder strewn upper ITZ ends at the base of a 4.0 meter high bedrock falls. No fish or habitat were observed.

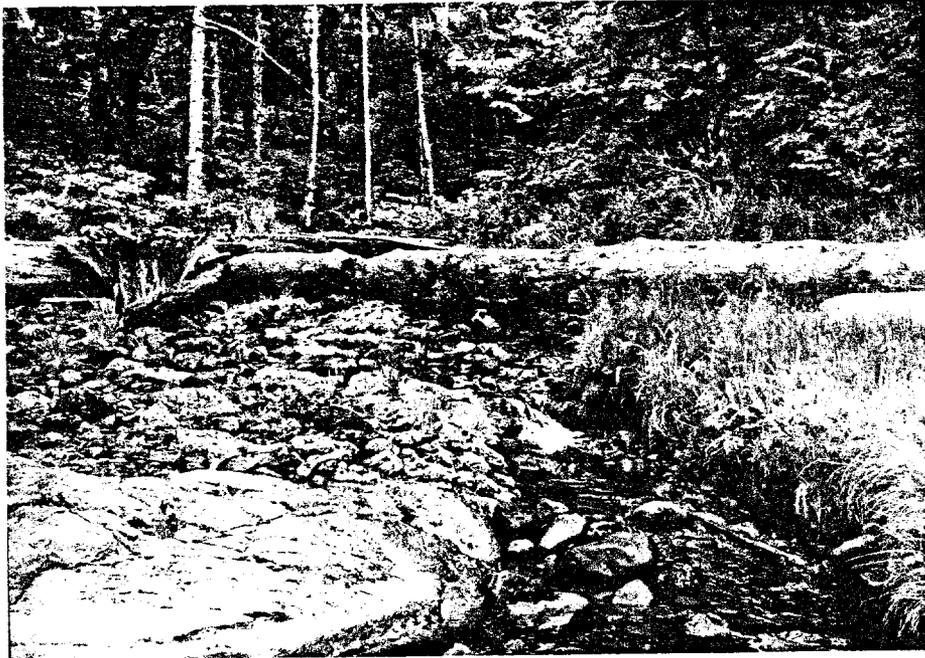
Fire Island #2

1. A clearcut unit borders this small, coarse channel just above the ITZ. Several juvenile DV and marginal habitat was noted.

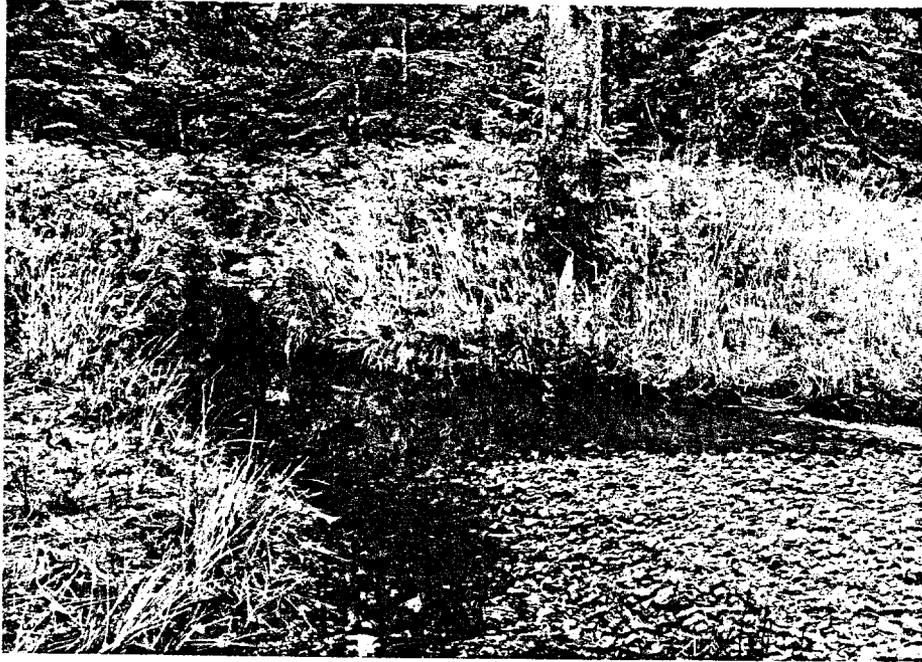
13. Confluence with Exchange Lake. Twelve pink salmon carcasses were observed along the banks near the mouth.

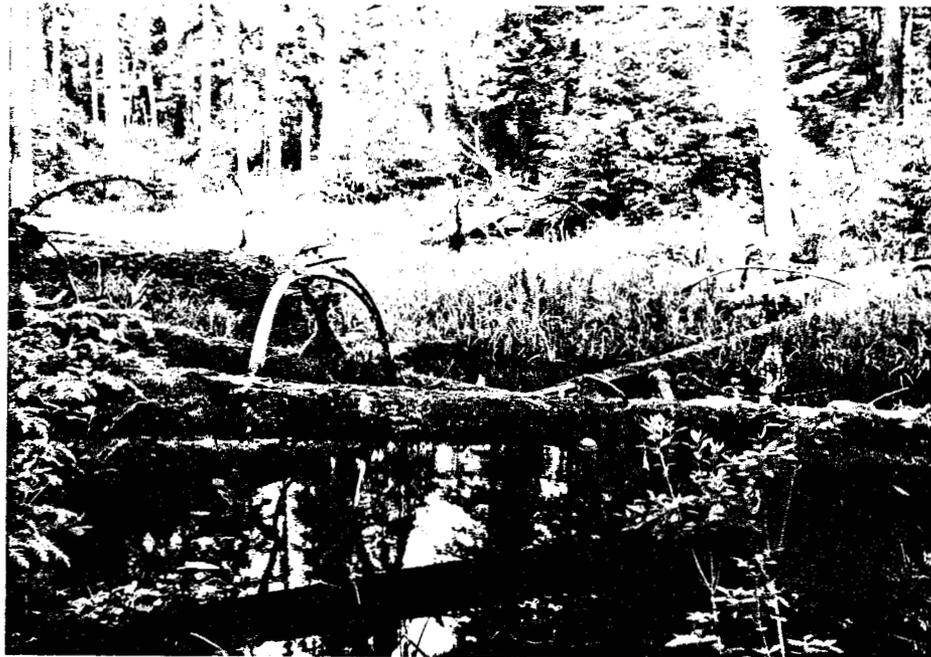
2. A large beaver system dominates the hydrology of the stream 65 m up from the ITZ.

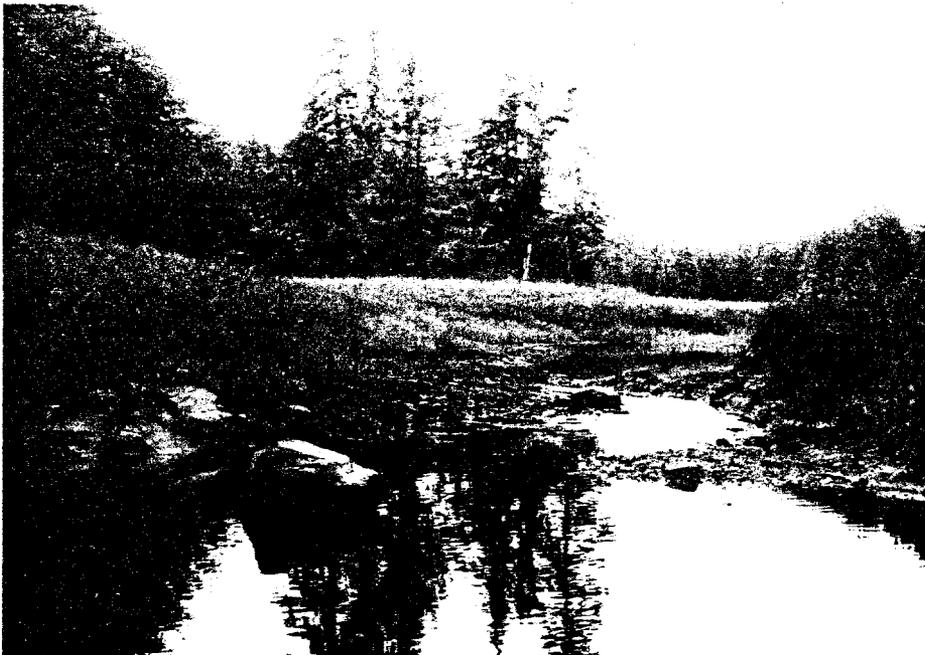
2. View down an extensive ITZ/marsh complex. Substrate was heavily silted and no fish or ASA was observed.

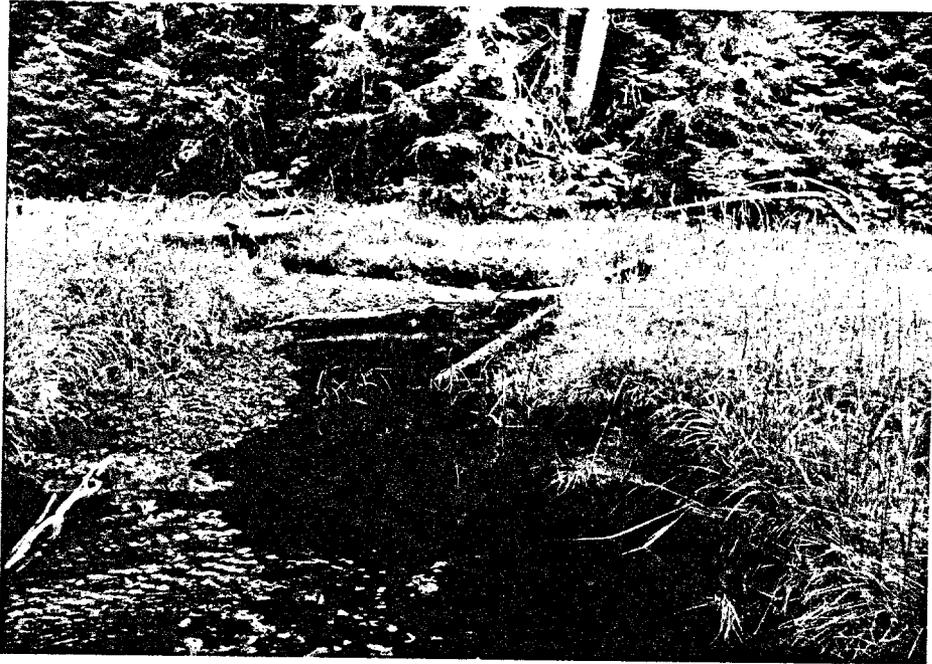
1. Upper ITZ rearing pools containing coho fry.

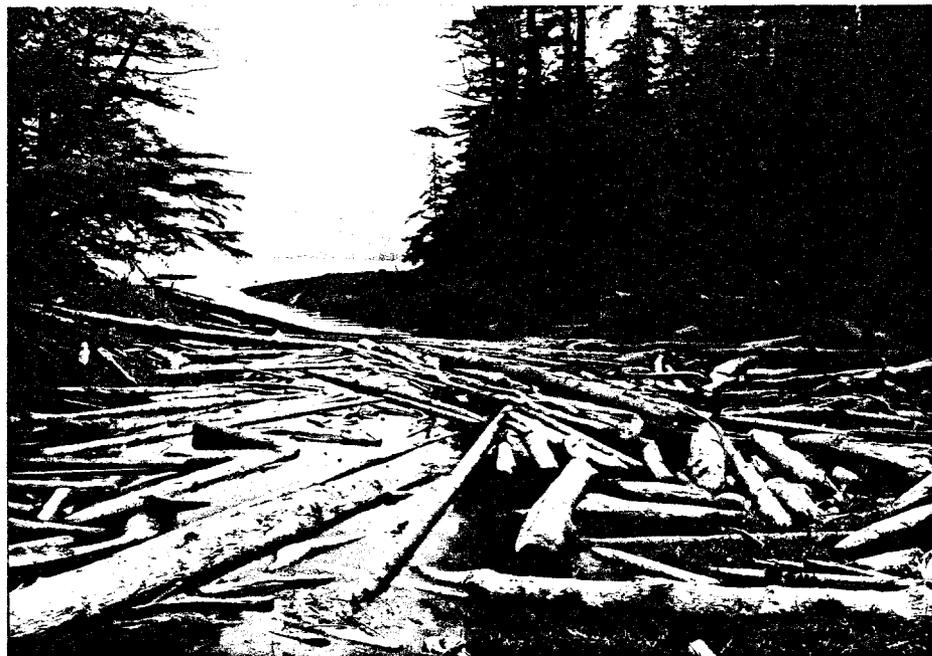
2. Downstream view of lower ITZ with beach debris.
Cove has open southeast exposure.

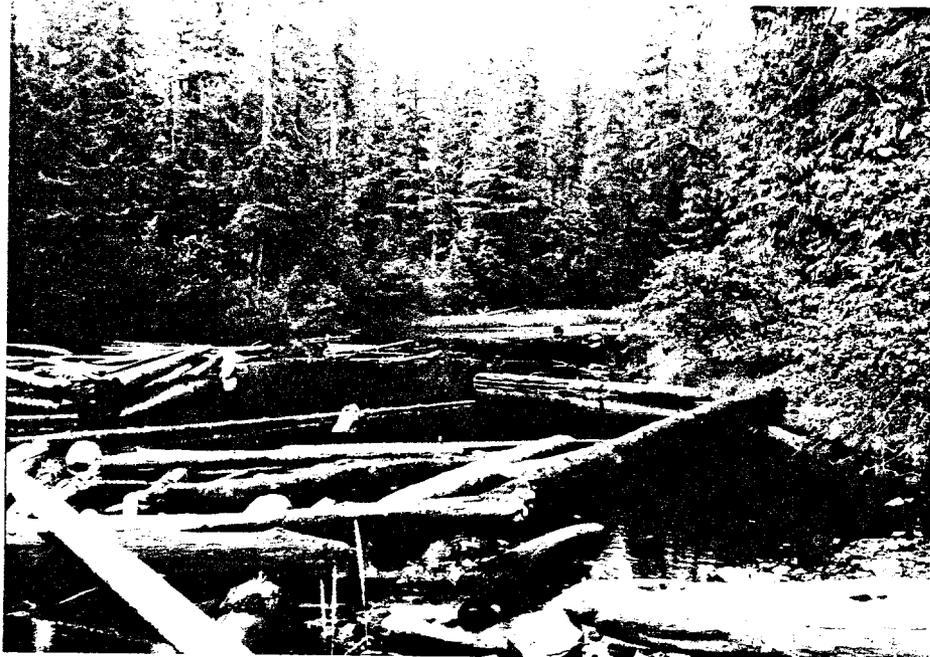
2. Intertidal rearing pond thick with coho fry.

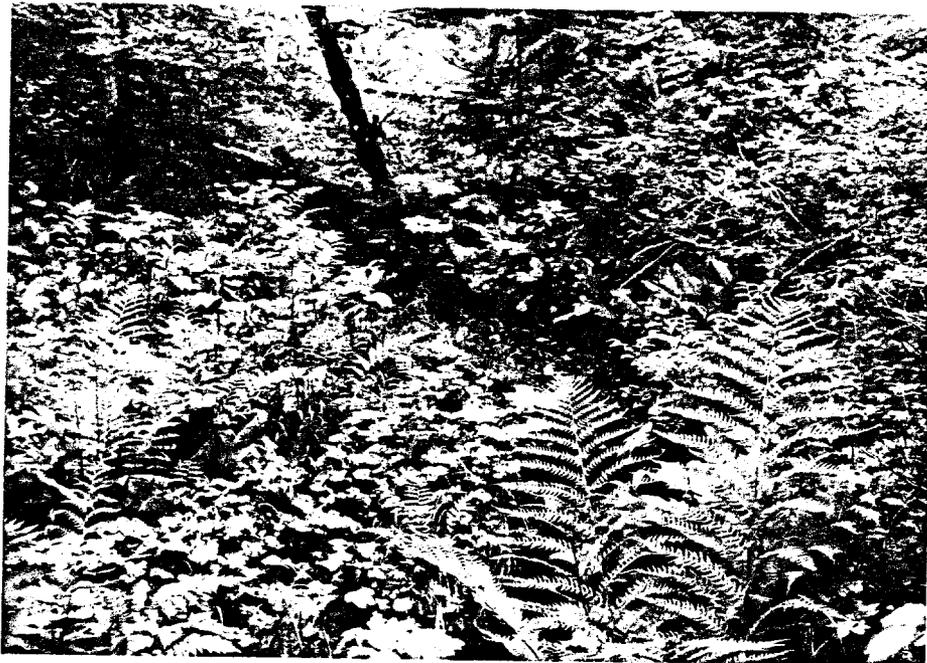
24. Survey Area "D-2": Section 5 has increased gradient through the forest. Fish habitat diminishes.

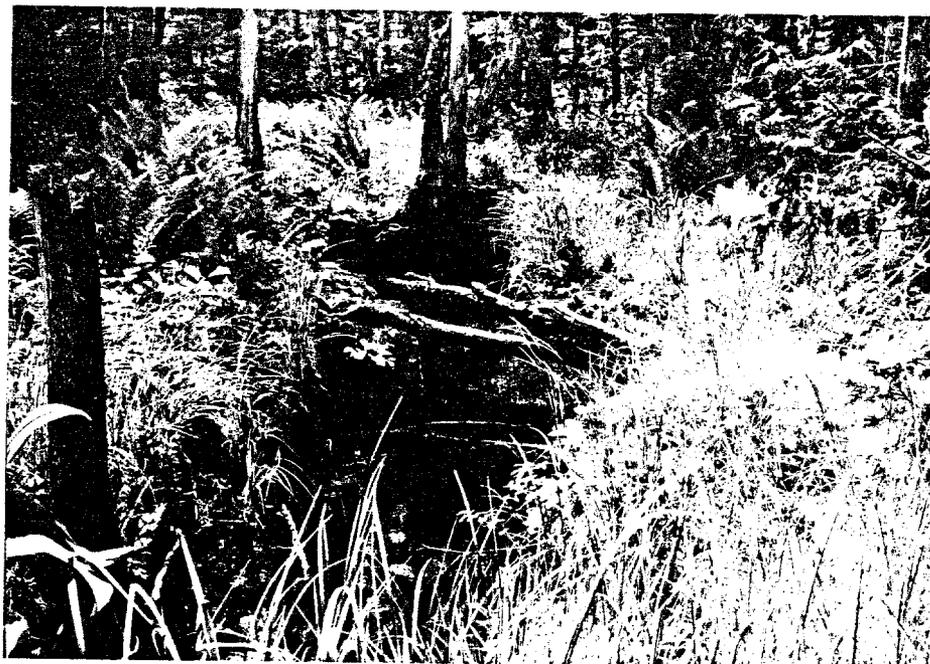
26. Survey Area "E". Sharply undercut banks and a good pool/riffle ratio provide good rearing habitat in Section 1.

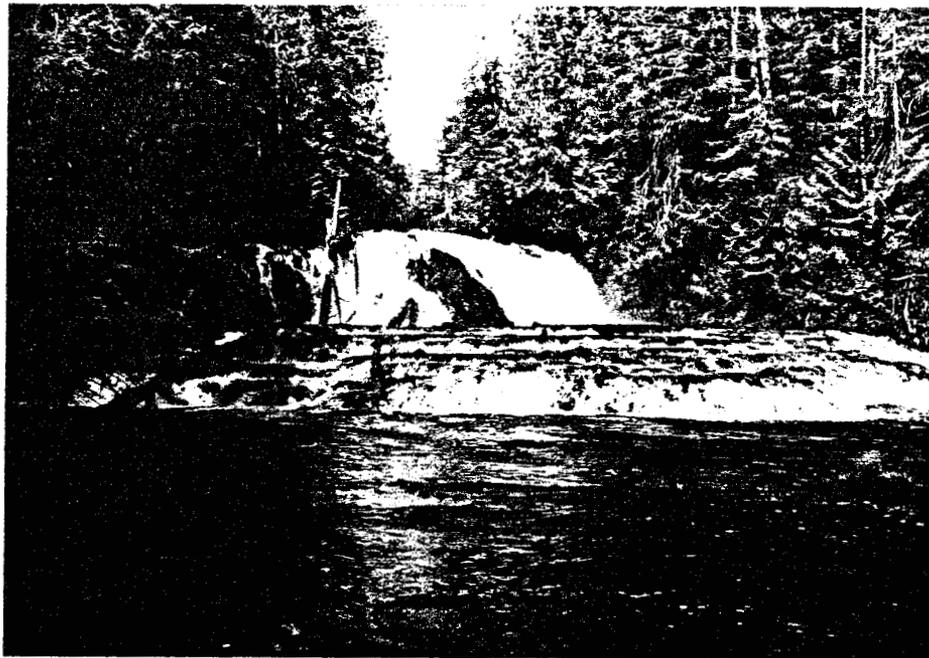
4. Section 2: Bedrock stair-step cascades culminate in a 12 vertical meter barrier falls.

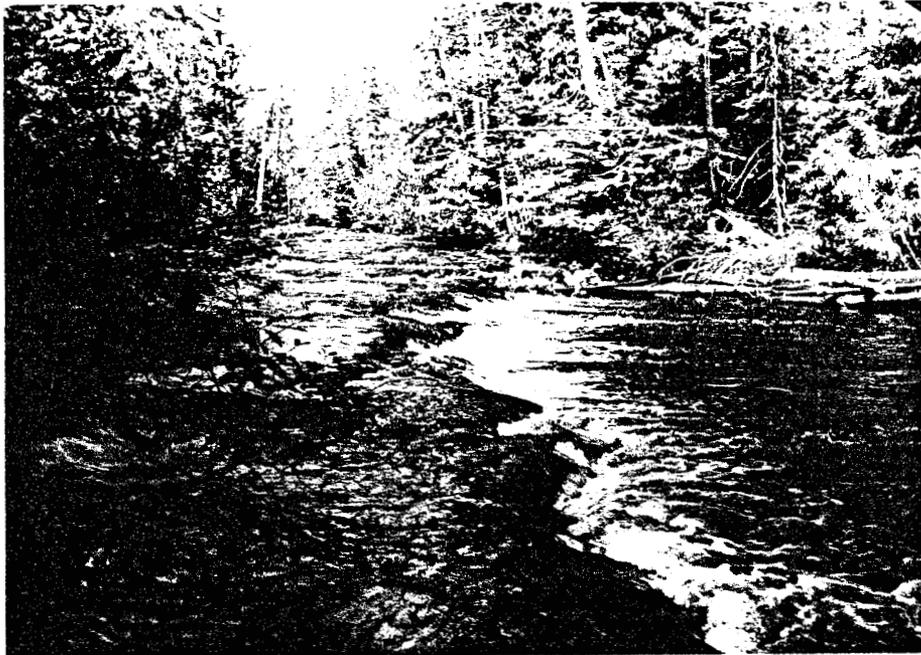
5. Section 2: Above barrier channel becomes a uniform progression of tiered cascades. Minimal rearing and no spawning habitat observed.

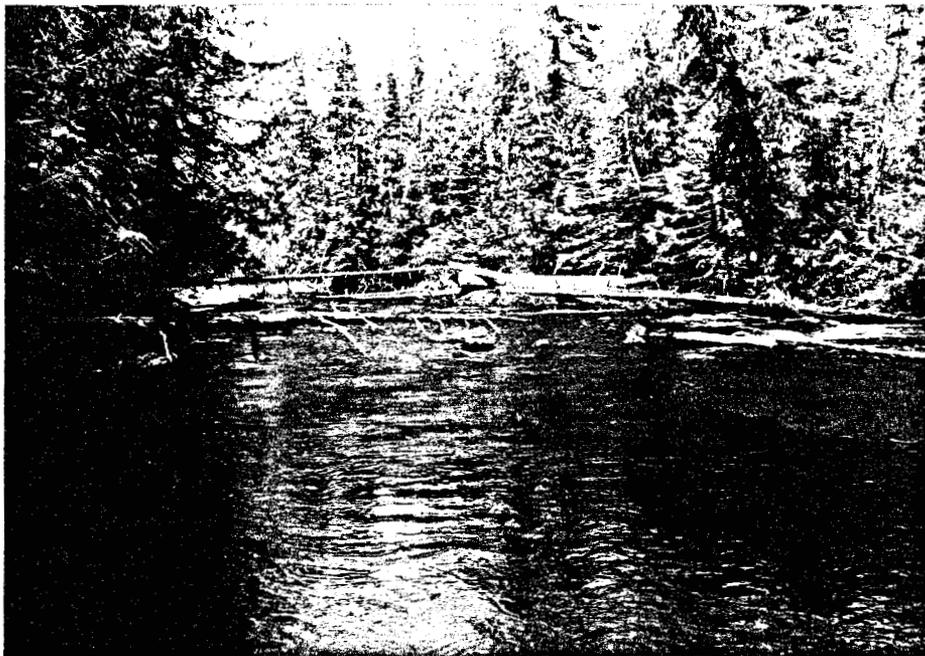
6. Section 4: View beyond Section 4 to lake confluence, left center. Aquatic moss and deep, slow pools provide limited rearing along left bank.

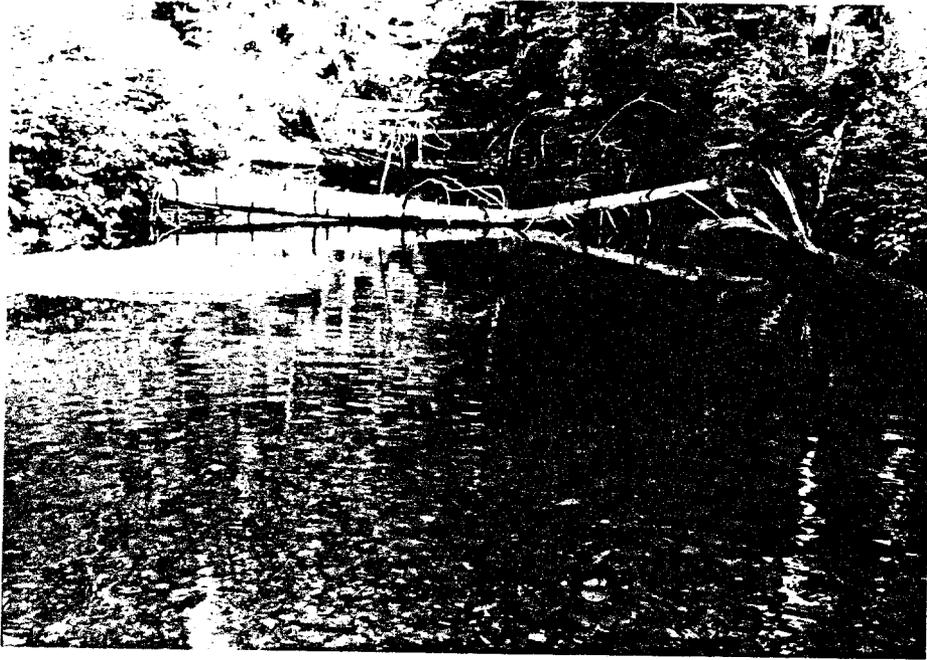
3. Section 5: Moderate debris loading and large, deep pools provide good rearing habitat.

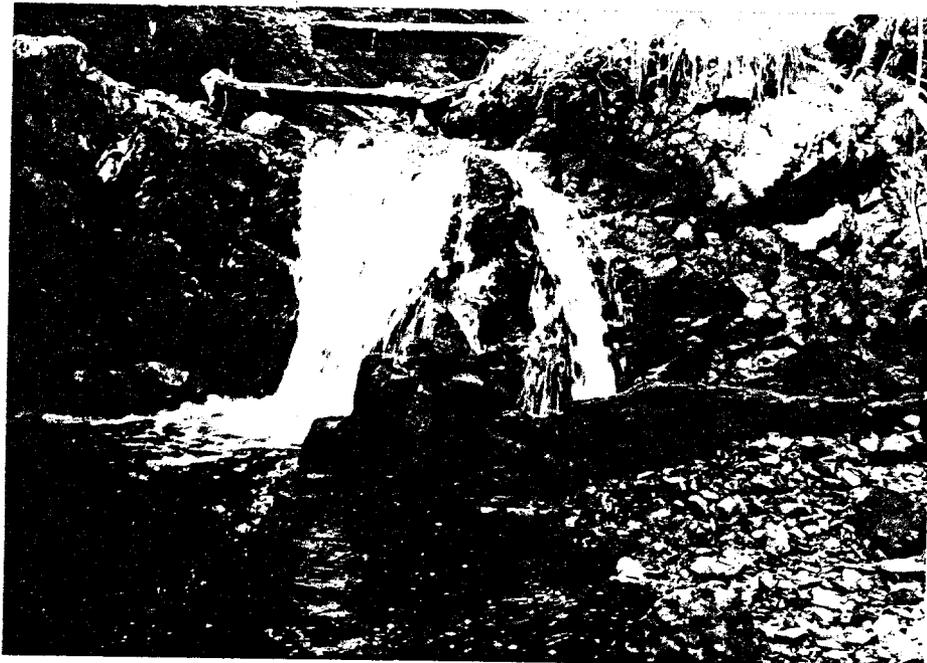
4. The third of 3 two meter falls in Section 8. A potential barrier to pink and chum salmon.

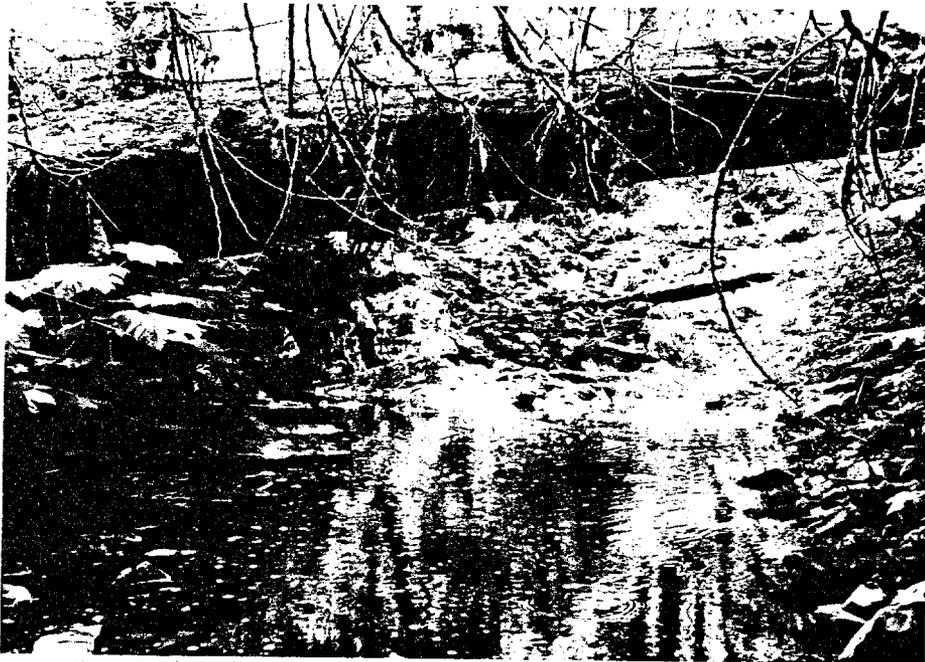
3. Bedrock cascades, logging debris and pools containing angular cobble provide limited rearing and marginal isolated spawning.

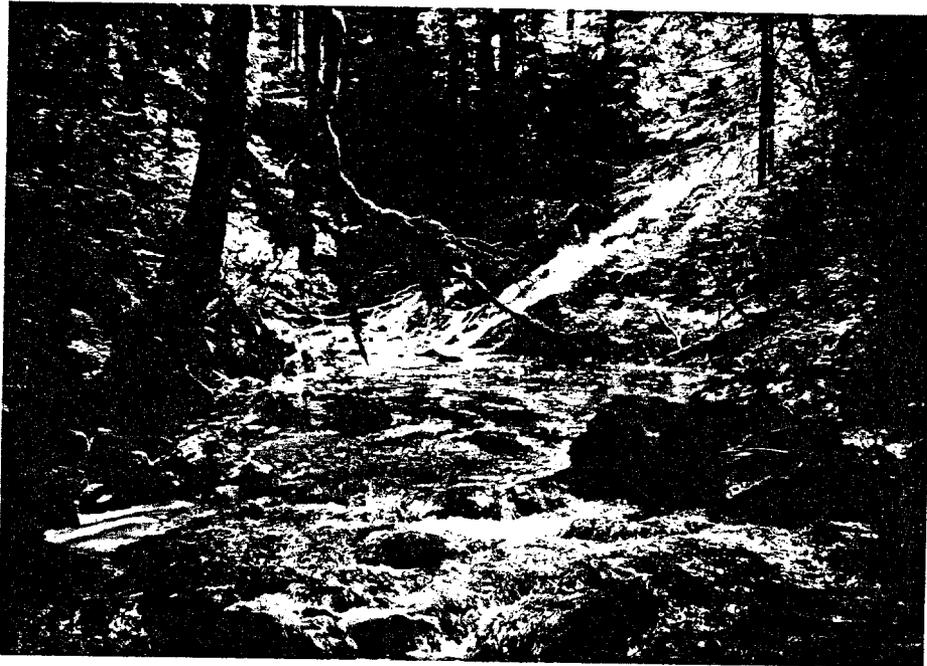
5. View beyond survey reveals a second barrier falls 12 vertical meters in height.
