Nomination Form  
Anadromous Waters Catalog

Region Southcentral USGS Quad(s) Seward A-3  
 Anadromous Waters Catalog Number of Waterway 226-40-16670  
 Name of Waterway "Anderson Creek"  USGS Name  Local Name  
 Addition  Deletion  Correction  Backup Information

SUBJECT: Trip Report – Anderson Creek  
Chenega Hydro Electric Project

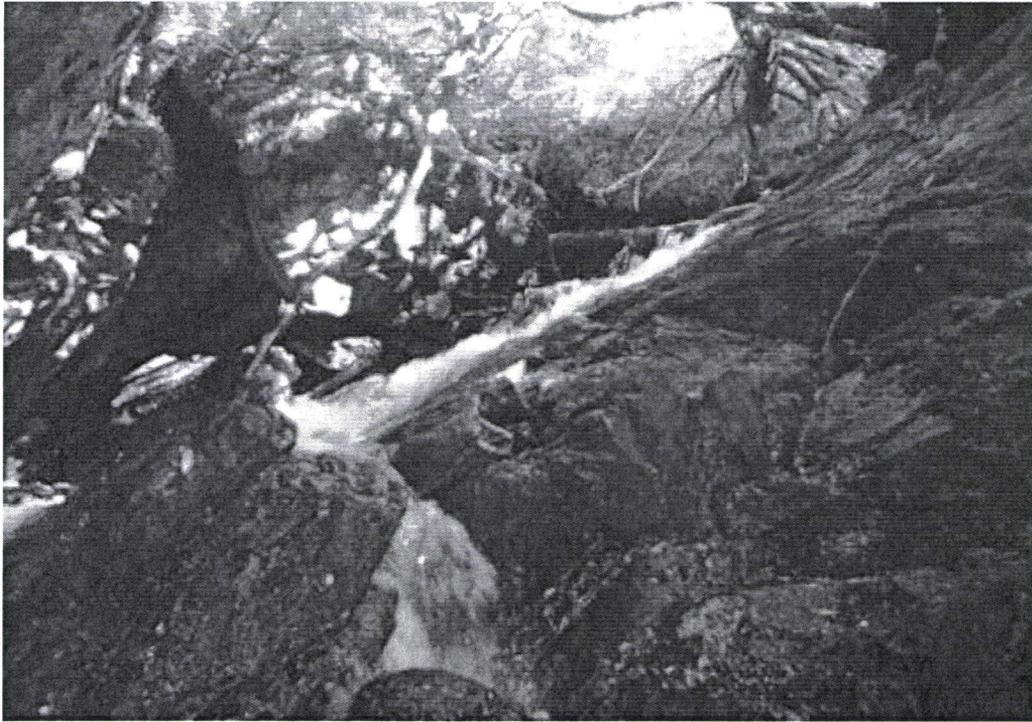
Ms. Arduser and I walked to tide water to begin sampling with an electrofisher. We observed about 125 adult pink salmon spawning in the tidally influenced portion of the stream below the barrier. I did not use the electrofisher where adult salmon were present. **We walked upstream to the barrier. The barrier is a bedrock controlled falls/cascade about 10-feet high on a 20-25% slope (Figures 1 to 3). There are no pools along the cascade.**

Figure 1. Barrier in Anderson Creek. View looking upstream.

The name of Evans Creek will be changed in the Anadromous Waters Catalog to the locally used name of Anderson Creek. Pink Salmon in the lower reach of Anderson Creek will be nominated for addition to the Anadromous Waters Catalog. The ADF&G has determined that the barrier in the lower reach of Anderson Creek will not allow fish passage. Based on fish sampling conducted by HDR Alaska, Inc. in 2009 and by the ADF&G, the upper limit of the specified portion of Anderson Creek will be moved to the location of the barrier.

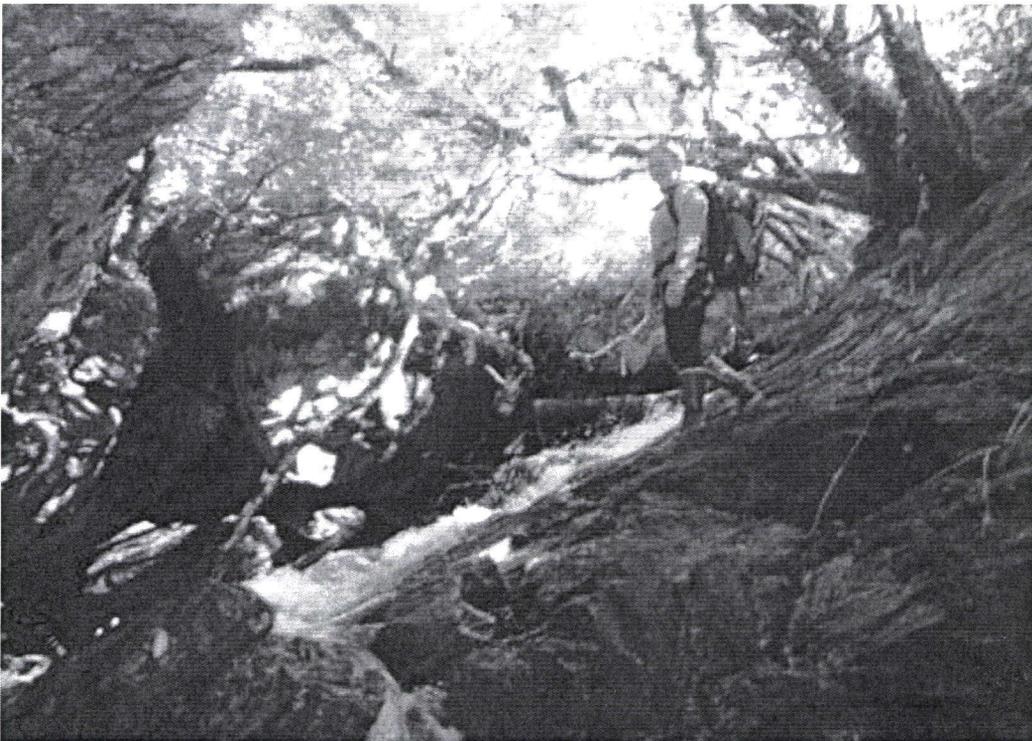
Figure 2. Barrier in Anderson Creek. View looking upstream.

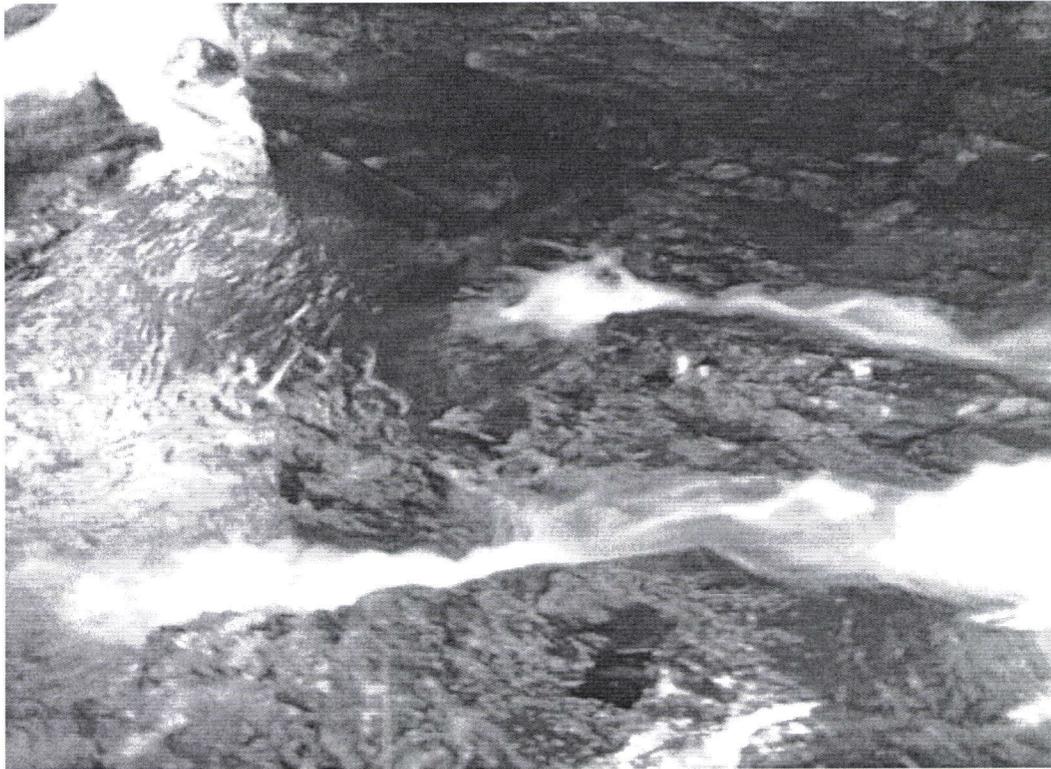
Figure 3. Barrier in Anderson Creek. View looking downstream.

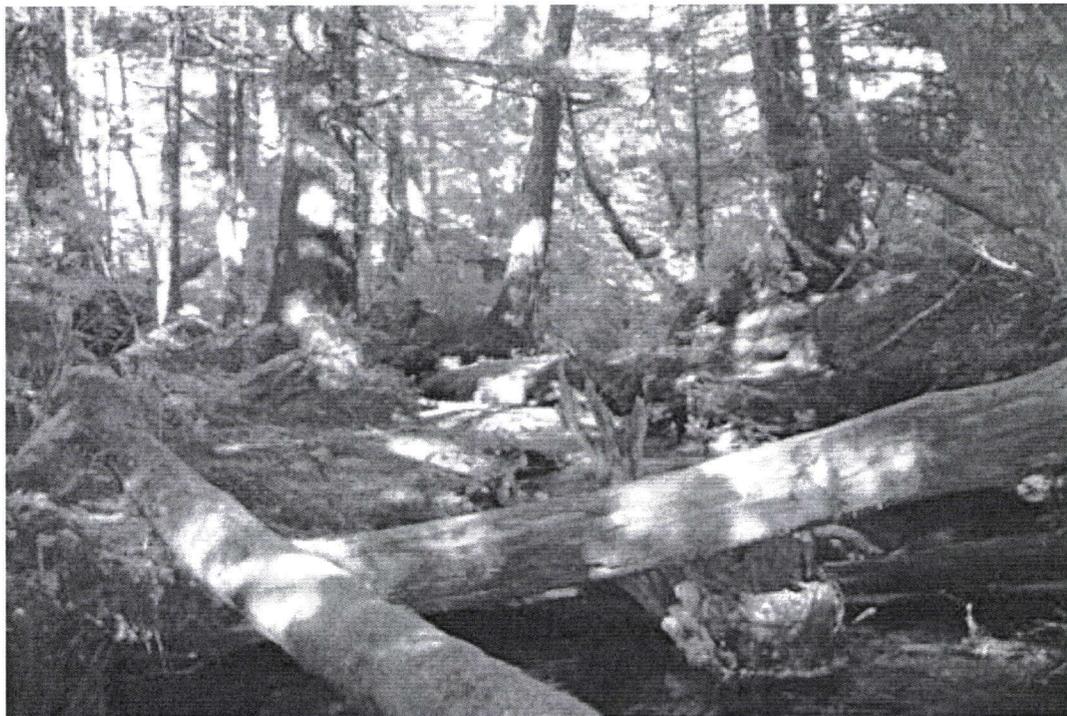
We walked upstream above the barrier about 0.5 mile sampling for fish presence. The stream is a low gradient channel with riffle-pool habitat in a mature spruce/hemlock forest. The stream channel has moderate sinuosity. Pools were formed primarily from large woody debris (Figures 4 and 5). The substrate is primarily of gravel and cobbles (Figure 6). We captured about 35 Dolly Varden 70 to 165 mm Fork Length (Figure 7). We ended our sampling at an abandoned log dam (Figure 8). The dam was built to provide water to a saltery that was operated in the area before the village of Chenega Bay was built.

Figure 4. Large woody debris in Anderson Creek. View looking upstream.

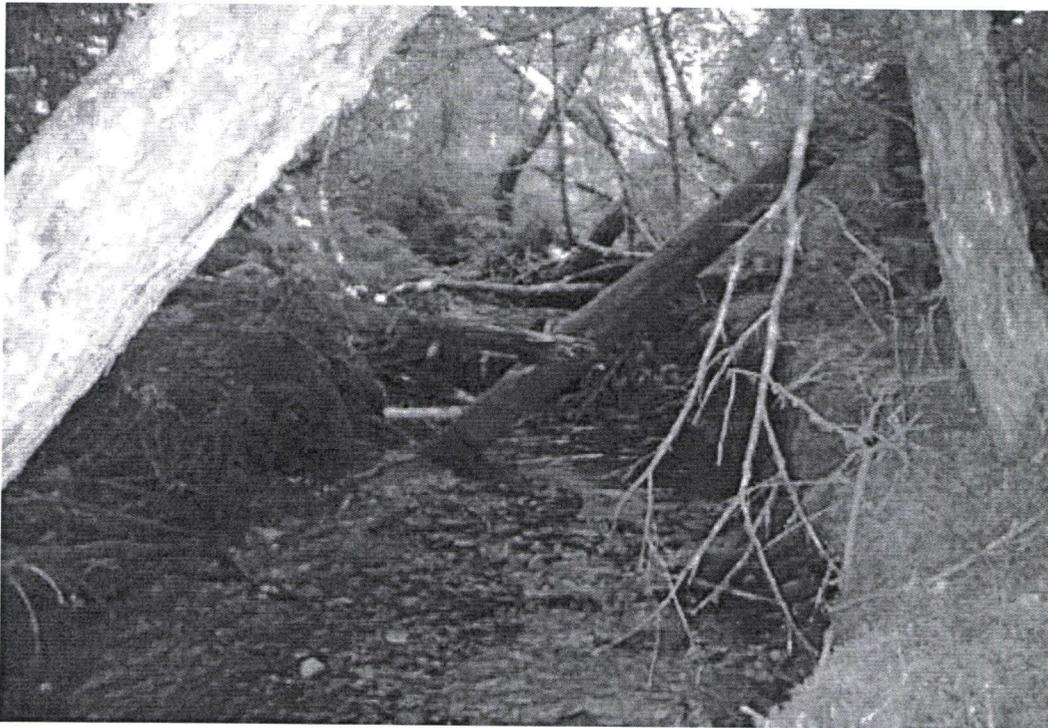
Figure 5. Large woody debris in Anderson Creek. View looking upstream.

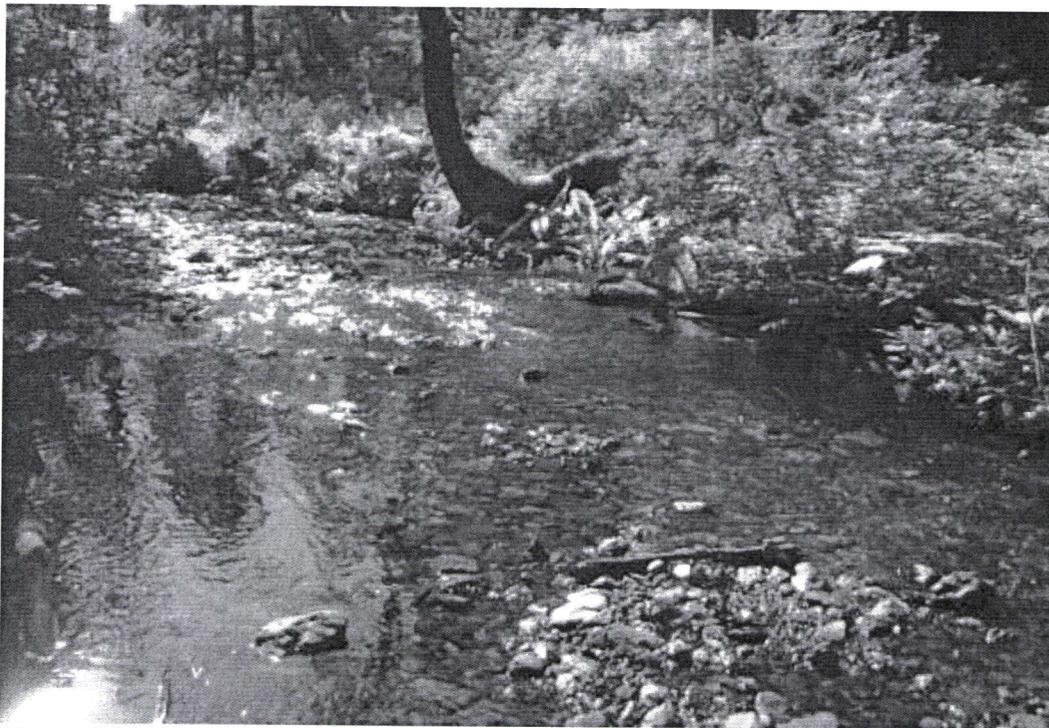
Figure 6. Riffles in Anderson Creek. View looking downstream.

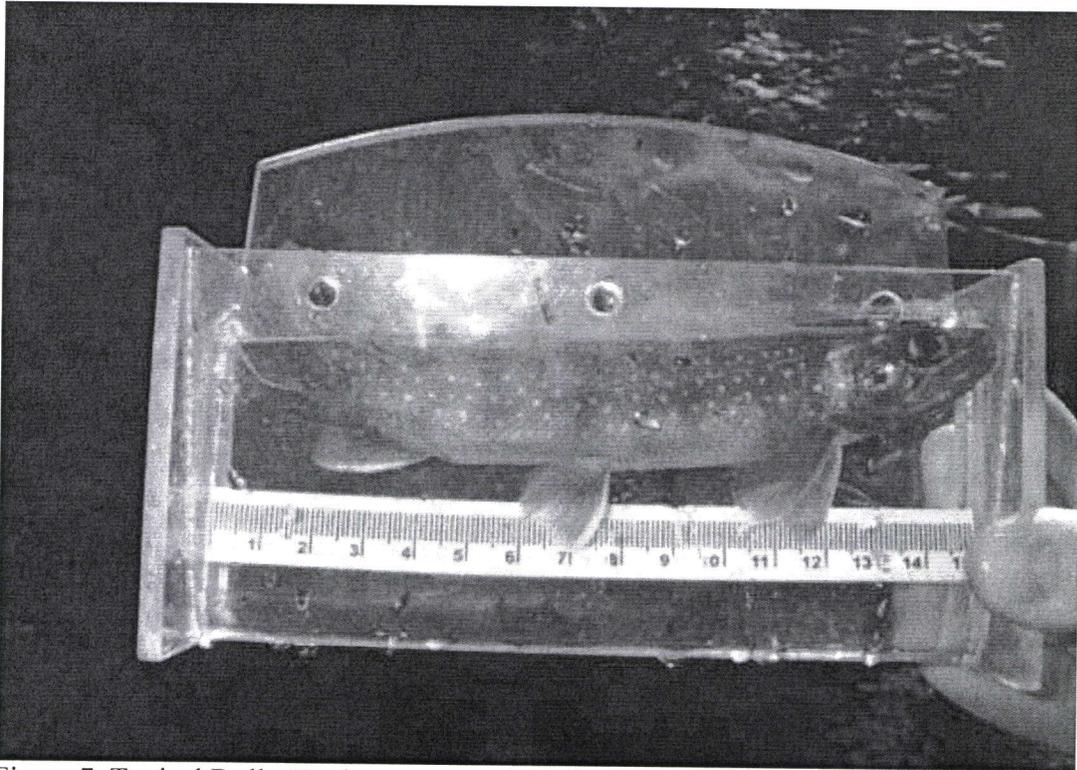
Figure 7. Typical Dolly Varden captured in Anderson Creek.

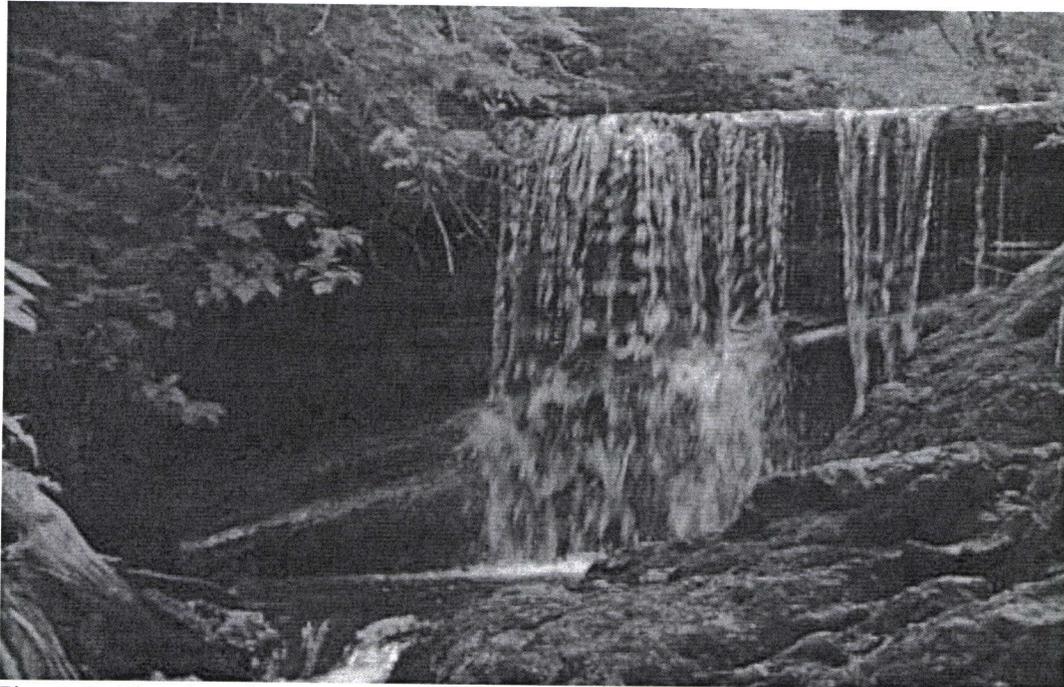
Figure 8. Abandoned wood dam in Anderson Creek.

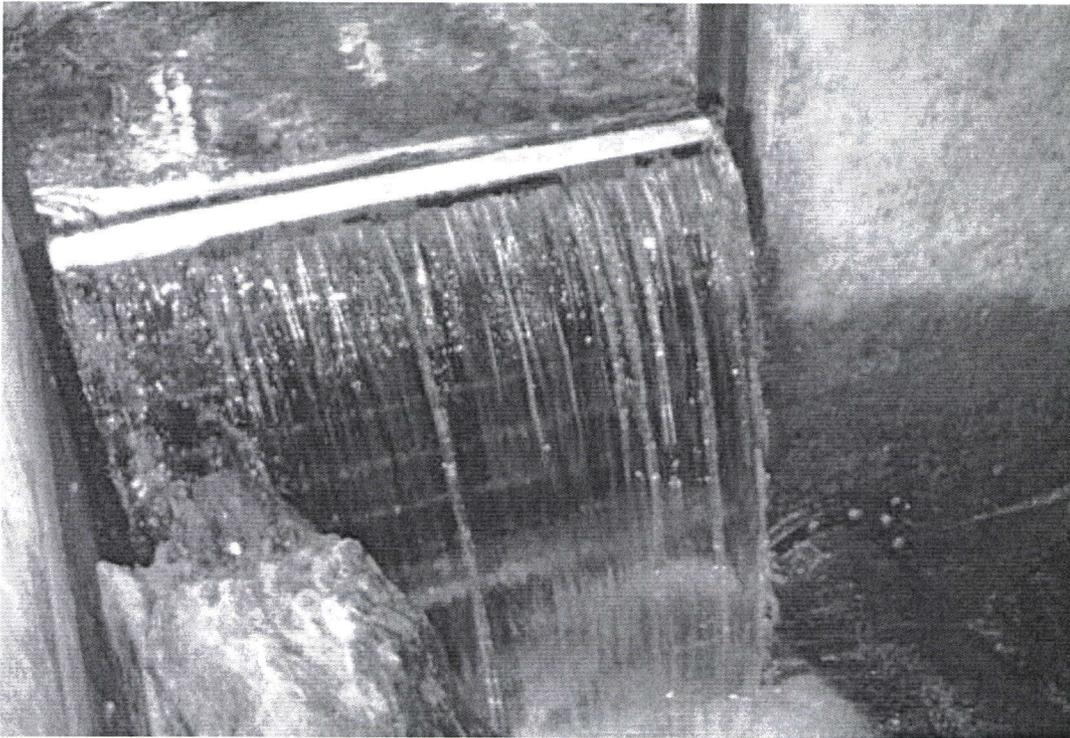
We walked upstream to an impoundment on Anderson Creek. The impoundment is the village drinking water supply. Surplus water that flows over the impoundment will be used to power the proposed hydroelectric facility (Figure 9).

Figure 9. Surplus water flowing over impoundment in Anderson Creek.
