State of Alaska
Department of Fish and Game
Sportfish Division

Nomination Form
Anadromous Waters Catalog

Name of Waterway 33 Mile Creek USGS Name Local Name
 Addition Deletion Correction Backup Information

115-32-10250-2077-3082 Route Correction

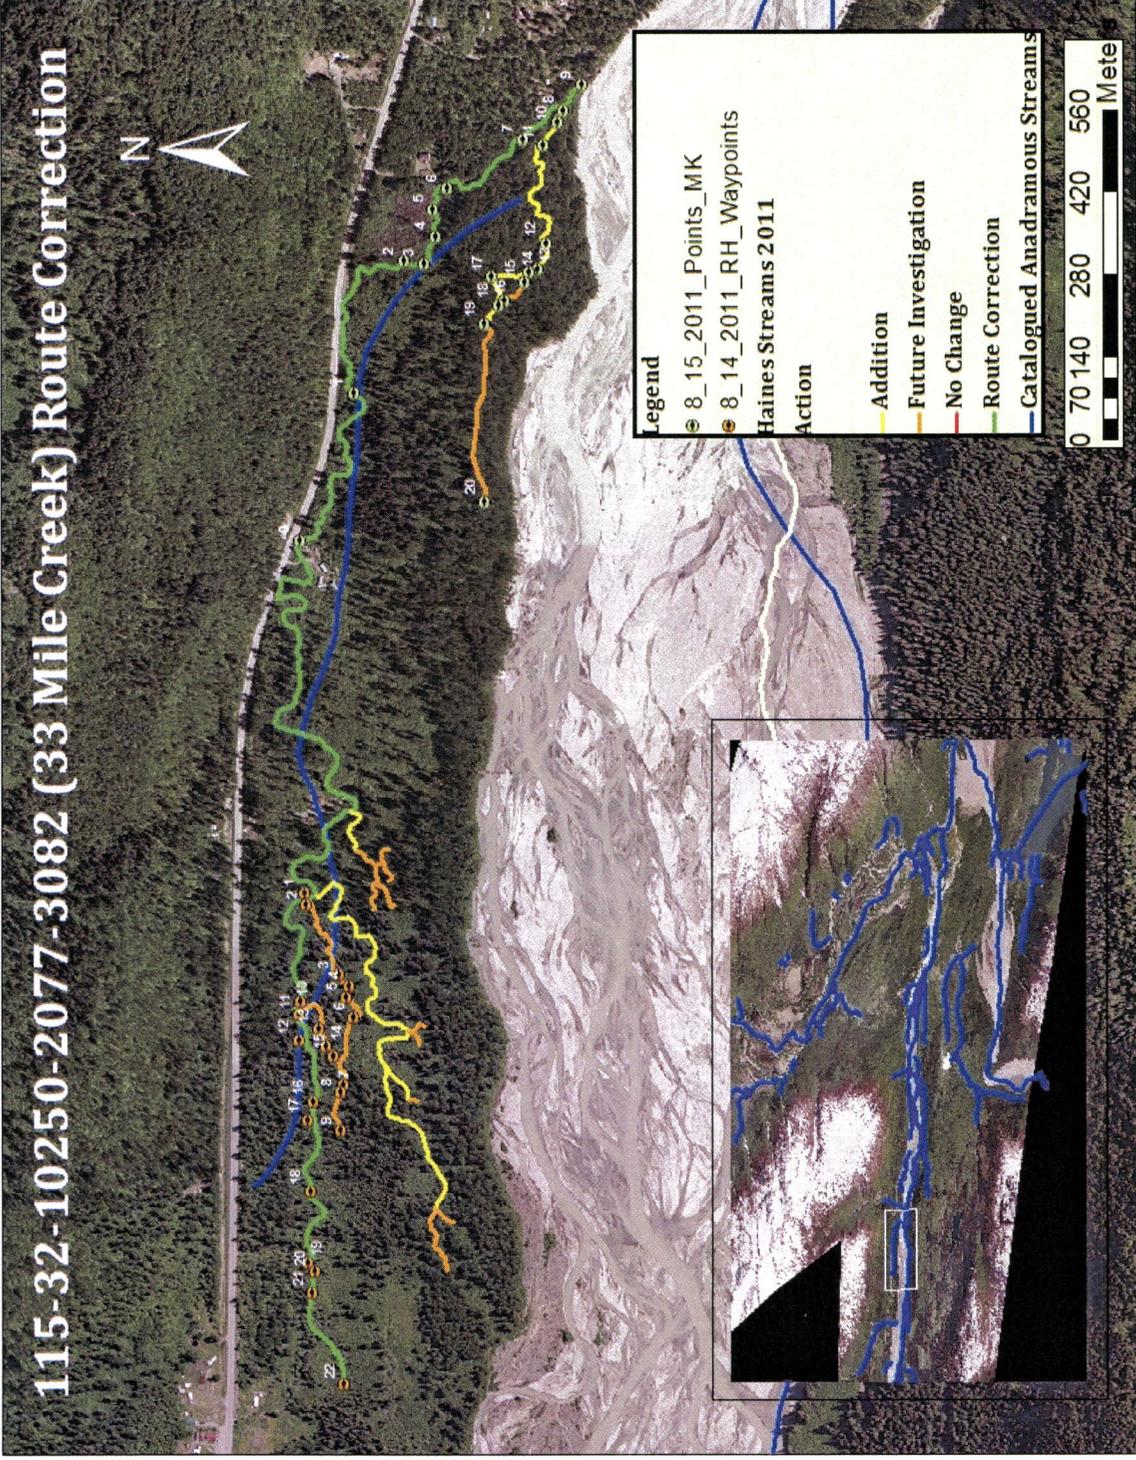
Figure 1: Map detailing the 33 Mile Creek mainstem and tributaries.

Findings: Over the course of two days of surveying we mapped out the mainstem and associated tributaries of 33 Mile Creek, and we found the catalog to be incorrect on many sections of the stream.

Recommendation: Update the stream route to coincide with our recent findings.
