Nomination #	<u>12-586</u>	<u>[Signature]</u>	<u>11/2/12</u>
		Fisheries Scientist	Date
Revision Year:	<u>2013</u>	<u>[Signature]</u>	<u>11/2/12</u>
		Habitat Operations Manager	Date
Revision to:	Atlas <u> </u>	<u>[Signature]</u>	<u>10/25/12</u>
	Both <u>X</u>	AWC Project Biologist	Date
Revision Code:	<u>C-9</u>	<u>[Signature]</u>	<u>11/20/12</u>
		Cartographer	Date

Peterson Creek Route Correction

Stream: Peterson Creek (113-41-10185) Route Correction

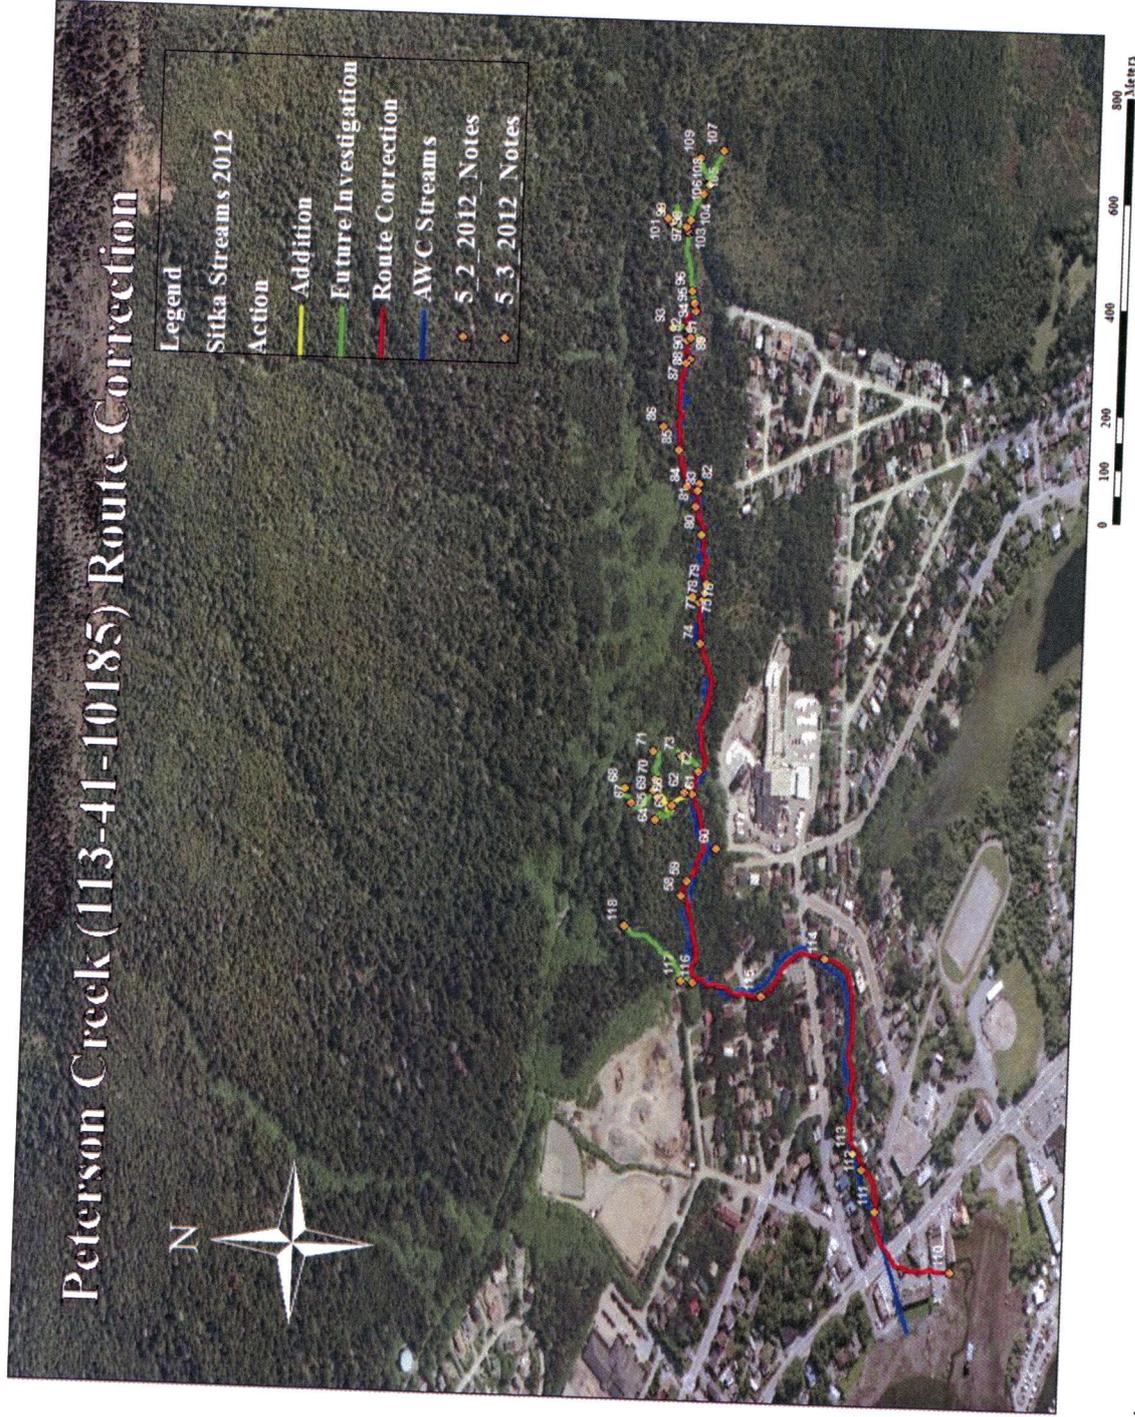
Figure 1. Map of Peterson Creek: Stream No. 113-41-10185 Route Correction.

Findings: This short stream provides rearing habitat for coho salmon, pink salmon fry and Dolly Varden char. This stream presents many restoration opportunities including perched culverts (Wpts 115, 116), and debris removal throughout lower mainstem.

Recommendations: We recommend adding this stream course to the Anadromous Waters Catalog.

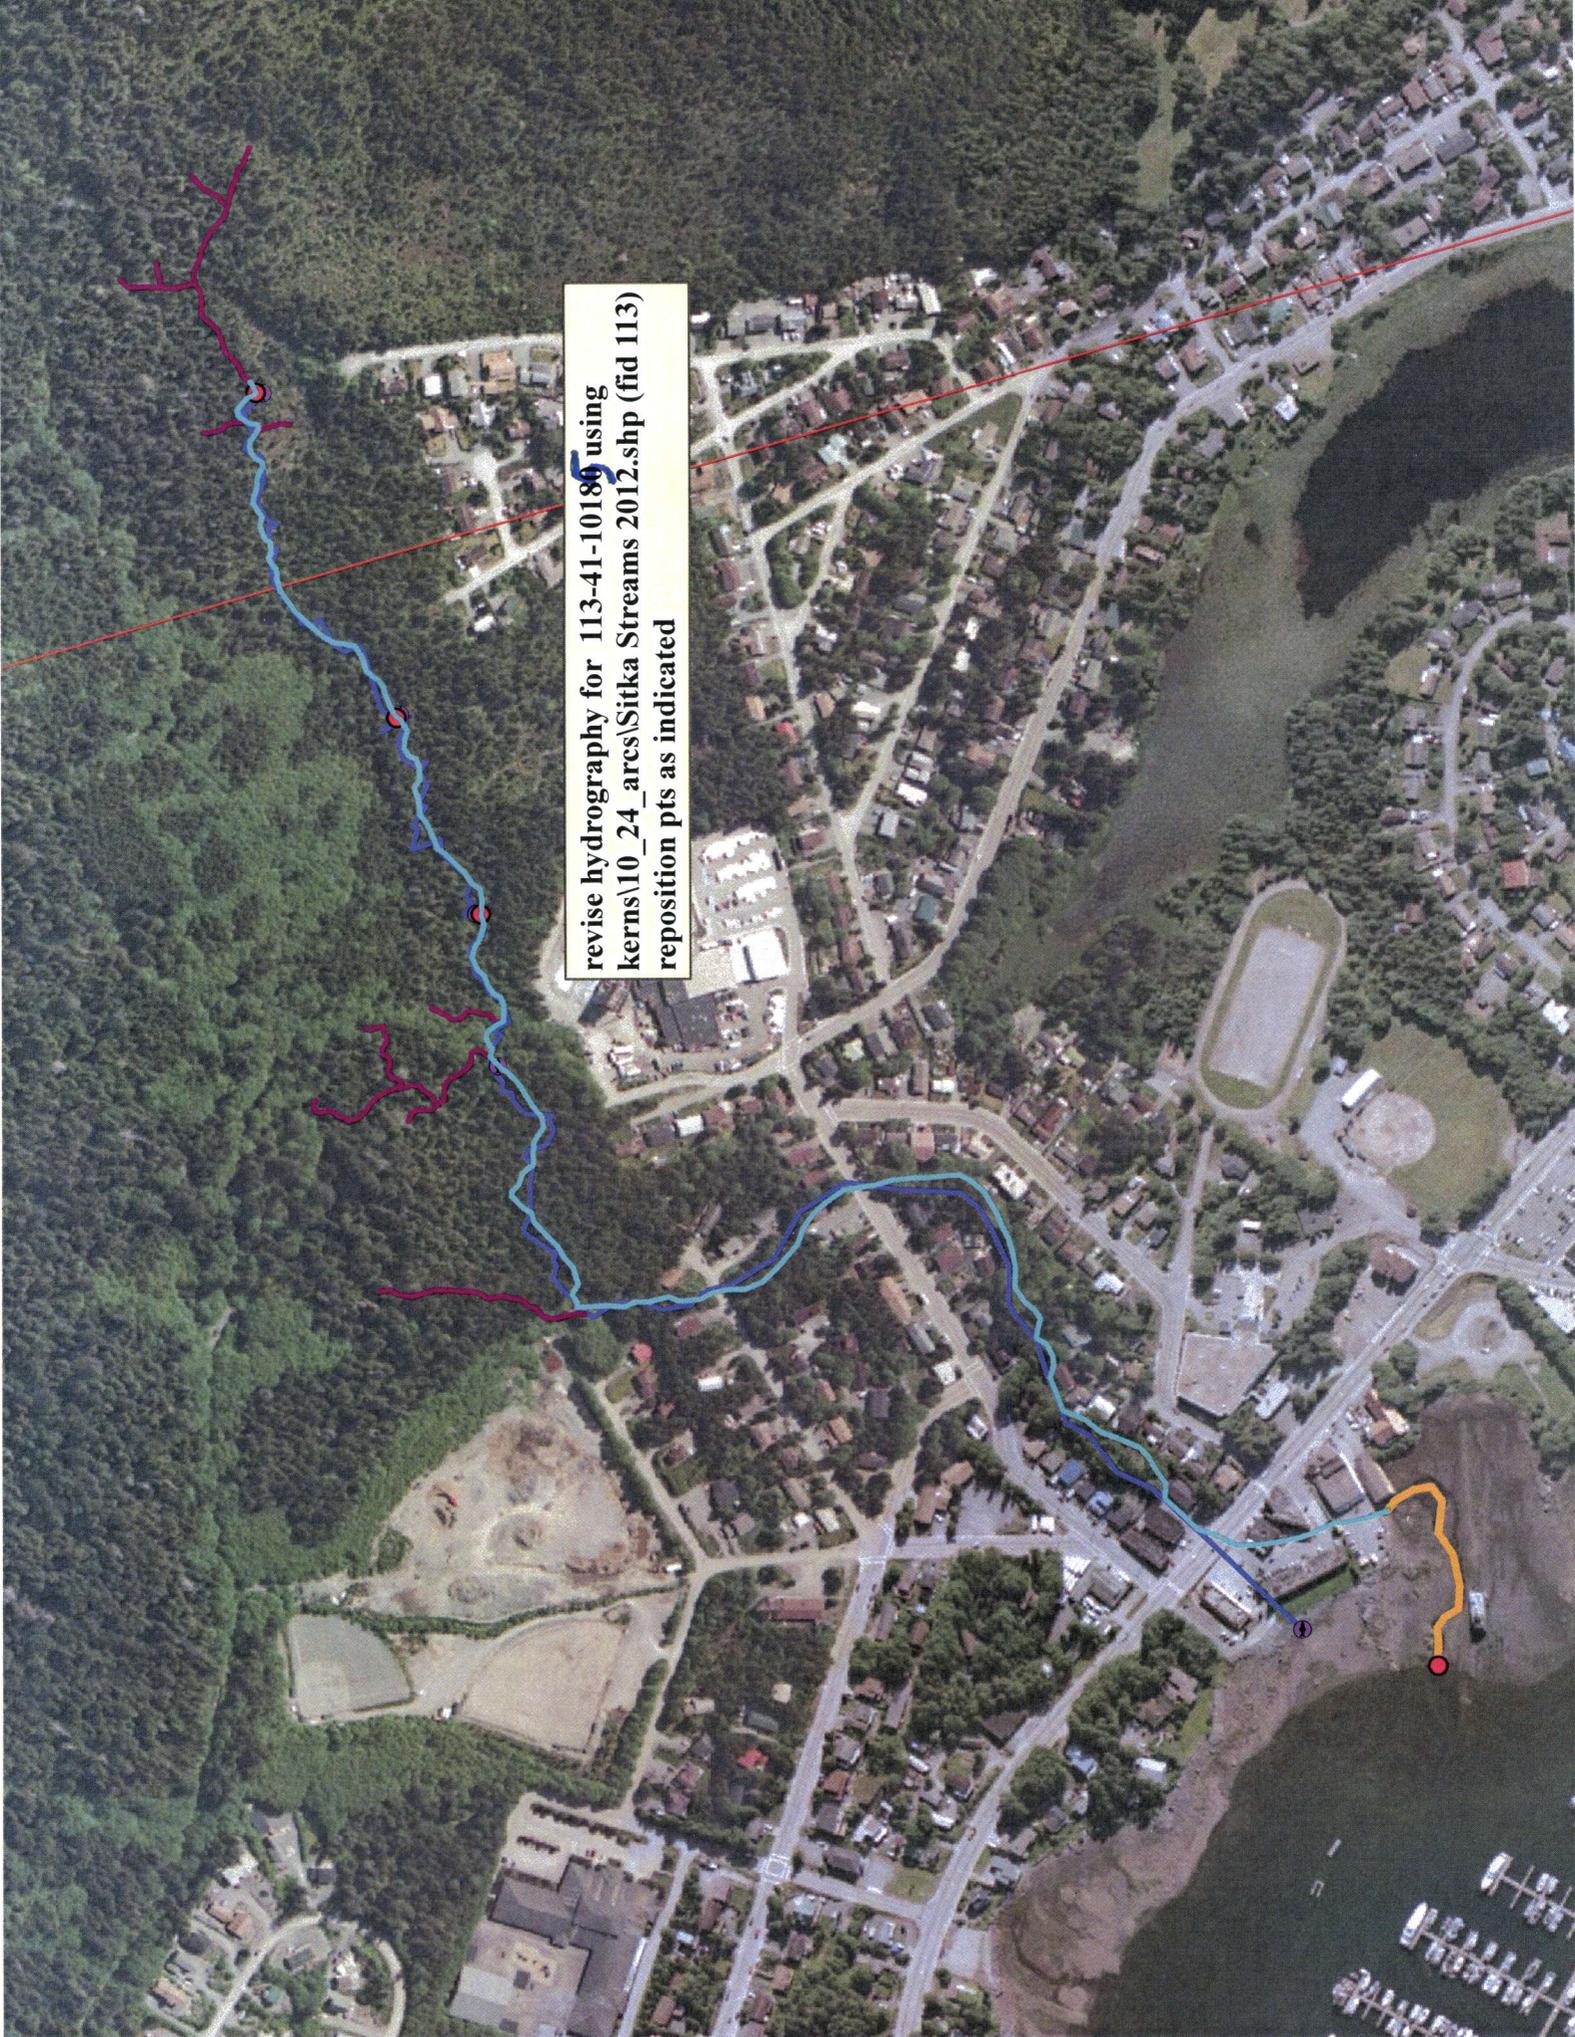
Comments:
 Coordinates (Lat,Long): Upper(57.06383,-135.332699) Lower(57.063804,-135.330241)
Revise hydrography and reposition pt as indicated

revise hydrography for 113-41-10180 using
kerns\10_24_arcs\Sitka Streams 2012.shp (fid 113)
reposition pts as indicated
