Nomination Form  
Anadromous Waters Catalog

Anadromous Waters Catalog Number of Waterway 106-44-10090

**106-44-10090 Route Correction**

Stream: 106-44-10090

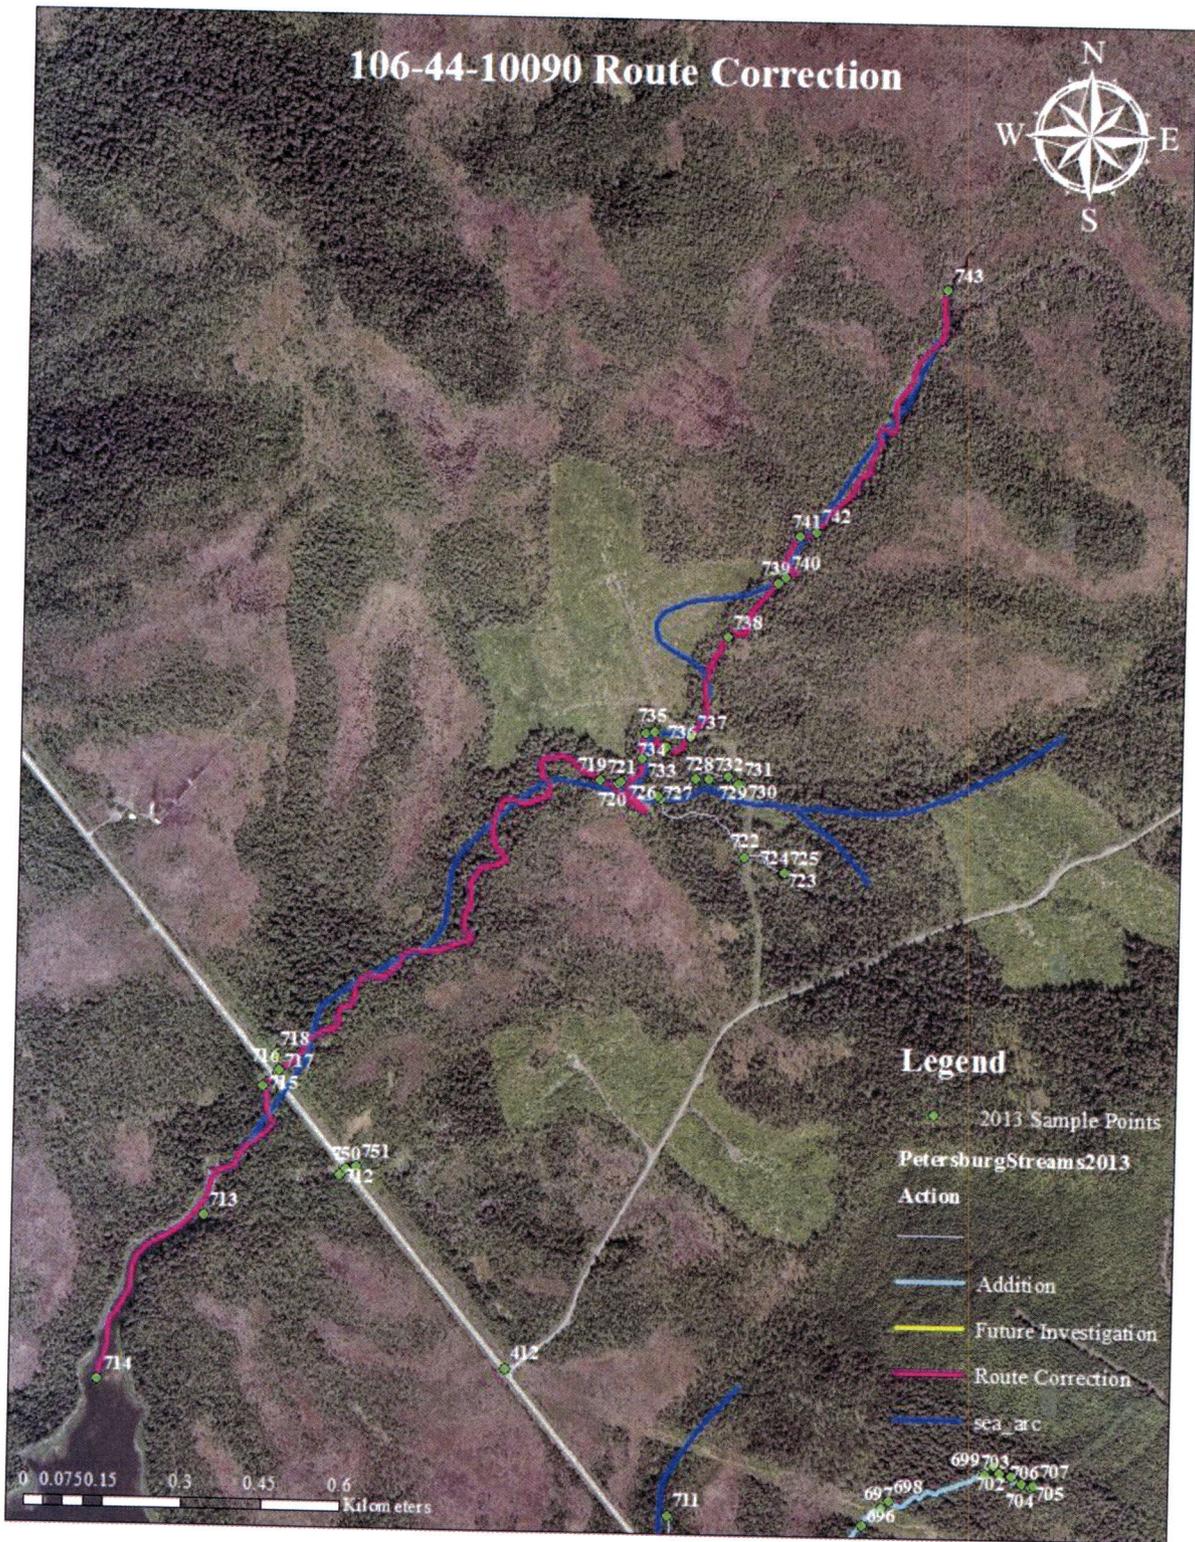
Figure 1. 106-44-10090 Route Correction map.

Findings: This stream's route differs from that illustrated in the AWC.

Recommendations: Update this stream's course to reflect its sinuosity in the AWC.
