Fish Survey
Nomination Form
Anadromous Waters Catalog

Anadromous Waters Catalog Number of Waterway: 106-44-10038

Site Information Survey: SEA14MIT69 Date Observed: 06/21/2014 Legal Desc.: C059S079E26
Site: 10203294

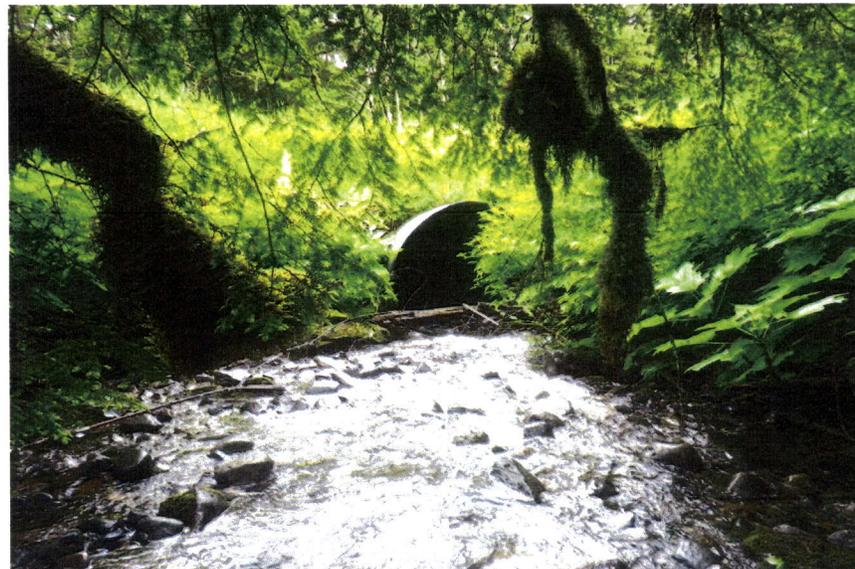
IMGP9744.JPG
Inlet

Additional Comments: This information was collected as part of the ADF&G Fish Passage Project. This nomination supports the addition for presence of dolly varden char in AWC Stream #106-44-10038 on the north end of Mitkof Island. Debris jam at inlet. Possibly manmade log weir 175' upstream. Upstream is steeper than downstream. Upstream is a cascade-pool system while downstream is riffle-pool.

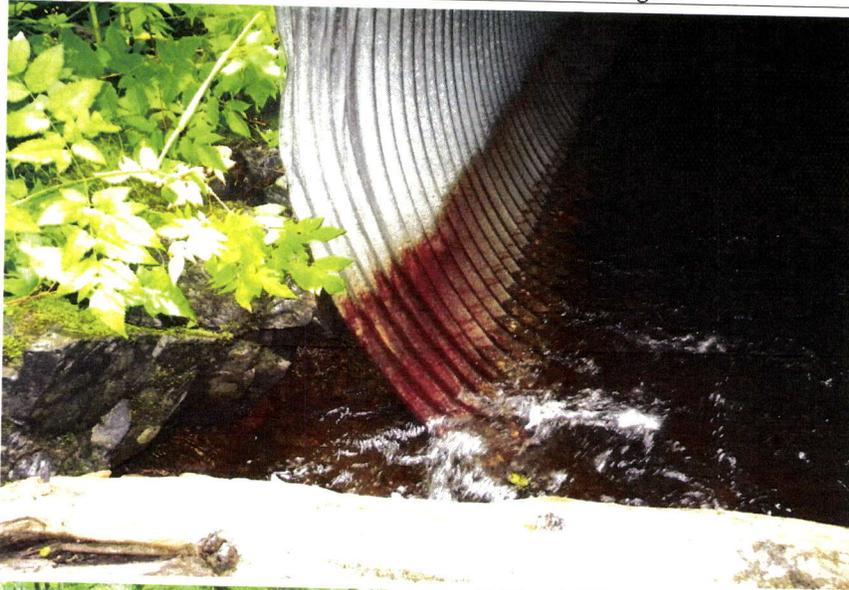
IMGP9751.JPG
Rustline

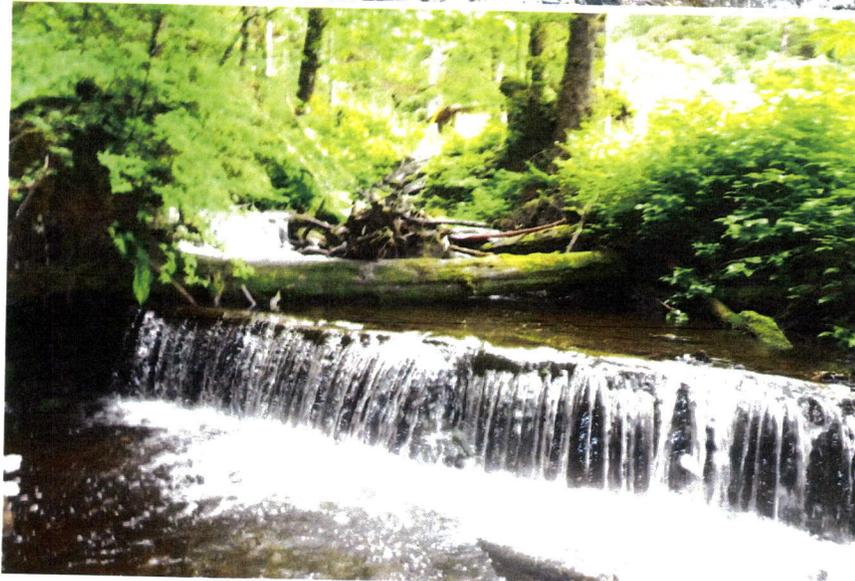
IMGP9753.JPG
Upstream about 200 feet log
wier

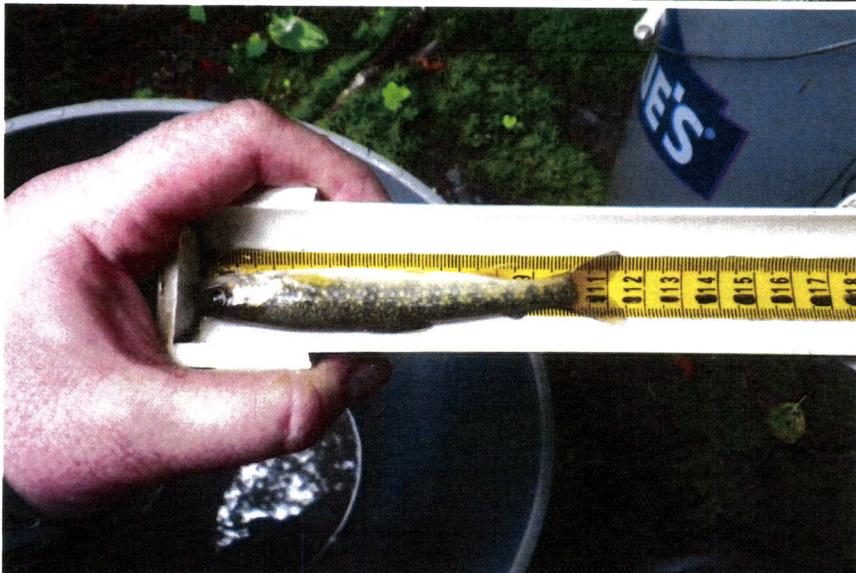
IMGP9775.JPG
Downstream Dolly Varden
