State of Alaska
Department of Fish and Game
Division of Sport Fish

Fish Survey
Nomination Form
Anadromous Waters Catalog

Anadromous Waters Catalog Number of Waterway: 106-44-10072

Name of Waterway: Luna Creek

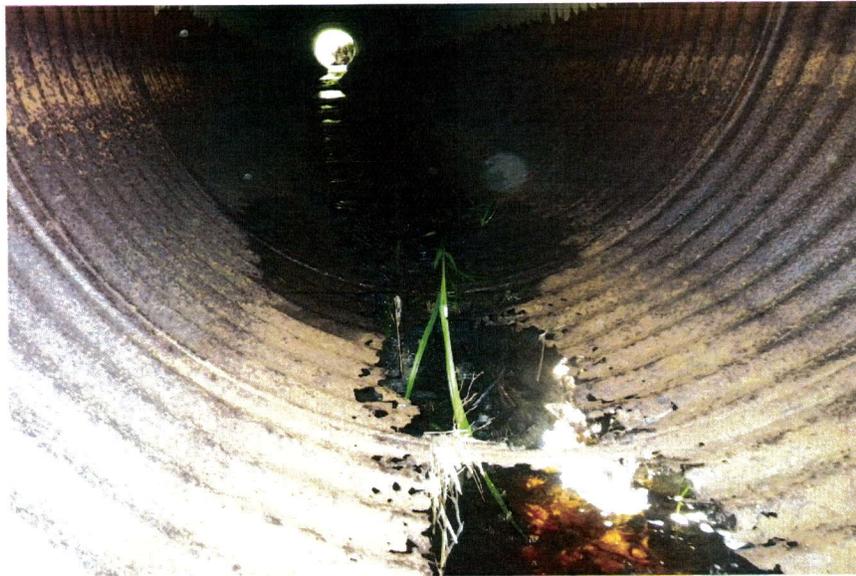
IMGP9481.JPG
Damage in outlet

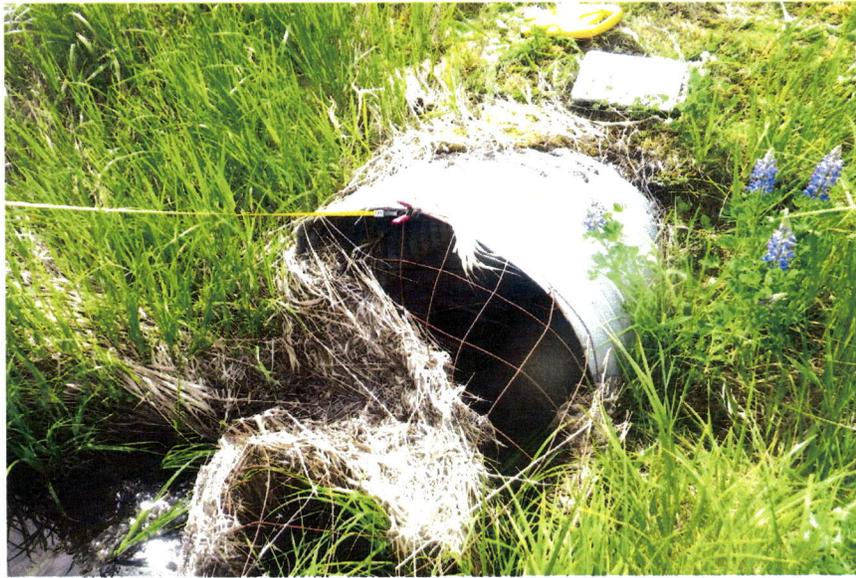
Additional Comments: This information was collected as part of ADF&G's Fish Passage Assessment project. This nomination provides back up information for AWC Stream #106-44-10072, Luna Creek for the presence and rearing of juvenile coho salmon. Beaver grate at inlet and extensive evidence of beaver activity both up and downstream. One coho trapped, others observed downstream.

IMGP9489.JPG
Inlet
