Anadromous Water Catalog Volume Southeast Region 1

USGS Quad Craig D-4

Name of Waterway S. Fork of Starkey Creek tributary

Anadromous Water Catalog Number of Waterway
103-90-10310-2018-3005

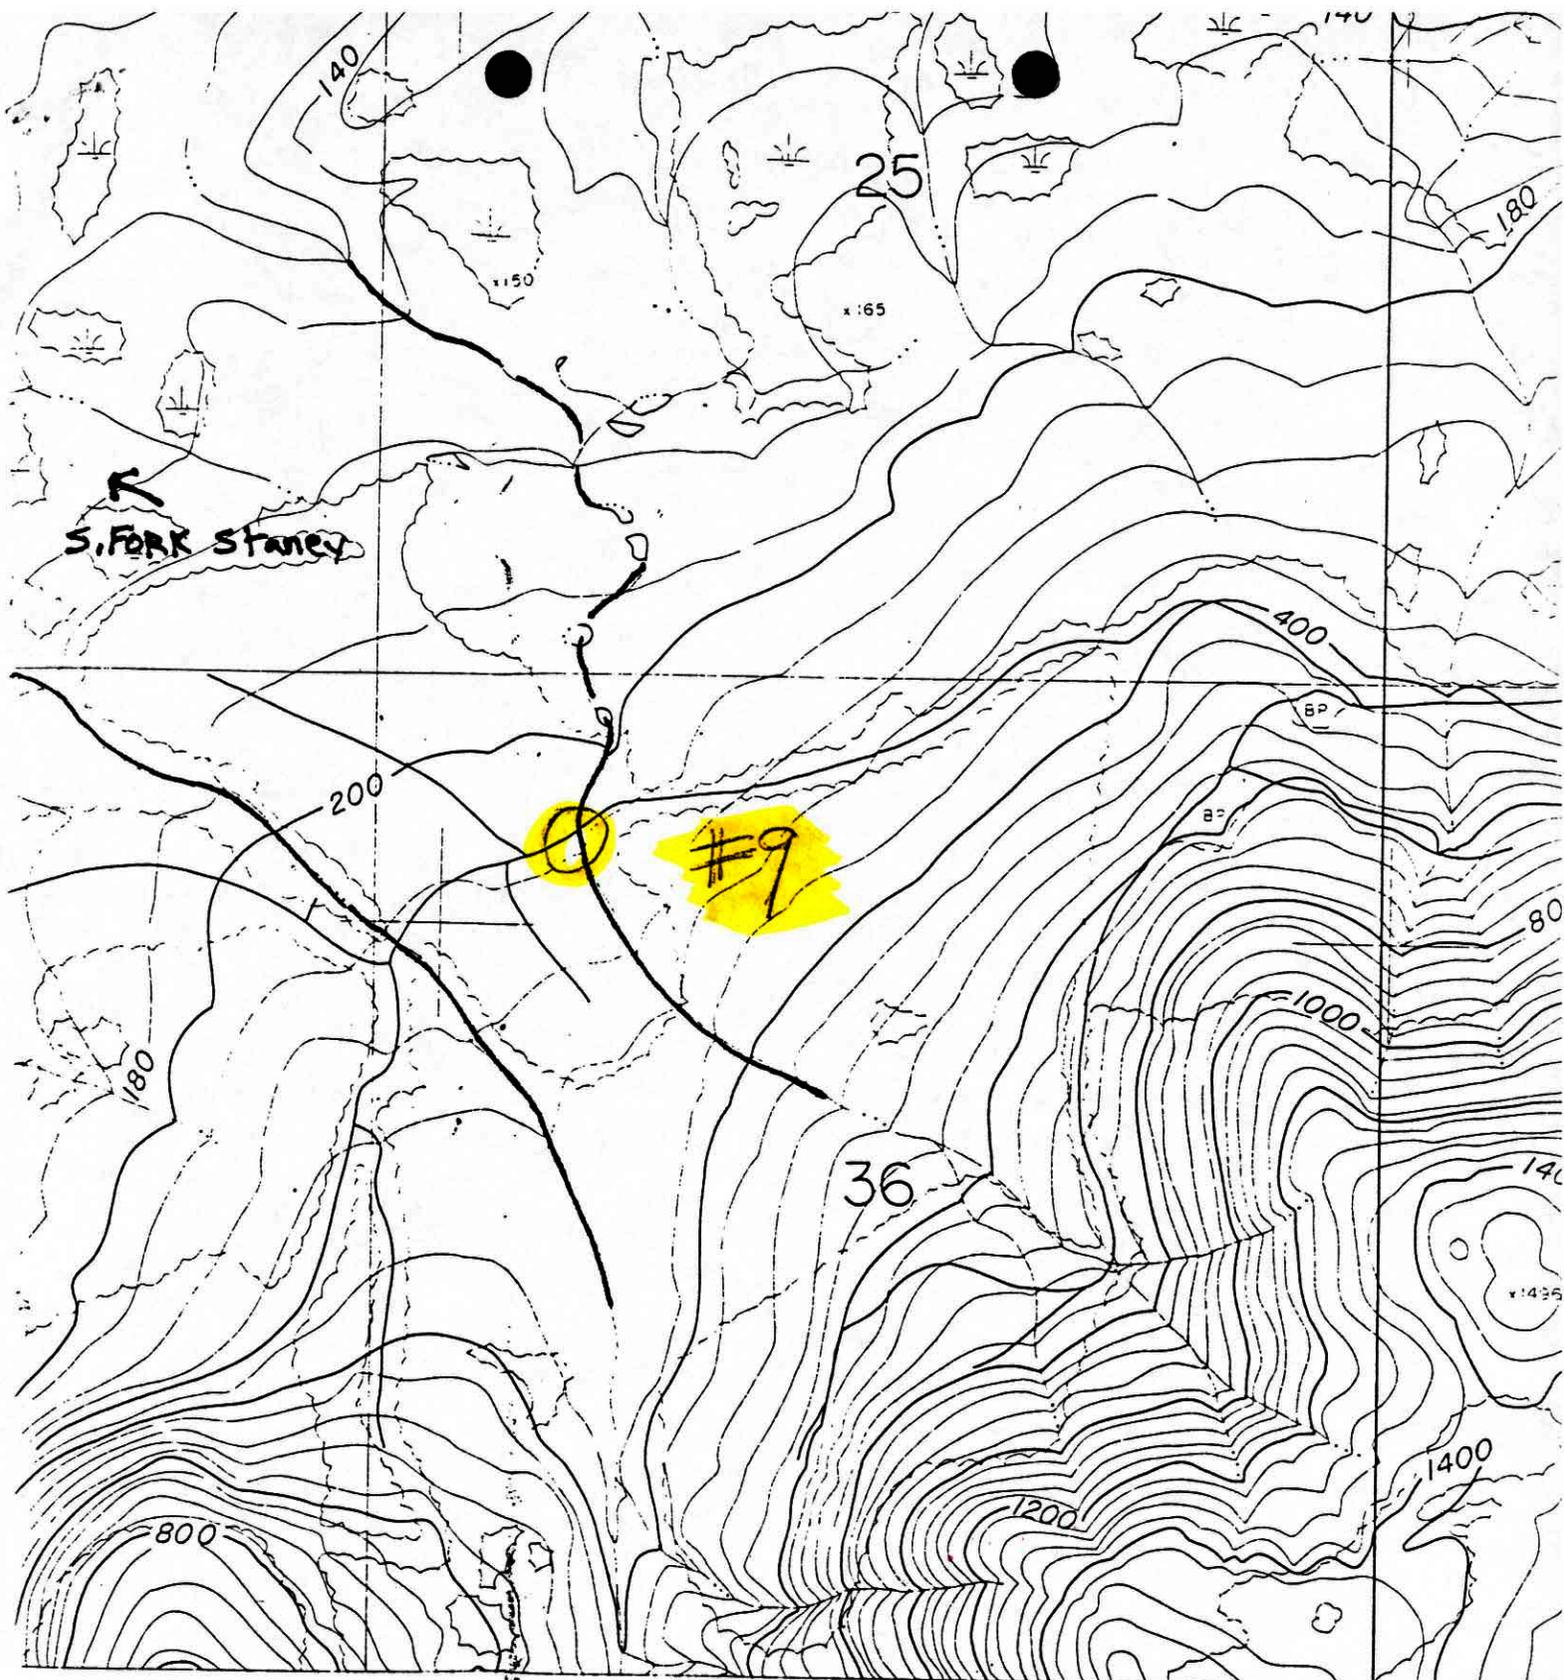
- 2- A 36" cmp, provides partial fish passage. Culvert outlet has a 6" drop-off. Coho salmon stream. Recommend a 48" cmp with armoured outlet pool. Pool development with boulders might mitigate scouring.

- 1- A 48" cmp, does not pass fish. Culvert outlet has a three foot drop-off. Anadromous cutts, dollies. Need to replace existing pipe with a 60" cmp with rip-rap armoured outlet.

- 1- A 48" cmp, was not bedded to pass fish, culvert outlet has a 3' drop. Coho salmon stream. Need to replace the existing pipe with a 60" cmp, with rip-rap armoured outlet pool.

Culvert is failing, and the road is washing out.

- 1- A 48" cmp, does not pass fish. Culvert outlet has a 2' drop-off. Anadromous dollies, cutts. Remove culvert (road is closed at mp 7.35 at old bridge site), or replace with a 60" or 72" with a rip-rap armoured outlet pool.

- 2- A 24" cmp, does not pass fish. Has a 16" drop at the outlet. Will need a new culvert, recommend a 36" cmp. Anadromous dollies, cutts. Upstream habitat is marginal.

- 1- A 36" cmp, culvert inlet is covered over by a large gravel deposit. The streamcourse was diverted down the road, and has washed the road surface for 50-60 feet. Coho salmon stream. Culvert should be replaced with a 60" or 72" cmp, with large rip-rap pool at the outlet.

An 18" cmp has failed and road is washing out. Not a fish stream.

- 1- A 48" cmp, does not pass fish. Culvert outlet has scoured down to a 2' drop-off. Coho salmon stream. Need to replace existing pipe with a 72" cmp, with a rip-rap armoured outlet pool.
