State of Alaska
 Department of Fish and Game
 Nomination for Waters
 Important to Anadromous Fish

Anadromous Water Catalog Volume Southeast Region 1
 USGS Quad Craig C-3
 Name of Waterway Thome River Tributary
 Anadromous Water Catalog Number of Waterway
102-70-10580-2017-3010-4006

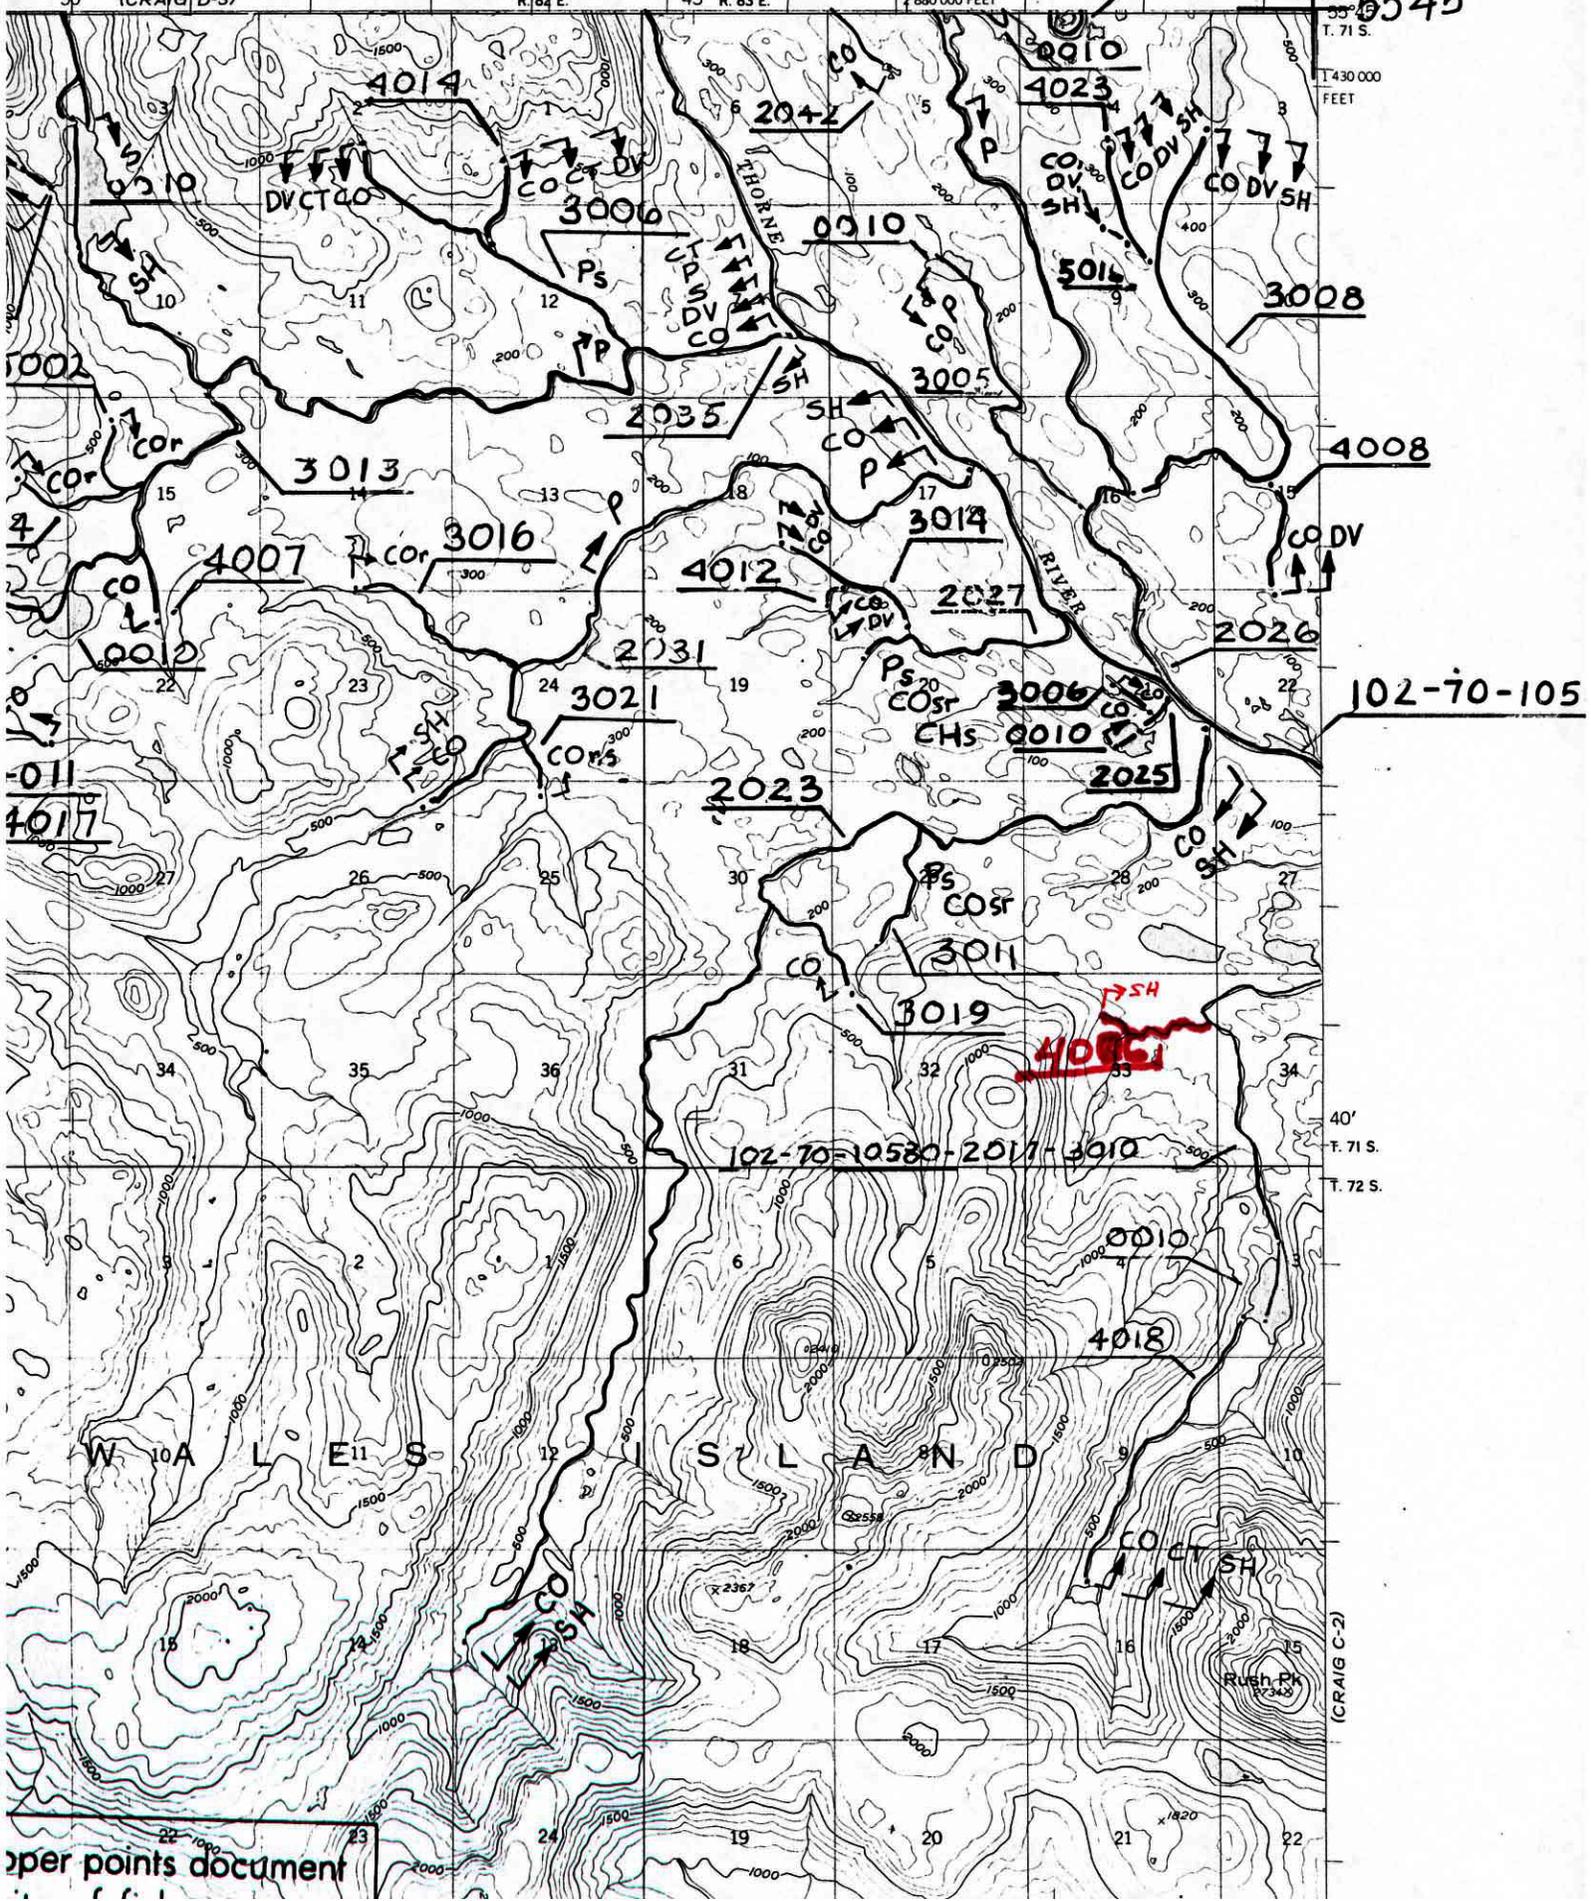
Comments: Provide any clarifying information, including number of fish observed, location of fish survey data, etc.
Presence of steelhead confirmed by USFS fishery biologist Vince Harkay in conjunction with culvert replacement project

2 A 72" arch cmp, provides partial fish passage. Culvert outlet has scoured down to a 1' drop. Major coho stream. May be able to mitigate scouring by developing the outlet pool. Culvert should be pulled after logging has been completed on this road system.

A 36" cmp, provides partial fish passage. Culvert outlet has a 6" drop-off. Could develop a pool with boulder rip-rap.

A 24" cmp, does not pass fish. Culvert outlet has a 1' drop-off. Inlet is crushed, and culvert is failing, washing out the road. Marginal fish stream, goes dry in the summer. Replace existing cmp with a new pipe, bedded to pass fish.

A 36" cmp, does not pass fish. Culvert outlet has a 1' drop-off. Coho rearing stream. Need to replace existing pipe with a 48" or 60" cmp, bedded to pass fish.

A 36" cmp, provides partial fish passage. Culvert outlet has a 6" drop-off. Culvert has developed a major scour pool below the outlet. Could use a 60" cmp. Coho salmon stream.

A 36" cmp, does not pass fish. Culvert outlet has a 10" drop-off. Coho salmon stream. Need to remove or replace culvert. This pipe was not properly bedded to pass fish.

A 120" arch cmp, does not pass fish. Major stream, very steep gradient(8%+). Resident fish stream. May be able to mitigate with outlet pool development. Site probably needs a bridge or similar structure to maintain longterm fish passage.
