# MEMORANDUM

Department of Fish and Game  
Division of Habitat

SUBJECT: Vanderbilt Creek Tributaries  
Trip Report

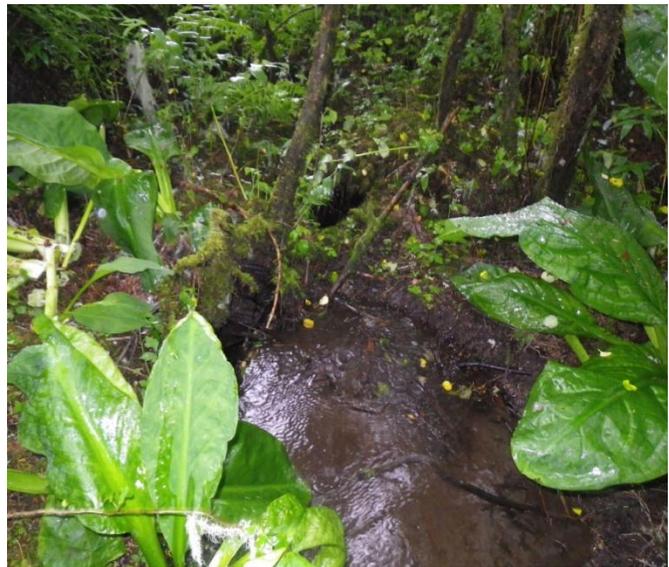
On October 27<sup>th</sup> 2011 we tracked and trapped the main inlet to the pond. The inlet stream goes subterranean upstream about 100 feet from the pond creating a barrier to fish migration (Figure 2). We tracked and trapped a drainage ditch which collects runoff from behind the church and drains into the pond (Figure 3). The outlet of the pond is located at the entrance of church parking lot and the back left corner of the Dragon Inn. The Pond drains through a 36' crushed culvert and meets a small tributary creek which originates uphill of the Dragon Inn (Figure 4). The creek immediately passes through another 36' culvert and drains into Vanderbilt Creek (Figure 5). We set traps in the pond, at outlet of the pond, and behind the Dragon Inn. We tracked and trapped the drainage ditch (Figure 6). We were not able to set traps right next to the road due to low flow, but continued up stream and set traps where it veers right into a residential neighborhood (Figure 7).

Figure 2. Pond inlet above subterranean section

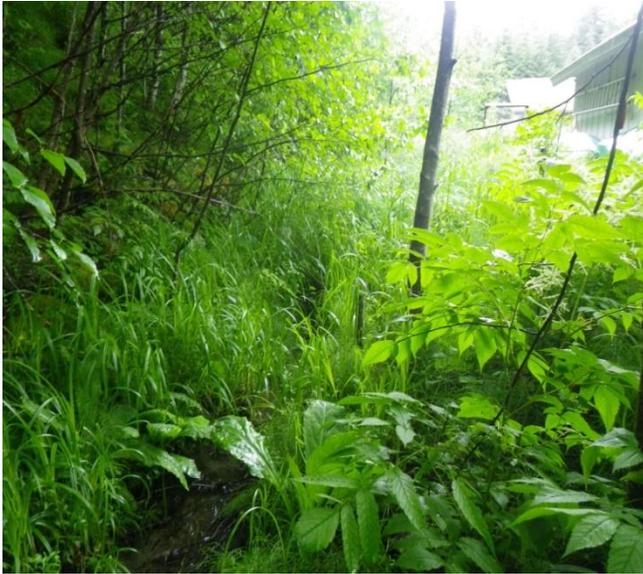
Figure 3. Drainage ditch behind church

We will continue to investigate the drainage ditch behind the church as anadromous fish habitat, as there is no barrier that would prevent fish use. The small creek behind the Dragon Inn adjacent to the church contains a small amount of spawning habitat, as you claim you documented. The ADOT&PF ditch that extends along the roadside and into the residential area does not provide fish habitat. See Figure 11 for an area map.

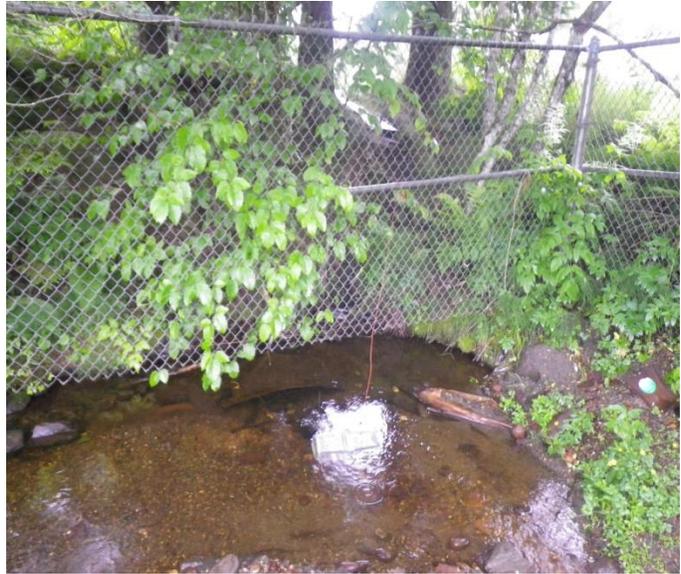
Figure 4. Pond outlet and crushed culvert

The pond provides excellent rearing and overwintering habitat for coho salmon and Dolly Varden char. The presence of larger individuals indicates that this pond is used for more than a year. We recommend that the pond, inlet, and outlet be added to the Anadromous Water Catalog and will submit a nomination. The culvert under the entrance to church must be replaced. We will cc: ADOT&PF so they are aware of a mitigation opportunity. We will cc: the CBJ and ask that they investigate land ownership and the responsibility of the landowner to maintain fish passage.

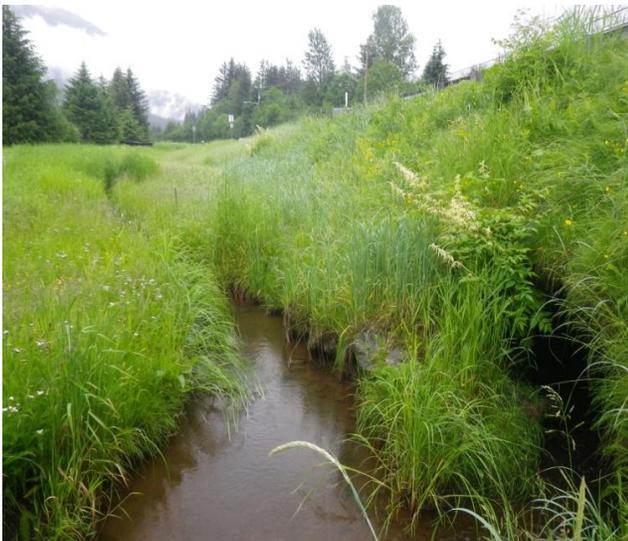
Figure 5. Culvert draining into Vanderbilt Creek

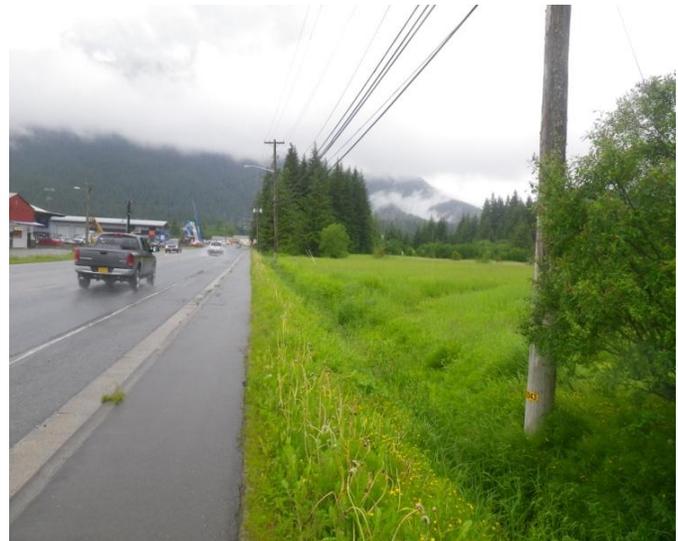
Figure 6. DOT drainage ditch

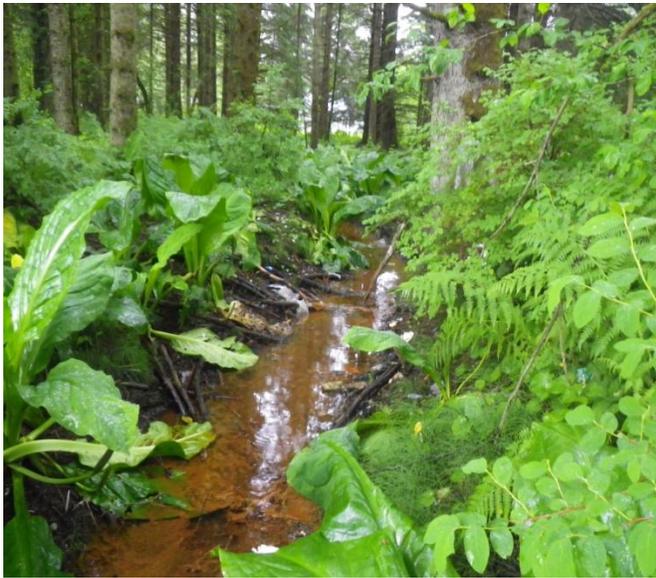
Figure 7. Drainage ditch in residential area

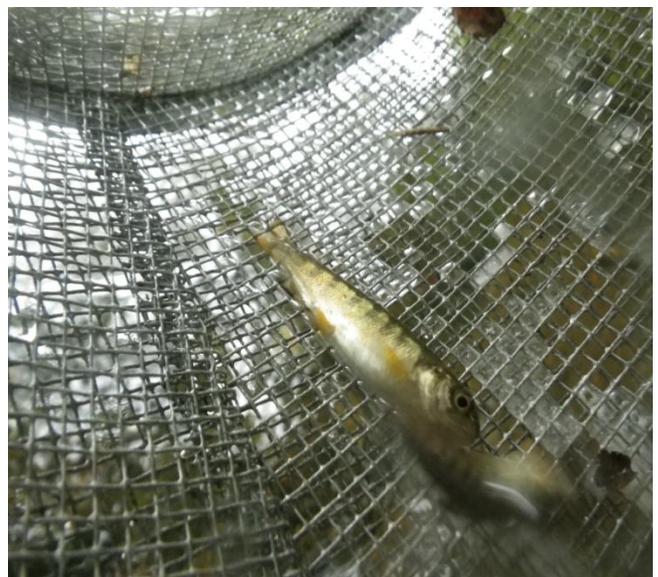
On June 1<sup>st</sup> 2012 we returned to the drainage ditch behind the church for a follow up investigation for AWC cataloging purposes. We electrofished the ditch and captured a total of 15 Dolly Varden char. We also noticed young of the year coho trying to enter the outlet of the crushed culvert to the pond (Figure 10).

Figure 10. Coho from the pond outlet
