EAST CREEK**CORRECTION****Water body name:** East Creek**Survey date:** 10/21/2013**Water body number:** 111-40-10060**Species & Lifestage:** COr**Watershed:** Mendenhall River-Frontal Gastineau Channel**MTR:** C040S066E **Quad:** Juneau B-2

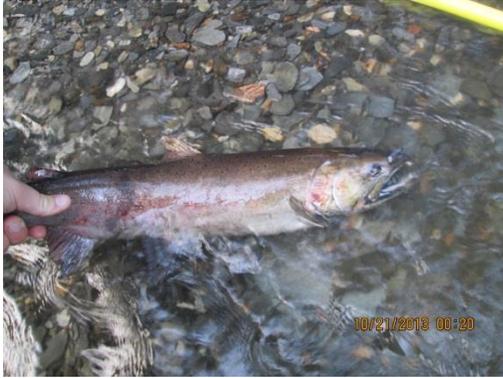
Findings: I surveyed East Creek over the course of two days using an electrofisher unit and a GPS (Table 1). I captured a rearing coho salmon and Dolly Varden char with an electrofisher and an adult coho salmon with a hand net (Figure 1). There is a culvert under Schneider Drive in Switzer Village that is a barrier to fish passage (Figure 2). I ended the survey because only capturing resident fish beyond culvert in Switzer Village.

Figure 1.—Adult female coho salmon.

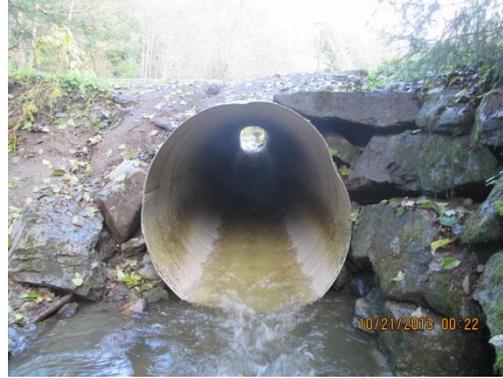
Figure 2.—Outlet of Schneider Drive culvert.

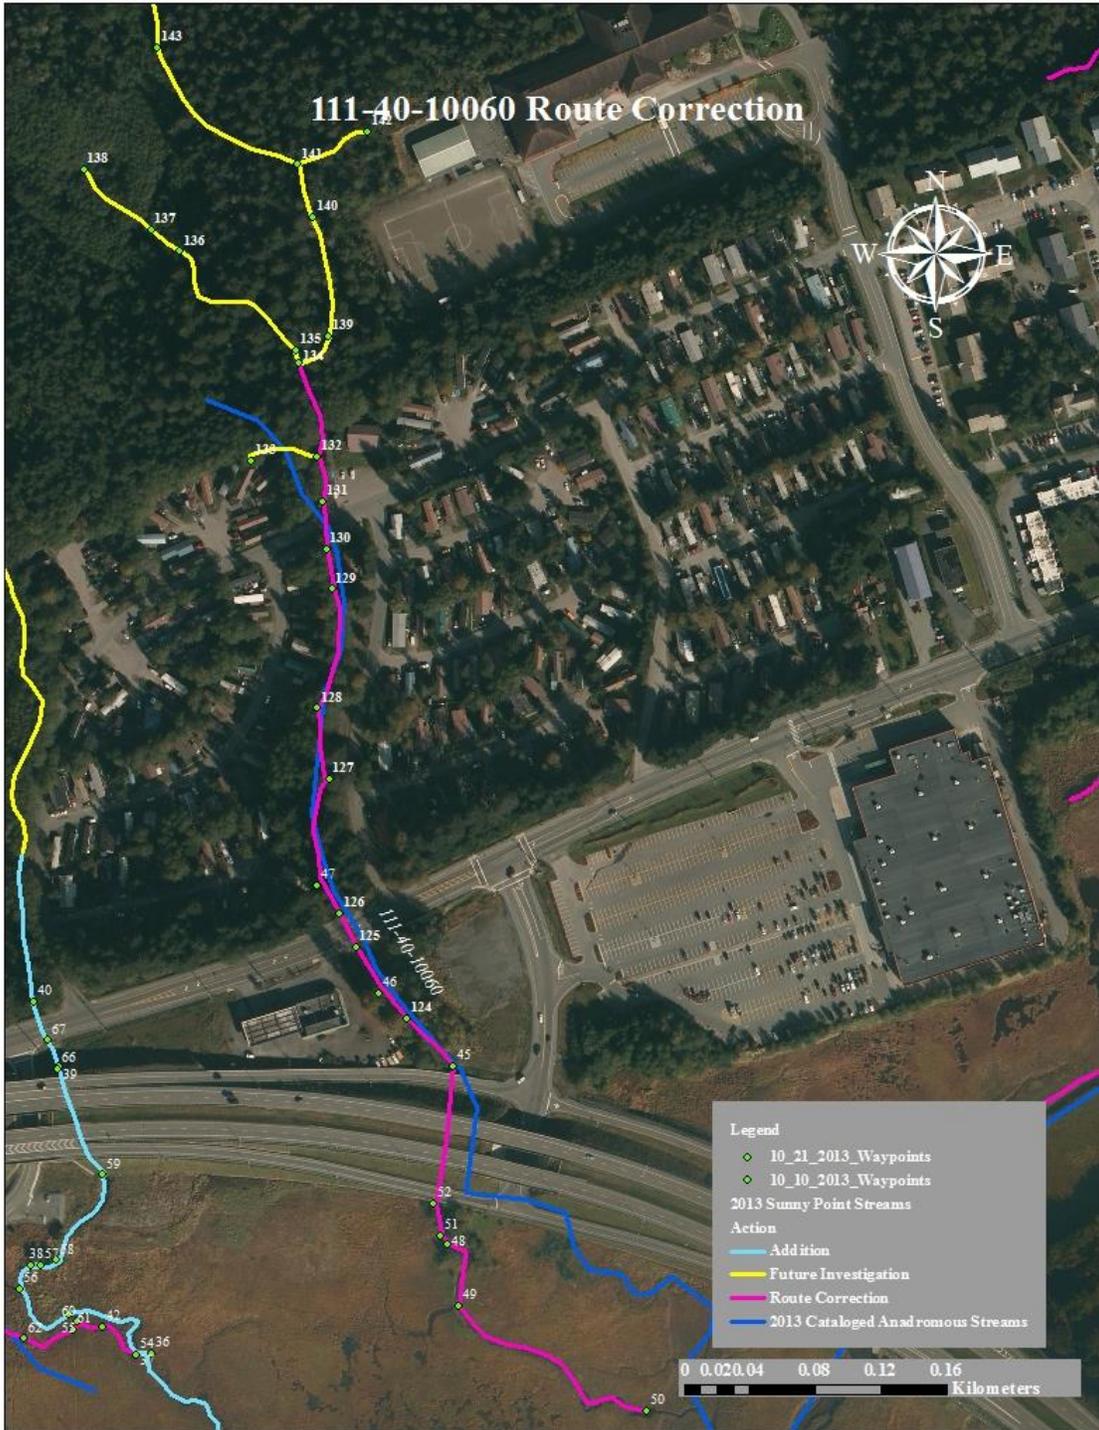
Figure 3.—111-40-10060 route correction map.

Recommendations: Correct the route that is in AWC.
