111-50-10750-2033**CORRECTION****Water body name:****Survey date:** 10/7/2013**Water body number:** 111-50-10750-2033**Species & Lifestage:** COsr, Ps, CTp, DVp**Watershed:** Admiralty Island-Frontal Lynn Canal**MTR:** C041S066E **Quad:** Juneau B-2

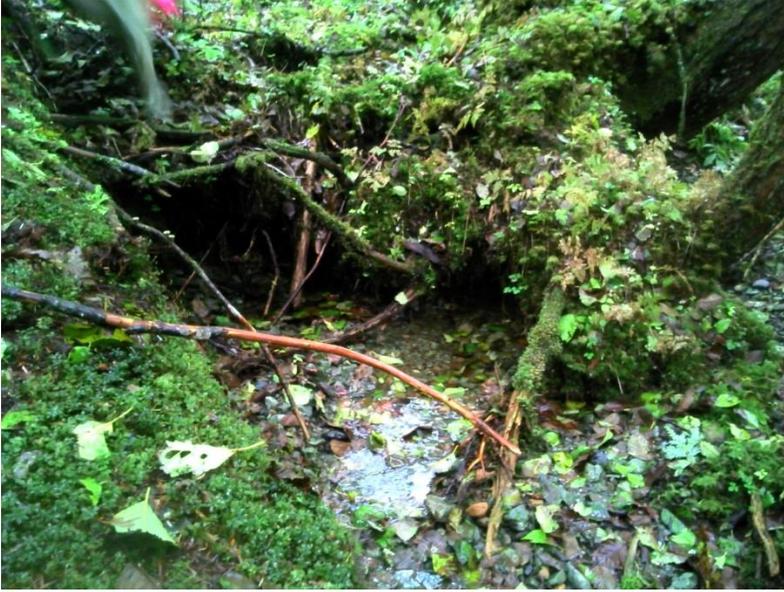
Findings: We surveyed stream 111-50-10750-2033 and caught coho salmon, Dolly Varden char, and cutthroat trout using an electrofishing unit (Table 1). During our survey we also visually identified an adult coho salmon and a female pink salmon. We ended the survey because water was seeping out of gravel and clay substrate on hillside.

Figure 1.-Water seeping out of gravel and clay substrate.
