111-50-10100-2035 TRIBUTARY**ADDITION****Water body name:****Survey date:** 1/28/2014**Water body number:****Species & Lifestage:****Watershed:** Admiralty Island-Frontal Lynn Canal**MTR:** C039S064E **Quad:** Juneau B-3

Table 1.–111-50-10100-2035 Tributary survey data.

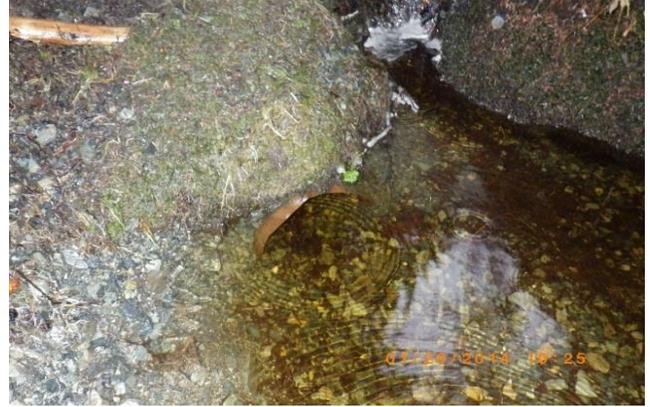
Findings: We survey a tributary to Stream No. 111-50-10100-2035, which passes through a 12” culvert under the road to the Saga Eagle Valley Center (Table 1). We electrofished and caught three juvenile coho salmon (*Oncorhynchus kisutch*, Figure 1) below the culvert (Figure 2). There was too much ice to effectively electrofish upstream of the culvert. It appeared there was little low through the upstream side of the culvert due to it being crushed or filled with debris. We tracked the stream down to the confluence with Stream No. 111-50-10100-2035 (Figures 3 and 4).

Figure 2.—Outlet of culvert where coho salmon were caught.

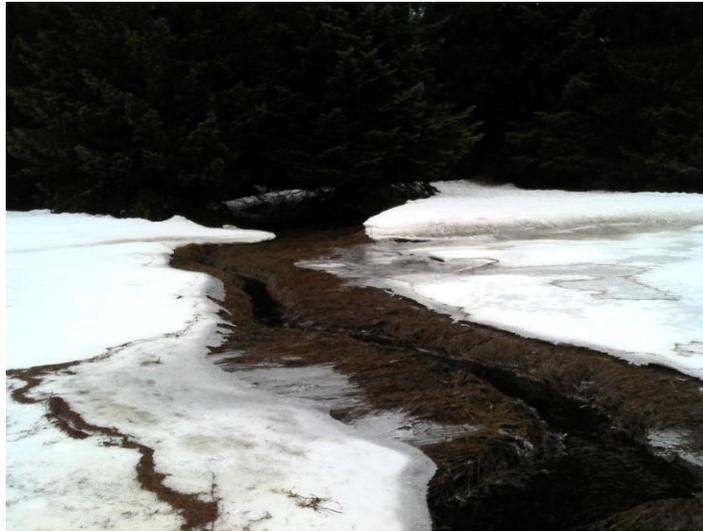
Figure 3.— Outlet of tributary into Stream No. 111-50-10100-2035
