111-50-10350 (AUKE NU CREEK)**CORRECTION****Water body name:** Auke Nu Creek**Survey date:** 3/12/2015**Water body number:** 111-50-10350**Species & Lifestage:** Ps**Watershed:** Admiralty Island-Frontal Lynn Canal**MTR:** C040S065E **Quad:** Juneau B-2

Table 1.-111-50-10350 survey data.

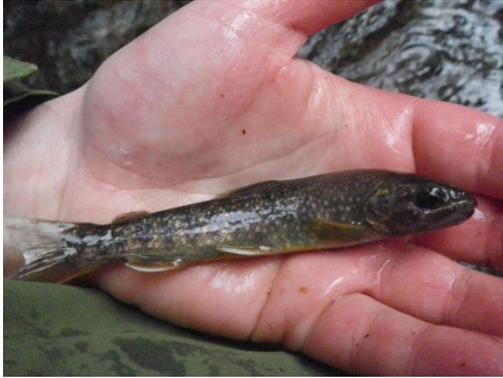
Figure 1.—Captured Dolly Varden char.

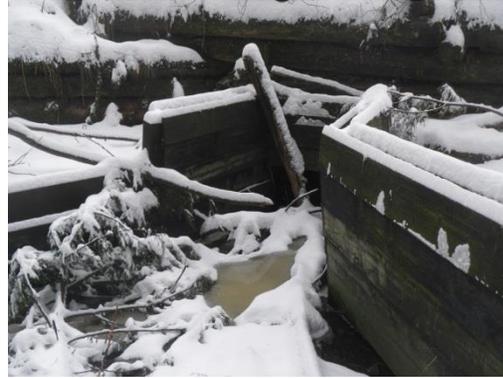
Figure 2.—Inlet of Glacier Highway culvert.

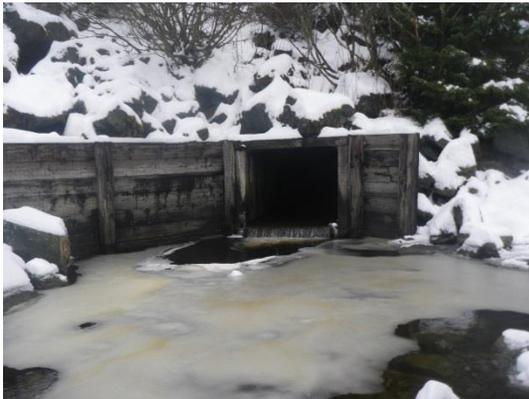
Figure 3.—Outlet of Glacier Highway culvert into Auke Bay.

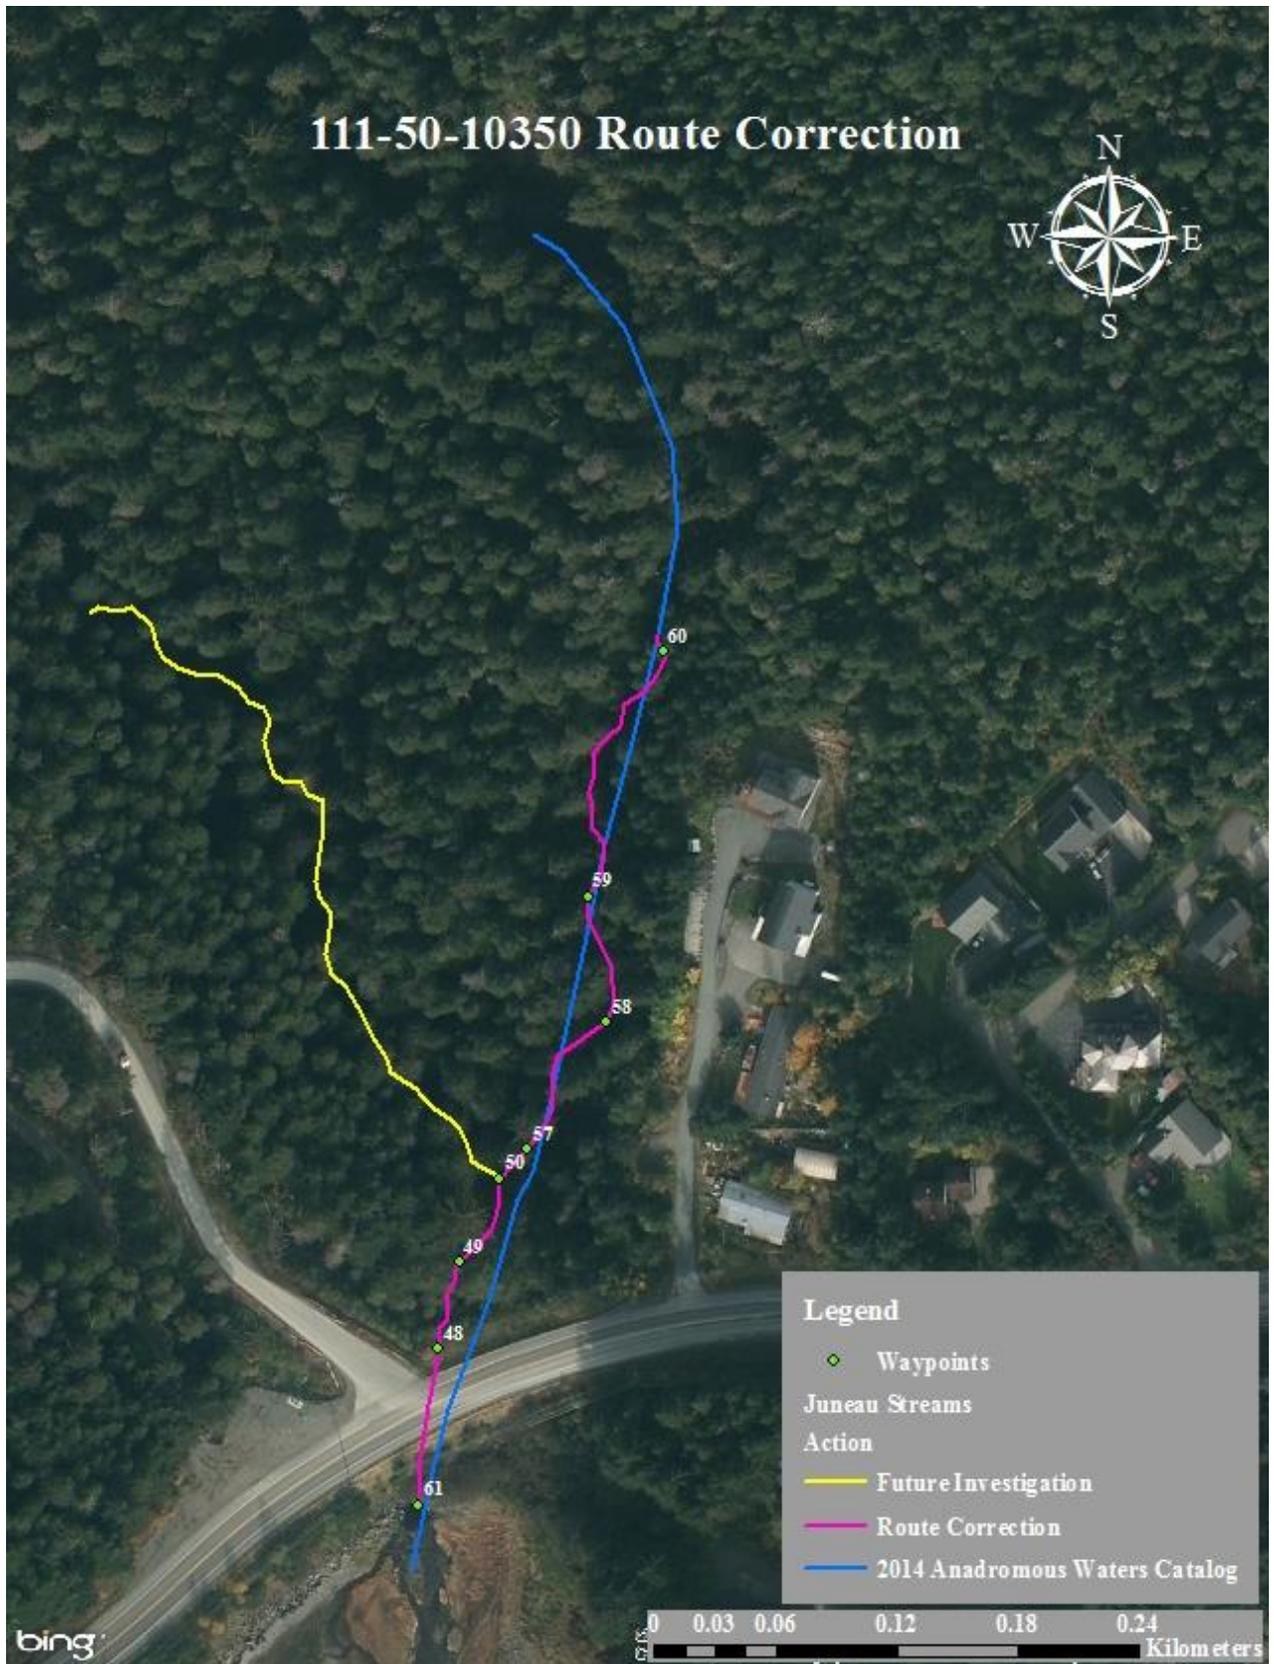
Figure 4.-111-50-10350 route correction map.

Recommendations: Correct the current route in the Anadromous Waters Catalog.
