114-31-10080-2003 SHOTTER CREEK**CORRECTION****Water body name:** Shotter Creek**Survey date:** 7/9/2015**Water body number:** 114-31-10080-2003**Species & Lifestage:** COsr**Watershed:** Port Fredrick-Frontal Icy Strait**MTR:** C043S061E **Quad:** Juneau A-5

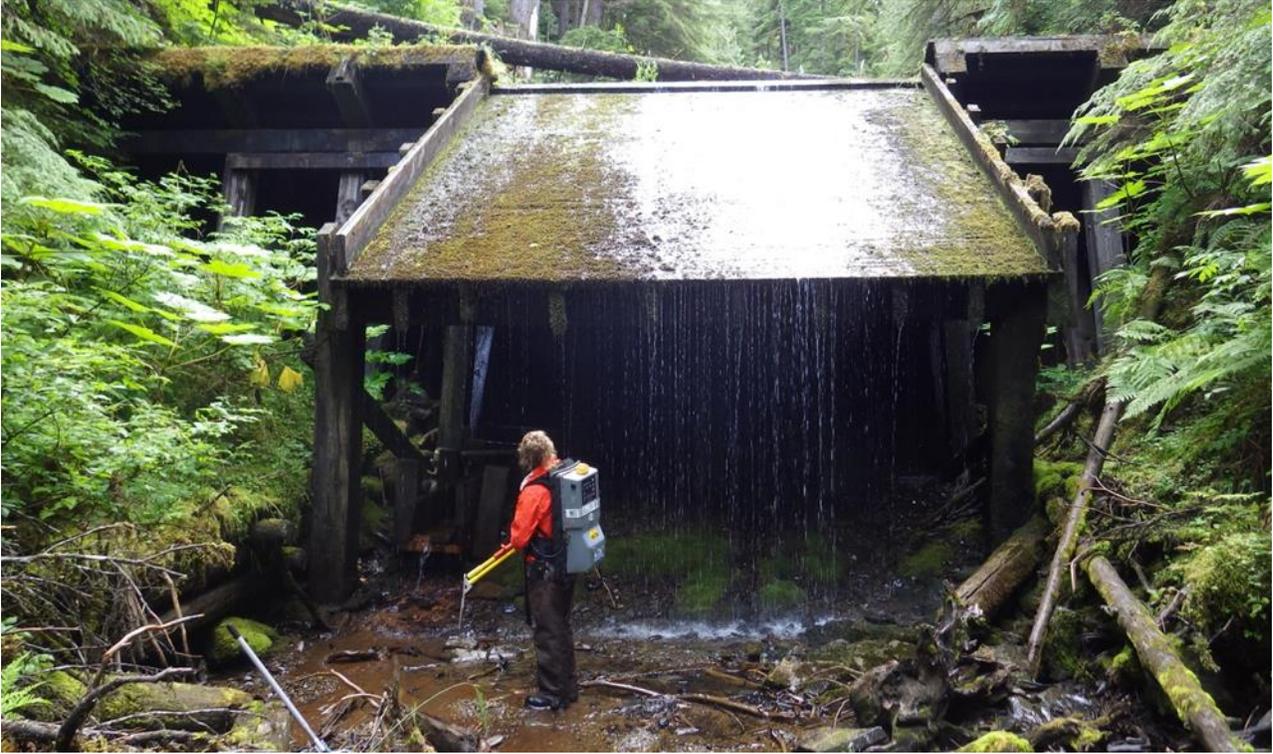
Findings: We sampled Shotter Creek using an electrofisher and a GPS (Table 1). We captured coho salmon, cutthroat trout, and Dolly Varden char. The upper extent of fish use is at an old 3-4 m high dam and spillway spanning across the creek (Figure 1). Sediment filled in the area upstream of the dam and there was a small amount of water overtopping the spillway. We did not walk upstream of the dam, but from what we could see the stream was dry (Figure 2). Shotter Creek used to be the primary water source for Hoonah up until the late 1980's.

Figure 1.-Tess Quinn below the spillway.

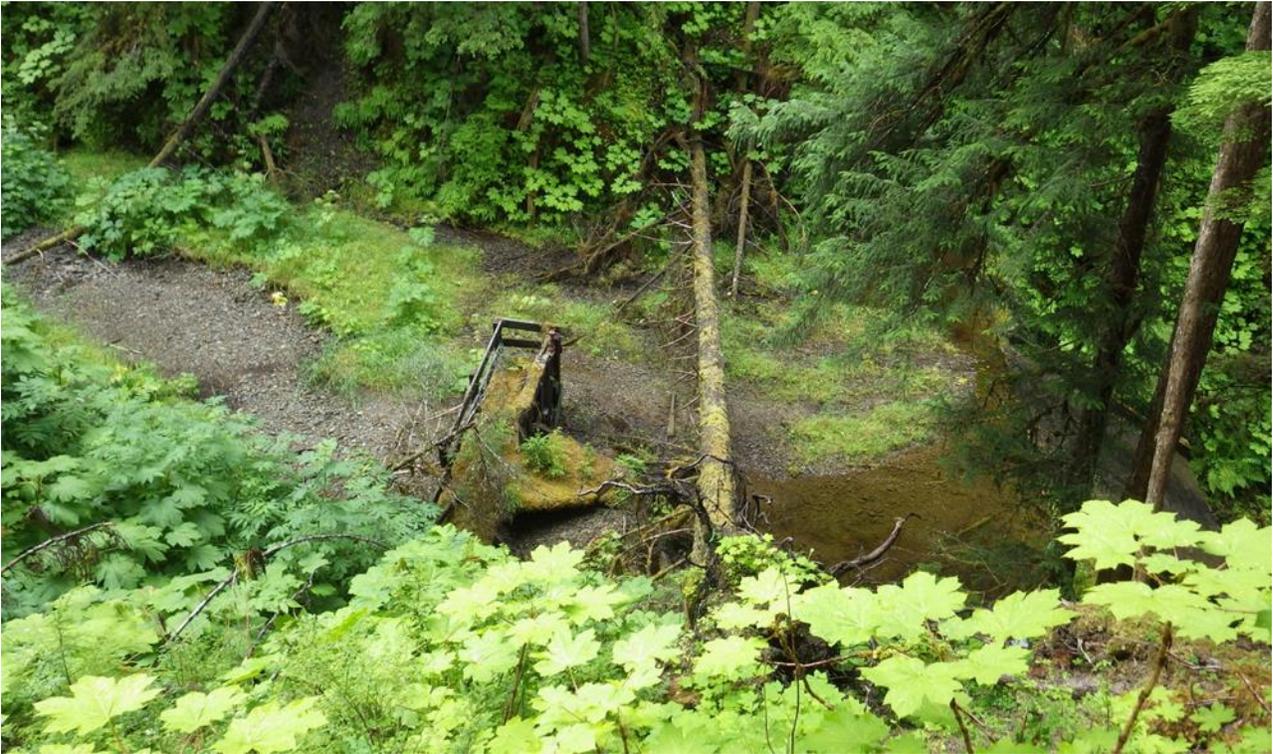
Figure 2.- Looking down at Shotter Creek immediately upstream of the dam.
