101-23-23

5-19-76

R.Larson, Jackinsky

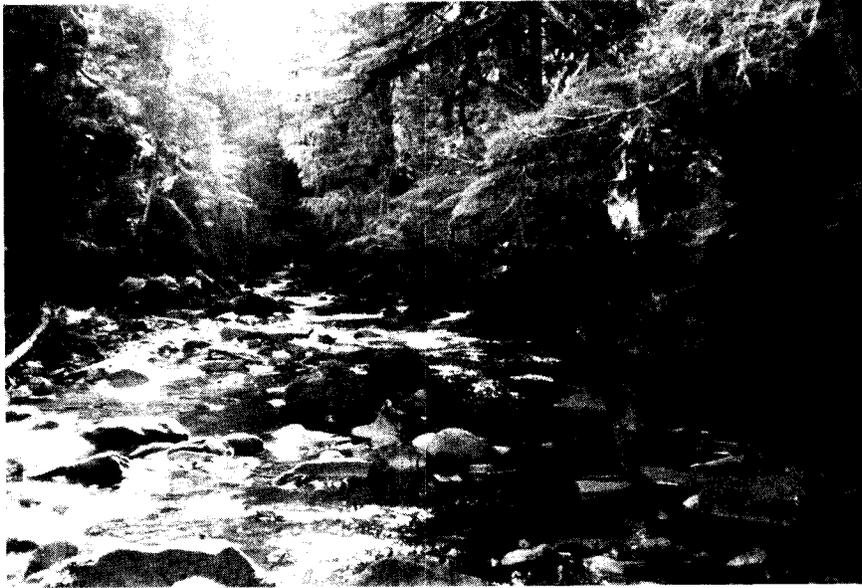
101-23-26.
Station #1. Look-
ing upstream.

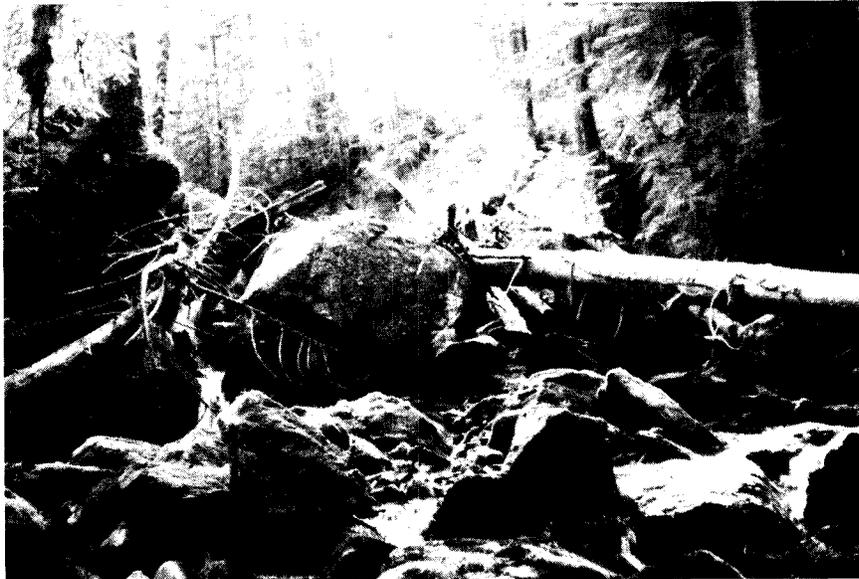
101-23-26.
Barrier falls.

Gorge continues, mostly bedrock streambed, very steep gradient.

Distance about 1 mile to this point.
