Dog Salmon Creek (102-60-038)Date: 7/16/82FISHERIES REHABILITATION AND/OR ENHANCEMENT
NEW PROJECT OPPORTUNITY FORM*

POTENTIAL FISHWAY VERIFICATION FORM

**FEASIBILITY ANALYSIS FOR THE
DOG SALMON FALLS FISH PASSAGE FACILITY**

Dog Salmon Creek - Project Verification

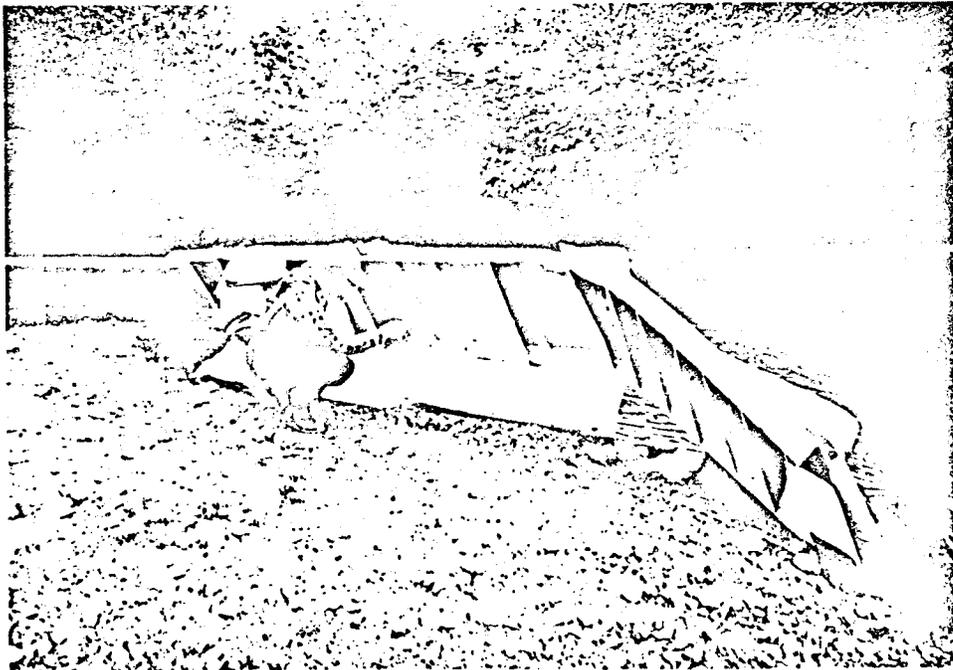
Continuous abrasion of the aluminum fishway caused by a cavitation like vibration cut through cables holding the fishway onto the bed of the channel. The fishway was subsequently carried down stream by high velocity flood flows and destroyed.

Twisted fragments of the fishway are presently strewn in and along the stream bed nearly to the mouth at salt water.

In the early 1970's, an aluminum steppass was installed by the Forest Service at the main falls in Dog Salmon Creek. This structure has subsequently been destroyed by ice and flood conditions. Many remains of this steppass were present in the lower stream.

Remains of Previous Steeppass
installed on Dog Salmon Creek

In order to re-establish a series of fishways on Dog Salmon Creek, the most feasible and structurally safe would be the excavation, by blasting a slot through the left bank rock wall. An Alaska steep pass would again be installed, however, bolted and grouted into the trough. A protective baffle, sluice gate like (figure 1), could be bolted to the rock above the intake to give protection against the onslaught of impending flood flows.
