## Nomination Form Anadromous Waters Catalog

## 112-42-10200 CORRECTION

Water body name: \*Muri Creek Survey date: 8/17/2022

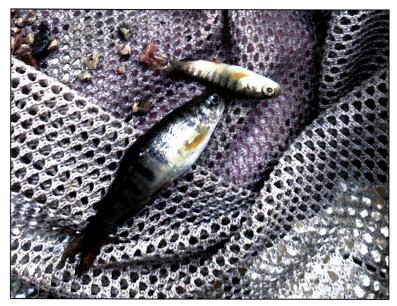
Figure 1.-Juvenile coho salmon captured at waypoint 1510.

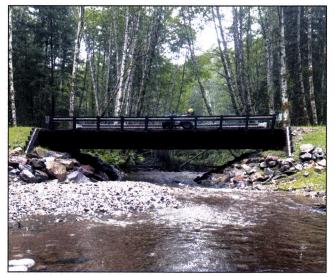
Figure 3.-Bridge at waypoint 1510.

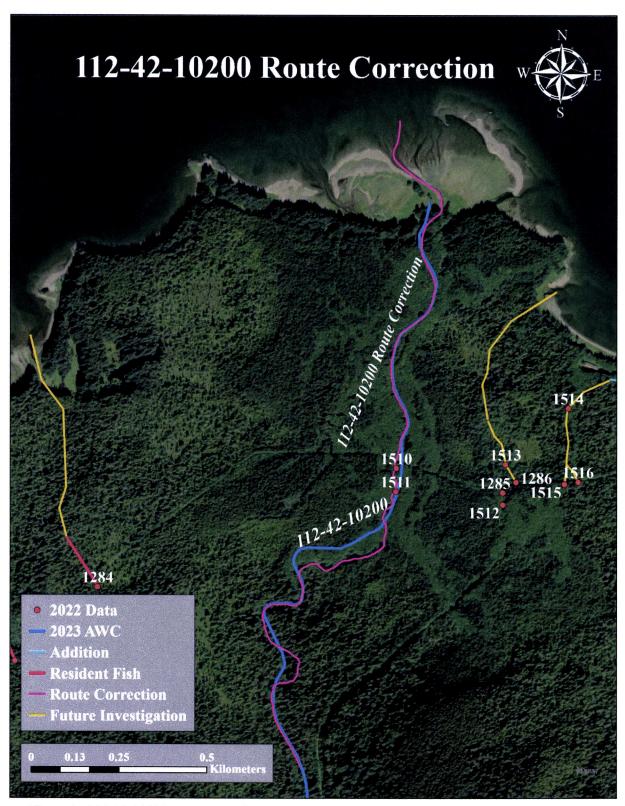
Figure 4.–112-42-10200 route correction map.

**Recommendations:** Correct Stream No. 112-42-10200 in the anadromous waters catalog to reflect the field verified stream path drawn using updated imagery and USFS data (Figure 4).
