# Alaska Department of Fish and Game

## 114-31-10130 Tributary 4

## ADDITION

**Survey date:** 6/27/2022

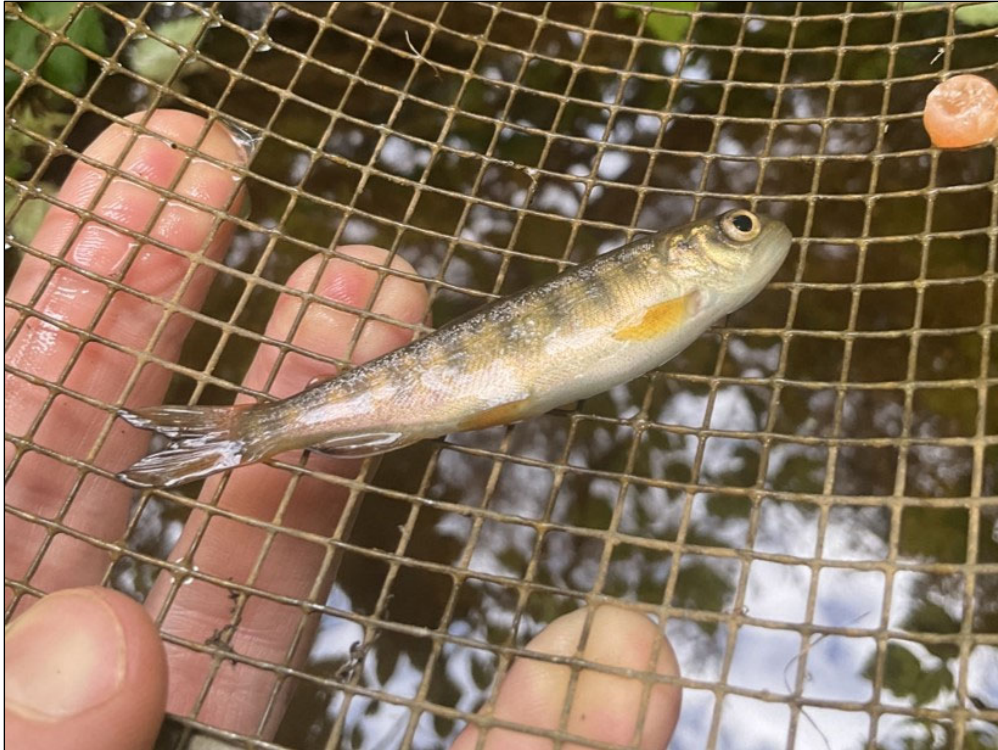
**Findings:** We surveyed this uncataloged stream using a baited minnow traps and GPS and captured juvenile coho salmon. The tributary stream was dry/disconnected just upstream of where it flows under an old bridge; however, it was actively being fed by roadside drainage from a sheer bedrock fall/chute on the downstream side of the river-right bridge abutment (Table 1; Figures 1–3).

Figure 1.—Juvenile coho salmon captured at waypoint 864.

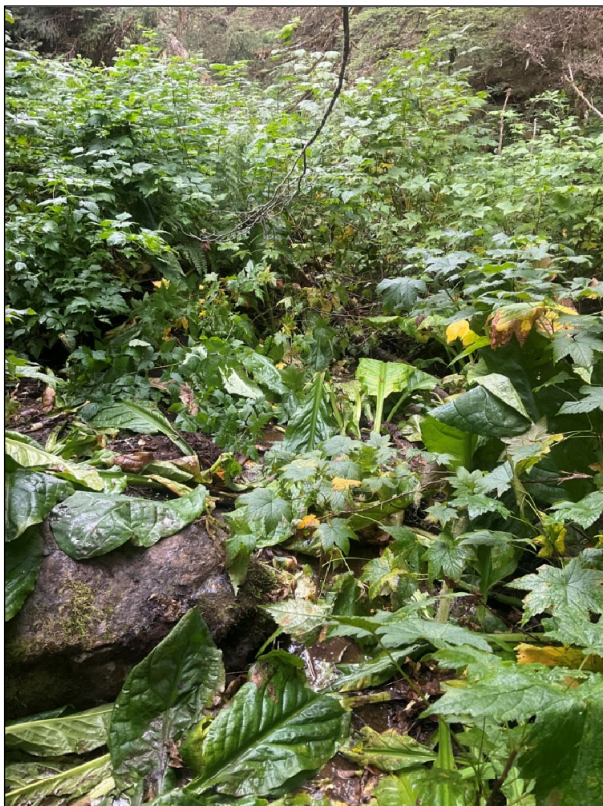
Figure 2.—Channel overgrown with skunk cabbage at waypoint 864.

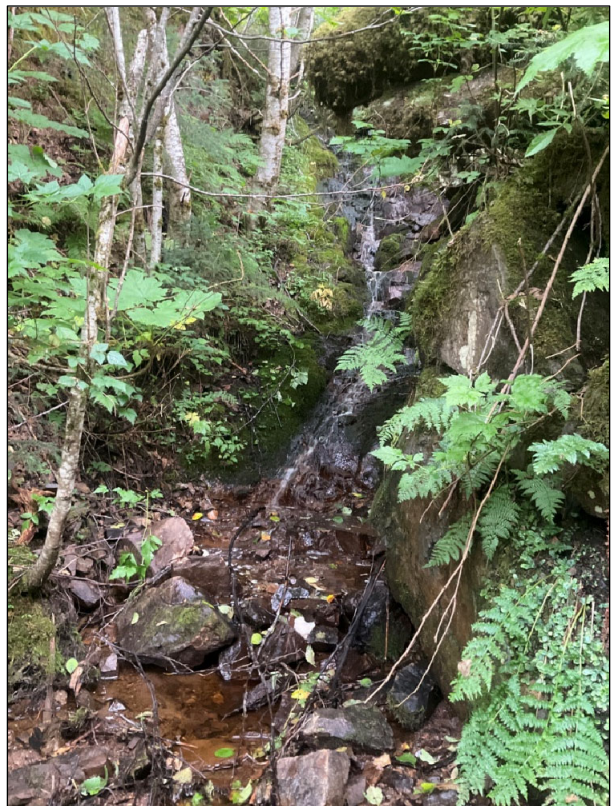
Figure 3.—Water feeding into tributary 4 from bridge-side bedrock fall/chute at waypoint 864.
