Alaska Department of Fish and Game

Habitat Section
Southeast Region

114-27-10300 Tributary 8

ADDITION

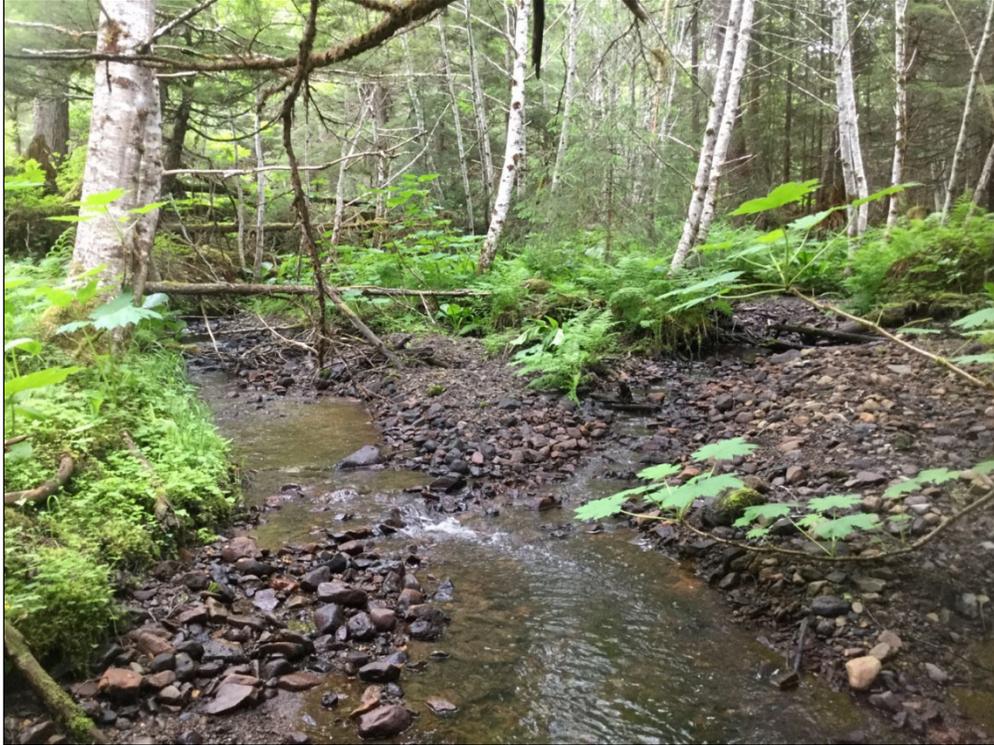
Figure 1.—Channel at waypoint 739.

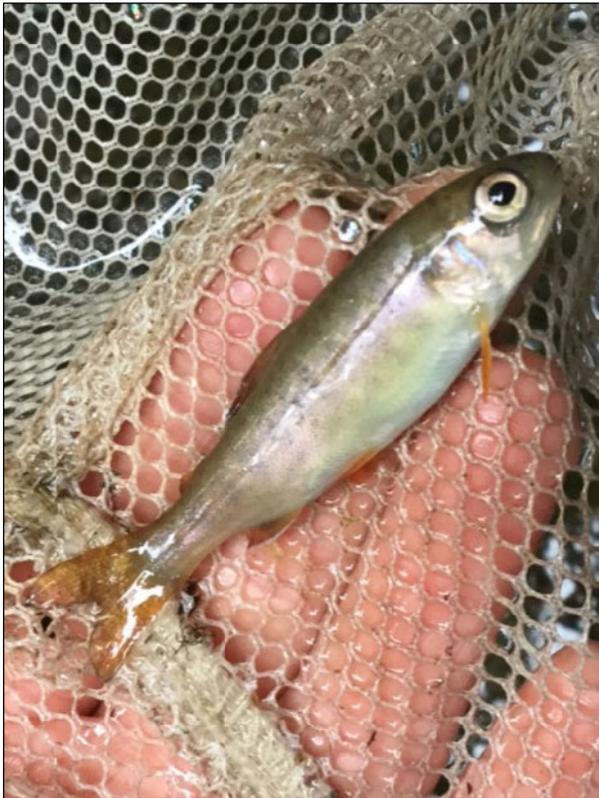
Figure 2.—Juvenile coho salmon captured at waypoint 746.

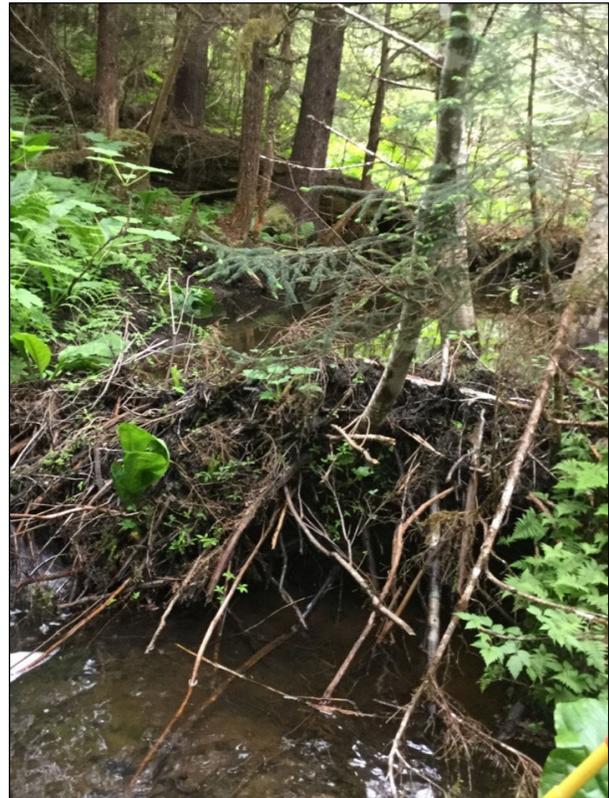
Figure 3.—Beaver dam at waypoint 750.
