# Alaska Department of Fish and Game

Habitat Section  
Southeast Region

## 114-34-10200 Tributary 12

## ADDITION

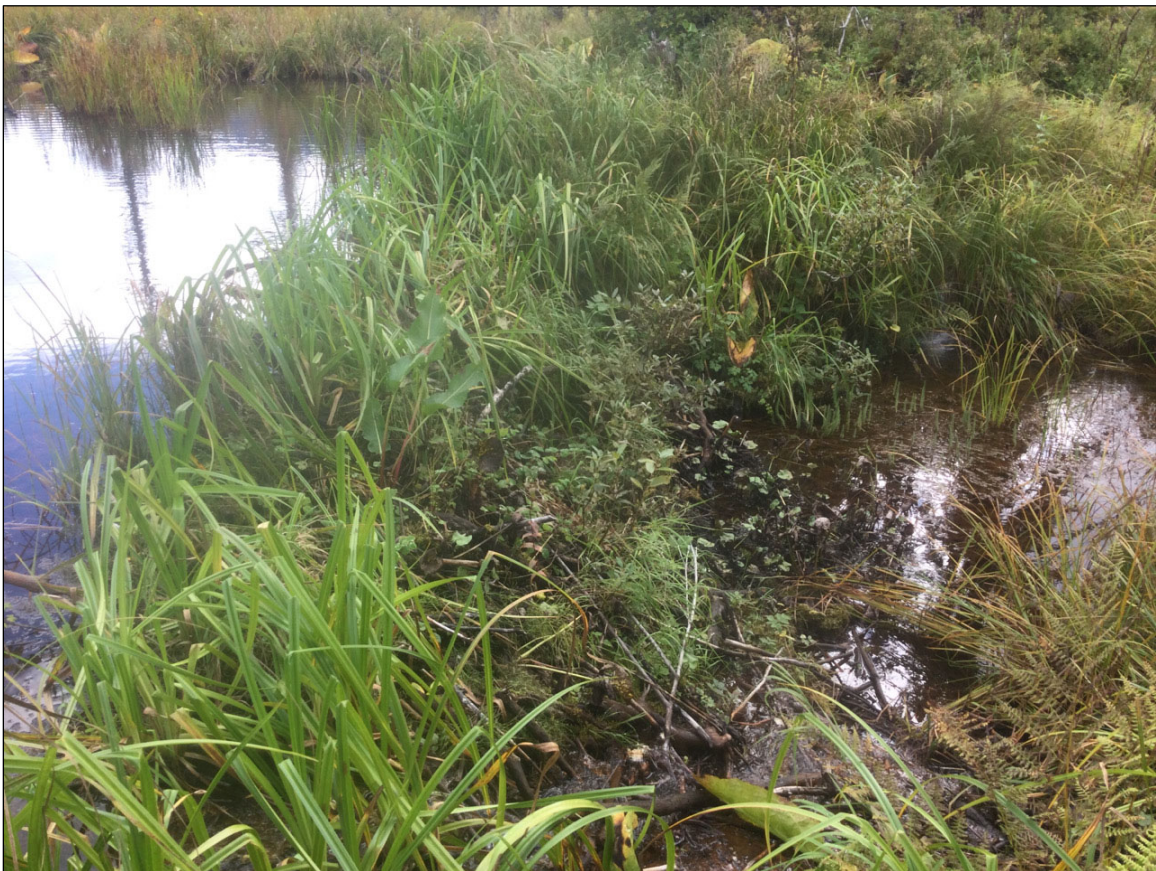
**Findings:** We surveyed this uncataloged stream using a backpack electrofisher, baited minnow traps, and GPS. We captured juvenile coho salmon. Pictures of juvenile coho salmon were not taken; however, fish identification was verified by a Habitat Biologist. The tributary stream flows over a 4 ft tall beaver dam which may block juvenile fish passage (Table 1; Figure 1).

Figure 1.—Beaver dam below which juvenile coho salmon were captured at waypoint 1850.
