Alaska Department of Fish and Game

Habitat Section
Southeast Region

114-34-10100-2032 Tributary 1

ADDITION

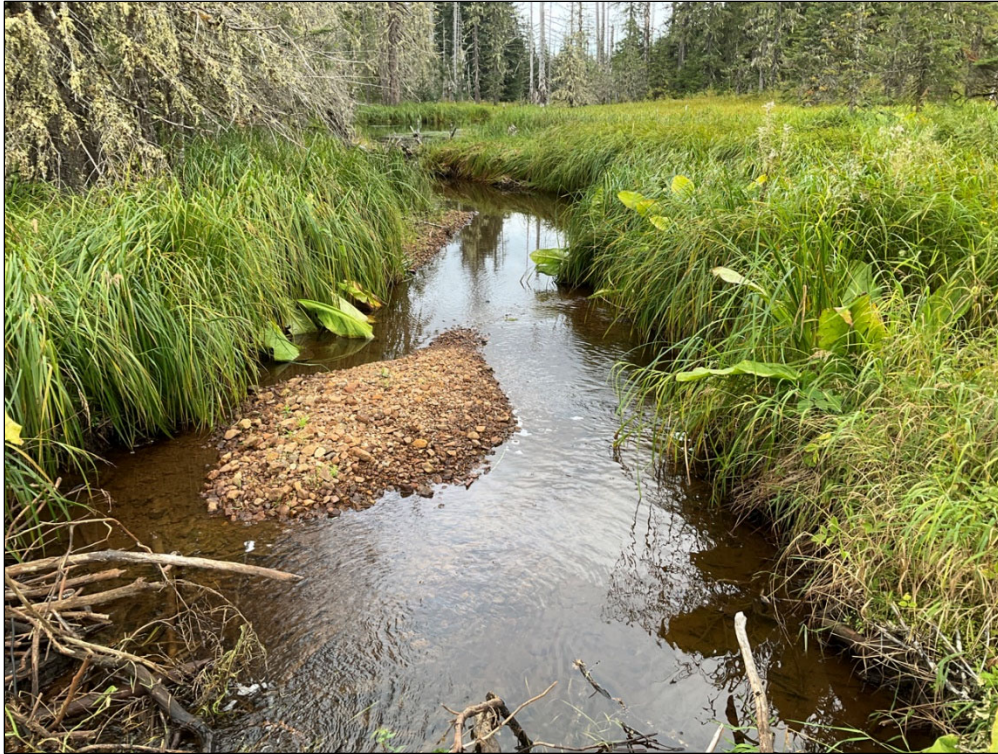
Figure 1.—Channel at waypoint 1755.

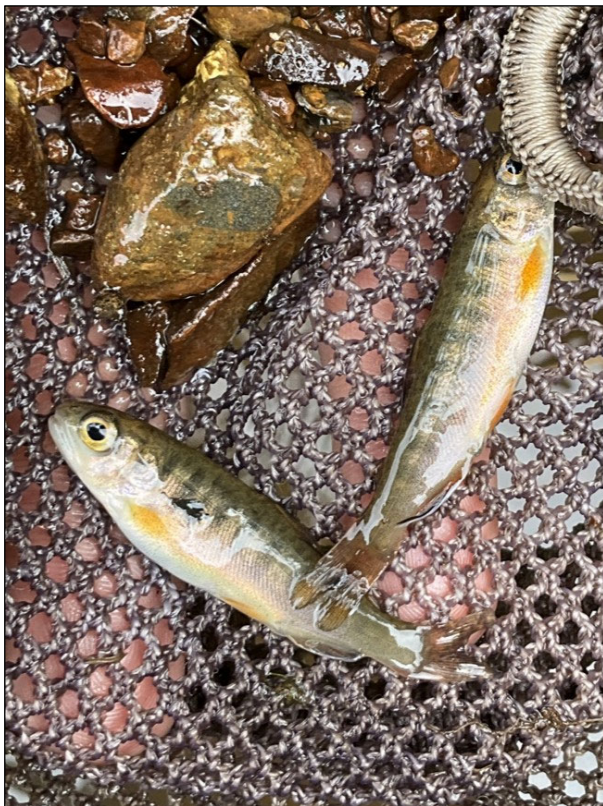
Figure 2.—Juvenile coho salmon captured at waypoint 1756.

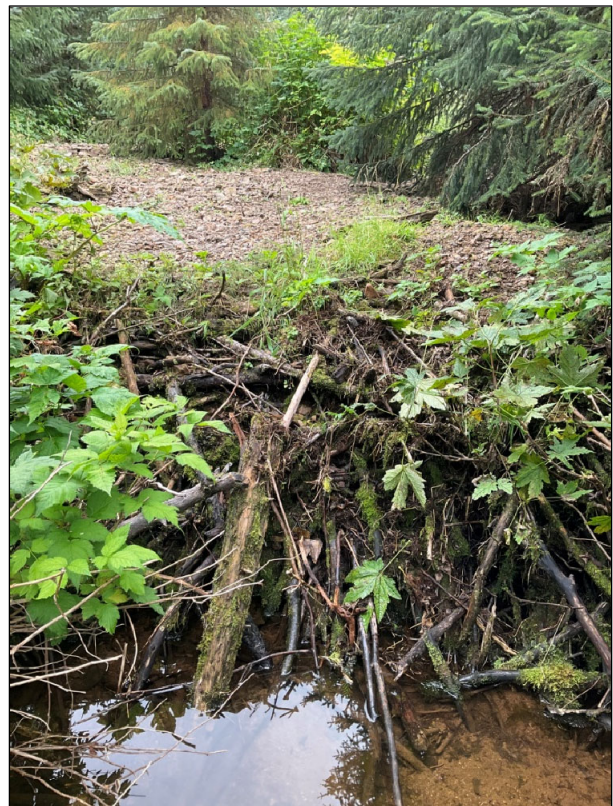
Findings: We surveyed this uncataloged stream using a backpack electrofisher and GPS and captured juvenile coho salmon. The tributary stream is buried under gravel bedload for at least 100 ft upstream of a 5 ft tall beaver dam, with subsequent beaver dams affecting the channel path downstream (Table 1; Figures 1–3).

Figure 3.—Beaver dam with stream buried in gravel upstream at waypoint 1758.
