Alaska Department of Fish and Game

Habitat Section
Southeast Region

114-33-10230 Tributary 11

ADDITION

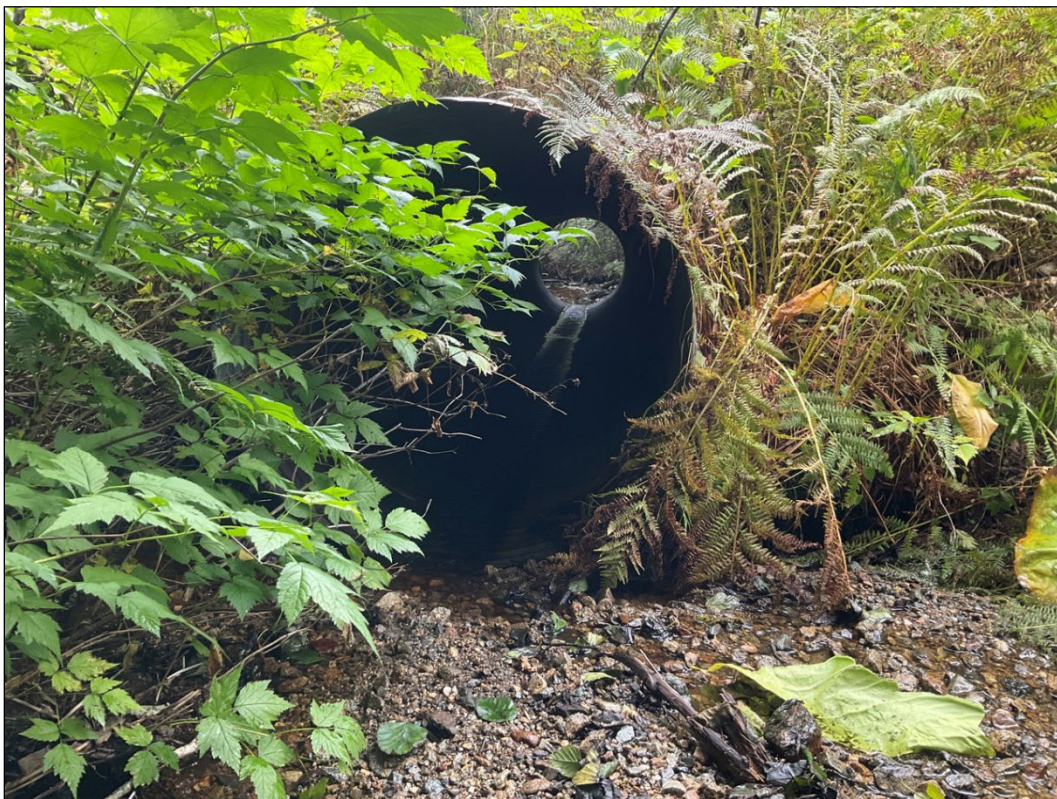
Figure 2.—Culvert inlet at waypoint 1795.

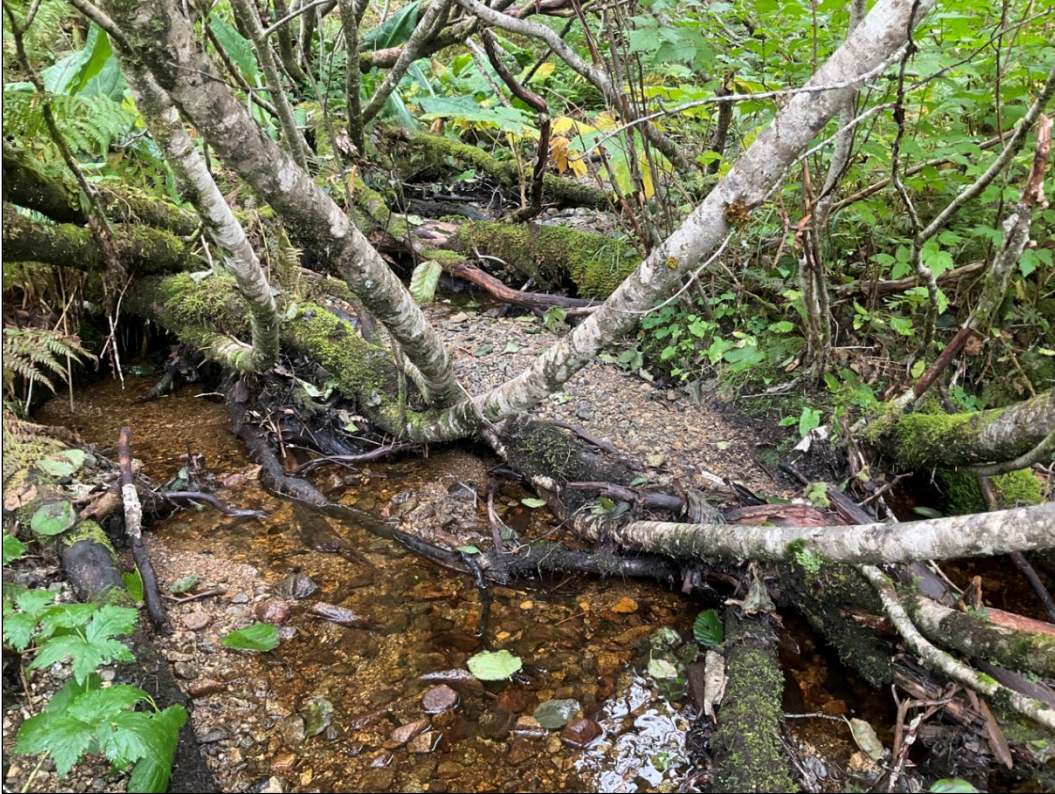
Figure 3.—Channel at waypoint 1795.

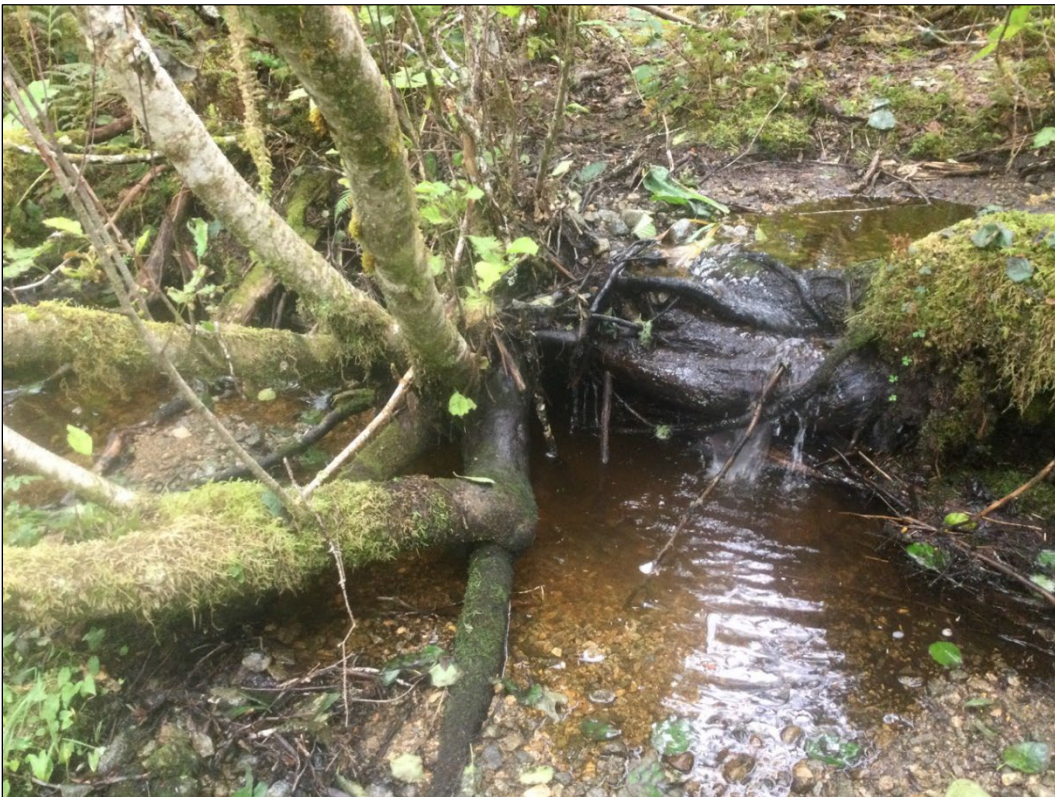
Figure 4.—Rootwad/debris jam at waypoint 1796.
