Alaska Department of Fish and Game

113-51-10040

ADDITION

Survey date: 8/3/2023

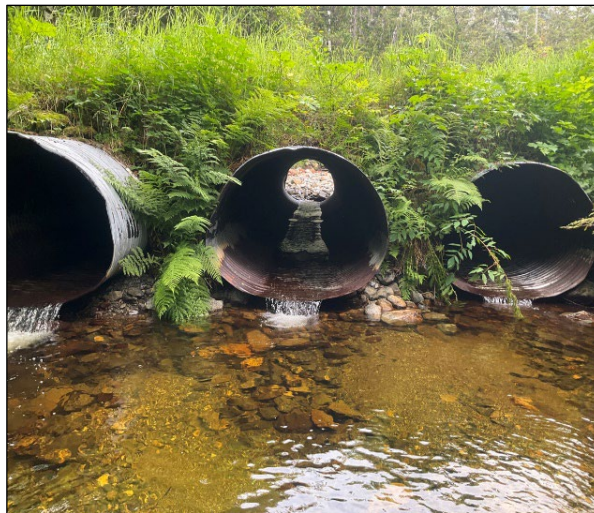
Figure 2.—Outlets of the triple culvert bank waypoint 436.

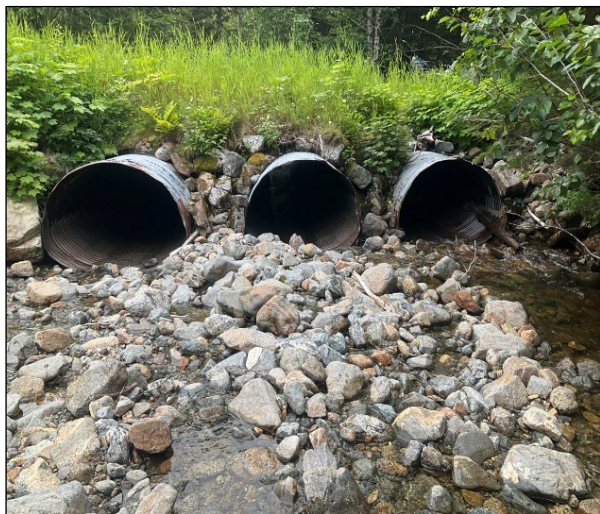
Figure 3.—Substrate impounded upstream of culvert inlets at waypoint 435.

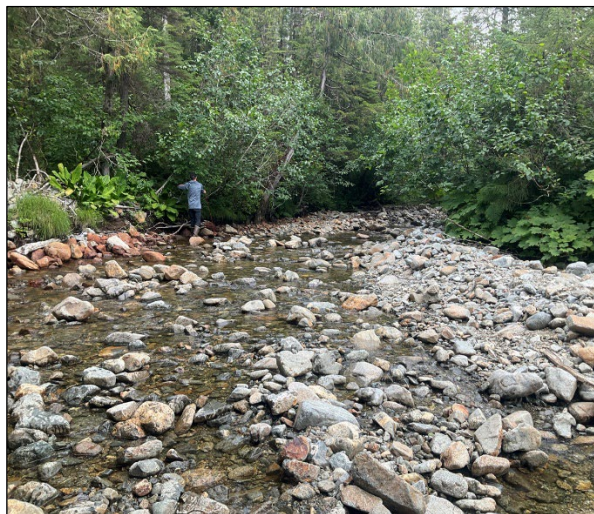
Figure 4.—Substrate upstream at waypoint 435.
