Appendix I: Juneau

Guide to direct fieldwork for cataloging anadromous water bodies in Southeast Alaska

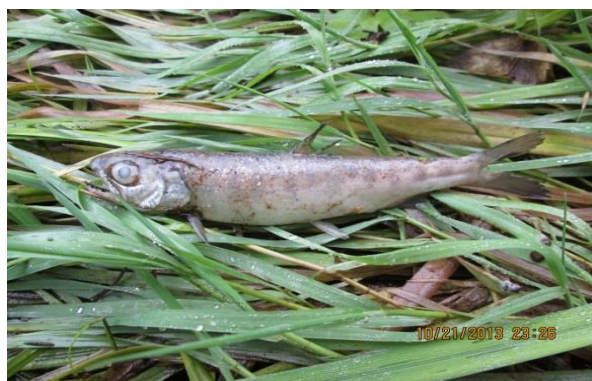
Findings: I surveyed stream number 111-40-10070-2010 using a backpack electrofisher and a GPS (Table 1). I found two dead juvenile coho salmon while electrofishing and also captured two live juvenile coho salmon (Figures 1, 2). This tributary is a ditch that is along Glacier Highway and is influenced by rainfall. I ended the survey because there was not enough water to continue electrofishing.

| Waypoint | Latitude | Longitude | Notes | Sample Effort | Sample Results |
|---|---|---|--|---|---|
| 155 | 58.3594 | -134.5076 | Found two dead coho that look to have run out of air. Culvert here that goes under Alaway Ave. | EF | 2 CO |

Figure 1.—Dead juvenile coho salmon.

Recommendations: Add stream to AWC (Figure 3).

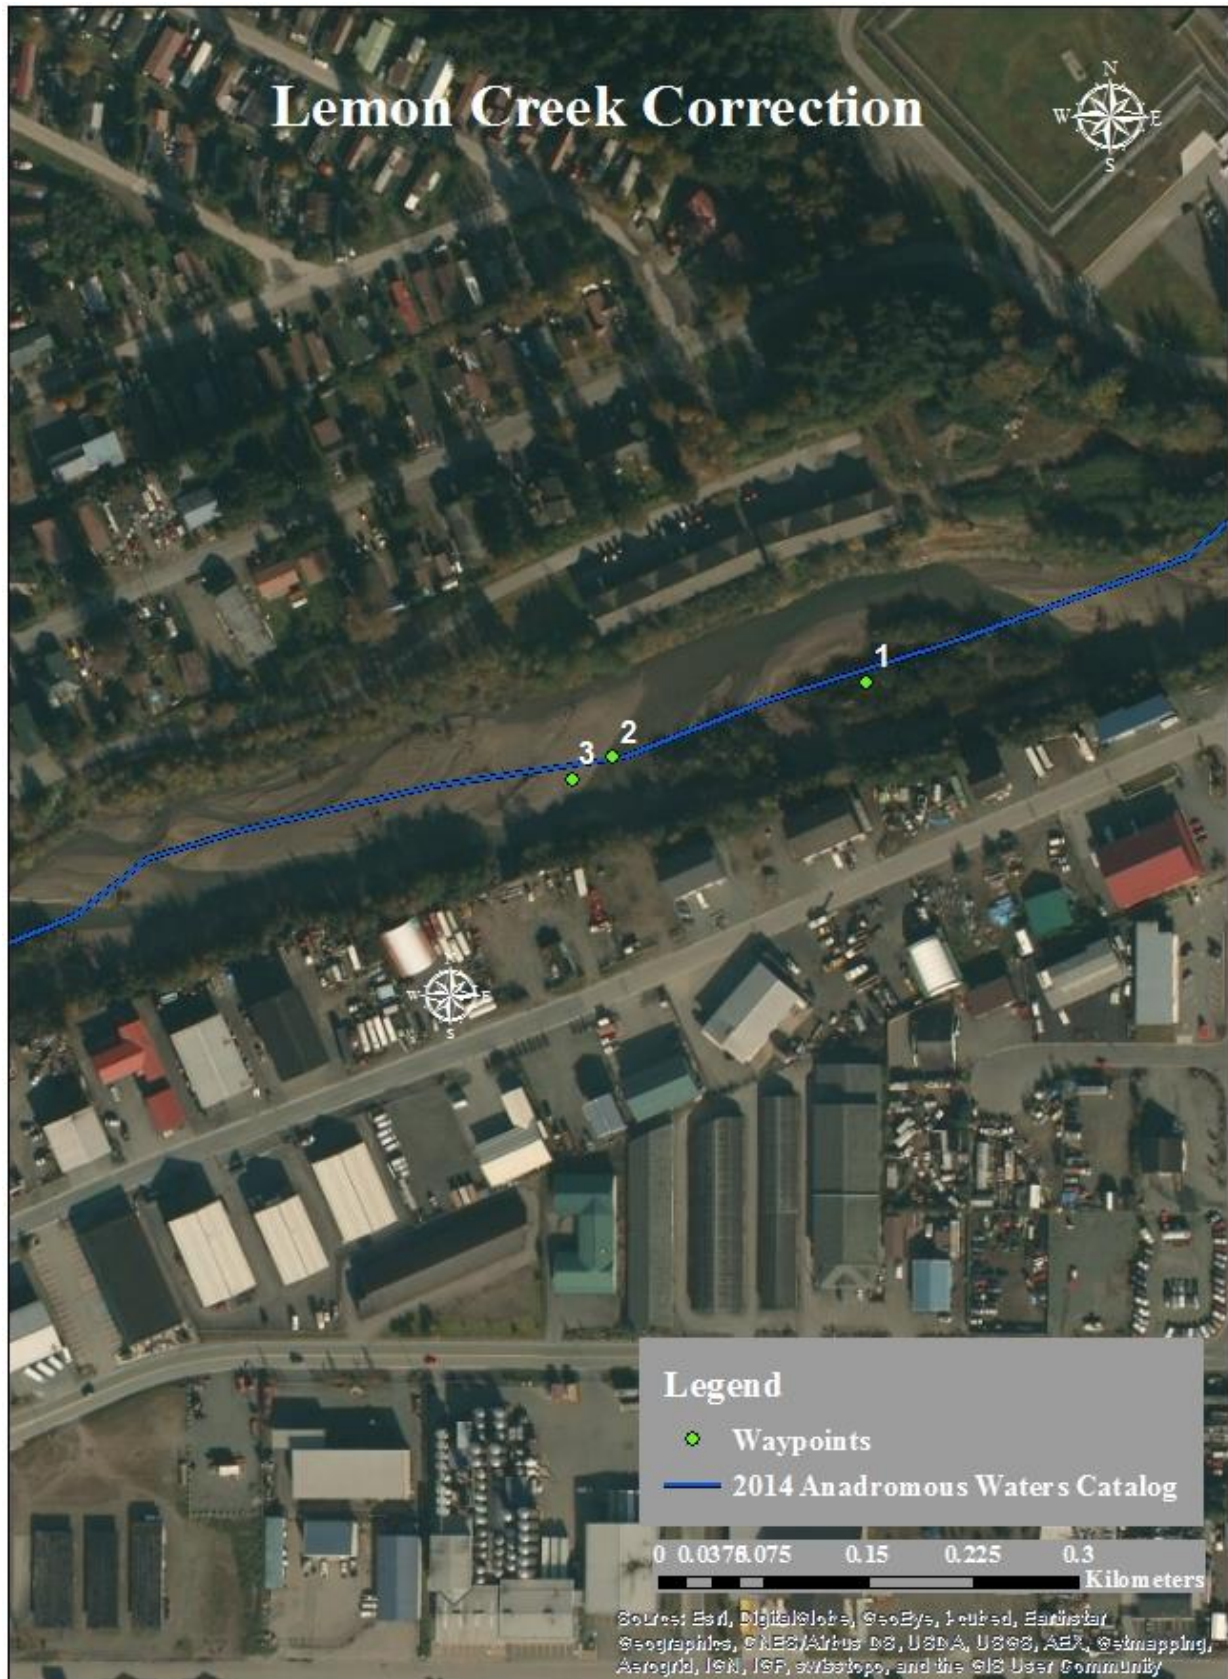
Figure 2.-111-40-10100 survey map.

Findings: I visually observed about 80 pink salmon, including 3 spawning pairs downstream of waypoint 1 (Table 1, Figures 1, 2).

Recommendations: Correct to add spawning pink salmon at waypoint 1 (Figure 2).

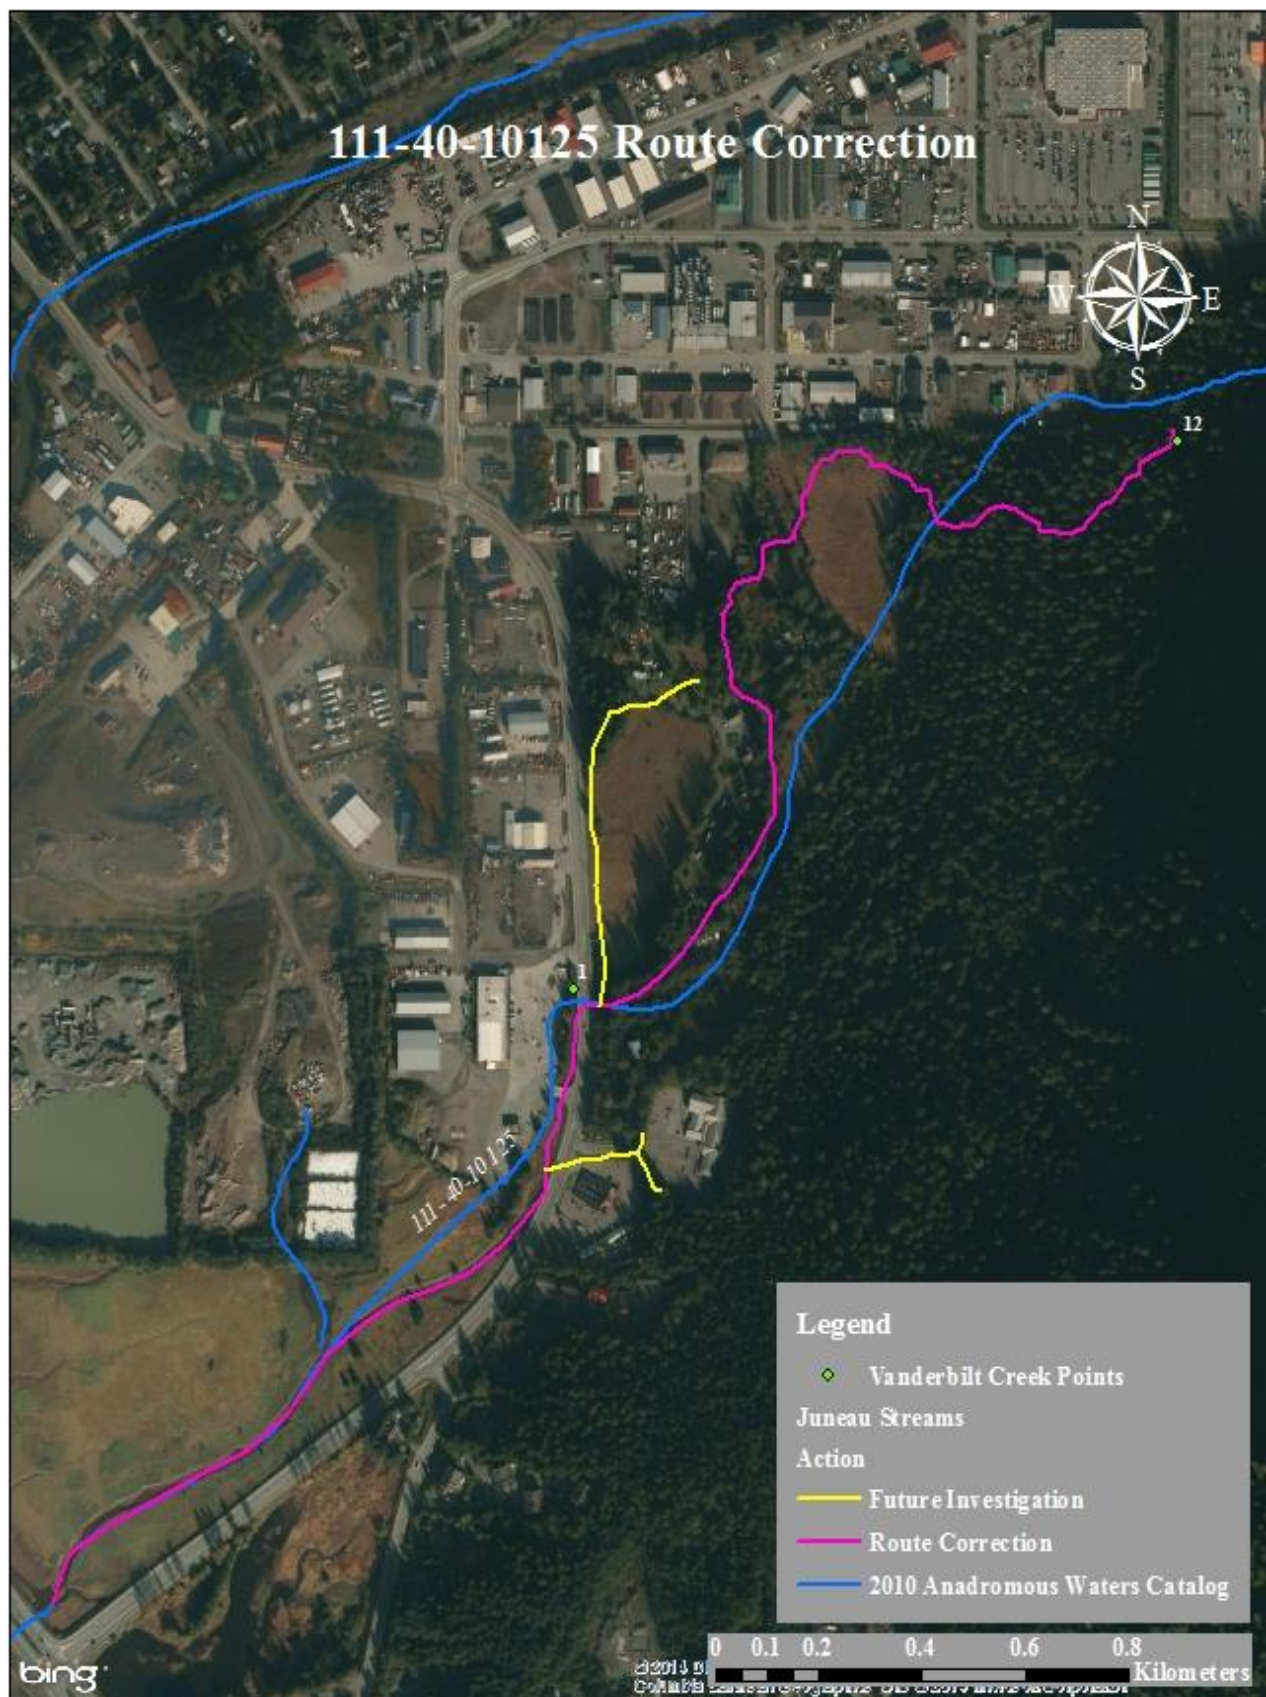
Figure 2.—111-40-10125 route correction map.

Findings: The tracked route follows a much more sinuous path than the AWC illustrates (Table 1). The coordinates provided in the table indicate the upper and lower extents of Vanderbilt Creek for species listed in the AWC. We found a spawned out chum salmon on the stream bank (Figure 1). This stream has been adversely impacted by human activity. There were tent camps along the bank as well as a tremendous amount of human excrement, trash, and yard debris. This stream would greatly benefit from a clean-up effort and rehabilitation. The following table and map provide additional data on the creek correction.

Recommendations: Add stream to the AWC (Figure 2).

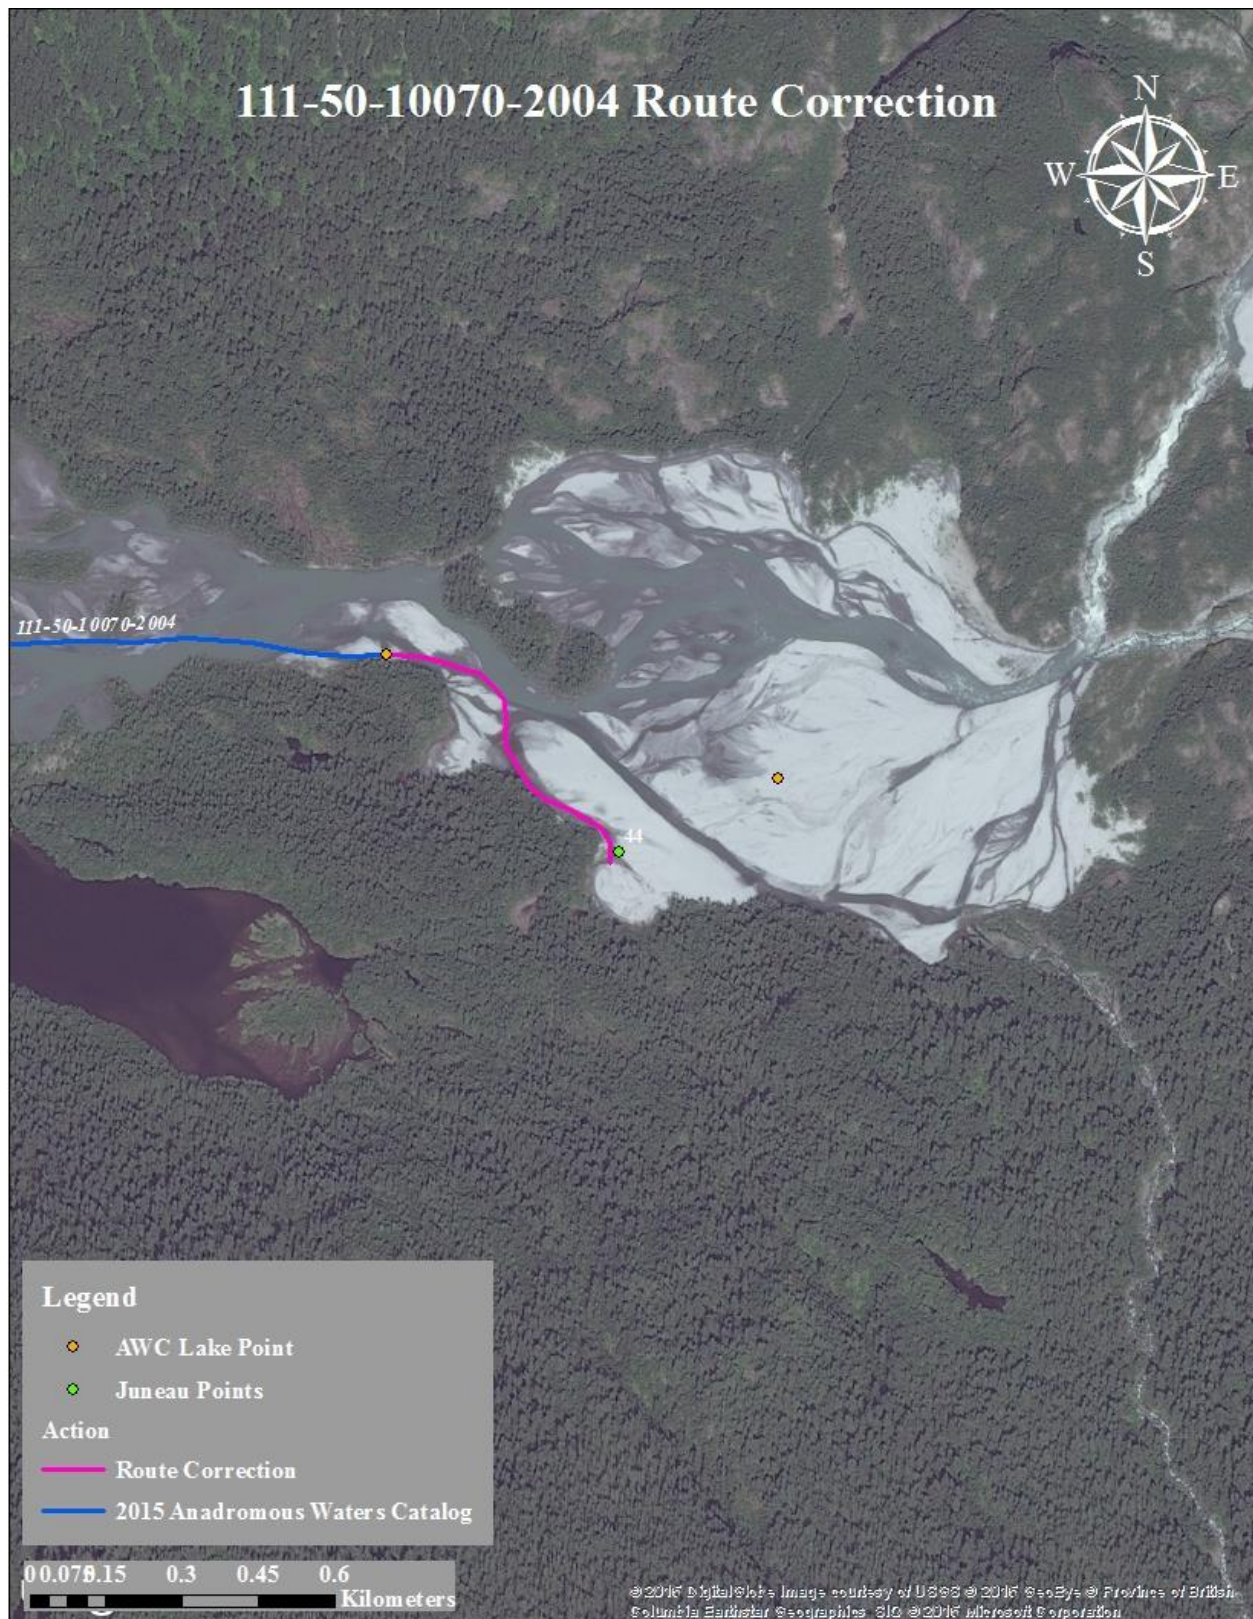
Figure 3.—111-50-10070-2004 route correction map.

Figure 2.—Herbert River Lake no longer exists. It is currently a braided alluvial fan.

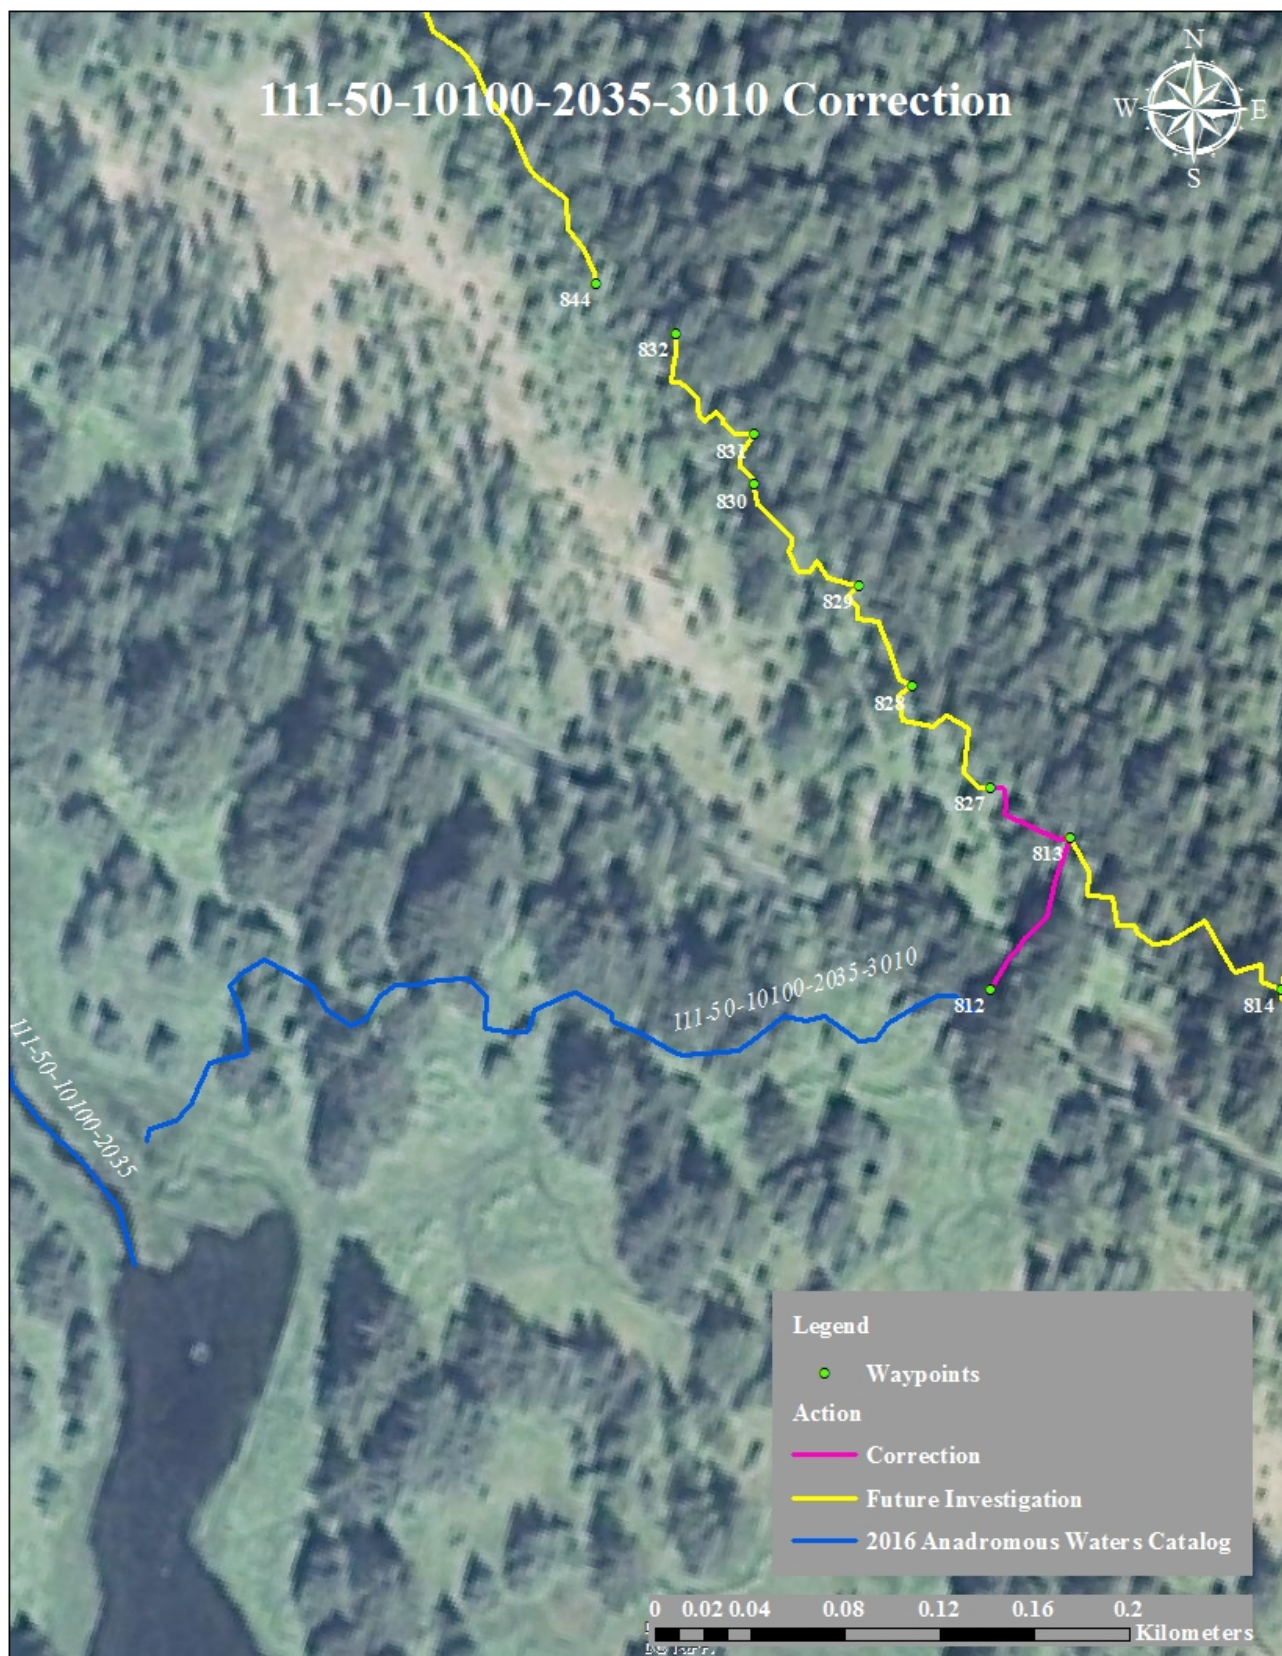
Figure 4.—111-50-10100-2035-3010 correction map.

Findings: We surveyed this stream beginning at its intersection with the road (Table 1; Figure 1) using an electrofisher and a GPS and found coho salmon (Figure 2). The stream was covered in ice at several points, making it difficult to fish. We ended the survey where the stream empties a wetland and ceased to have a defined channel (Figure 3).

Recommendations: Extend stream No. 111-50-10100-2035-3010 in the Anadromous Waters Catalog. Investigate upper reaches of the stream at a later date, when ice and snow are not present (Figure 4).

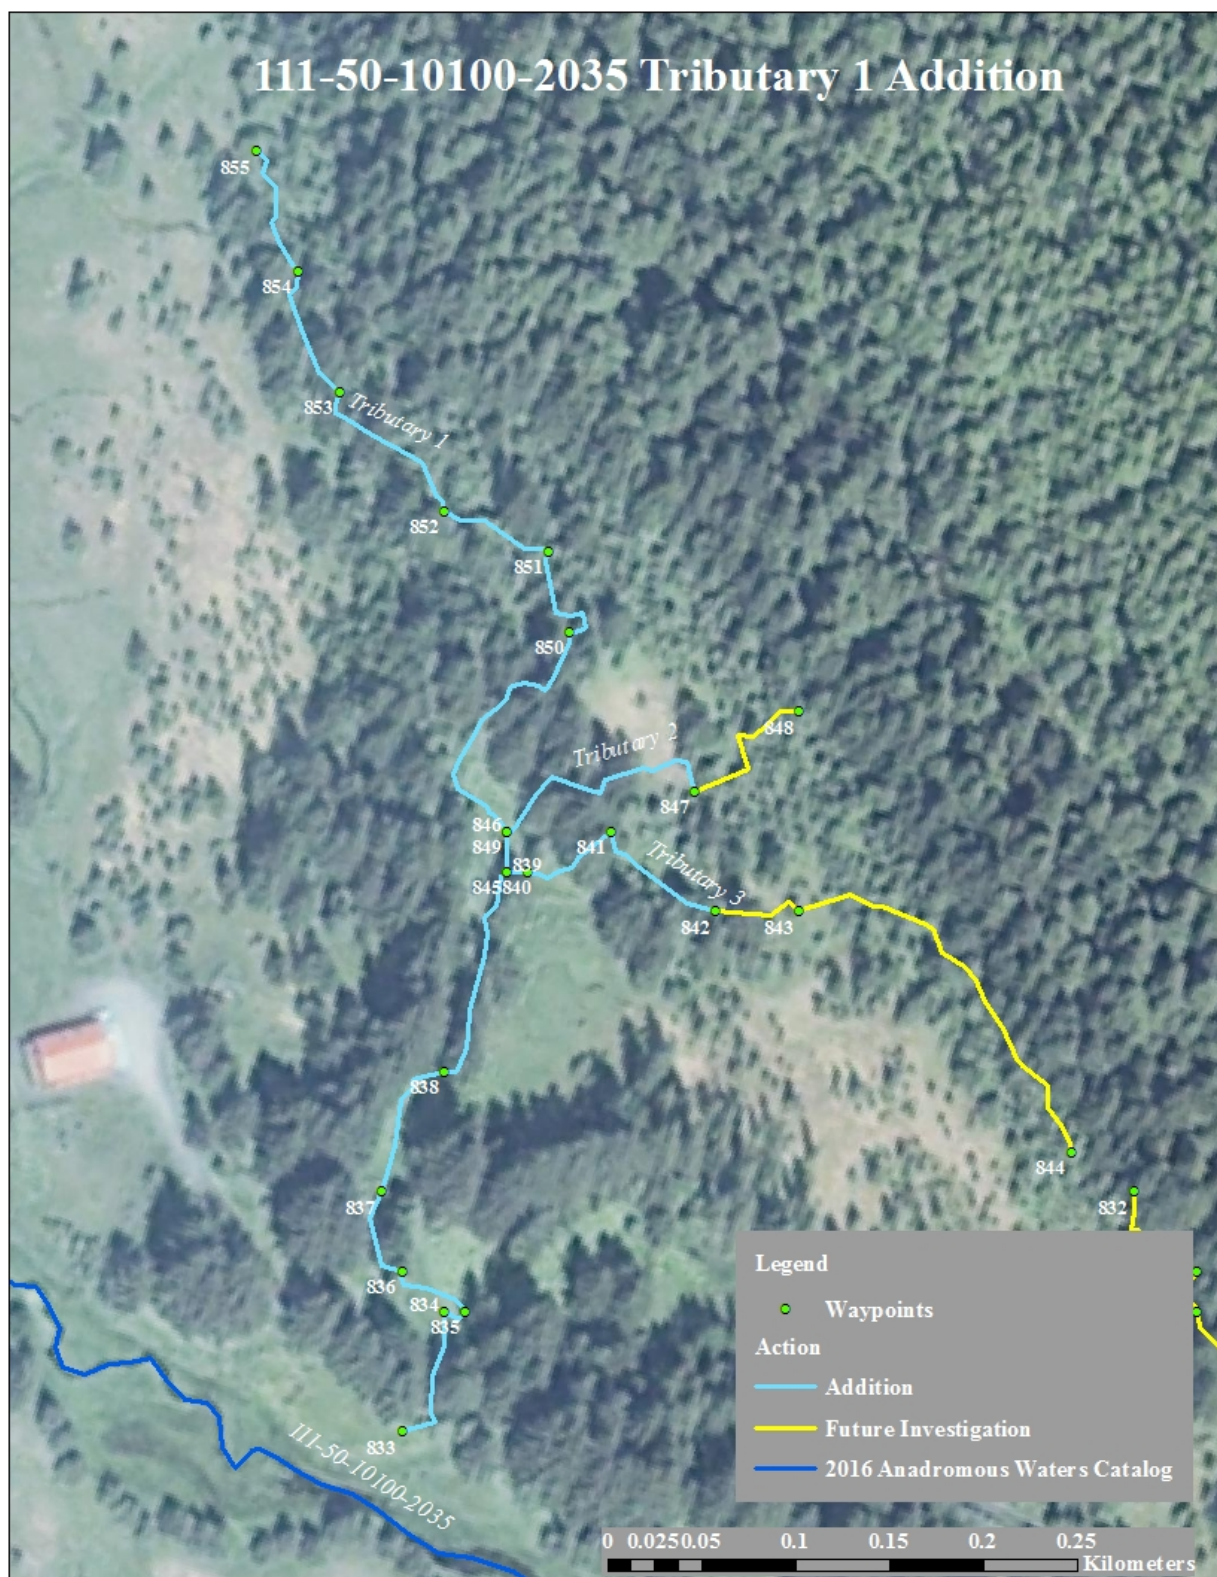
Figure 3.—111-50-10100-2035-3014 (tributary 1) addition map.

Findings: We surveyed this stream using an electrofisher and a GPS and found coho salmon and stickleback (Table 1; Figure 1). The stream is incised and less than 12 inches wide as it crosses the meadow (Figure 2). We ended the survey where the stream channel became undefined.

Recommendations: Add stream between waypoints 833 and 855 to the Anadromous Waters Catalog (Figure 3).

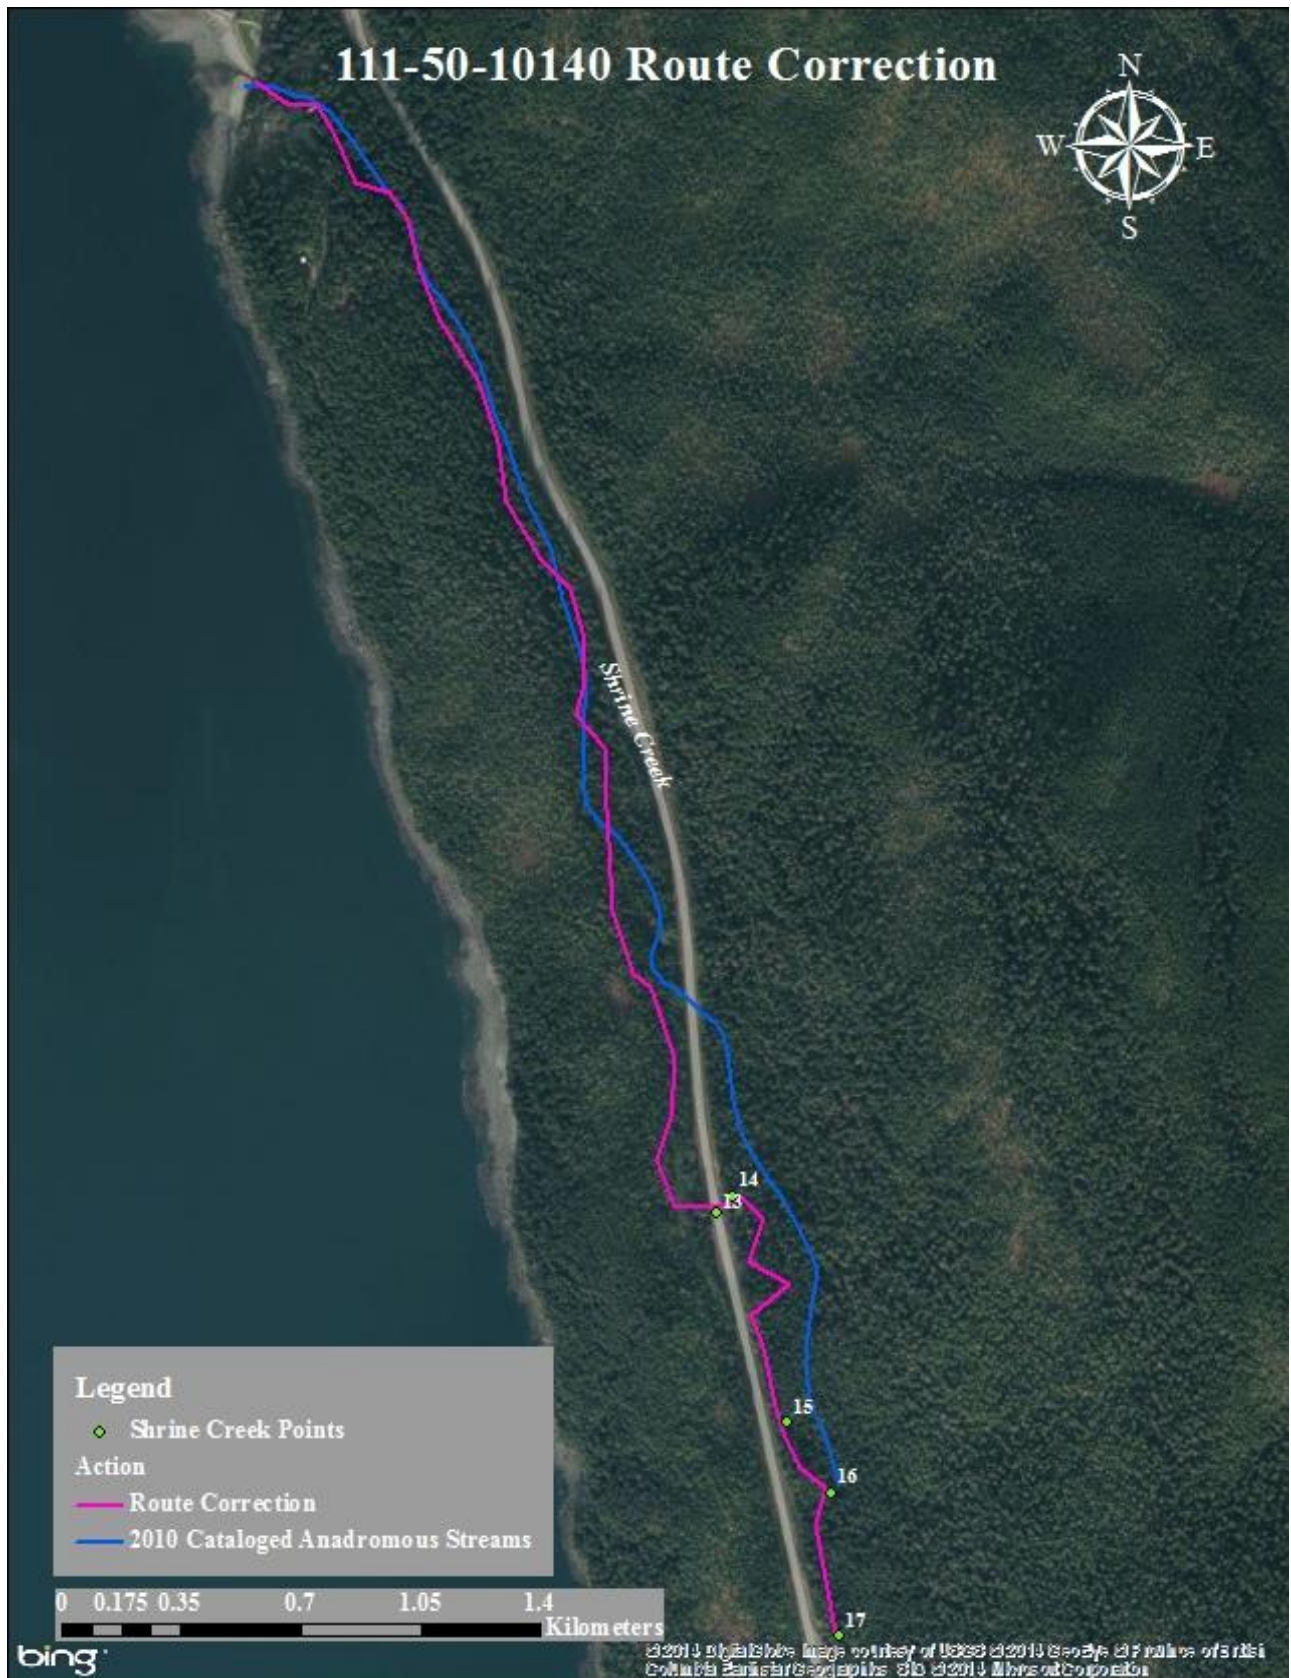
Figure 5.—111-50-10140 route correction map.

Findings: We surveyed Shrine Creek using a backpack electrofisher and a GPS (Table 1). The upper extent of anadromy extends past the cataloged upper limit. We captured juvenile CO and P salmon and found an old car (Figures 1, 2, 3, and 4). The stream crosses Glacier Highway in a different location then what is shown in AWC.

Recommendations: Correct the current route in the AWC (Figure 5).

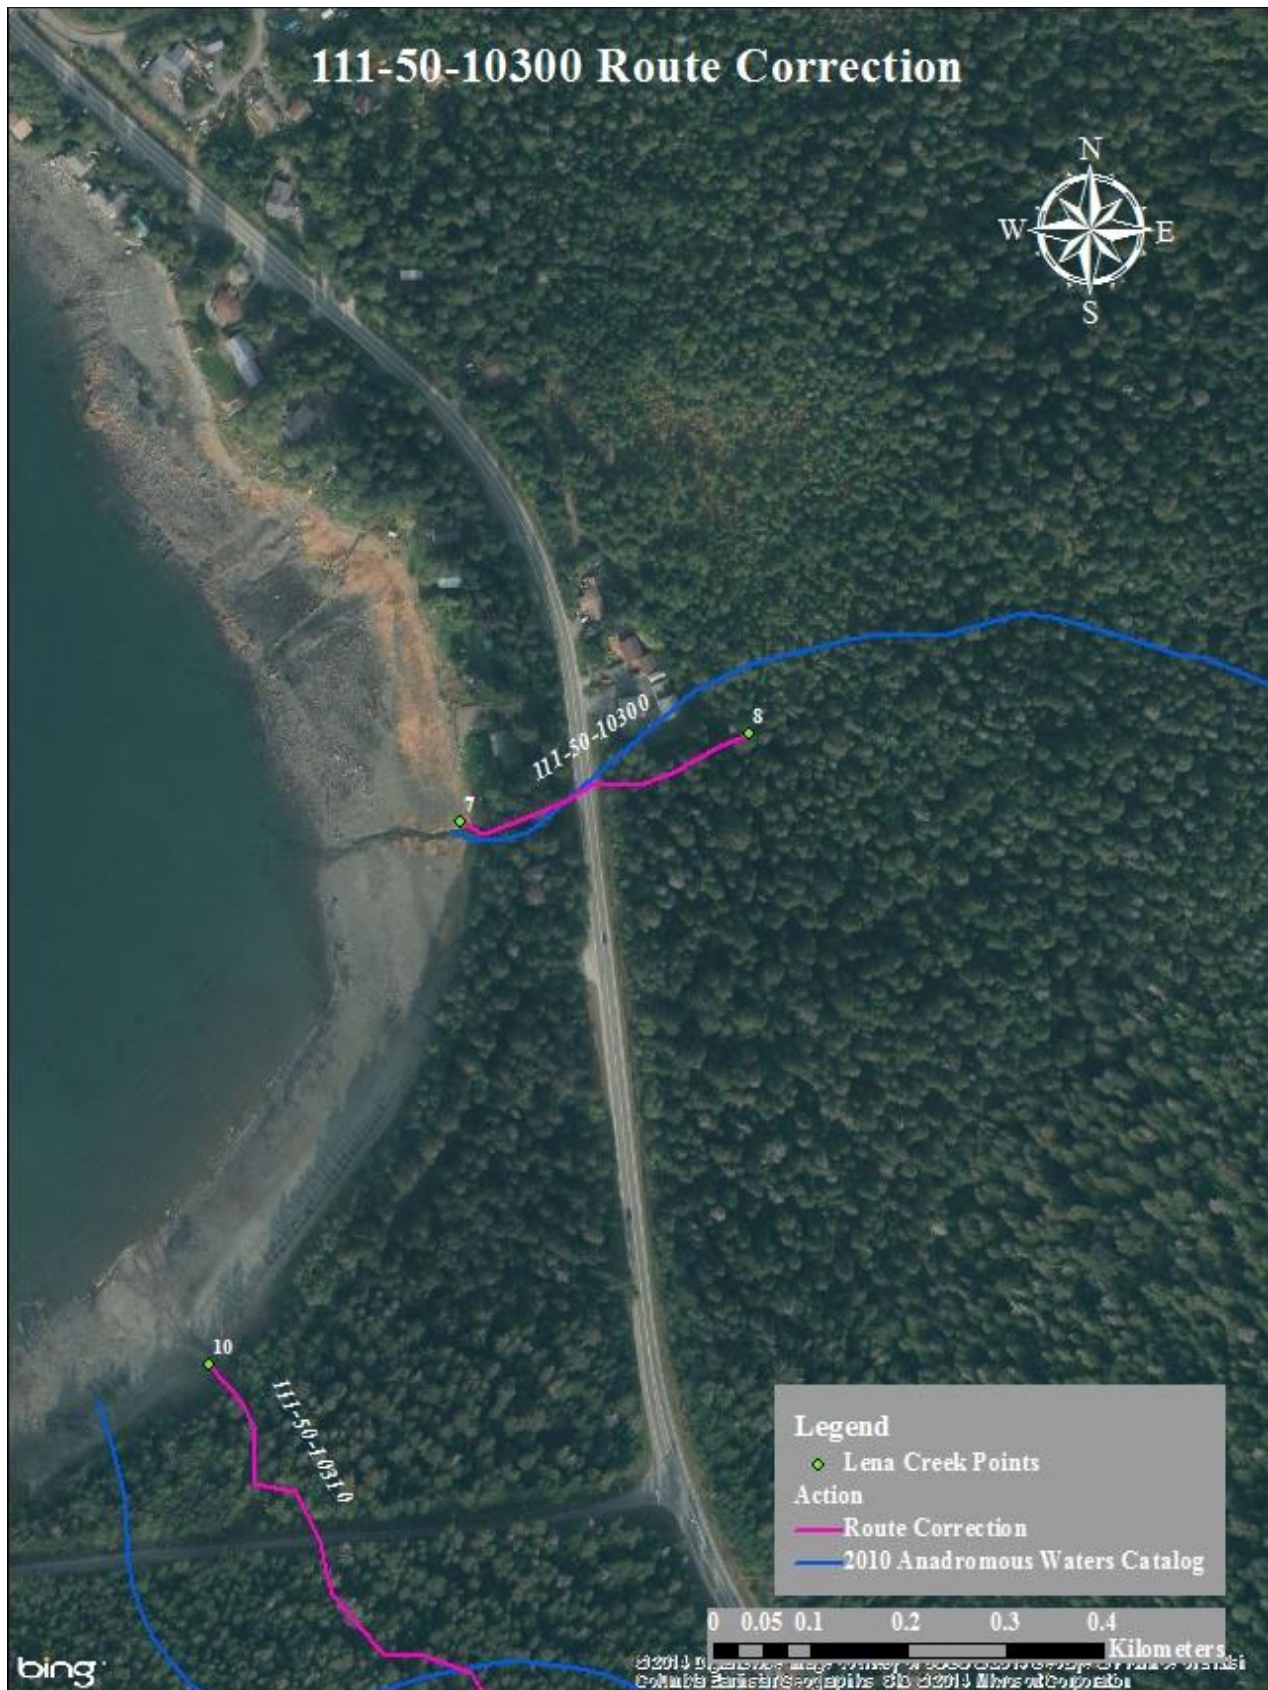
Figure 1.–111-50-10300 route correction map.

| Waypoint | Latitude | Longitude | Notes | Sample Effort | Sample Results |
|---|---|---|--|---|---|
| 8 | 58.3959 | -134.7458 | End of anadromy. Huge bedrock waterfall. Gradient 45-50% and approximately 140' long. | RS | |

Recommendations: Correct the current route in the AWC (Figure 1).

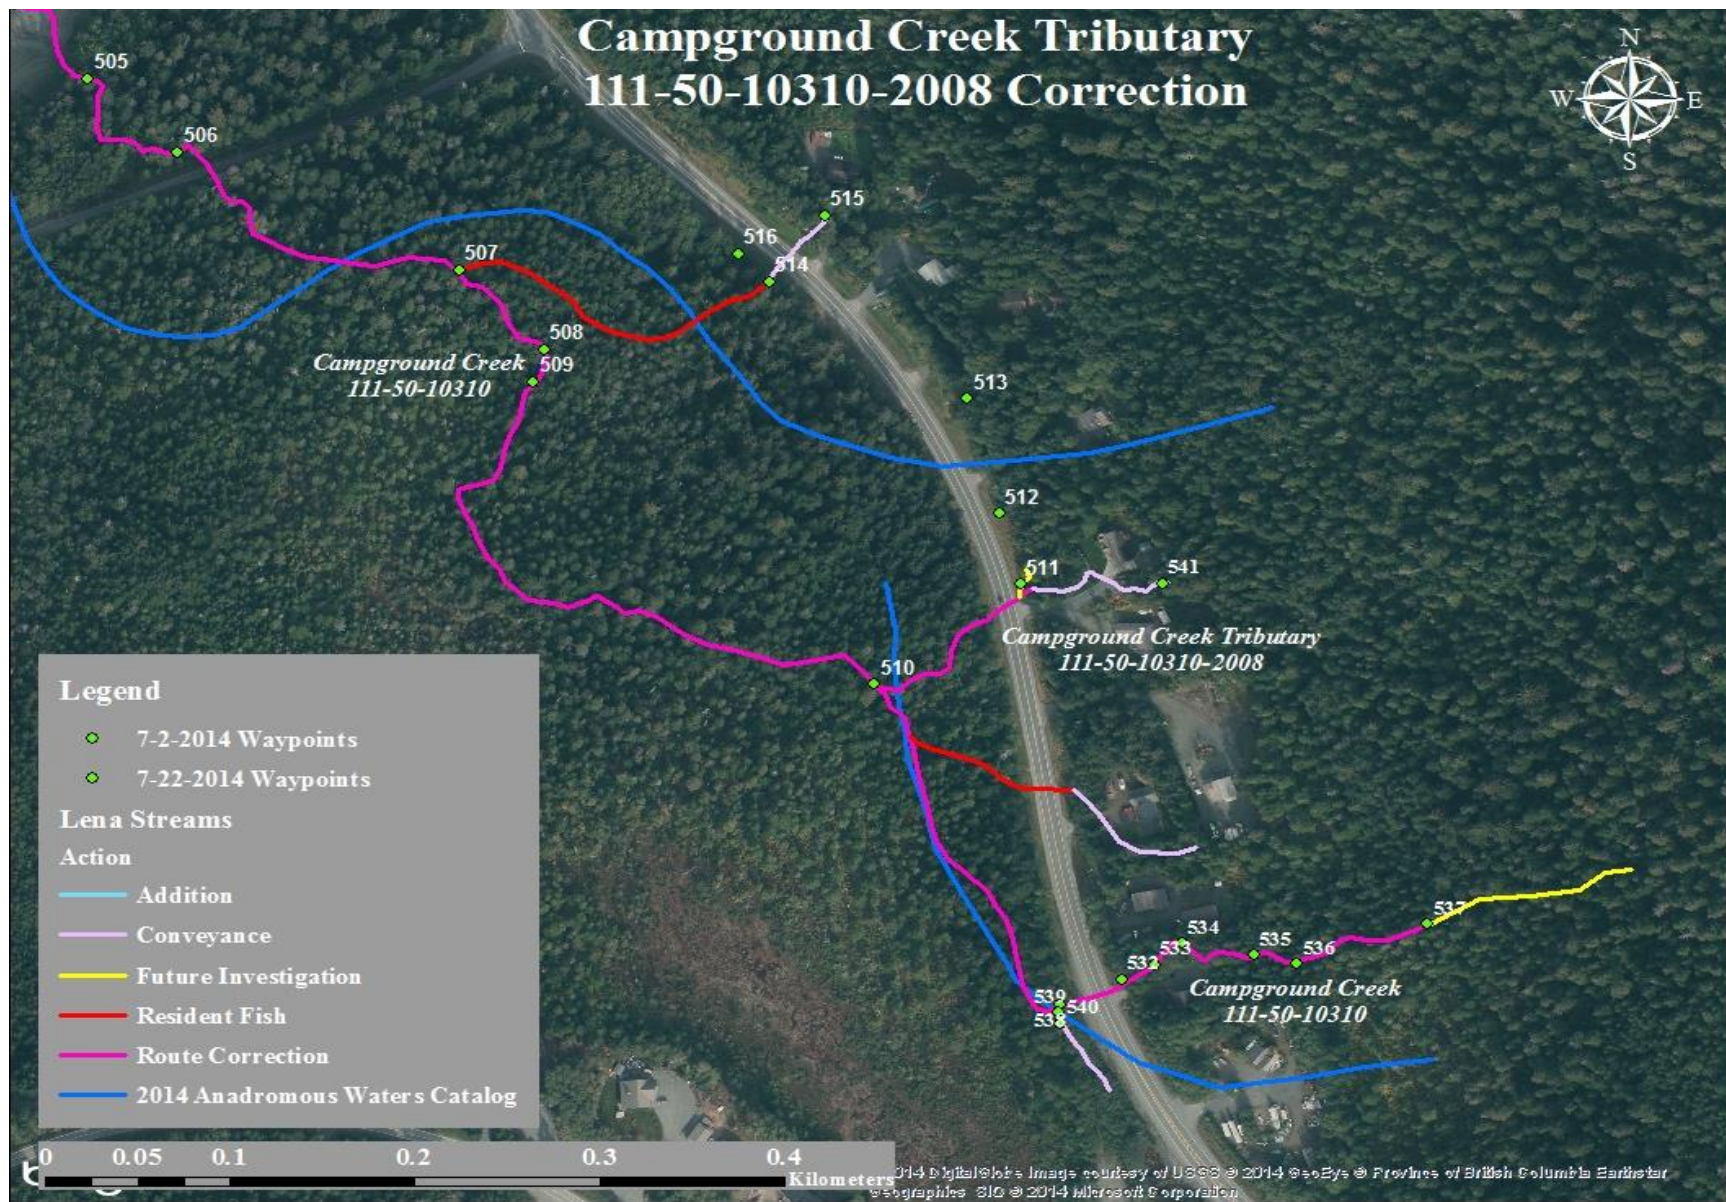
Findings: We conducted a survey of a tributary to Campground Creek using a backpack electrofisher and a GPS (Table 1). We found that the mainstem of Campground Creek should extend where a tributary is cataloged (Stream No. 111-50-10310-2008). The currently cataloged mainstem above the confluence should be changed to a tributary.

Figure 1.–Correction map. Previous tributary route (111-50-10310-2008) is mainstem. New tributary is now 111-50-10310-2007.

Recommendations: Switch Campground Creek and tributary headwaters location (Figure 1). The new tributary location will end in an odd number (-2007). This stream is currently only listed for cutthroat rearing, additional trapping is needed.
