Mr. Chairman, Board Members My name is Roland Briggs I am speaking in opposition to 375. I have been participating in the Ugashik Village setnet fishery since 1965. Since that time we have dealt with all sorts of proposals targeting this fishery from village residents in the late 60's proposal to closing the sites to this one now by the **Department to take away some of our fishing opportunity in an out of cycle meeting.**

Figure 1 Set net Configuration 2013

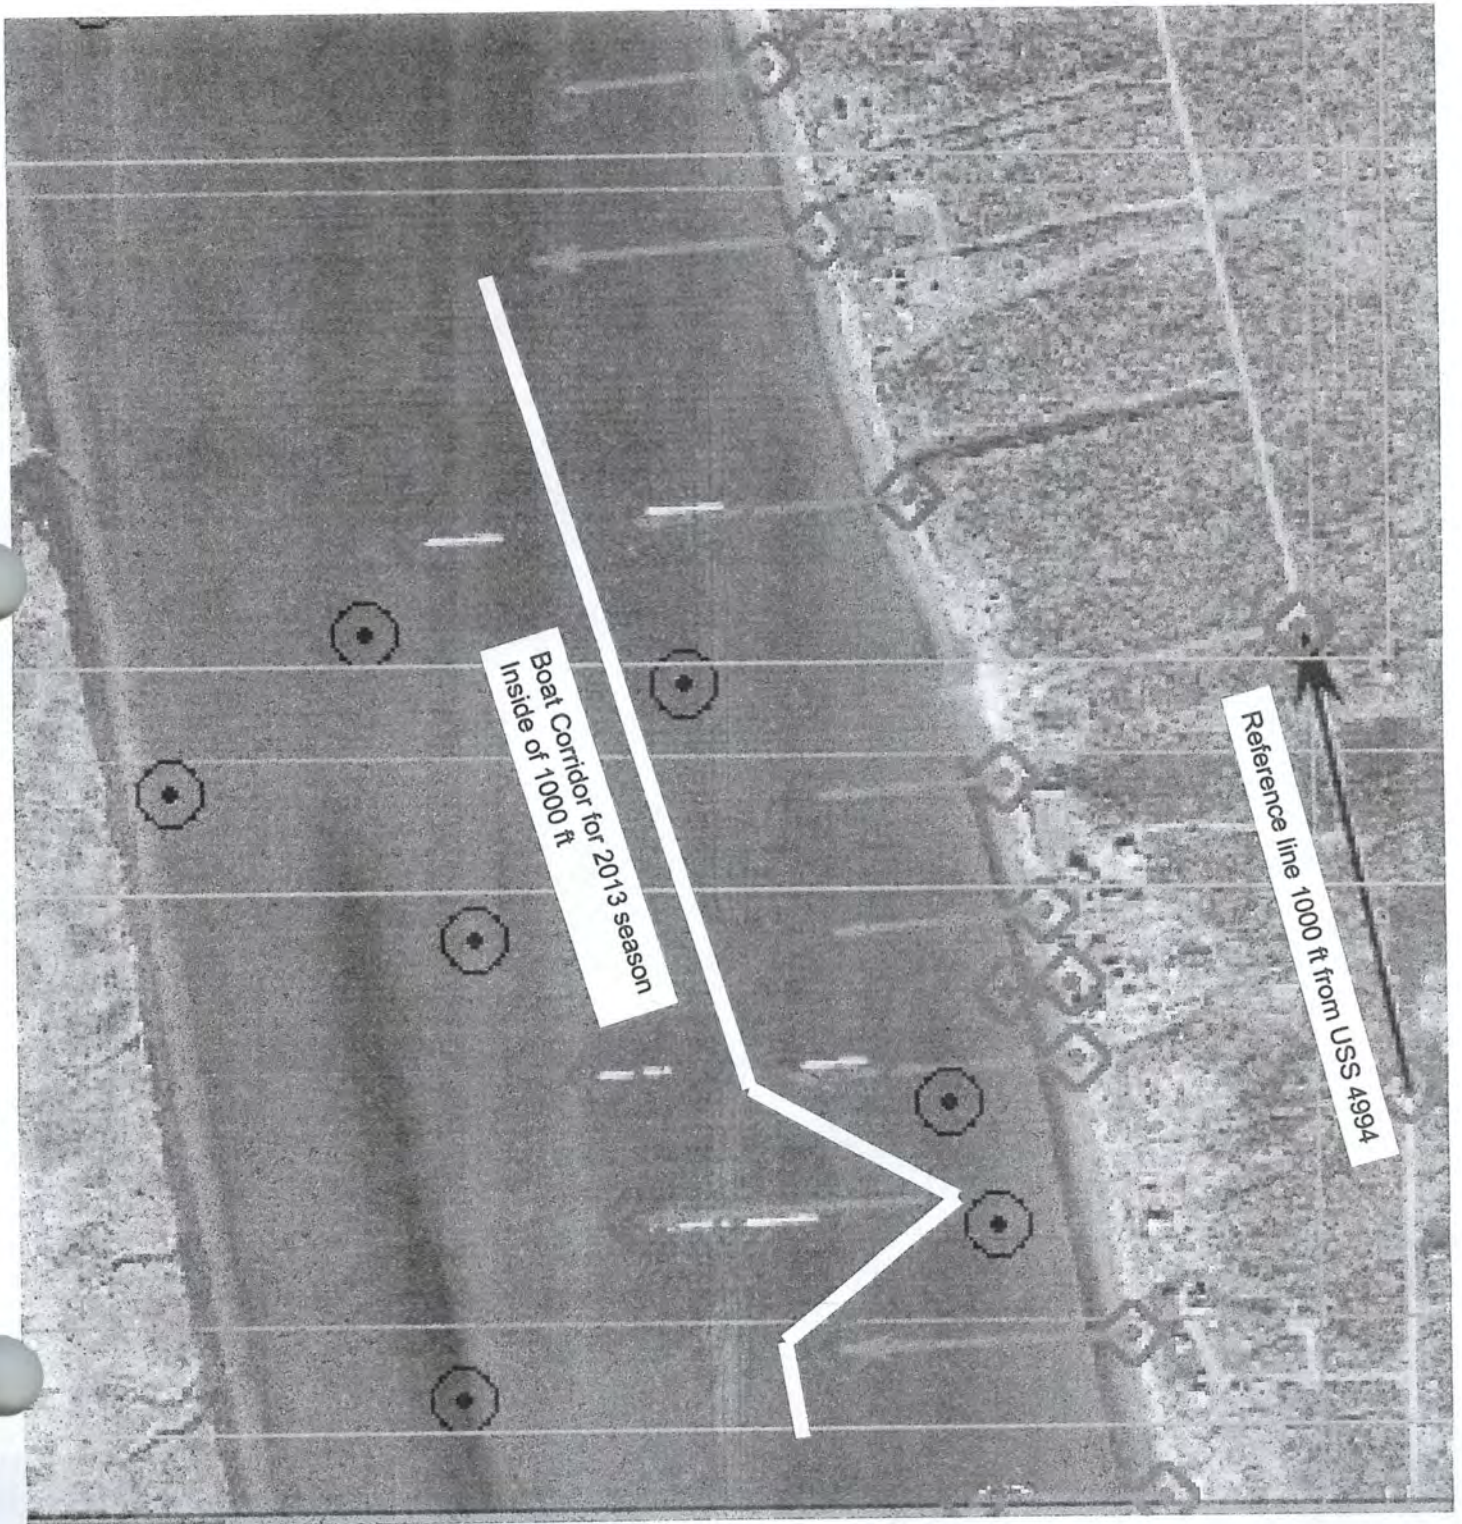
Ugashik set net configuration in 2013 fishing season
Showing a navigation corridor just outside of 600ft and inside of 400 ft
For boat traffic. All lines are to scale

- See Figure 1 please note the navigation corridor for boat traffic, inside of 1000 ft.
- **I spoke with trooper Ball during the October meeting who was dispatched by trooper Quist during the fishing season to the village stat area. He was there over an opening and an additional tide.**
- **When ask if he saw any navigation issues He said he did not observe any navigation issues.**

I thought the Board wanted, Boats to be able to travel inside of 1000 ft past the nets. Thus the above configuration I fished in 2013. This corridor was only there when the fishing, was actually happening, when the fishery was closed there were only a buoy's there.

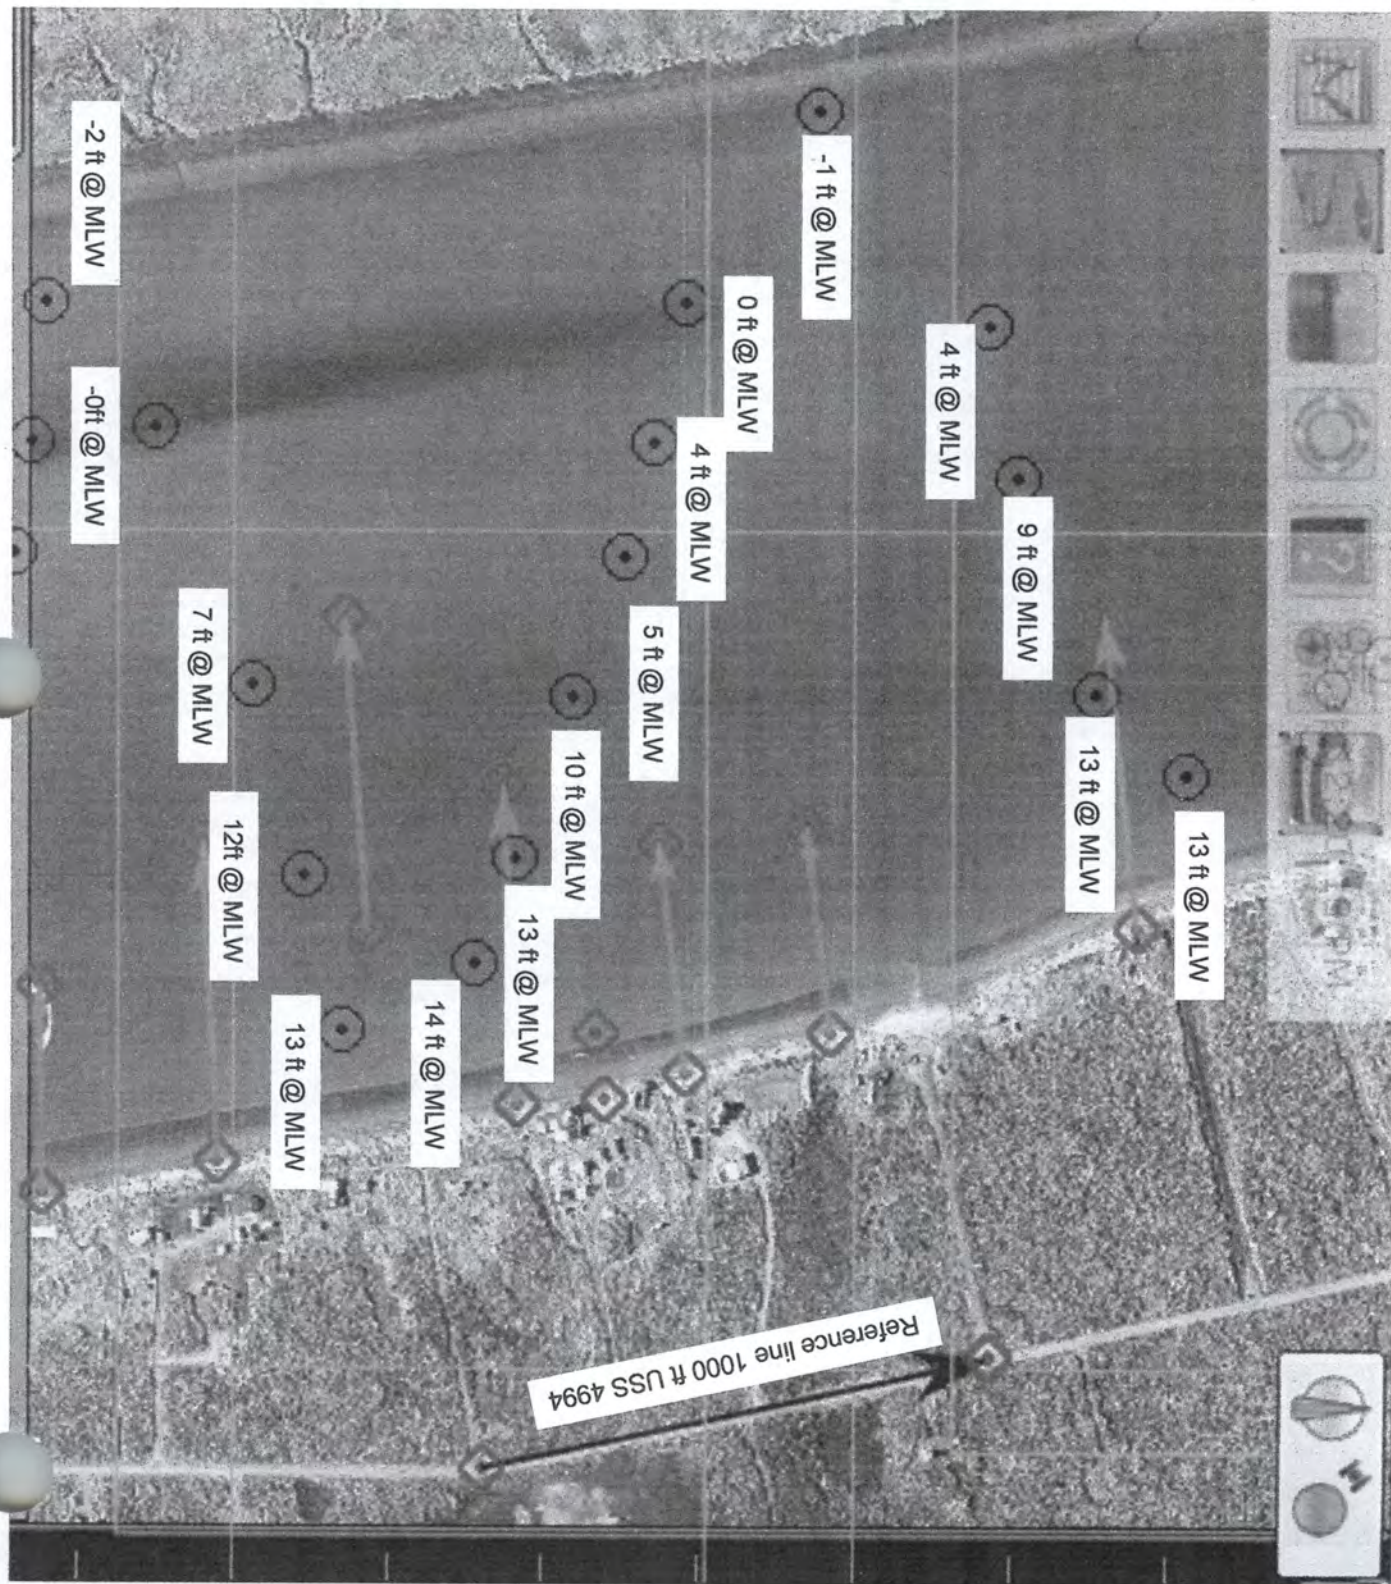
Figure 3 water depth at Mean Low Water

Depth taken on 11-3-2014 adjust to MEAN LOW WATER

Low tide 8:25 AM -0.9 ft

High tide 3:04 PM 19.5 ft

Water depth change from Mean low water to Mean High water is 12 ft at the village Of Ugashik
Shows the channel is along the EAST SHORE DEEP PART WITHIN 400 FT OF SHORE.

Figure 3 shows the approx water depth at mean low water. At MLW there is still 3 to 4 ft of water at 1000ft.
