Sand Point Area Stream  
Clearance Feasibility Study

Number 135

**Special Report To  
Aleutians East Borough  
(Cooperative Agreement No. 93-003)**

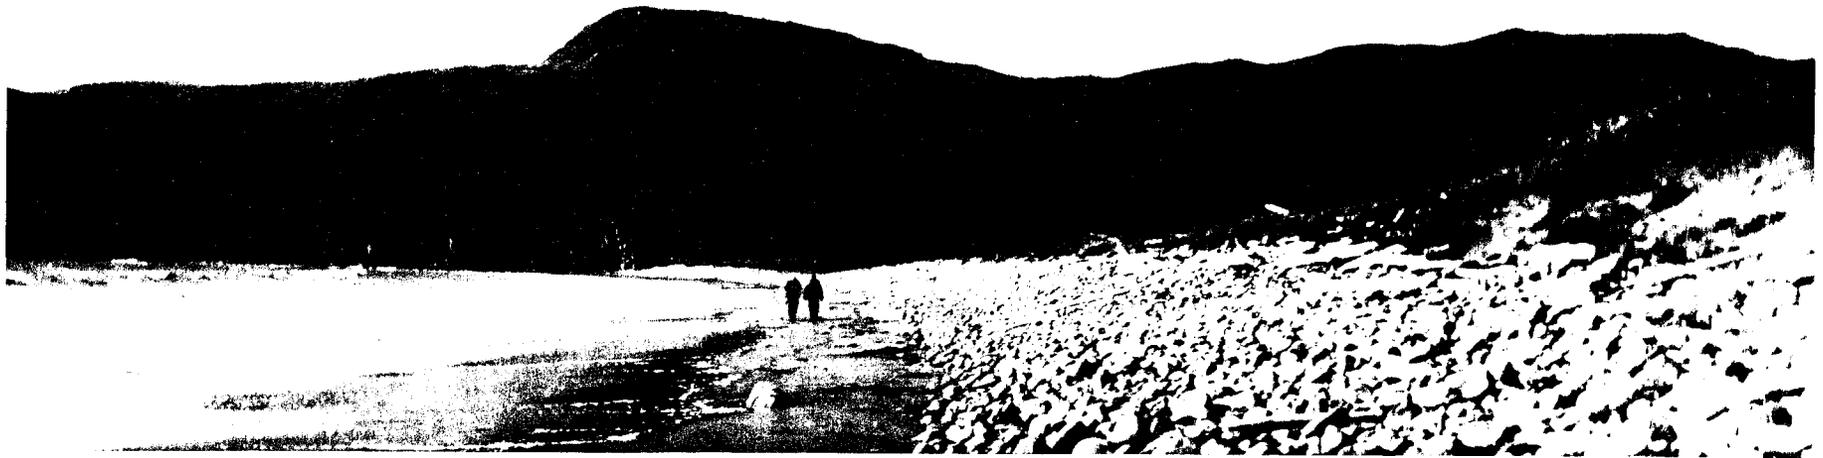
**Figure 2:** Ocean side of the beach berm of Red Cove Lake at approximately high tide (14 September 1992). Note the large-sized cobble.

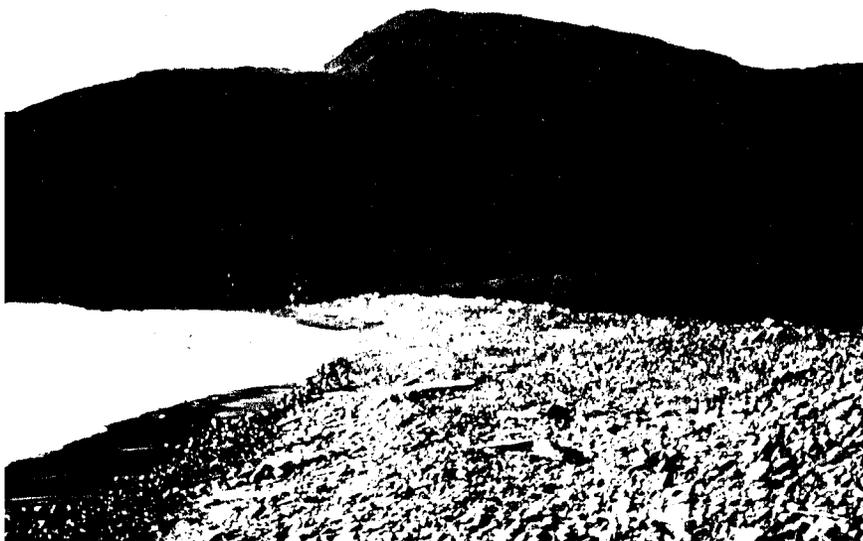
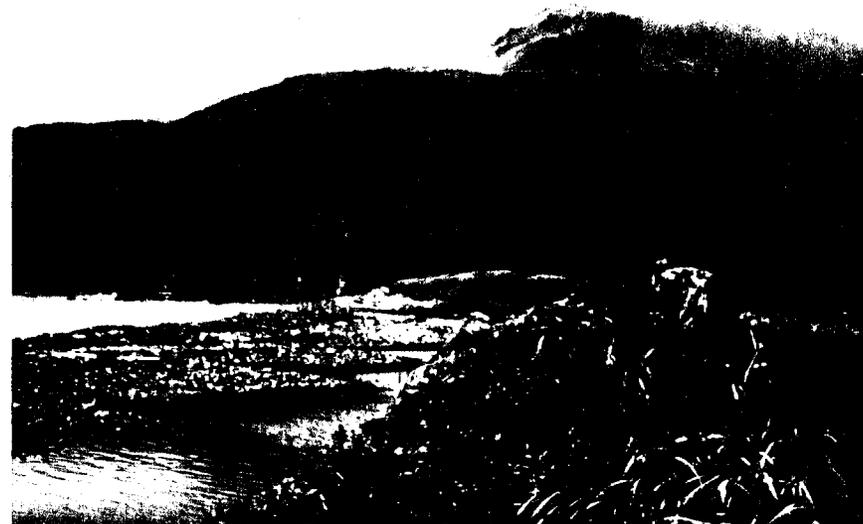
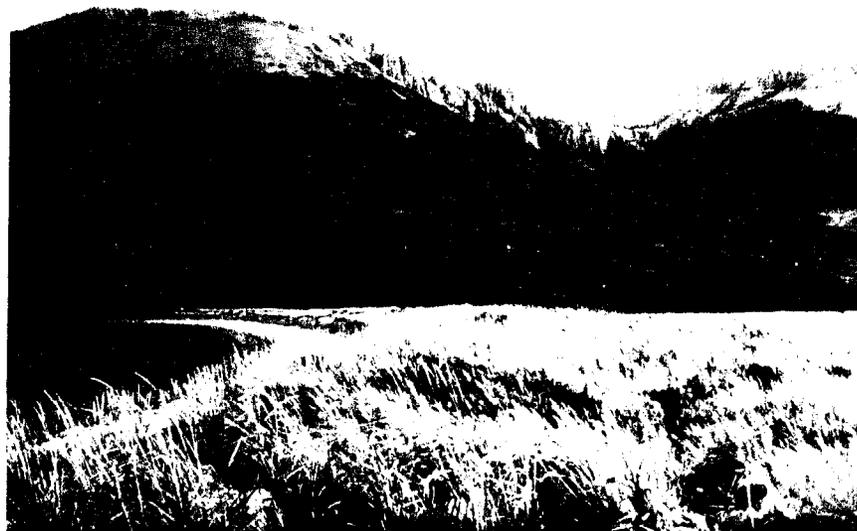
**Figure 4:** Beach berm of Red Cove Lake at approximately the vicinity of the normal outlet (14 September 1992). Note the large sized cobble. Beach berm of Red Cove Lake at approximately the vicinity of the normal outlet (14 September 1992). Note the small difference in elevation between the lake and the ocean. Vegetated portion of the beach berm of Red Cove Lake (14 September 1992). Note the small difference in elevation between the lake and the ocean.

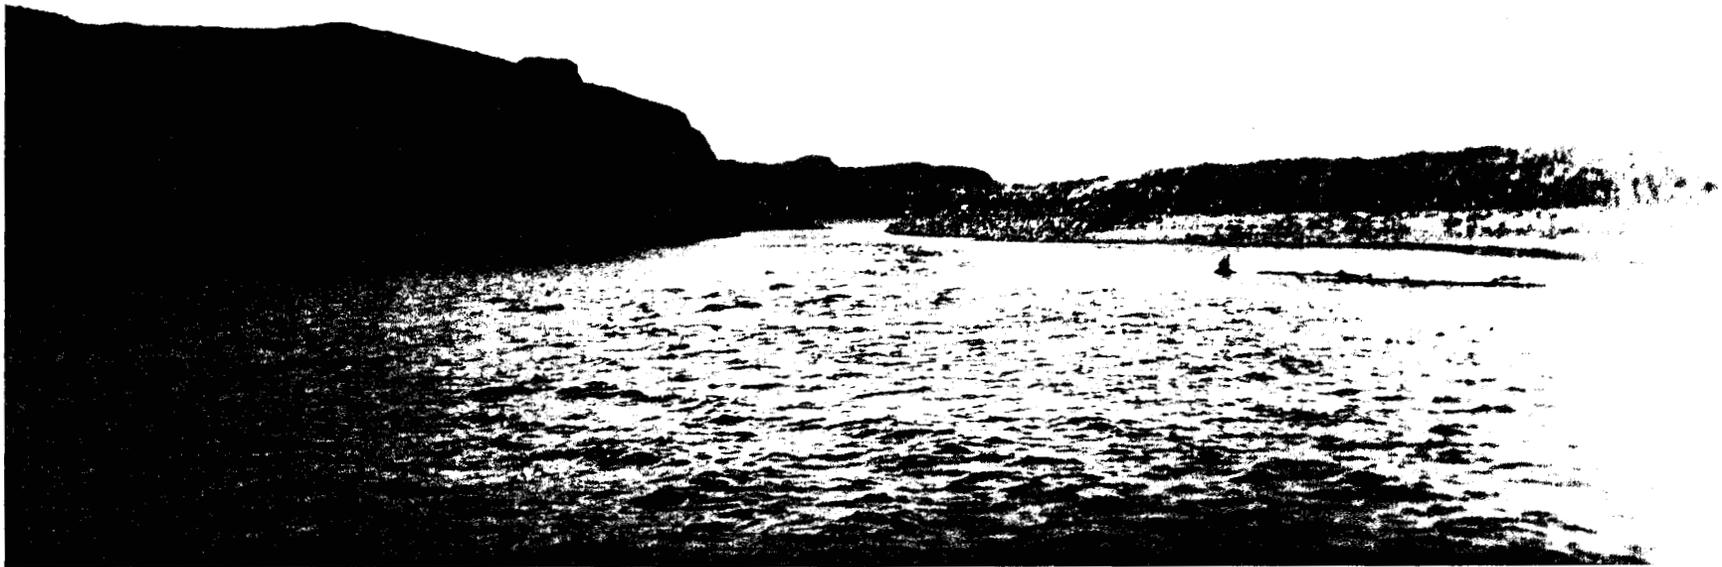
**Figure 7:** Outlet of John Nelson Lake viewed from the lake (14 September 1992). Note that the lake surface elevation is the same as sea level in the background.

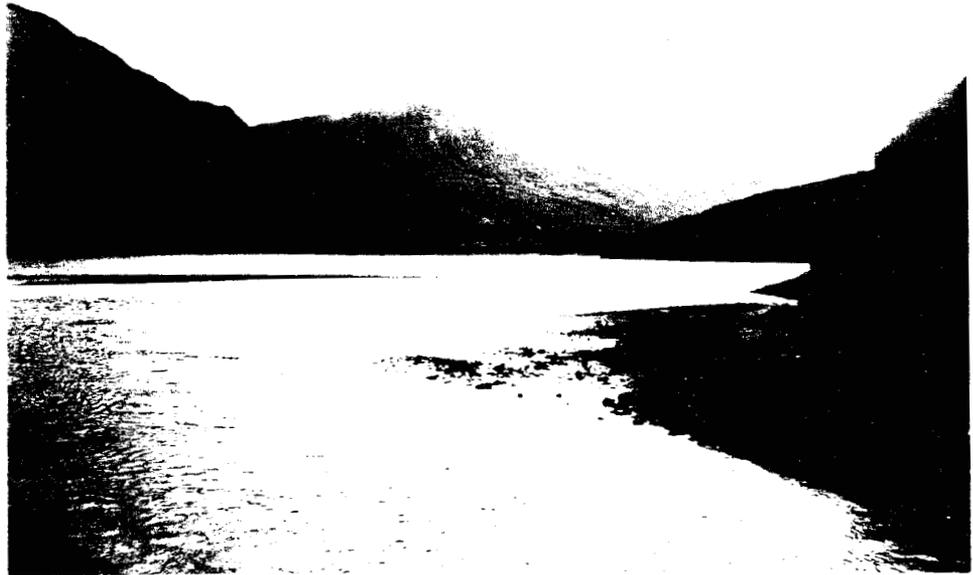
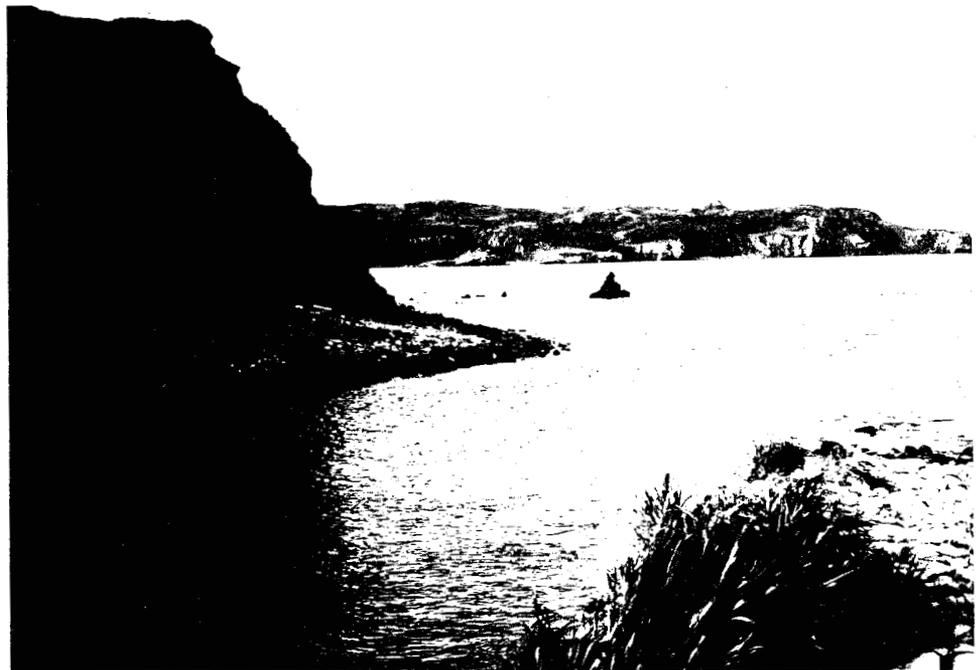
**Figure 8:** (Upper photograph) Outlet of John Nelson Lake (14 September 1992). Lake is in background. (Lower photograph) Outlet of John Nelson Lake (14 September 1992). Ocean is in background.

year the channel typically becomes blocked during winter storms by rock and floating timbers. This channel shows erosion working toward the lake. The stream outlet has been kept open by the caretaker of the cannery at Squaw Harbor, located directly across Baralof Bay from John Nelson Lake. He has voluntarily maintained this stream to eliminate blockages for the last 8-10 years. This year, however, is expected to be his last, due to his retirement. Based on information from the caretaker, this stream must be opened every year. When the outlet is open, John Nelson Lake is flooded by seawater during high tides.

It is recommended that this system also be surveyed annually for escapement and, at least twice a year (May and mid to late summer), remove blockages to assure that passage is maintained for both smolt and adult migrations. As with Red Cove Lake, a shallow channel should be opened across the lowest elevation of the beach berm to initiate water flow that will assist with the expansion of the channel. Most of the blockages at John Nelson Lake result from timbers deposited by storms. Efforts to open the channel can be provided by hand labor with hand tools by three people in one day.

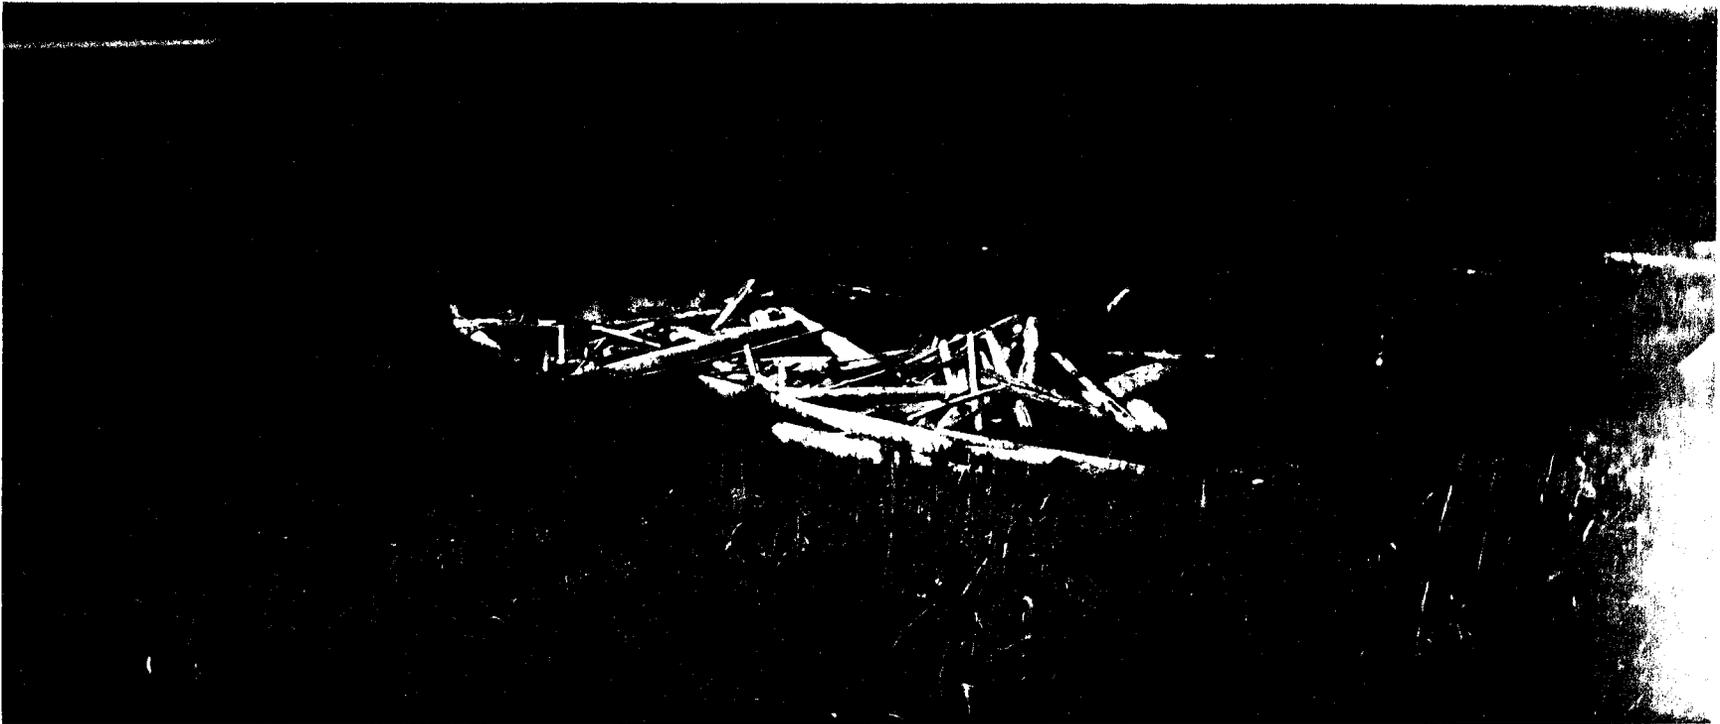
**Figure 12:** Log jam in the outlet stream from Wosnesenski Lake (15 September 1992) formed by a tsunami or storm-driven surge. A log jam such as this may periodically become a migration barrier for salmon smolts or adults.

1. Hire an all-labor force to open barrier on outlet: three people for one 12-hour day with chainsaws and other hand tools to cut/remove and burn driftwood. (This task is not expected to be repeated each year.)
2. Survey from aircraft twice per year for five years for spawner usage.

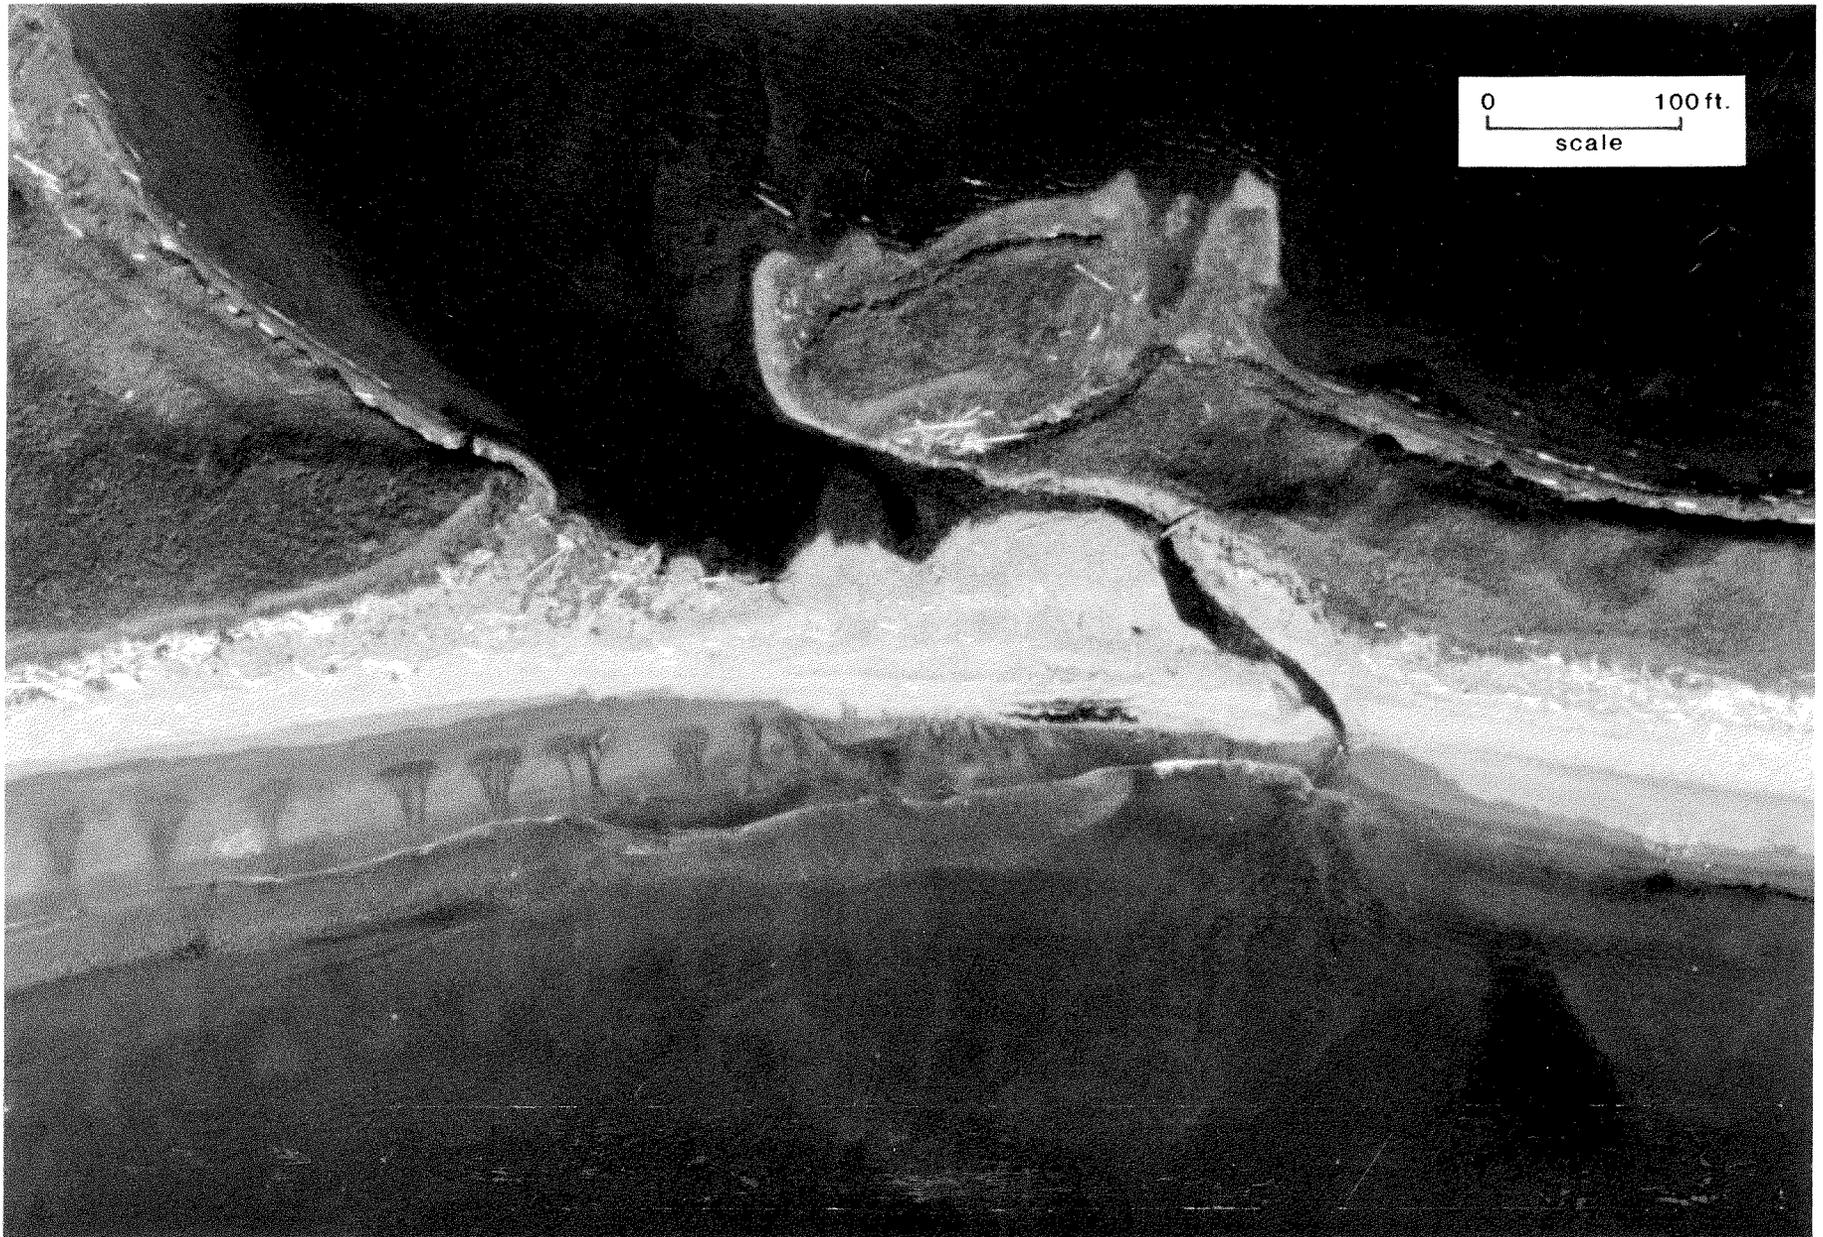
**Figure 1:** Aerial photograph of the free-flowing outlet stream of Red Cove Lake (9 September 1981). Note the V-shaped dark marks in the ocean beach (bottom-left) caused by the lake water leaching through the beach berm.

push rocks and gravel from the sea side onto the beach to raise and reinforce the beach berm, especially during a high tide. Because the lakes have relatively small drainage basins, the accumulation of fresh water inside the beach berms may not provide sufficient pressure to maintain the lake outflow during these events. In addition, because of the heavy surf action, the "fines" are sorted and extracted from the beach berm materials. It is evident in Figure 1 that Red Cove Lake drains through the beach berm, even when a free-flowing outlet stream exists.

The Red Cove Lake outlet (Figure 1) on 14 September 1992 was effectively blocked to prevent anadromous salmon migration by large, cobble-size (20-30 cm), smooth surface rocks (Appendix A) (Figures 2, 3, and 4). Water from the lake was percolating through the rocks at several points along the beach area adjacent to the lake. Adult coho salmon were observed jumping in the bay adjacent to the lake, and young salmonid fry were observed in the lake near the former lake outlet. It is apparent however, that under natural conditions, this blockage may be intermittent. Hauser (Appendix A) reported during an earlier investigation that the outlet stream from Red Cove Lake was free-flowing. It was approximately 6-8 in. deep and 10-12 ft. wide. Adult coho salmon were observed in the lake at that time. Also, on 9 September 1981, the outlet stream from Red Cove Lake was well-defined and functional (Figure 1).

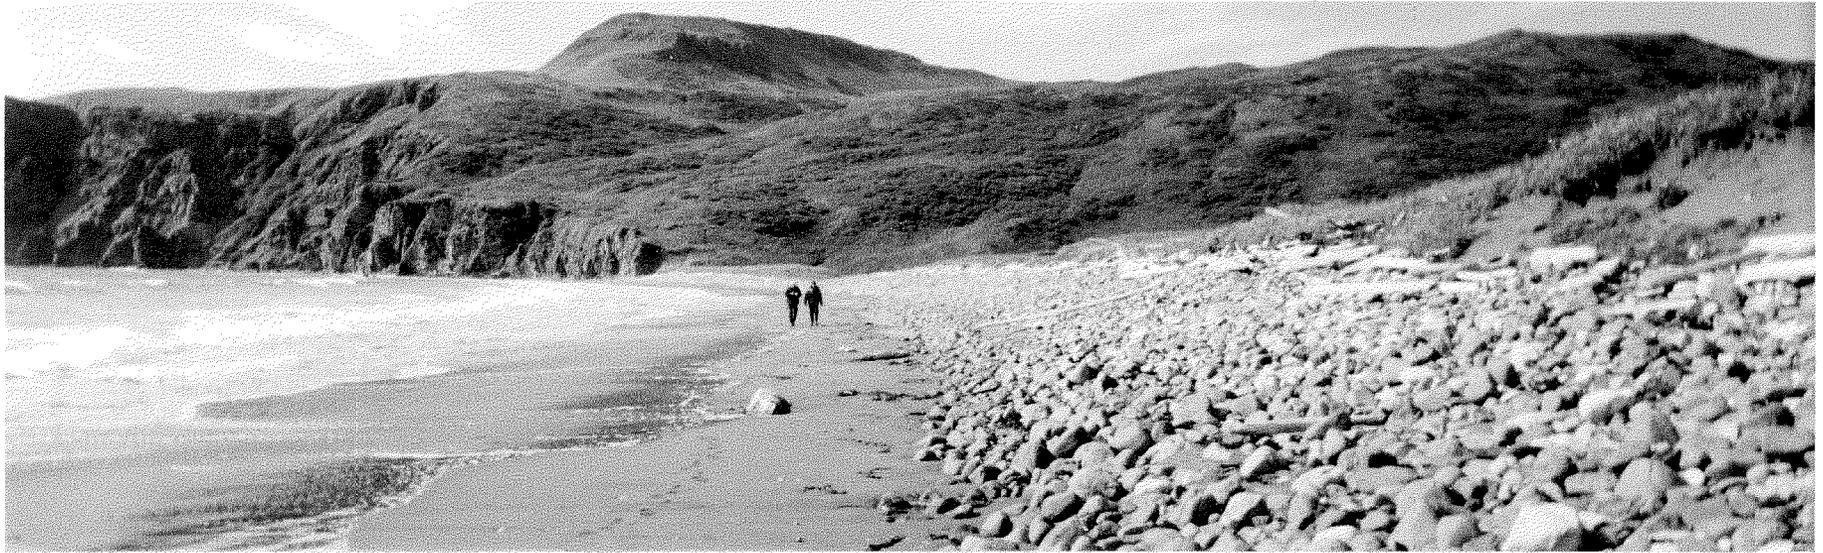
**Figure 2:** Ocean side of the beach berm of Red Cove Lake at approximately high tide (14 September 1992). Note the large-sized cobble.

It was concluded from the survey that a channel could be recreated by removing the rocks. The recommended method to recreate the channel is with the use of a small backhoe (e.g., Case 580 or equivalent) or small bulldozer (e.g., a Caterpillar D4 or equivalent). The channel should be approximately 70 m (230 ft) long and 5 m (16 ft) wide at the base (with banks sloped at 1:3) to create up to about 0.3 m (1 ft) of water depth flowing in the outlet stream to allow passage by the adult salmon (Figure 5). Because of the open exposure of the site and repeated storms, no structure is recommended to maintain a permanent opening. The site should be surveyed at least

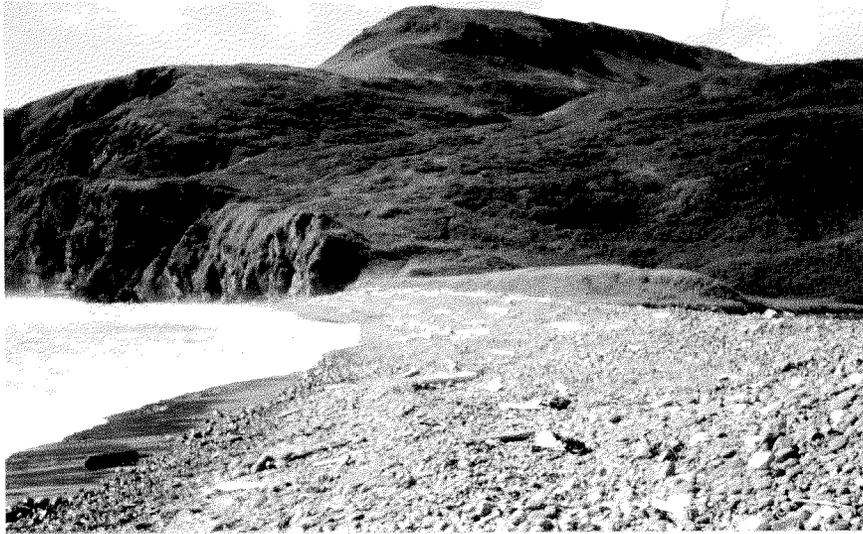
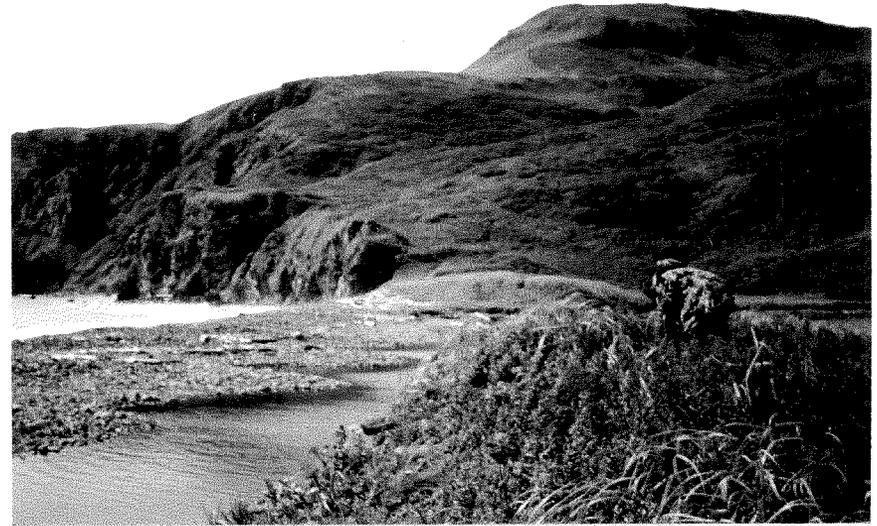
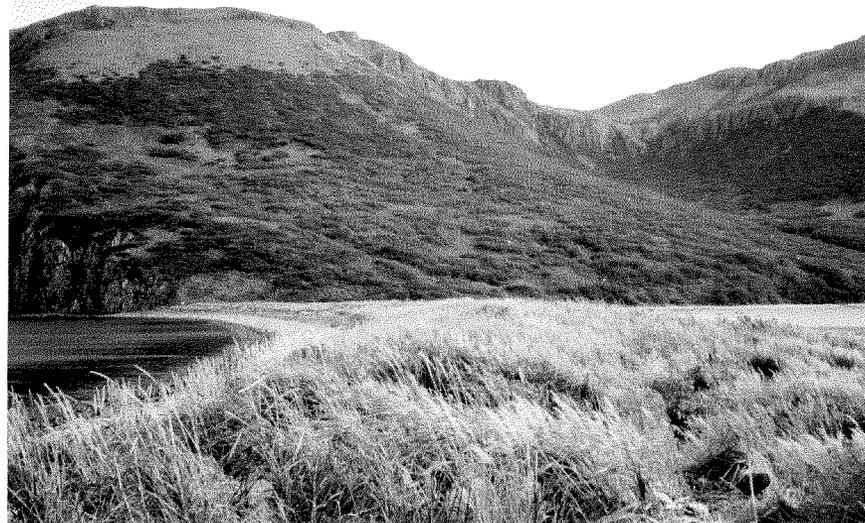
**Figure 4:** Beach berm of Red Cove Lake at approximately the vicinity of the normal outlet (14 September 1992). Note the large sized cobble. Beach berm of Red Cove Lake at approximately the vicinity of the normal outlet (14 September 1992). Note the small difference in elevation between the lake and the ocean. Vegetated portion of the beach berm of Red Cove Lake (14 September 1992). Note the small difference in elevation between the lake and the ocean.

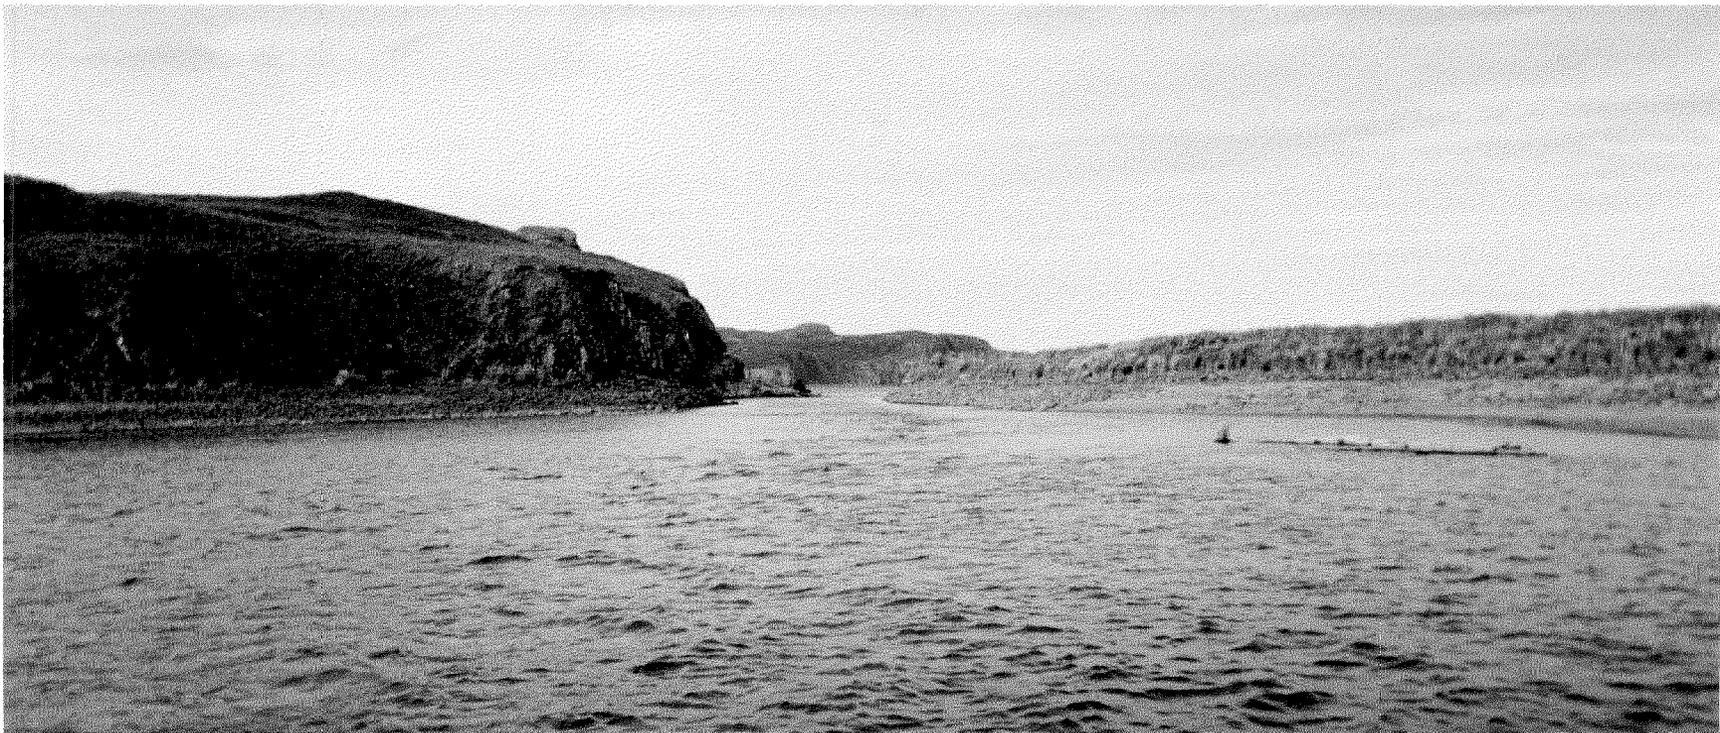
**Figure 7:** Outlet of John Nelson Lake viewed from the lake (14 September 1992). Note that the lake surface elevation is the same as sea level in the background.

John Nelson Lake (Figure 6) has an outlet directly to salt water on the north side of the lake (Figure 7). The west bank of the outlet is fractured rock but the east bank is made up of accumulated accretion of beach rock and sand. The channel is approximately 15 m (50 ft) wide and 60 m (200 ft) long at low tide (Figure 8). Each

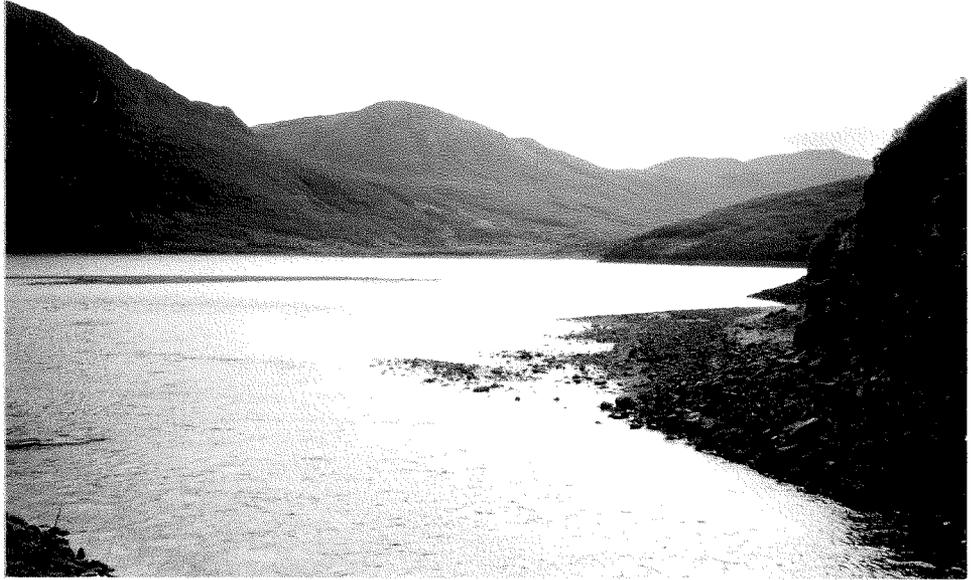
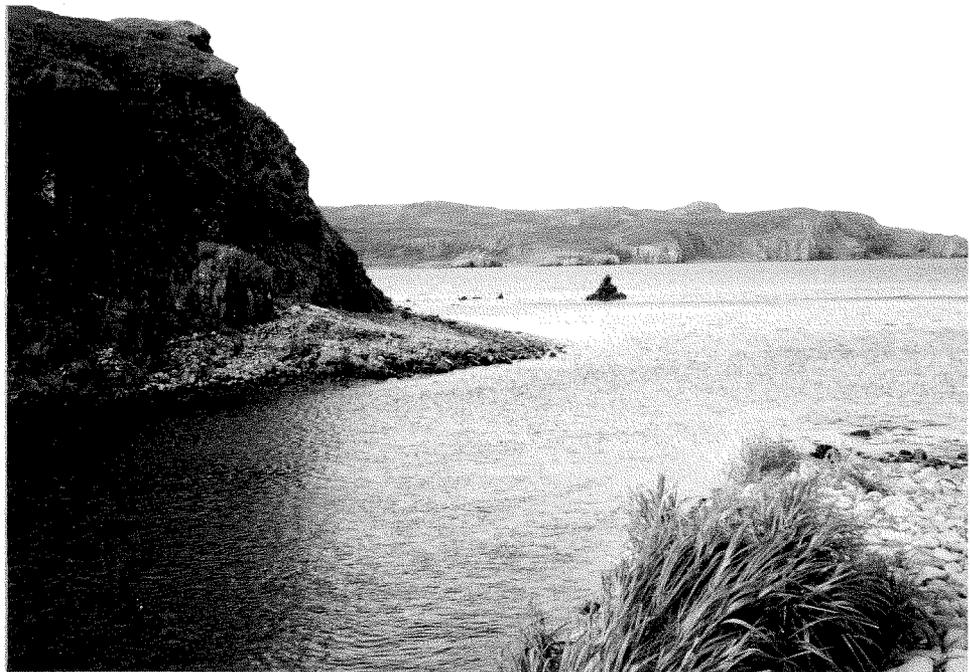
**Figure 8:** (Upper photograph) Outlet of John Nelson Lake (14 September 1992). Lake is in background. (Lower photograph) Outlet of John Nelson Lake (14 September 1992). Ocean is in background.

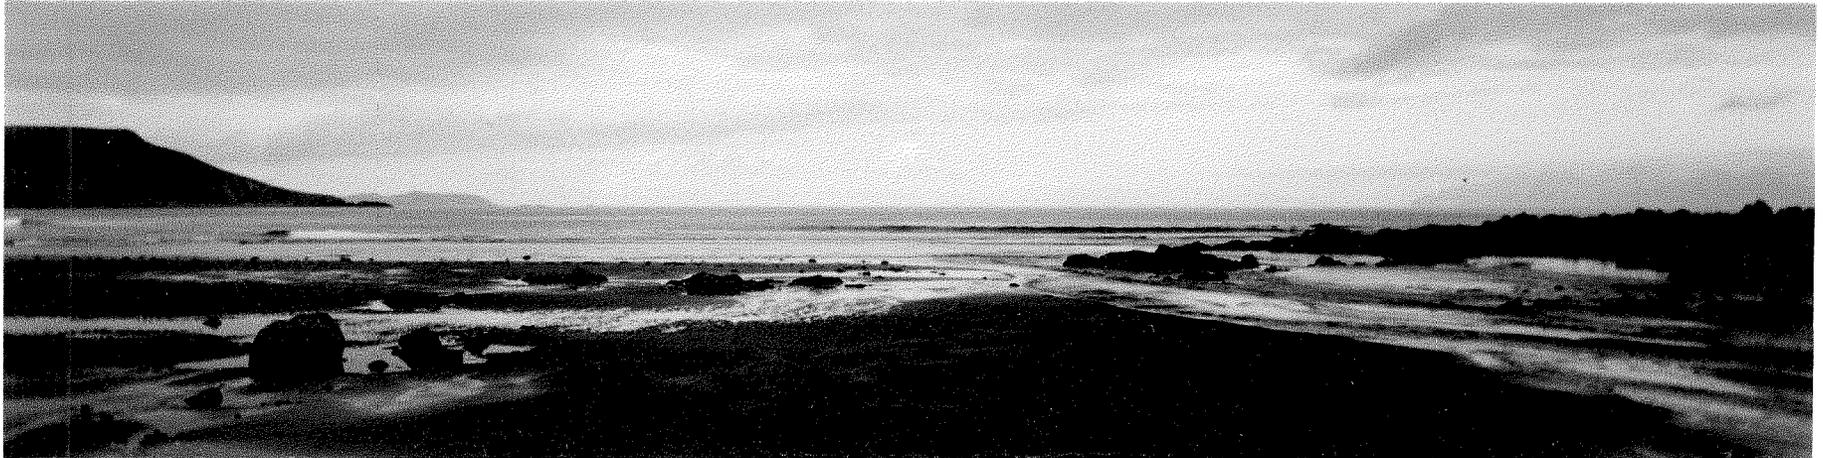
**Figure 10:** Intertidal reach of Wosnesenski Creek (15 September 1992). Note the shallow, widespread appearance of the water that may be a migration barrier during low tide.

Wosnesenski Lake is very shallow. The outlet channel from the lake has a low-gradient, well-developed meander pattern approximately 390 m (1,275 ft) to the beach (Figures 9, 10, and 11). The channel is 3.0 m (10 ft) wide and, at the time of the survey, was flowing approximately 11,356 liters/min (3000 gpm). The only blockage in the stream was found halfway up the stream at an elbow where several driftwood timbers and logs were jammed (8 m x 2.5 m) (Figure 12). This blockage could be removed with the use of chainsaws and would be the easiest of the three systems surveyed to keep open. The only blockage expected would be by timbers brought up by storm or high-tide surges. It appears that this does not happen often, as there was no evidence of other timbers lying in the area.

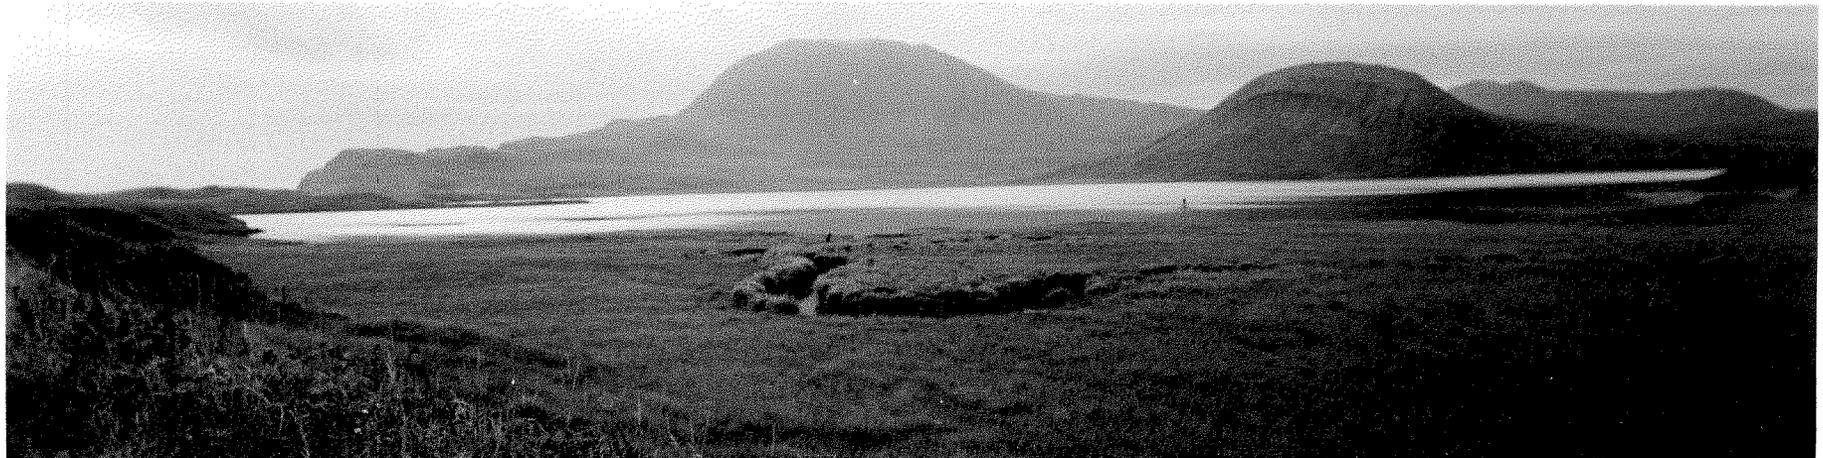
**Figure 11:** Outlet stream from Wosnesenski Lake (15 September 1992). Note that flat terrain and low stream gradient.

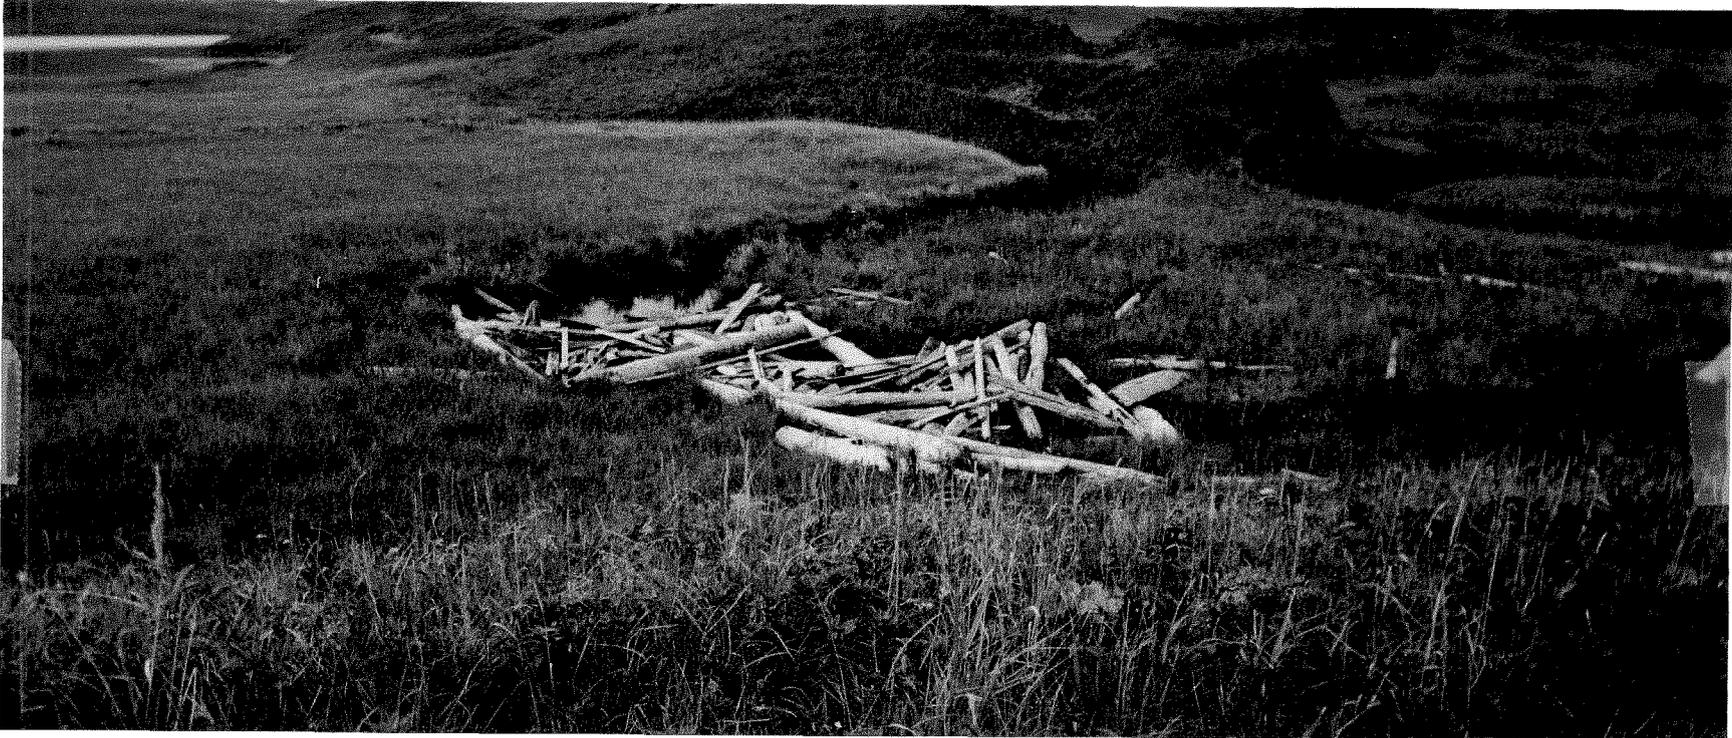
**Figure 12:** Log jam in the outlet stream from Wosnesenski Lake (15 September 1992) formed by a tsunami or storm-driven surge. A log jam such as this may periodically become a migration barrier for salmon smolts or adults.
