**EVALUATION OF HYDROACOUSTIC SITE ON THE YUKON RIVER TO MONITOR
PASSAGE OF SALMON ACROSS THE US/CANADA BORDER, 2003**

REGIONAL INFORMATION REPORT¹ NO.3A04-18

Alaska Department of Fish and Game
Commercial Fisheries Division
AYK Region
333 Raspberry Road
Anchorage, Alaska 99518

March 2004

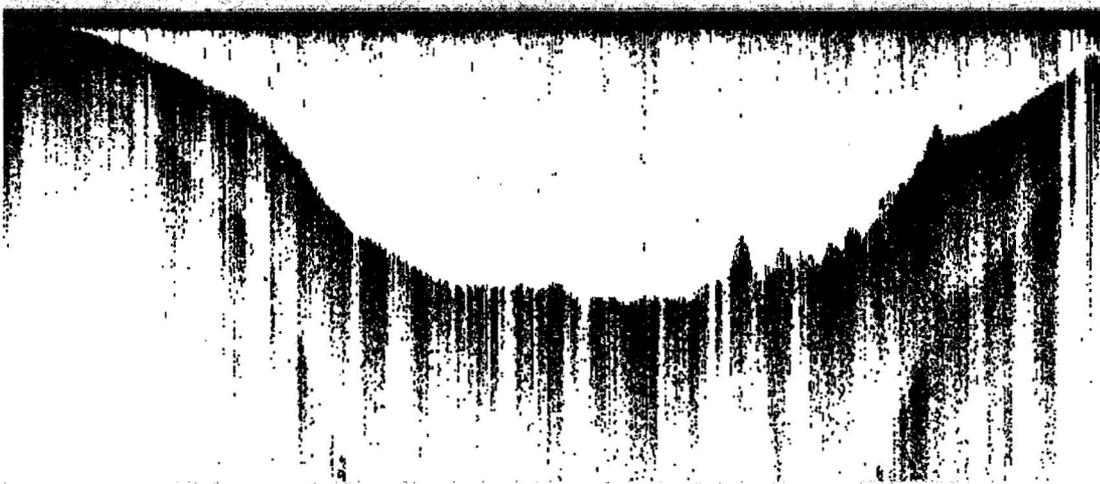
Chart 22: Few hundred yards down from Border. $N 64^{\circ}140.976'$, $W141^{\circ}00.612'$
