Kenai River

Restoration Project Assessment

KENAI RIVER RESTORATION PROJECT ASSESSMENT

Inter-Fluve, Inc.
1020 Wasco Street, Suite I
Hood River, OR 97031
(541) 386-9003
www.interfluve.com

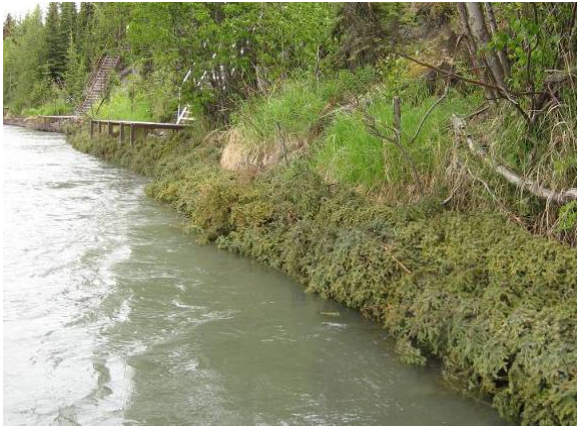
Typical cabled spruce tree revetment

Cabled spruce tree revetments (CSTs) include the cabling of spruce trees to the streambank in order to provide streambank protection and erosion control. CSTs may include a single layer of spruce trees, multiple spruce trees bundled together, or stacked layers. Spruce trees are placed parallel to the streambank, oriented with their tops facing downstream and typically overlap 1/3 to 1/2 their length in a shingle fashion. The trees are secured to the bank with cables and earth anchors (e.g. duckbill anchors). CSTs limit streambank erosion and also provide velocity refuge and cover for juvenile salmonid rearing.

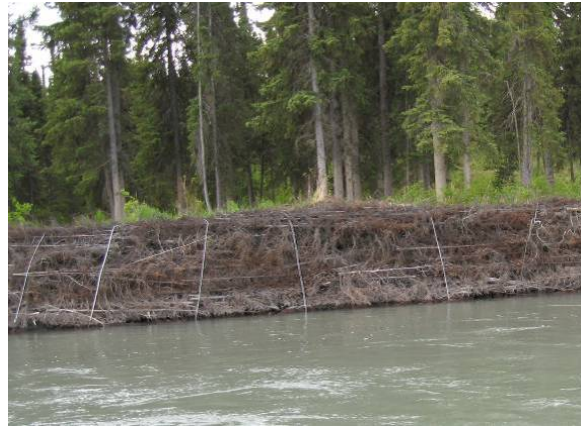
Large cabled spruce tree revetment with multiple stacked layers

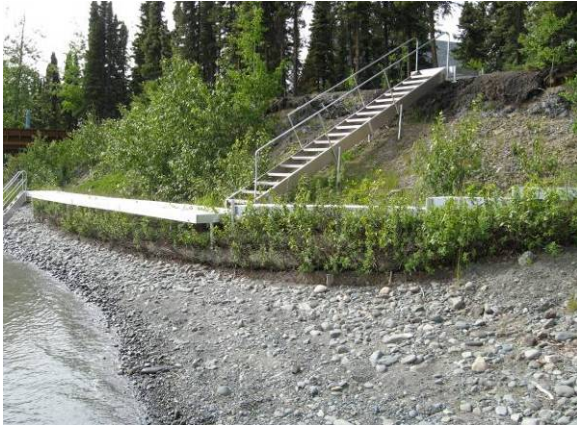
Typical bioengineered bank

For the purposes of this assessment, bioengineered bank treatments (BEBs) include a number of different restoration strategies including coir logs, live siltation, brush layering, and fabric-wrapped soil lifts. These techniques typically include the use of a coir log toe overlaid with fabric-encapsulated soil/gravel lifts that are layered with willow live stakes. The “brush layering” technique described in Walter et al. (2005) appears to be the most common design utilized on the Kenai River. Bioengineered banks are considered a fish-friendly method of bank stabilization.

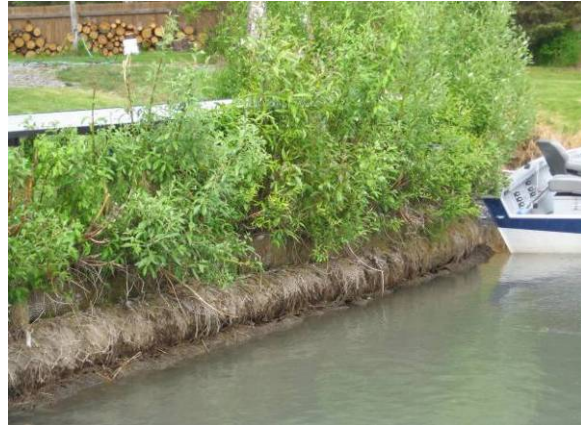
Bioengineered bank with coir log toe and good willow growth

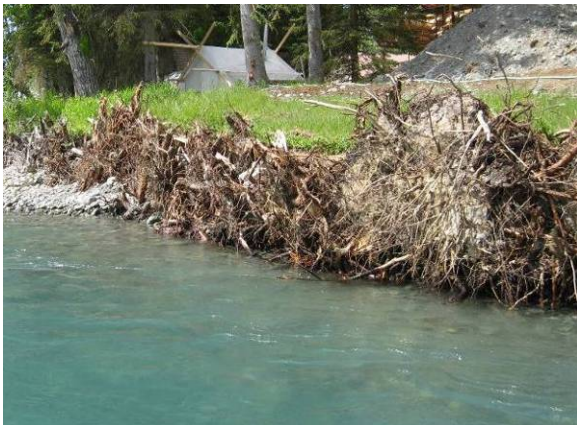
Typical rootwad revetment

Rootwad revetments consist of logs with attached rootwads that are buried into the bank to provide streambank protection and fish habitat. The boles are buried perpendicular to the river with the rootwad fan facing the river and protecting the bank. The rootwads are placed close together or overlapped to ensure continuous bank protection. The rootwads are backfilled with soil or gravel. Biodegradable erosion control fabric (e.g. coir) is often used to reinforce the backfilled material or to construct fabric-wrapped lifts on top of the tree boles. Rootwad revetments reduce streambank erosion and provide juvenile fish habitat.

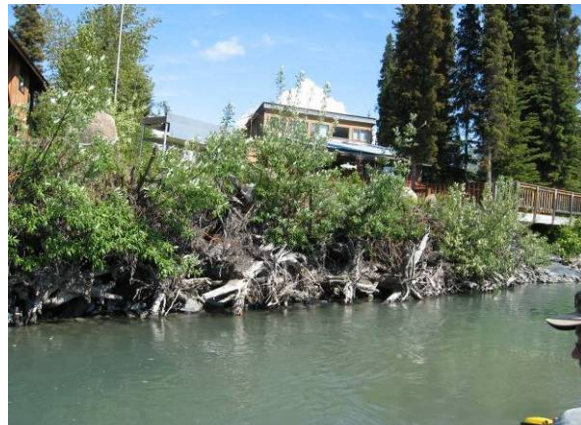
Rootwad revetment with willow live staking

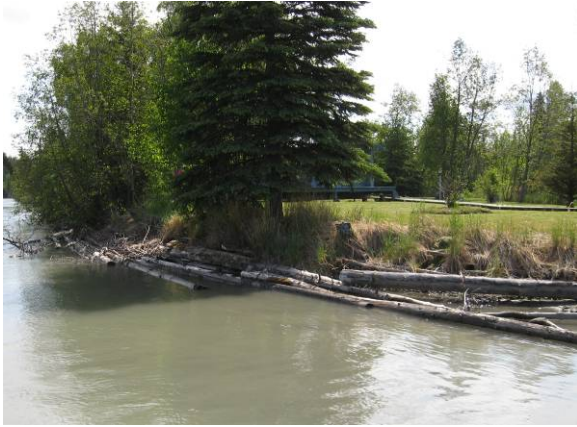
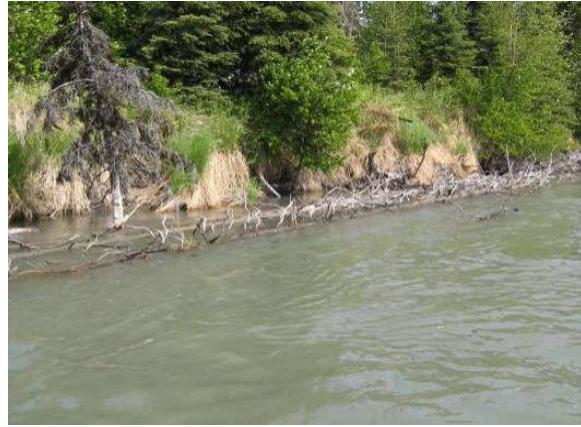
Typical tethered log treatment

Tethered logs include floating logs laid in the water parallel to the streambank and tethered to the bank with rope or cable. These treatments typically include logs in excess of 6 inches diameter and 15 feet long and may be single logs “shingled” along the bank or may consist of multiple logs extending out into the channel. Tethered logs reduce streambank erosion by dampening boat wake energy and by creating a velocity break along the shoreline. They also provide velocity refuge and cover for juvenile salmonid rearing.

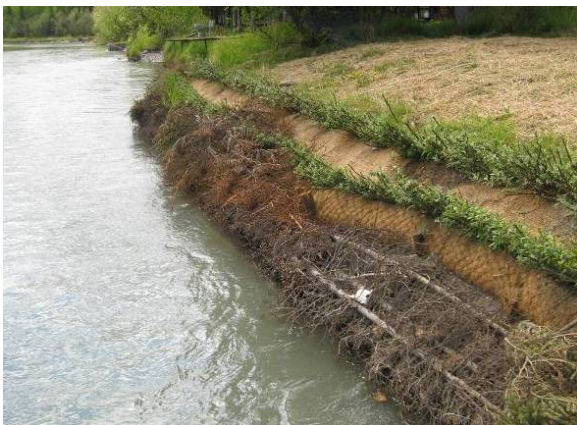
Typical combination approach (cabled spruce trees and bioengineered bank)

Many streambank treatments along the Kenai River include a combination of the above approaches. The most common combination projects incorporate BEBs and CSTs. For these techniques, a BEB is constructed first and CSTs are then installed along the bank in front of the structure. Combination approaches are common along the Kenai River. These treatments typically provide erosion control as well as fish habitat benefits.

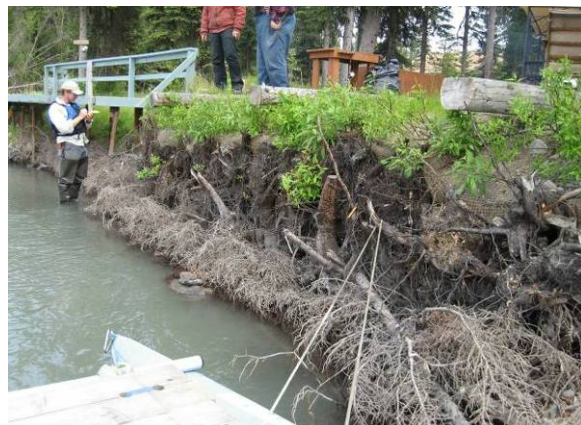
Combination approach using cabled spruce trees and rootwad revetment

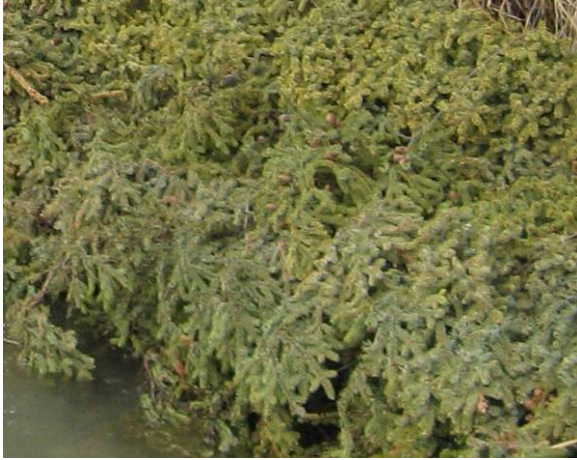
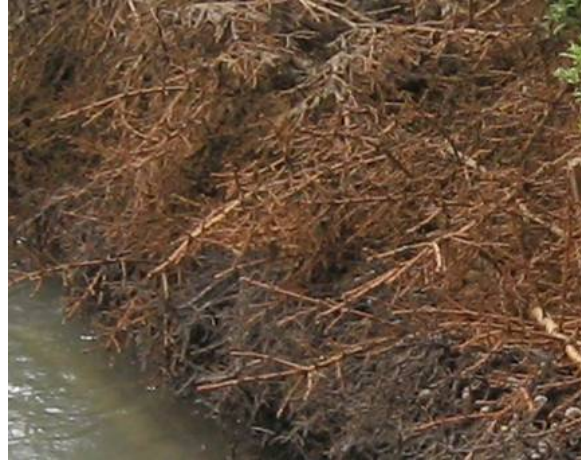
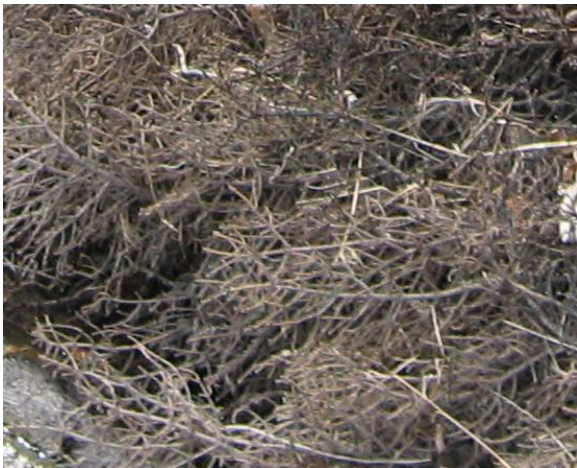
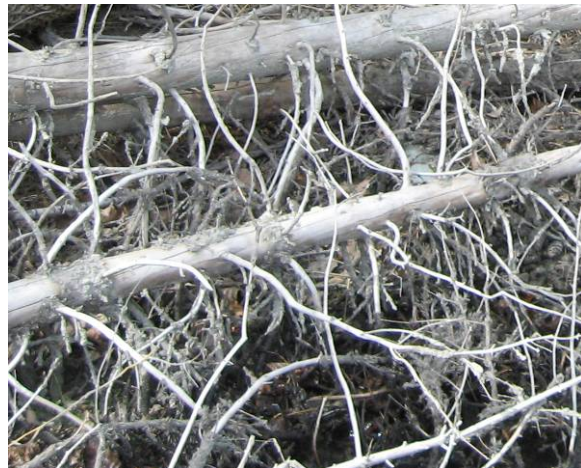
Green needles present
(0-1 years old)

Brown needles and/or cones present
(1-2 years old)

Needles absent but fine branches present
(2-3 years old)

No fine branches present
(>3 years old)

Projects were assigned age classes for cases where project age could be reliably determined. The age of the project, or time since last maintenance, was determined through visual inspection of vegetation growth (for restoration plantings) or vegetation decay (for CSTs). In some cases, conversations with landowners assisted with determination of project age or the time since last maintenance. A system for determining the age of CSTs was developed by combining the observed decay of the spruce trees with project age obtained from landowners. Indicators of decay and corresponding age are included in Table 2. Example photos of spruce tree ages are included in Figure 1.

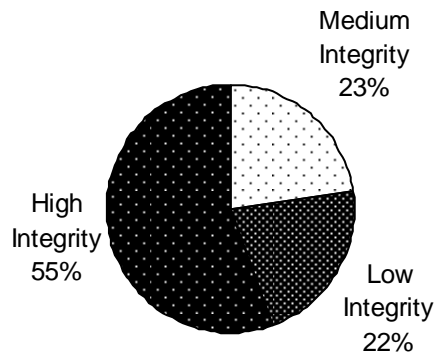
Figure 5. Results of project integrity/condition assessment for all projects.

More than half (55%) of the projects were identified as being in a High Integrity condition, with the remainder split evenly between Medium and Low Integrity (Figure 5). The integrity of projects varied by project type (Figure 6). All of the rootwad projects had High Integrity but the sample size is low. Greater than 70% of combination approaches were in the High Integrity category, with very few Low Integrity projects. Over half of CST projects had High Integrity with the remainder split evenly between Medium and Low Integrity. Bioengineered banks were mostly High or Low Integrity, with fewer projects of Medium Integrity. Tethered logs were mostly in the Medium Integrity category. Participation in the Cost-Share Program does not appear to influence project integrity (Figure 7).

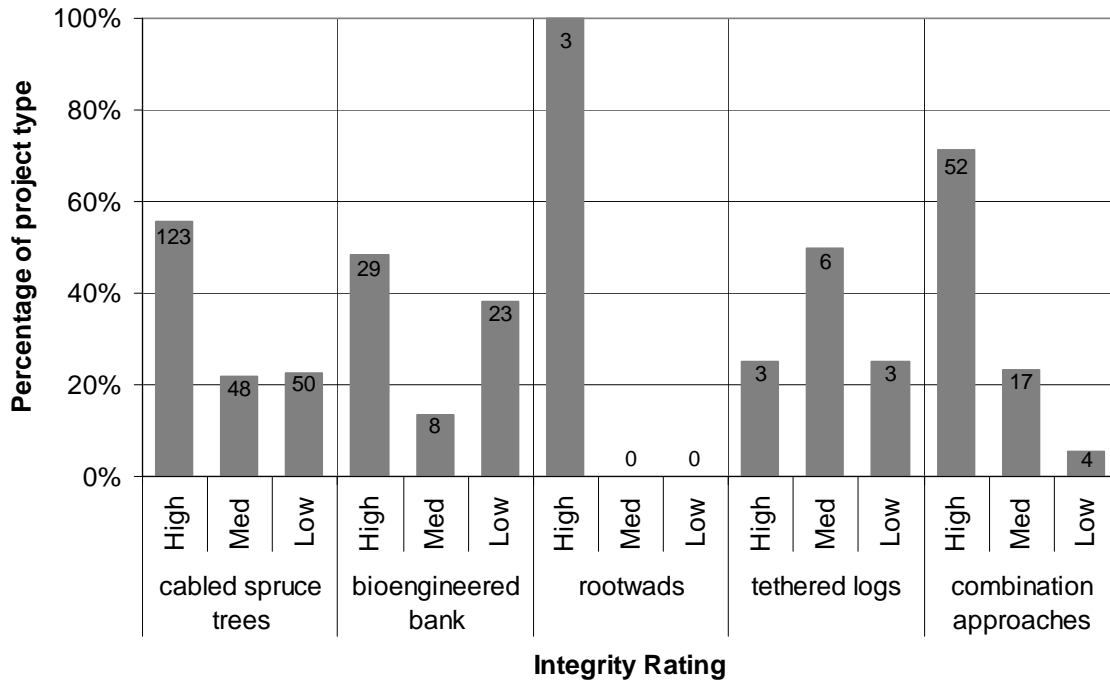
Figure 6. Integrity ratings by project type. The numbers of projects in each integrity rating category are provided on the bars. Combination approaches do not include those incorporating rip-rap.

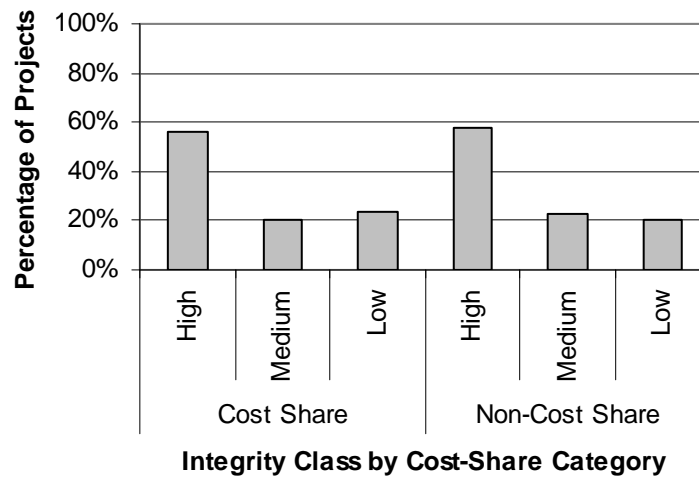
Figure 7. Effect of cost-share participation on project integrity. Participation in the Cost-Share Program does not appear to influence project integrity.

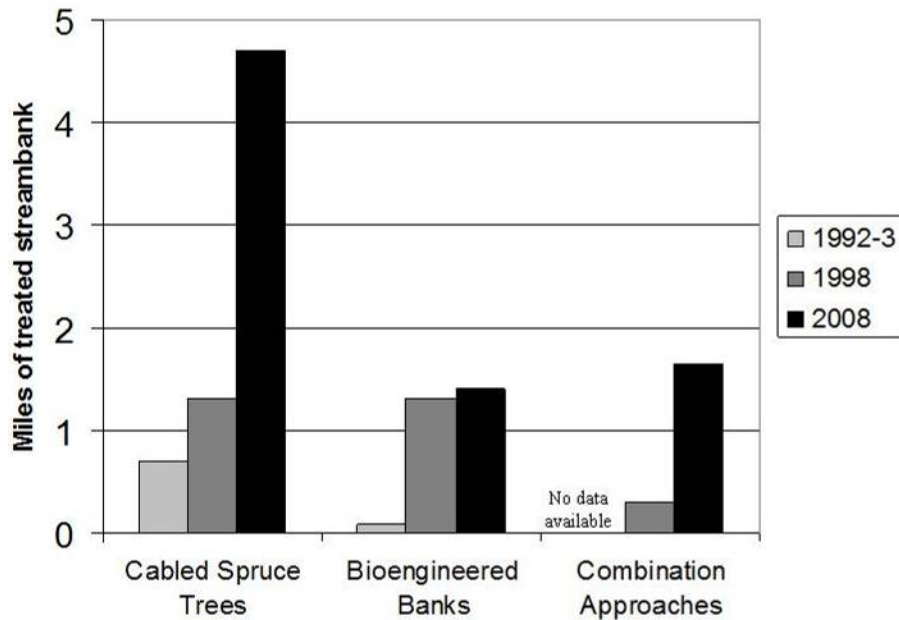
Figure 8. Change in frequency of projects since the early 1990s. 1992-3 data is from the 309 Study (Liepitz 1994); 1998 data is reported in Dorava (1999); and 2008 data is from the current study.

there has been an 8.8-fold increase in projects that use natural materials, such as CSTs and BEBs that reduce erosion but also provide some fish habitat benefit (Figure 8).

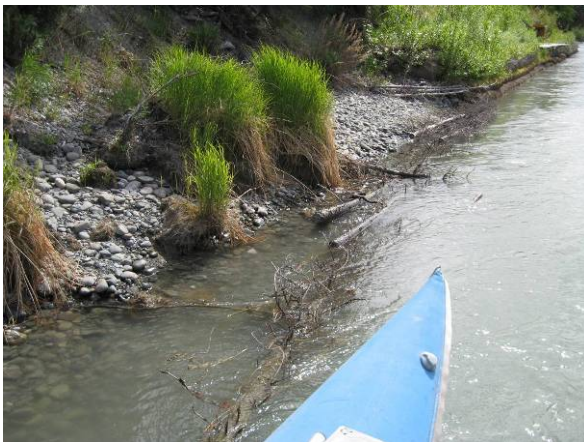
Figure 10. View looking upstream at BEB project near RM 31. Notice severe bank erosion and soil loss upstream of project (site of failed CST project) and effective bank protection provided by BEB.

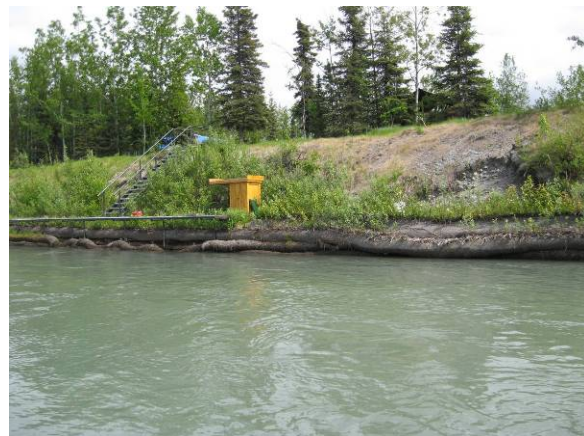
Figure 11. BEB near RM 31. BEB is halting erosion; however, fabric wraps are beginning to fail. Even with vigorous willow growth (as on the left side in this photo), eventual collapse of the wraps will undermine the bank and create continued erosion and failure of the willows.

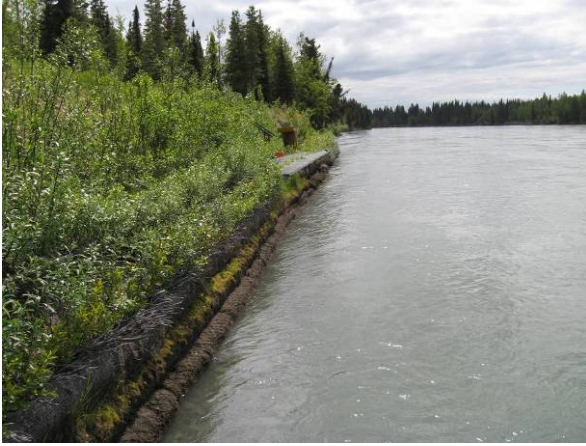
Figure 12. Bioengineered banks provide good bank protection but create linear, uniform banks with little cover habitat for juvenile fish (left bank near river mile 31).

Field observations and previous studies (Hauser et al. 2000) suggest that BEBs may provide less habitat cover due to their tendency to reduce near-bank complexity. This may be especially the case at lower river flows that do not inundate the willows. Stability of BEBs requires them to have little or no overhang that is accessible to juvenile fish. At high flows, willows will provide some overhanging cover but may not effectively reduce near-bank velocity. Furthermore, the smooth and linear nature of soil wraps and coir logs decreases the availability of velocity refuge, which on natural banks is provided by eddies, pocket water, alcoves, and the interstitial spaces within exposed tree roots or instream woody debris. Bank uniformity created by BEBs can be seen in Figure 12. This is typical of many of the BEB projects, where high velocities are present along the constructed bank and there is little in the way of bank overhang or instream wood cover.

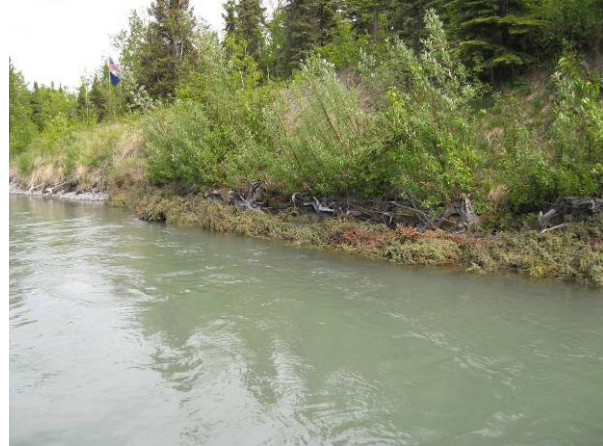
Figure 13. This combination project (rootwads plus cabled spruce trees) provides bank protection and a diversity of habitat cover along the bank (left bank near river mile 31).

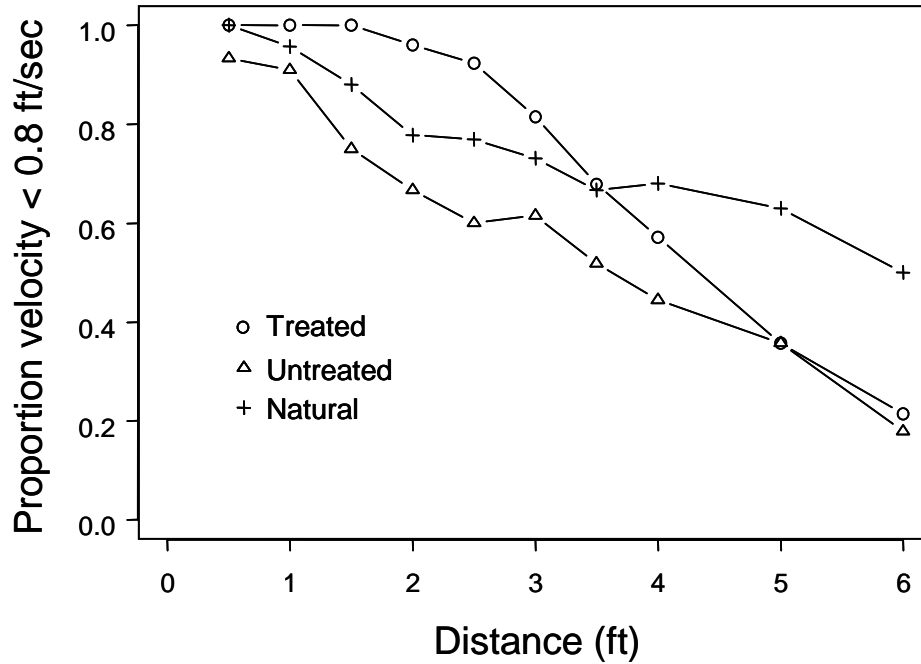
Figure 25. Mean proportions of low velocity values (≤ 0.8 ft/sec) by treatment type and distance interval. Means were computed across sites; initial proportions were computed across transects.

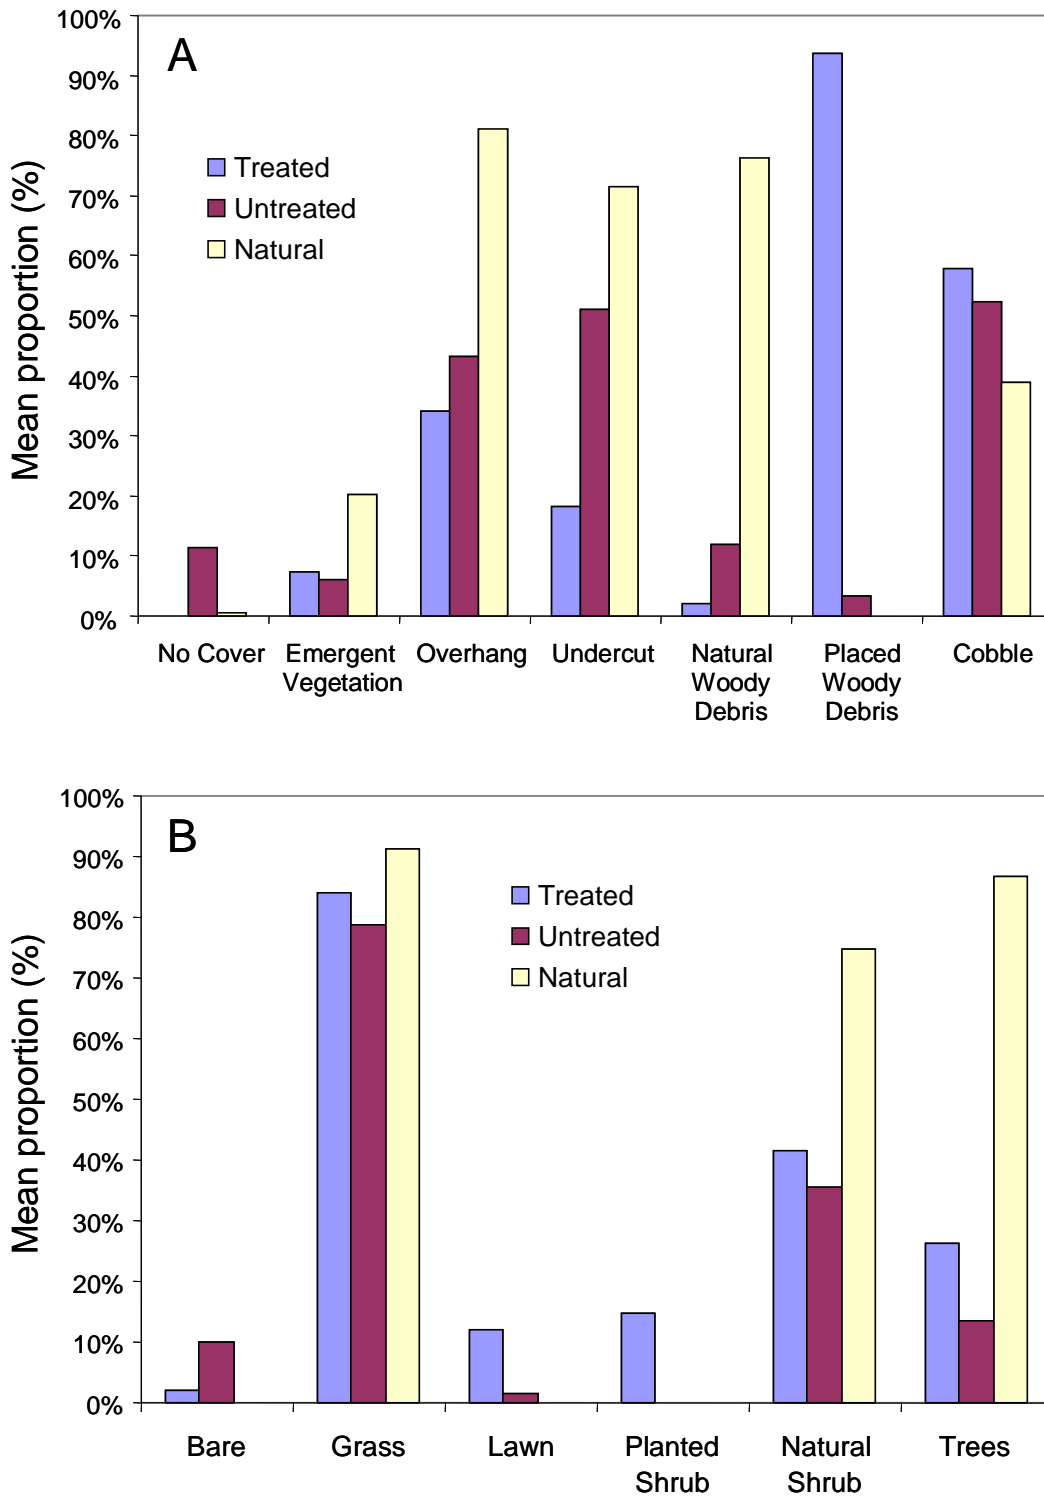
Figure 30. Mean proportion (%) across plots of (A) habitat-cover types, and (B) ground-cover (vegetation) types.

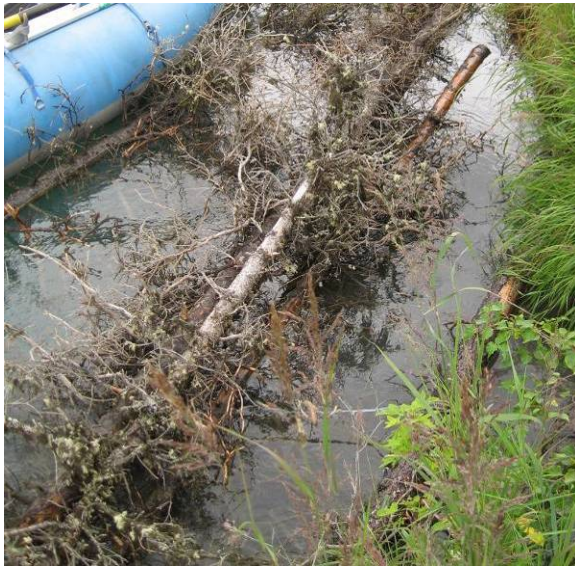
Figure 31. Loosely packed CSTs allow for juvenile salmon access to within and behind the structure, where there is good velocity refuge, overhanging vegetation, and access to undercut banks.

cover because buoyant CSTs provide fish access to underneath the structure. This is especially the case with loosely bundled CSTs and less the case with CSTs packed and secured tightly against the bank. The above observations suggest that tighter packed CSTs may have greater erosion protection but less access by juveniles (both beneath and within the CSTs); and looser packed CSTs may have less erosion protection but greater habitat benefit.

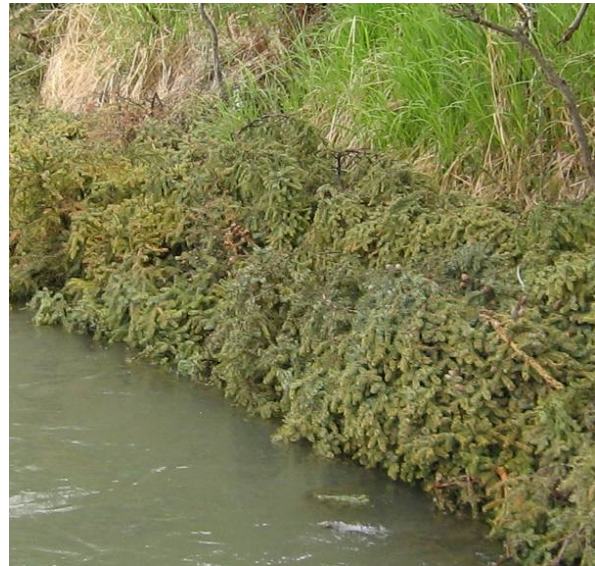
Figure 32. Tightly packed CSTs may provide more effective erosion control but may simplify the bank and limit access to within or behind the structure for juvenile salmon rearing.
