REVISED ANADROMOUS STREAM CATALOG OF  
SOUTHEASTERN ALASKA

Appendix B - District 2

Moira Sound Area Survey Data

By:  
Paul Novak

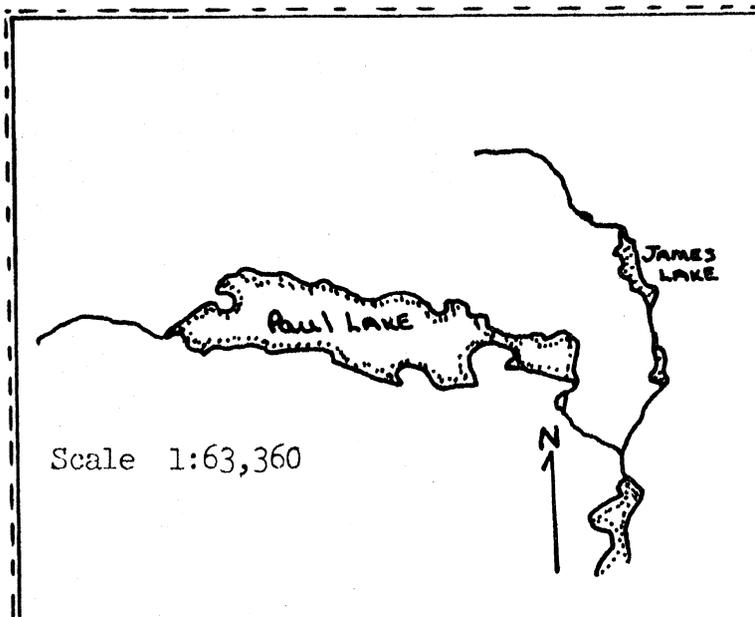
Dolomi Creek  
102-20-40  
Novak, Downey, Elton

1-2' Deep  
20' Wide  
Moderate Vel.

10% ASA  
Above falls to end  
of survey

Stream above Paul's Lake: 10 salmon  
sighted spawning in lower end of the  
stream. Ten feet wide, 8-10" deep  
with slow moving waters over gravel  
containing some silt. Alder at mouth  
with spruce along stream.

8-10' Falls barrier  
for pink salmon

100 yd. from falls to tributary  
Good spawning area  
25' Wide  
10" Deep  
50% ASA  
Gravel-Rubble

20' Wide  
8" Deep  
90% ASA

Gravel & Rubble  
150 yds Long  
60' Wide  
10" Deep  
Some silt along banks

Pink and chum remains  
were found from the falls  
to the I.T.Z.

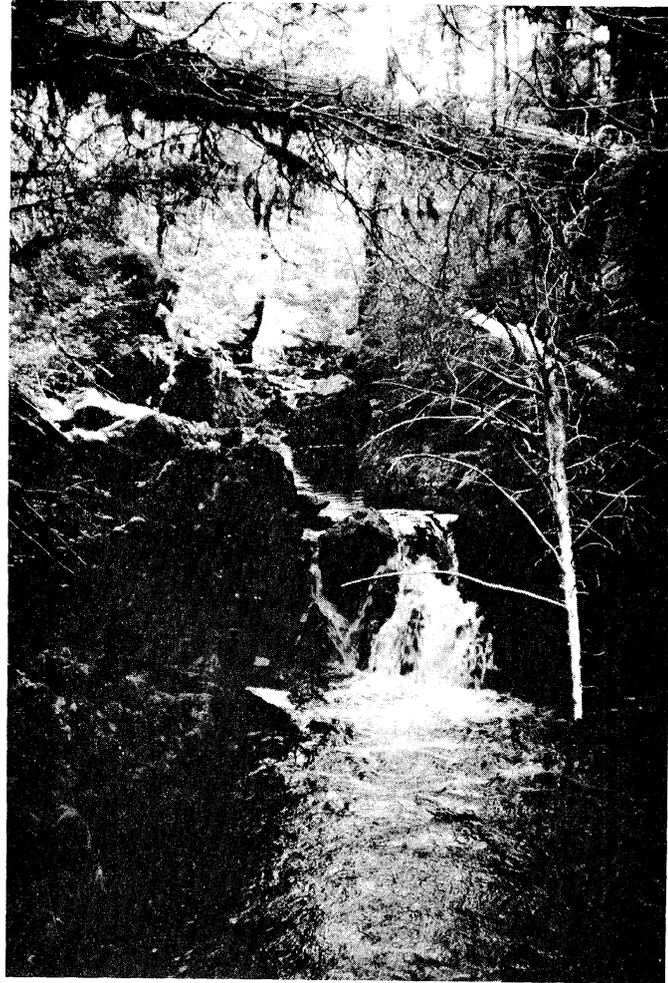
Johnson Cove - Moira Sound

Name \_\_\_\_\_ Catalog No. 102-30-07  
 Latitude N 55° 00' 56" WR No. \_\_\_\_\_  
 Longitude W 132° 02' 58" K No. \_\_\_\_\_  
 Geodetic Map No. Craig A-1 Work Area Ketchikan  
 Location Moira Sound Watershed Length \_\_\_\_\_  
 Drainage Area of Watershed \_\_\_\_\_  
 Water Supply Type Spring and drainage

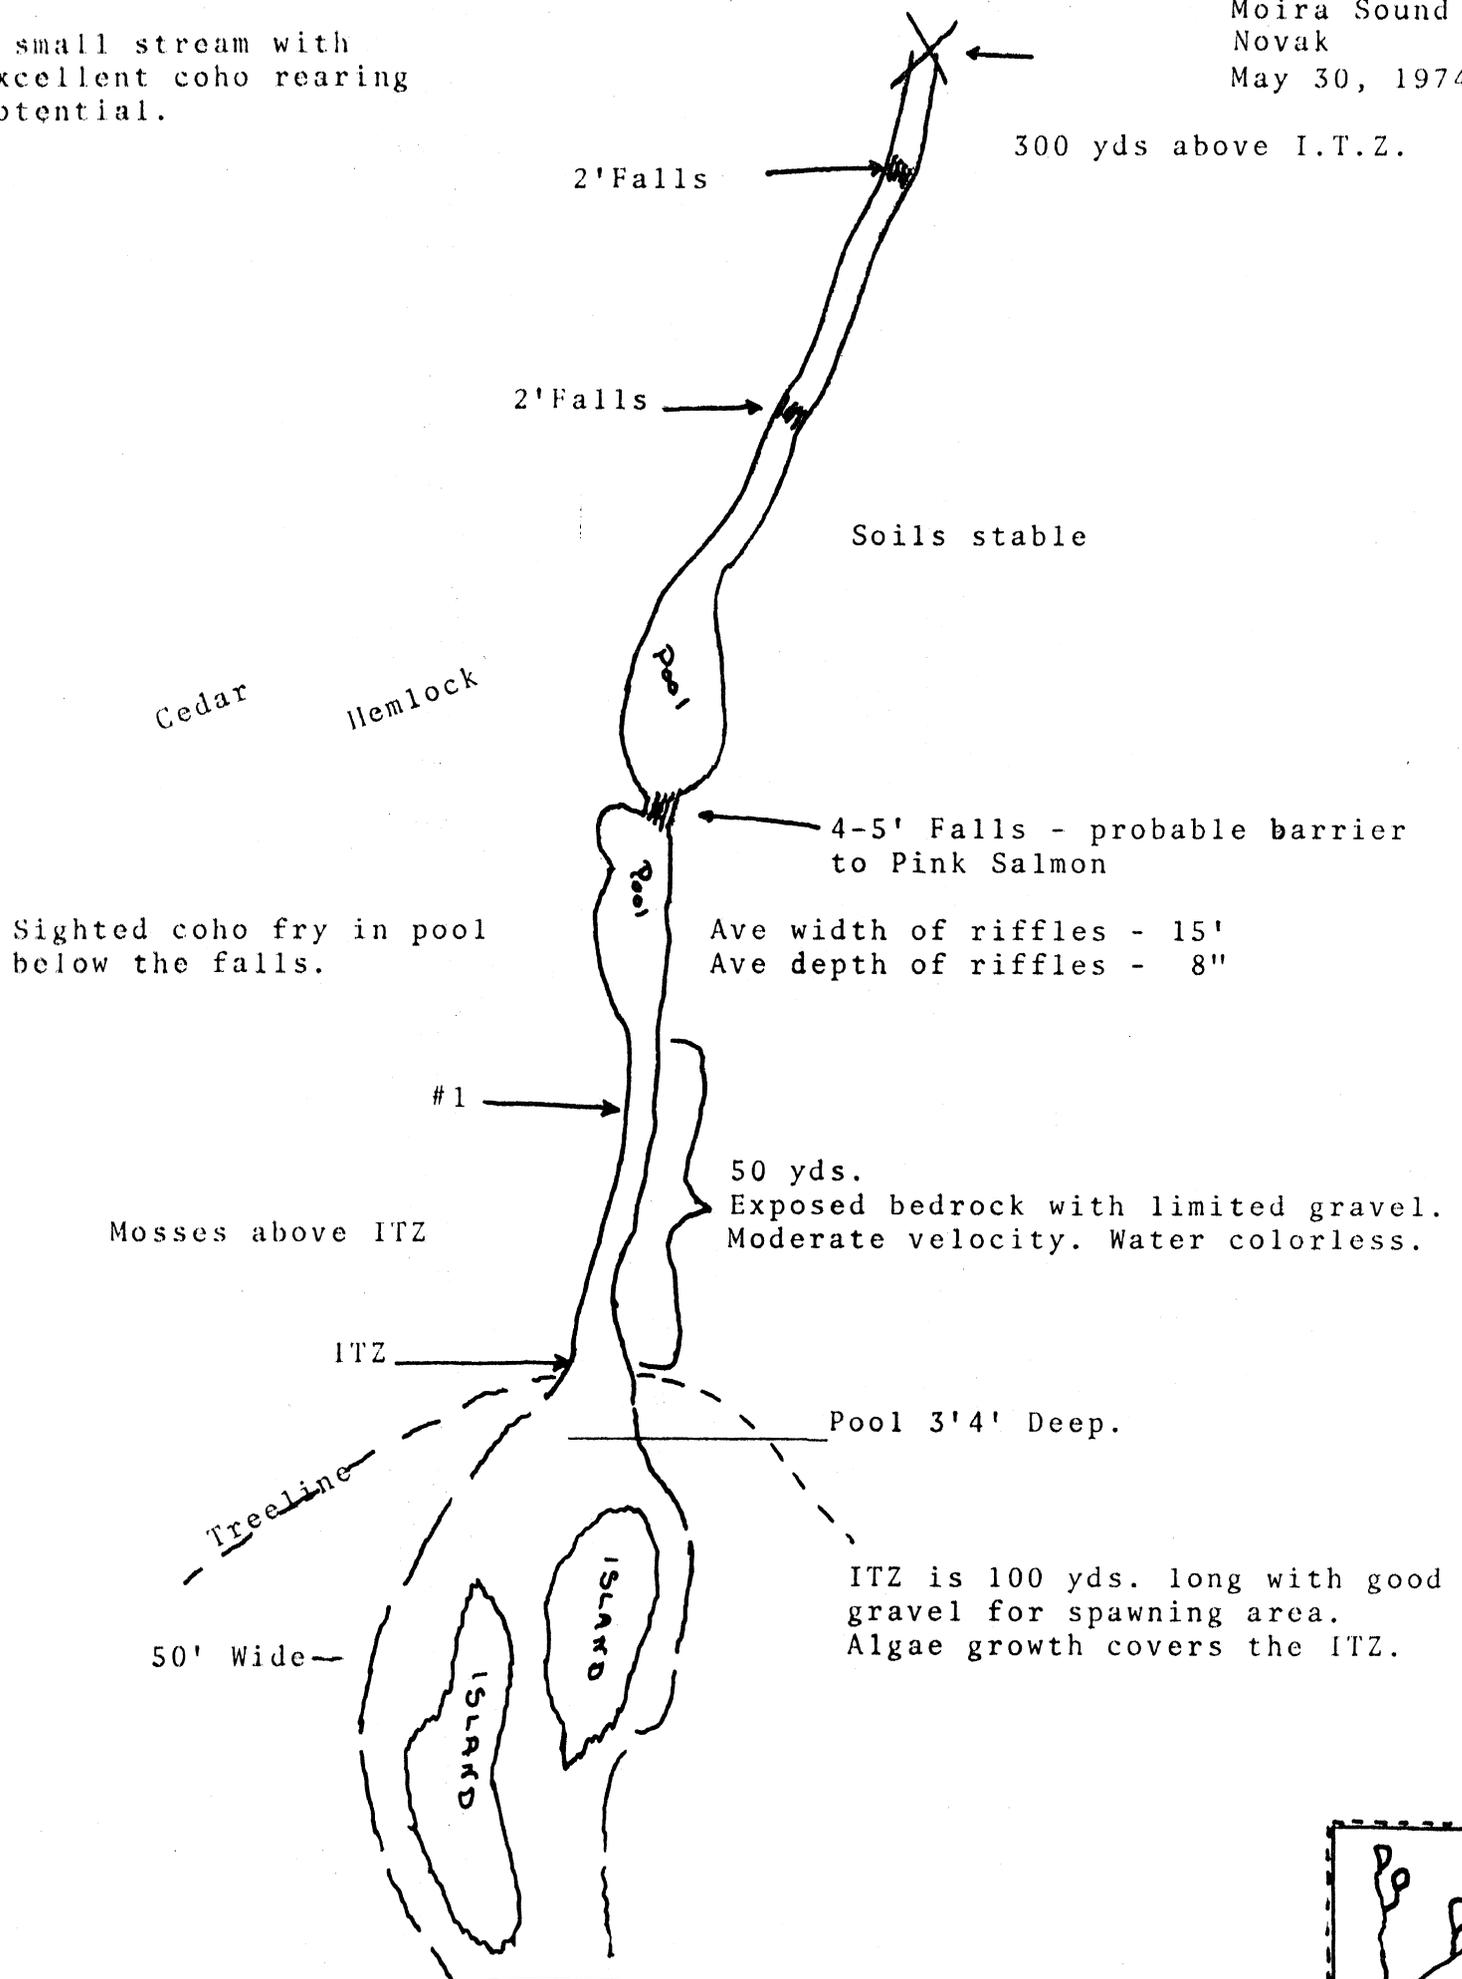
4-5' Falls - probable barrier to Pink Salmon

Sighted coho fry in pool below the falls.

Ave width of riffles - 15'  
Ave depth of riffles - 8"

50 yds.  
Exposed bedrock with limited gravel.  
Moderate velocity. Water colorless.

ITZ is 100 yds. long with good gravel for spawning area.  
Algae growth covers the ITZ.

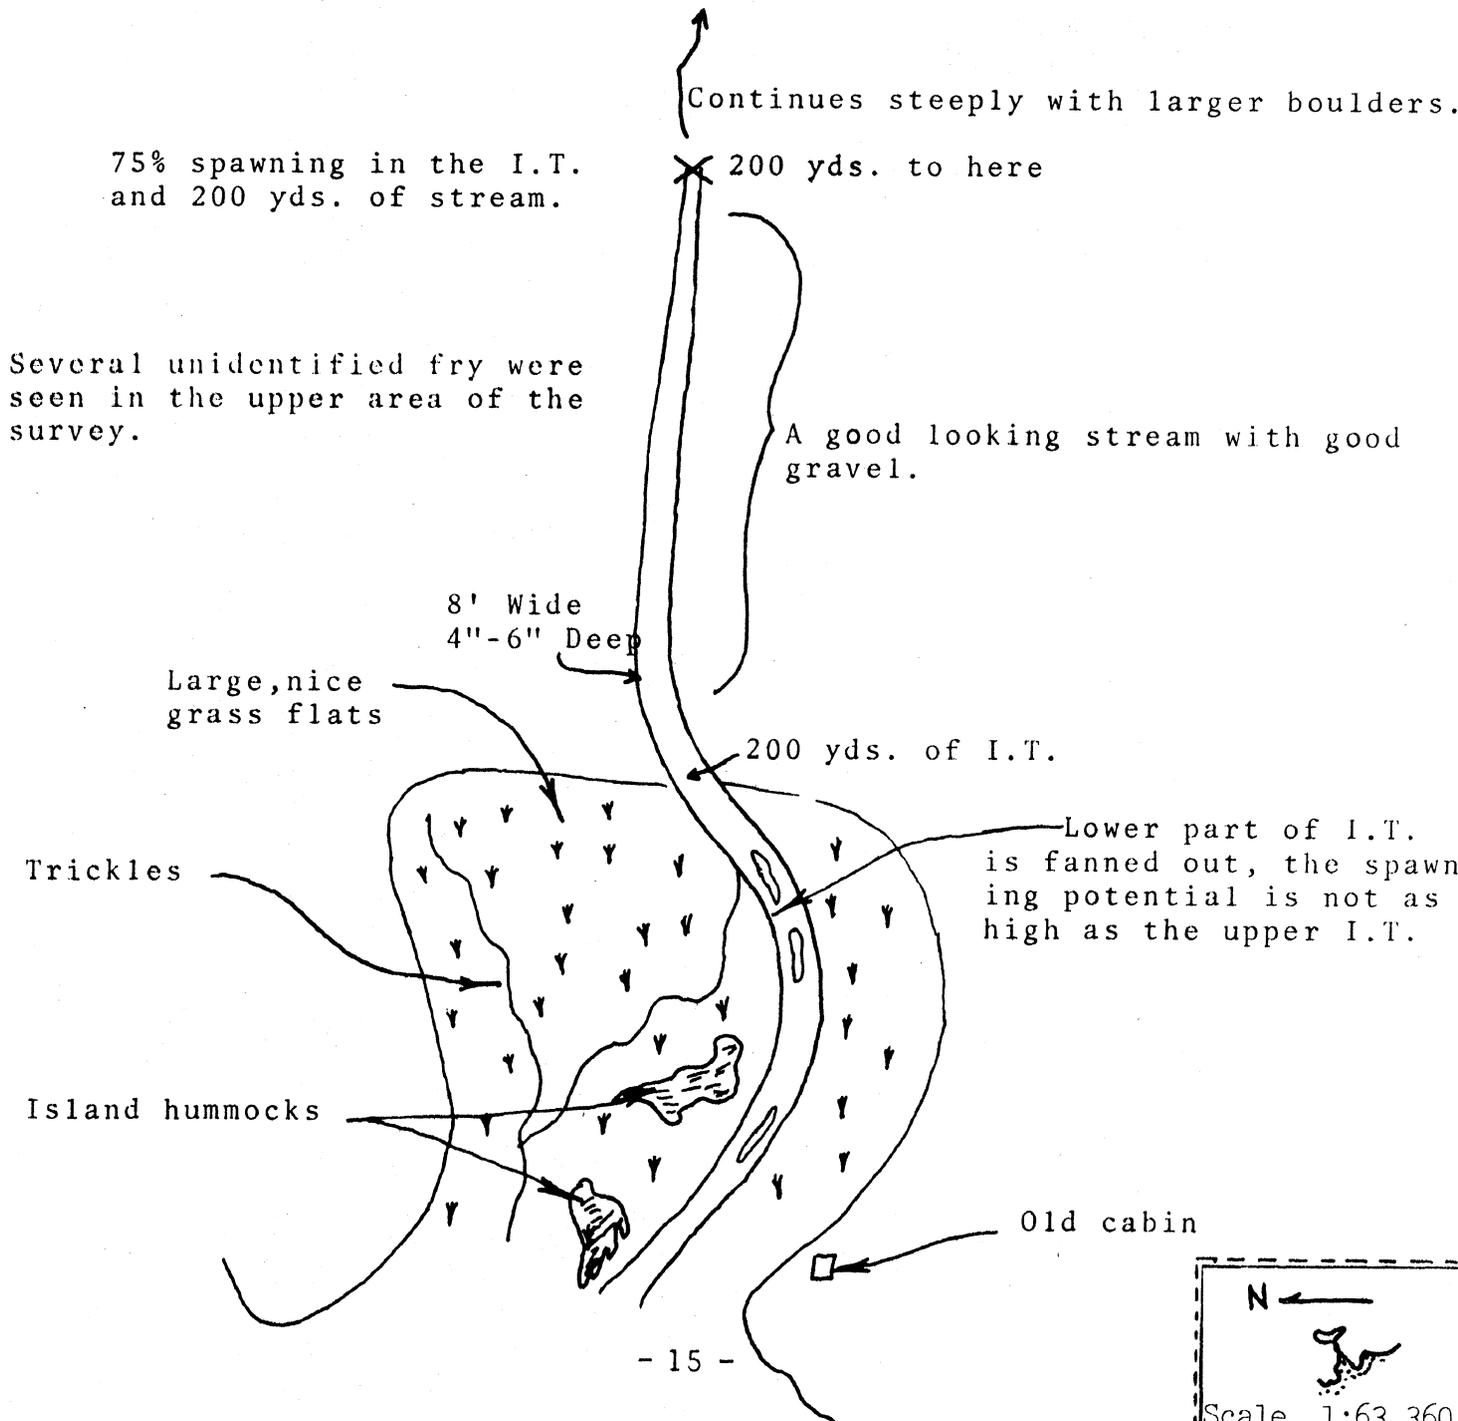
102-30-13  
Moira Sound  
E. side of Johnson Cove  
Downey  
May 30, 1974

75% spawning in the I.T. and 200 yds. of stream.

A good looking stream with good gravel.

8' Wide  
4"-6" Deep

Lower part of I.T. is fanned out, the spawning potential is not as high as the upper I.T.

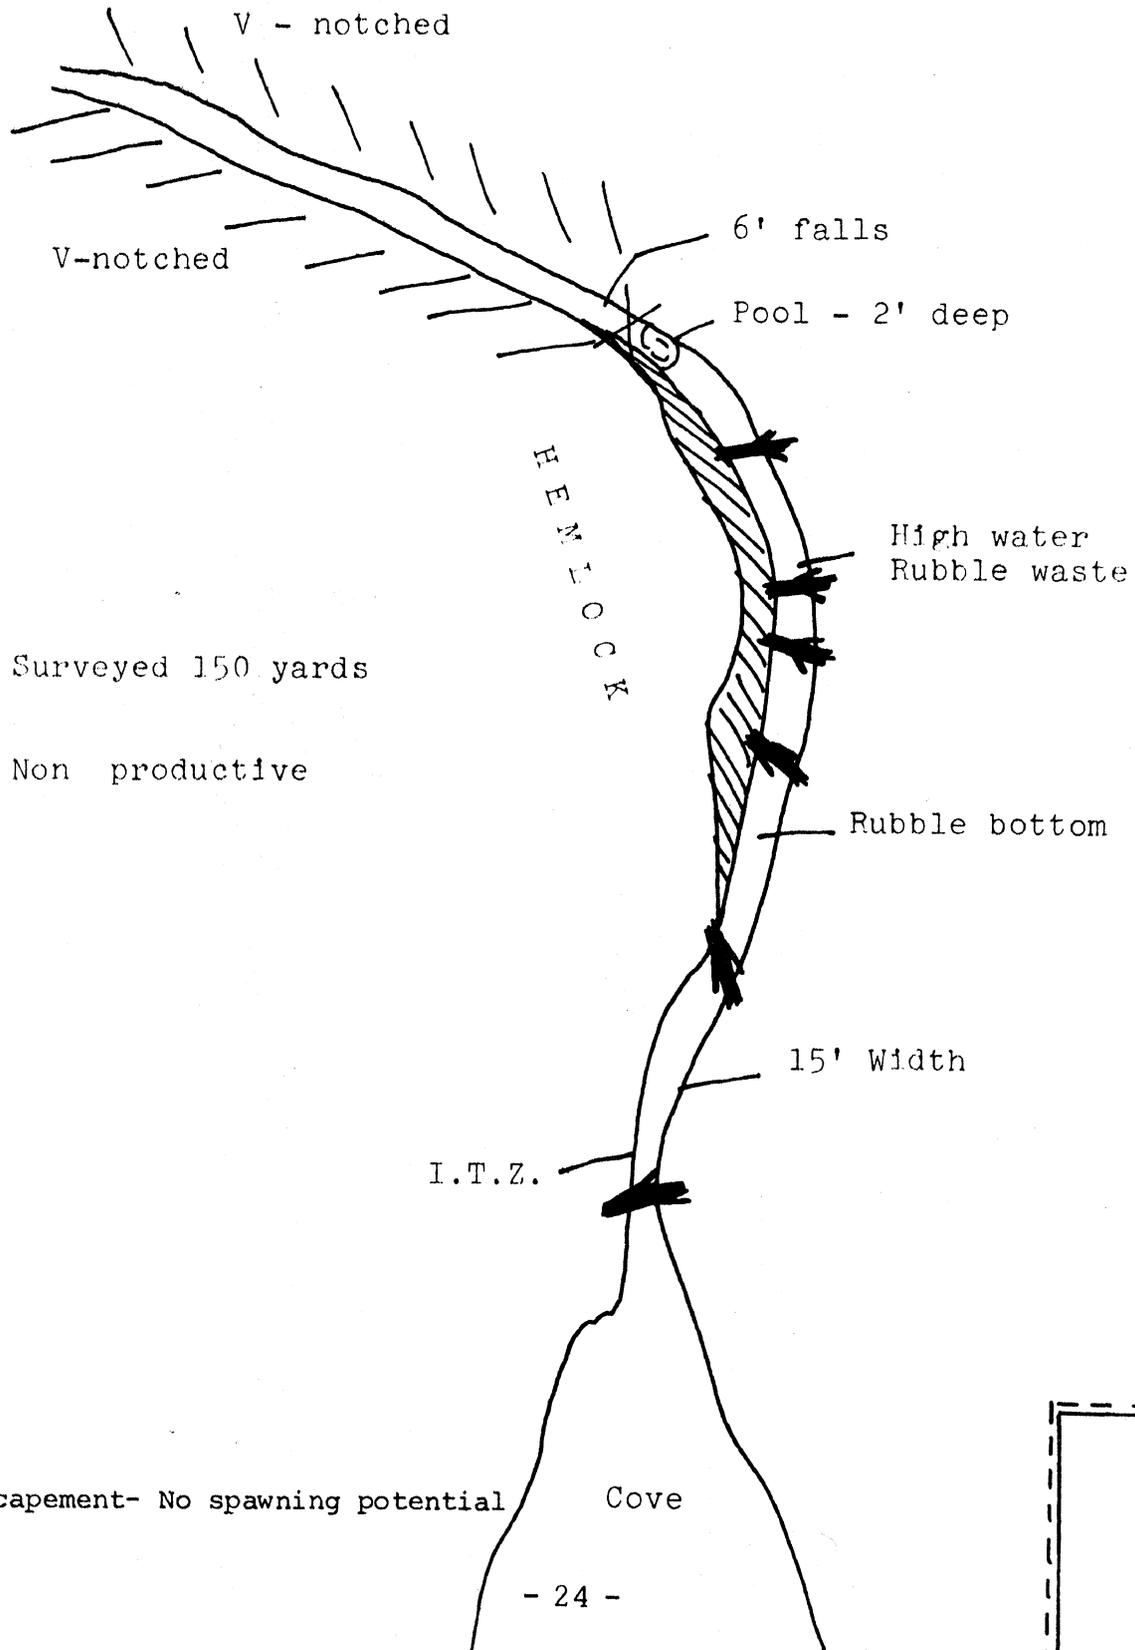
Moira Sound - South Arm  
102-30-24  
(#6 in notes)  
10-17-73  
Novak & Downey

Surveyed 150 yards

Non productive

Intermittent stream under normal flow conditions.

A small falls area above the I.T.Z. Blowdown and brush, very prevelant. No spawning riffle observed and termed this as a non-productive salmon stream.

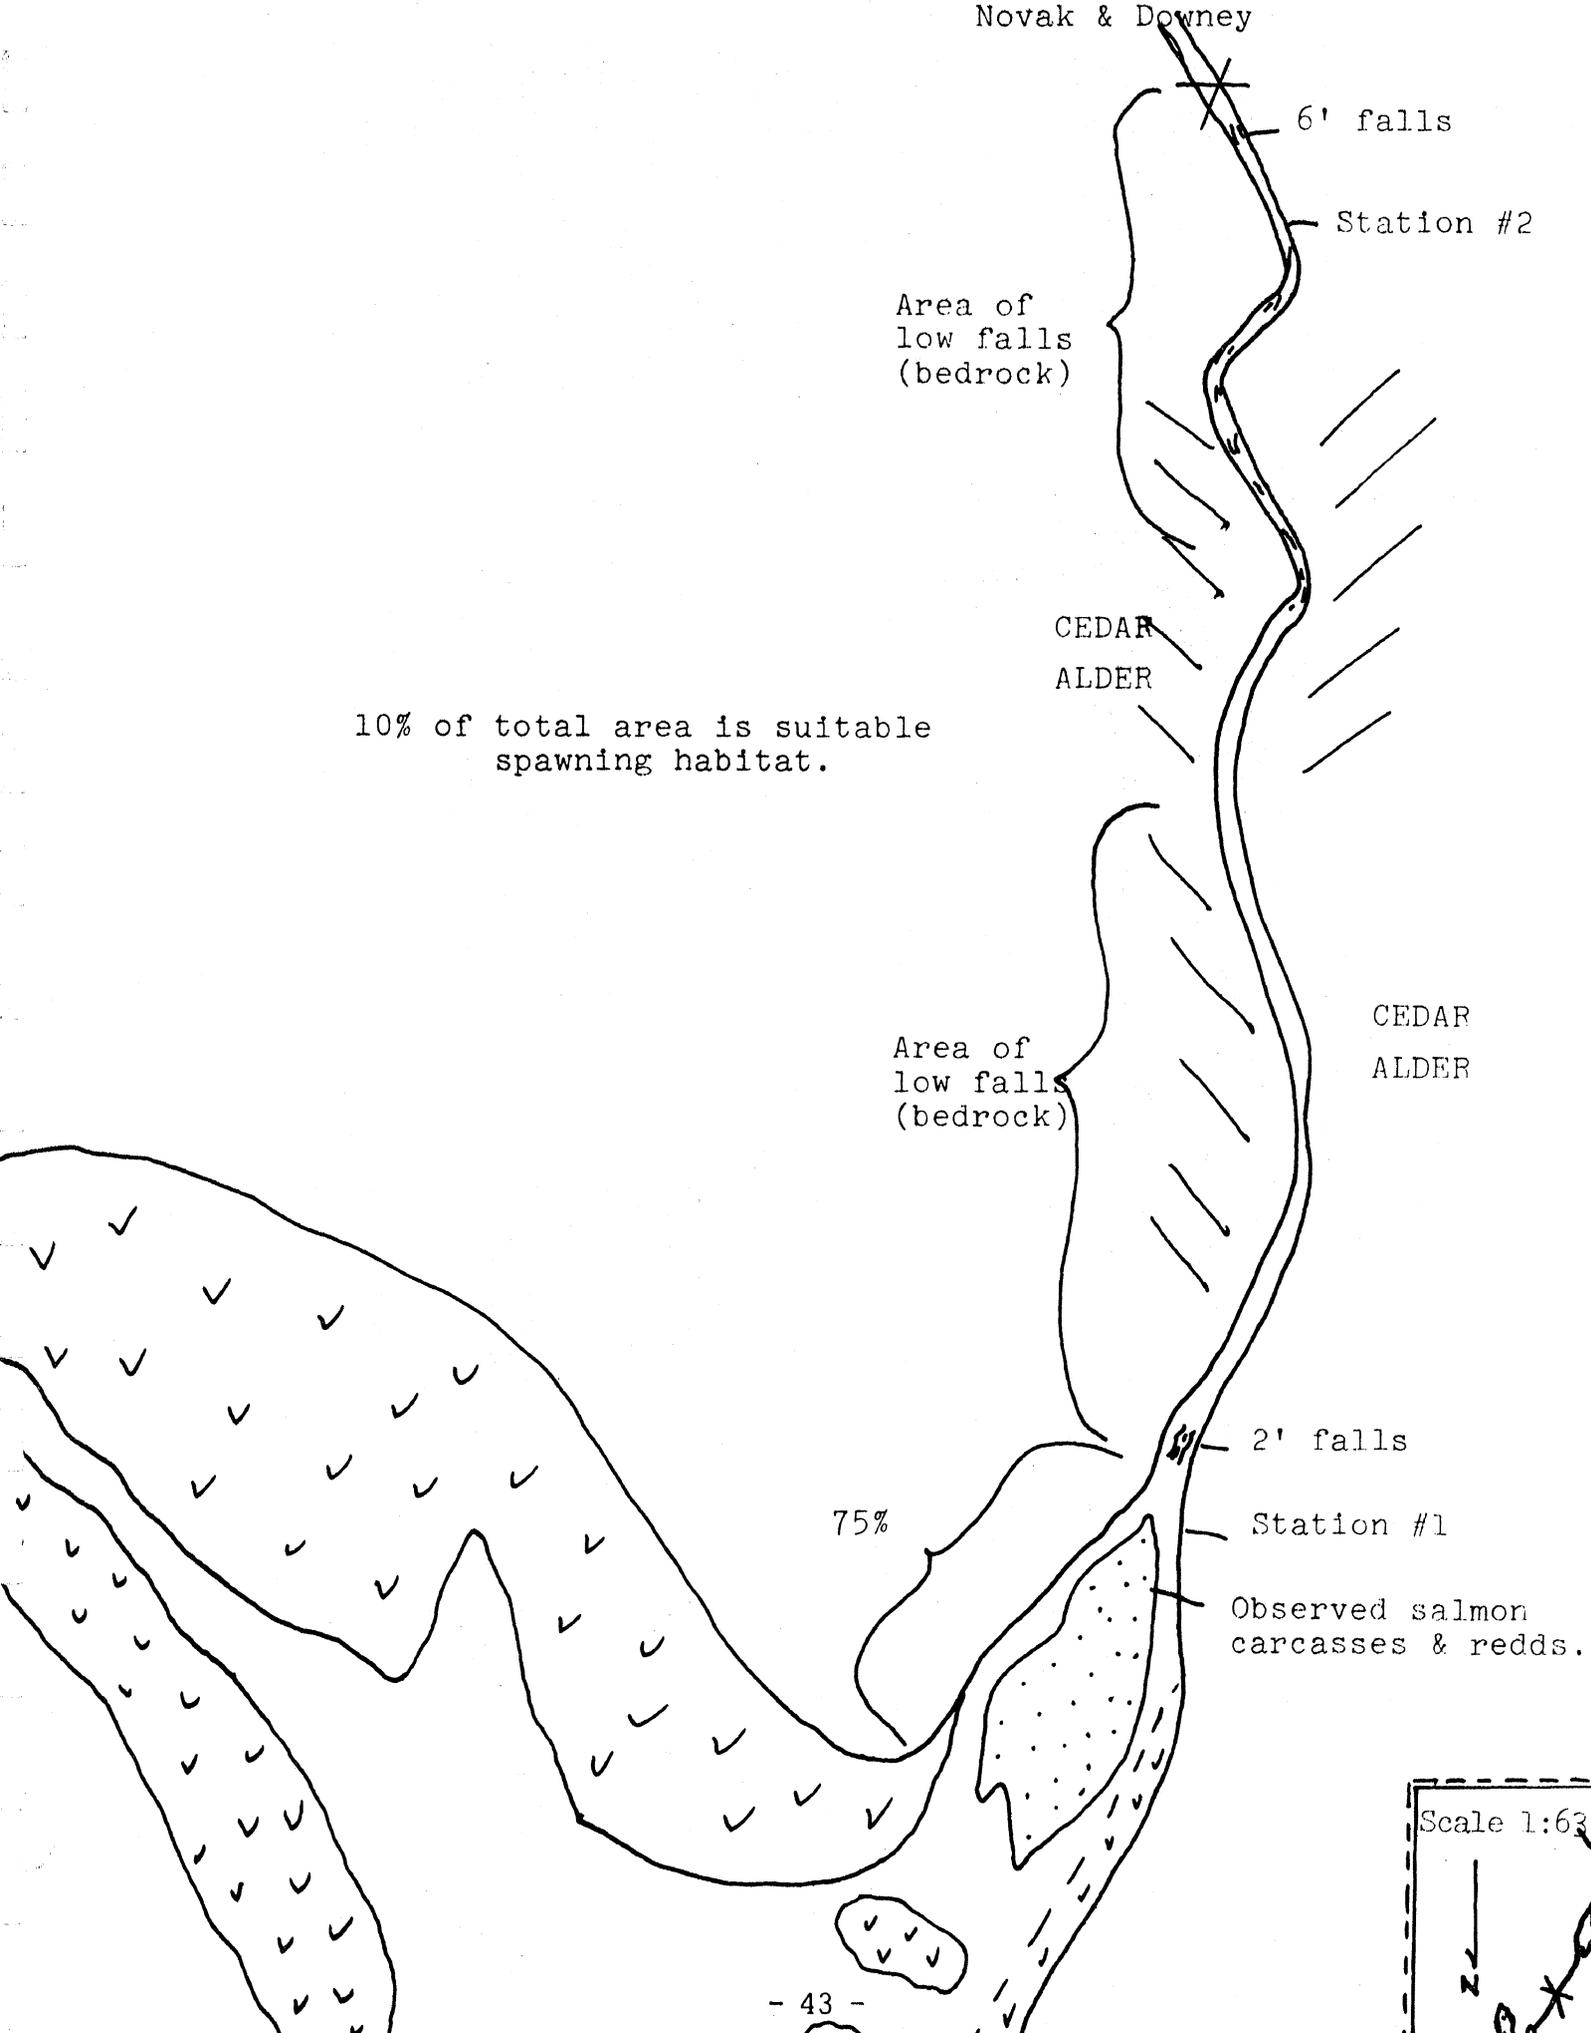
Area of low falls (bedrock)

10% of total area is suitable spawning habitat.

Observed salmon carcasses & redds.

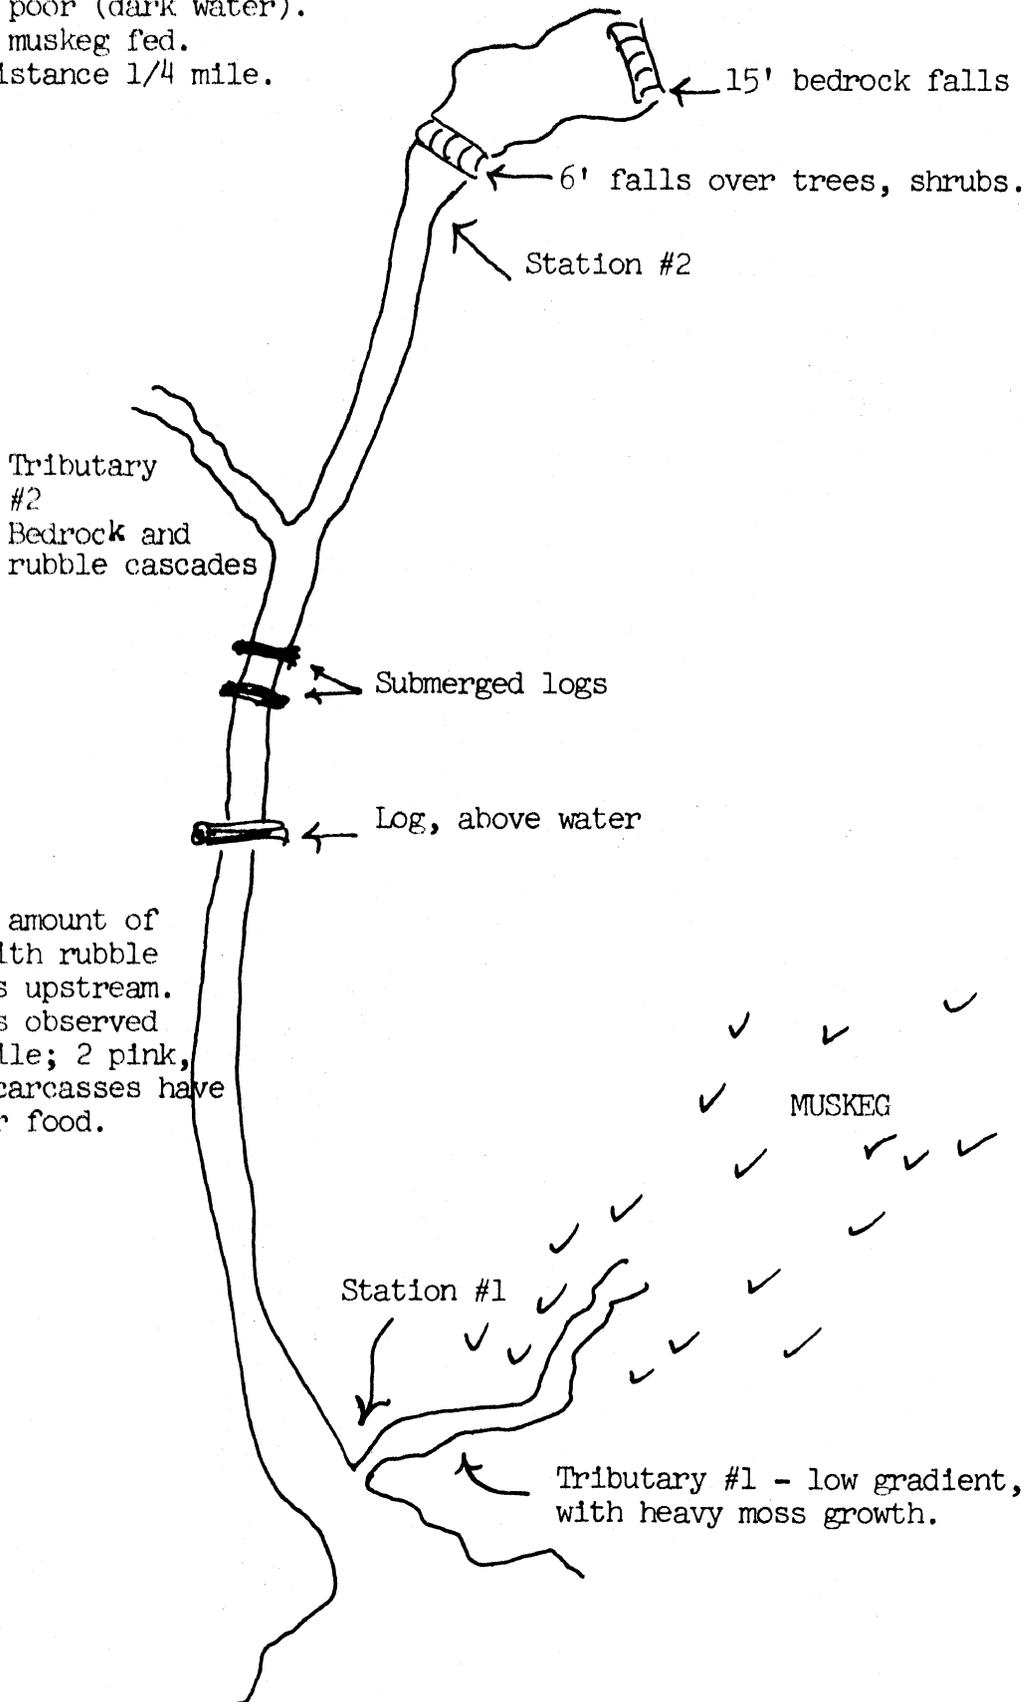
Water level up.  
velocity poor (dark water).  
Lake and muskeg fed.  
survey distance 1/4 mile.

Relative amount of  
gravel with rubble  
decreases upstream.  
300 chums observed  
in 1/4 mile; 2 pink,  
20 chum carcasses have  
made bear food.
